# **Construction Noise and Vibration Monthly Report – March 2022**

**Lichfield City Council**

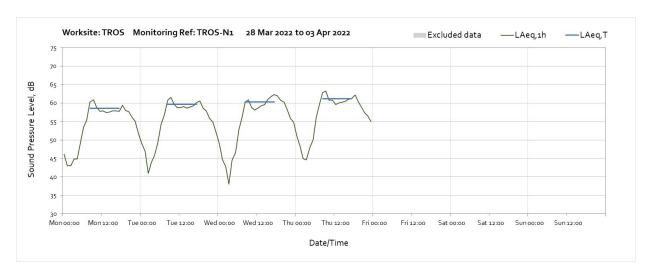
### Worksite:TROS - Monitoring Ref: TROS-N1

The following graphs show the hourly measured ambient noise level  $L_{Aeq,1h}$  and, where relevant, the averaged noise level  $L_{Aeq,T}$  values, where the time period T is as specified in Table 1 of HS2 Information Paper E23. Periods with adversely weather affected noise levels are greyed out and have been excluded from the calculation of the  $L_{Aeq,T}$  values in Table 3 of the main report.

Note: Missing data at 01:00 on Sunday 27<sup>th</sup> March 2021 was due to the clocks going forward at the start of British Summer Time

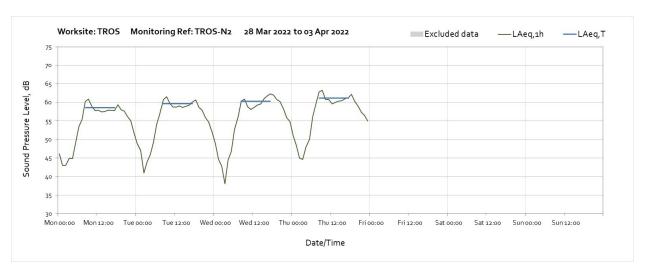
### **Worksite:TROS - Monitoring Ref: TROS-N2**

Note: Missing data at 01:00 on Sunday 27<sup>th</sup> March 2021 was due to the clocks going forward at the start of British Summer Time

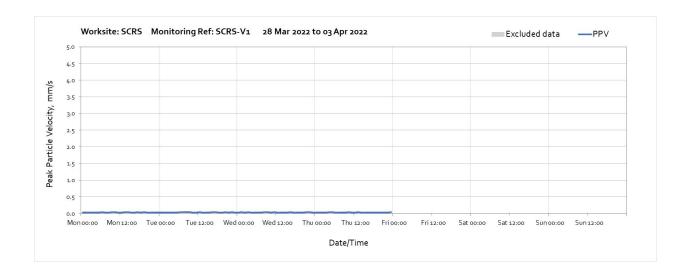
### **Worksite: SCRS - Monitoring Ref: SCRS-V1**

The following graphs show the hourly measured peak particle velocity PPV recorded during the monitoring period. The graphs show the resultant PPV due to vibration components on three orthogonal axis x, y and z. Where high values of PPV were caused by local interference with the vibration monitor, which are not representative of HS2 construction works, these values have been greyed out in the following charts and have been excluded to calculate values in Table 4 of the main report.

Note: Missing data at 01:00 on Sunday 27<sup>th</sup> March 2021 was due to the clocks going forward at the start of British Summer Time
