## Air Quality and Dust Monitoring Monthly Report – March 2022

London Borough of Hammersmith and  
Fulham

A report prepared by EWCs and MWCCs on behalf of HS2 Ltd.

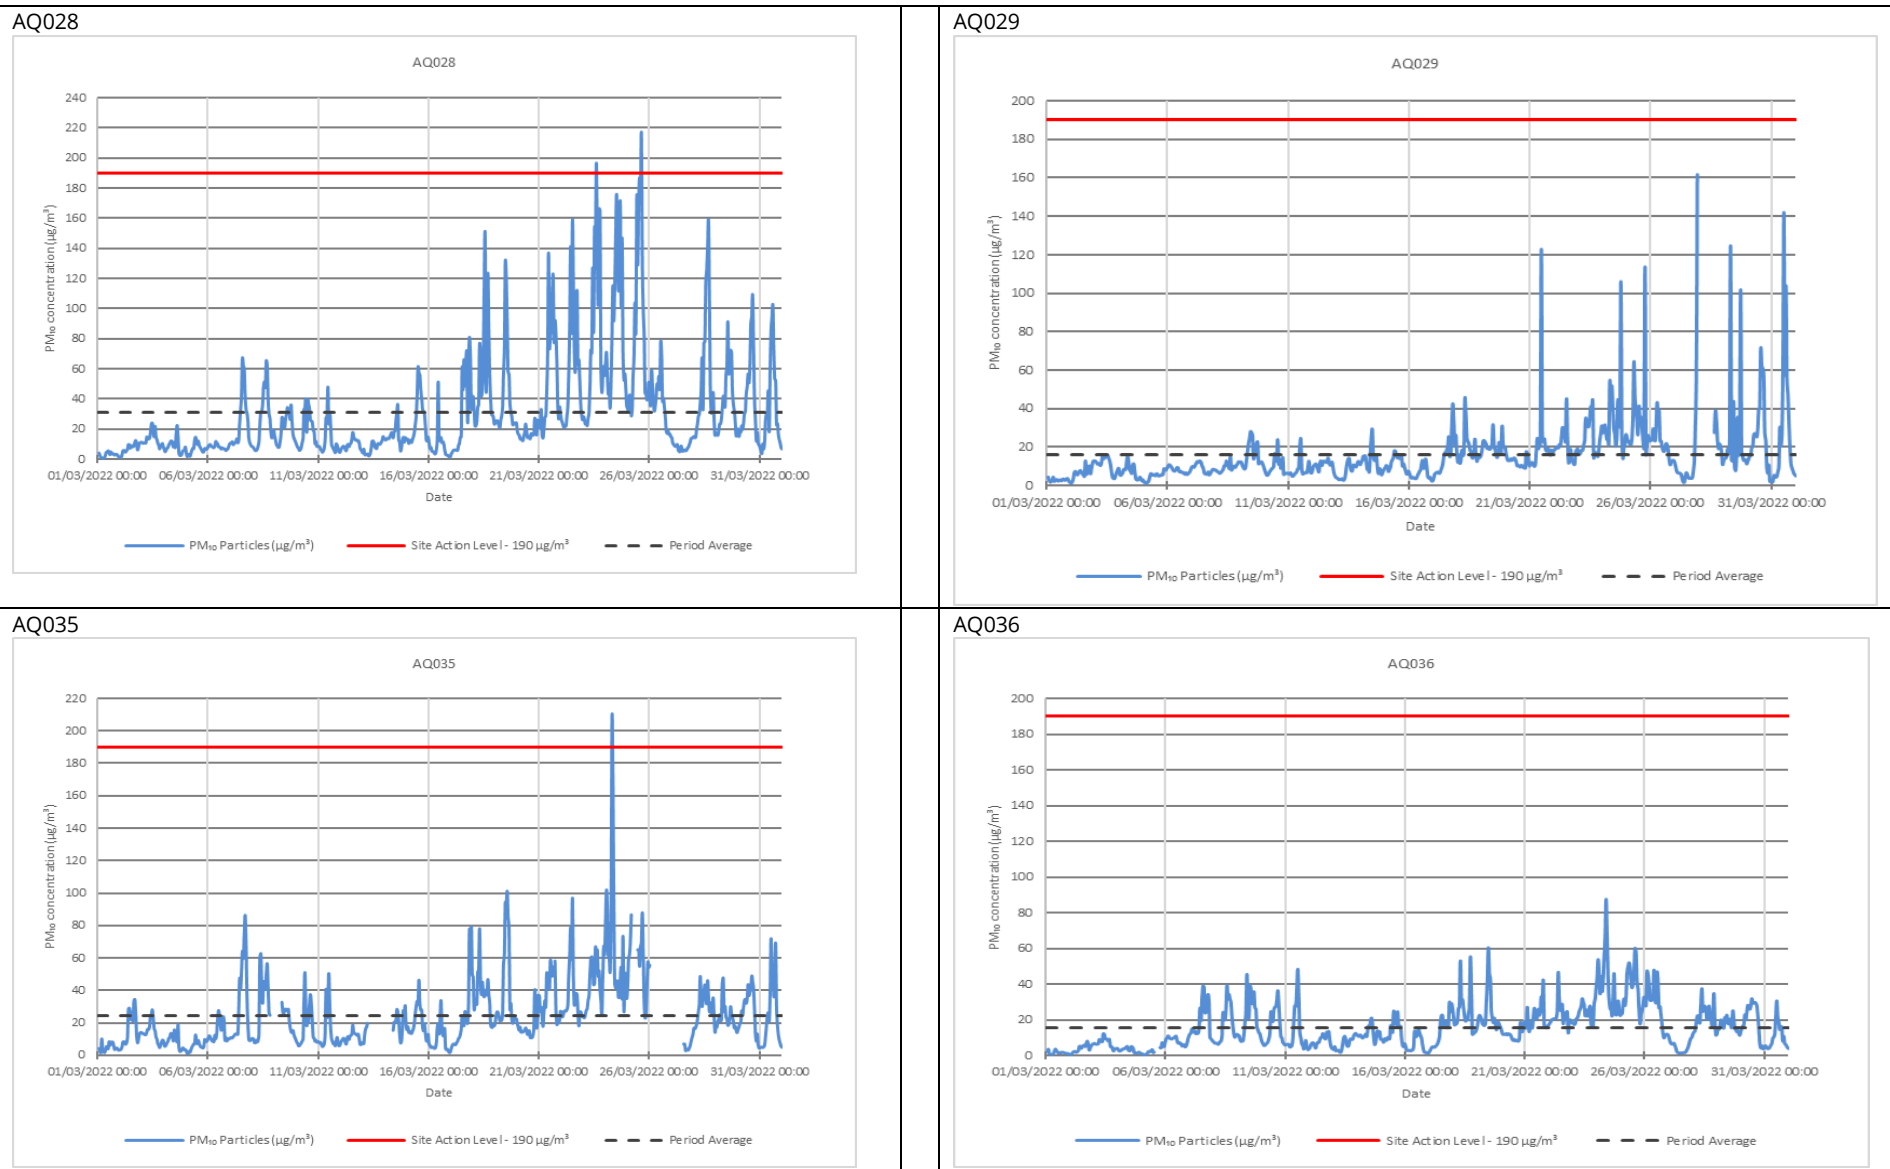
Figure 3: Construction dust 1-hour mean indicative PM<sub>10</sub> concentration for dust monitors

- 1.1.5 Four (4) dust monitors are installed around the worksite, where works are underway. The site returned a medium to high dust risk rating.
- 1.1.6 Dust monitoring locations and results are presented in Appendix B, Table 1, together with line charts of monthly data from each dust monitor in Figure 3. All continuous dust monitoring is undertaken using indicative monitors. Despite being Environment Agency (MCERTS) certified, indicative monitors carry a higher level of uncertainty than reference monitors, and therefore cannot be strictly compared with Air Quality Standards for human health and the environment. The purpose of the monitoring undertaken is to ensure the effectiveness of the on-site mitigation.

- 1.1.7 The trigger level for PM<sub>10</sub> concentrations of 190 µg/m<sup>3</sup>, over a 1-hour period, in accordance with the updated guidance document '*Guidance on Monitoring in the Vicinity of Demolition and Construction Sites – (October 2018)*' has been applied.

- 1.1.8 Dust trigger alerts were recorded during the monitoring period (March 2022) and are reported in Appendix B, Table 2.
- 1.1.9 Data capture was below 90% for monitor AQ035 in March 2022 due to power supply issues.

Monitoring site ID	Period exceeding trigger level	Investigation	Outcomes / Resolution / Remedial measures implemented
AQ035	24/03/2022 06:01 – 07:00; 207.6 µg/m³	No works were taking place at the time of the alert.	Site works begin at 8am.
AQ028	25/03/2022 14:01 – 15:00; 216.5 µg/m³	Fixing of rebar for propping beam. Prefabrication of rebar in West Box.  Waterproofing of capping beam. Excavation of London Clay for propping beam.	Any dust emitting activities e.g. concrete breaking, are wet down using jet wash bowser.  Dampening down of central route through West Box using jetter bowser.  This could have been caused by traffic backing up from the SCS temporary traffic lights at Victoria Road roundabout (see images below).
AQ028	23/03/2022 13:01 – 14:00; 196.6 µg/m³	Works were taking place to the East of the monitor at the time of the alert including digging, concrete breaking, crushing, and processing.	Supervisors have been reminded about the need for increased dust suppression during dry weather such as dampening down and water suppression on all potential dust generating activities. All equipment is switched off when not in use
