Air Quality and Dust Monitoring Monthly Report – April 2022 London Borough of Brent

A report prepared by EWCs and MWCCs on behalf of HS2 Ltd.

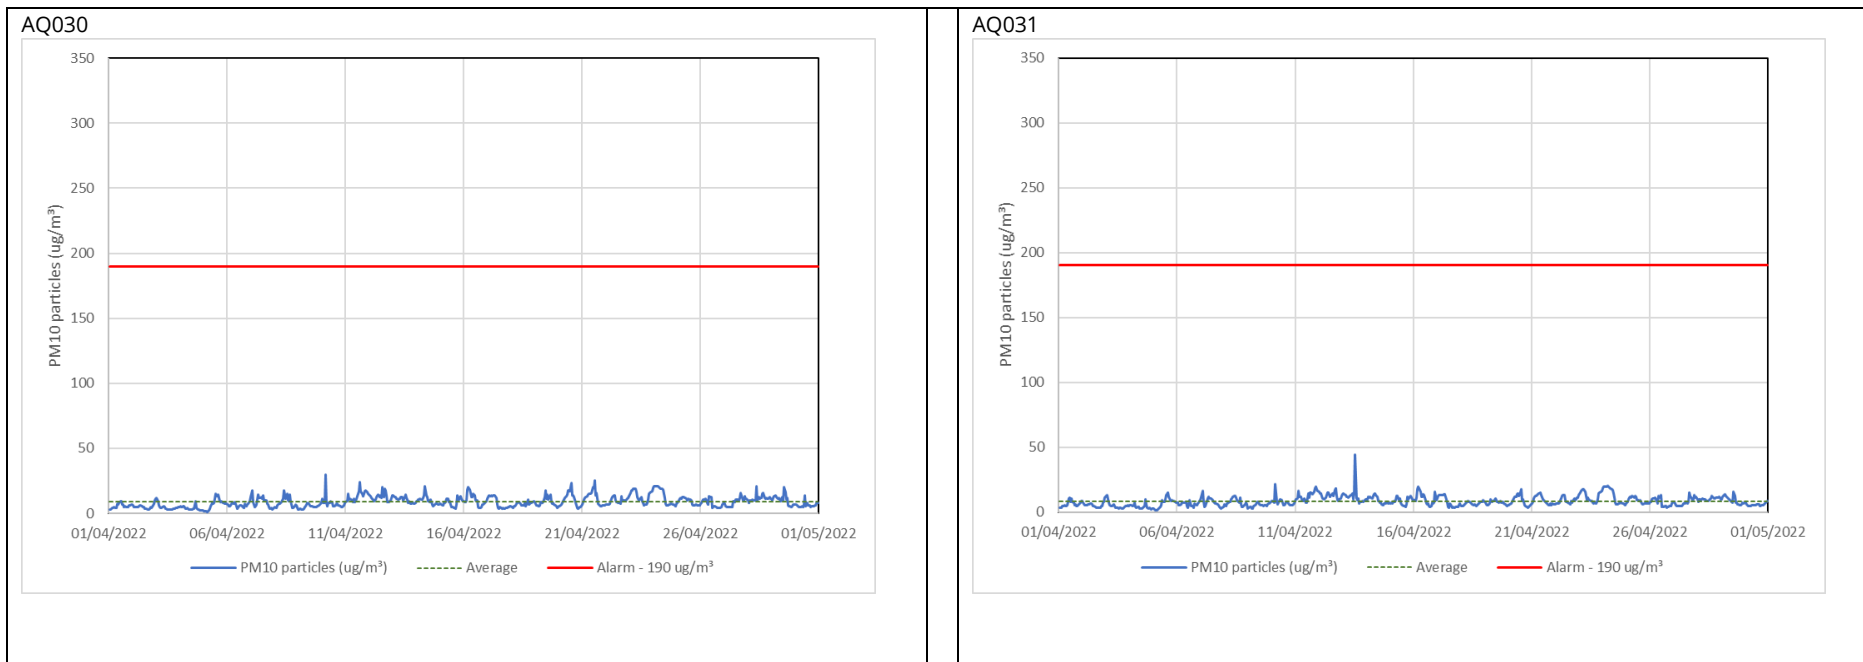
Figure 2: Construction dust 1-hour mean indicative PM₁₀ concentration for dust monitors

- 1.1.6 Dust monitoring location and results are presented in Appendix B, Table 1, together with line charts of monthly data from the dust monitor, in Figure 2. The continuous dust monitoring is undertaken using indicative monitors. Despite being Environment Agency (MCERTS) certified, indicative monitors carry a higher level of uncertainty than reference monitors, and therefore cannot be strictly compared with Air Quality Standards for human health and the environment. The purpose of the monitoring undertaken is to ensure the effectiveness of the on-site mitigation.

- 1.1.7 The trigger level for PM₁₀ concentrations of 190 µg/m³, over a 1-hour period, in accordance with the updated guidance document '*Guidance on Monitoring in the Vicinity of Demolition and Construction Sites – (October 2018)*' has been applied.

- 1.1.8 No (0) dust trigger alerts were recorded during the monitoring period (April 2022).
