Construction Noise and Vibration Monthly Report – April 2022

West Northamptonshire District Council

Non-Technical Summary

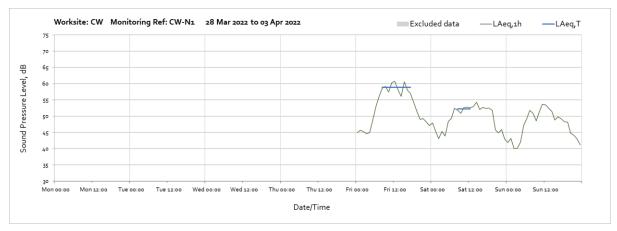
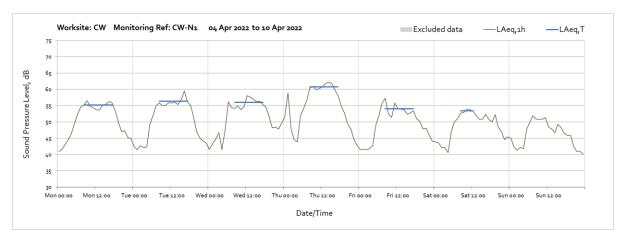
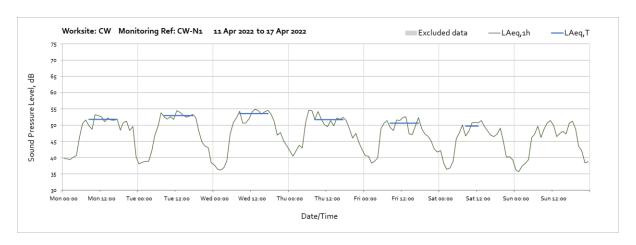
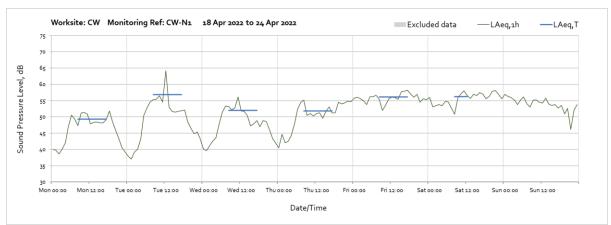
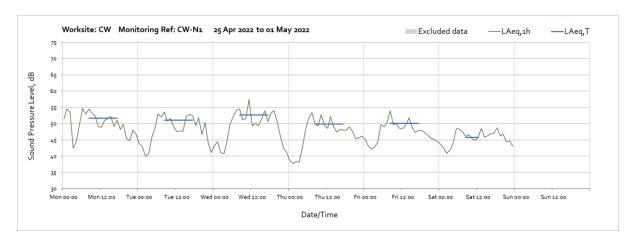
Worksite: CW - Monitoring Ref: CW-N1

The following graphs show the hourly measured ambient noise level $L_{Aeq,1h}$ and, where relevant, the averaged noise level $L_{Aeq,T}$ values, where the time period T is as specified in Table 1 of HS2 Information Paper E23. Periods with adversely weather affected noise levels are greyed out and have been excluded from the calculation of the $L_{Aeq,T}$ values in Table 3 of the main report.

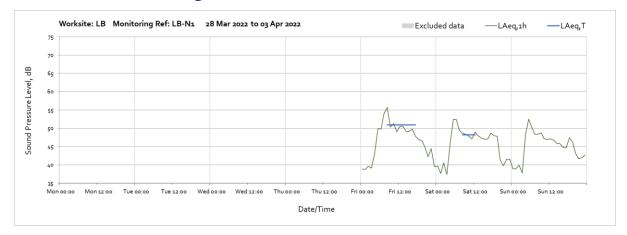
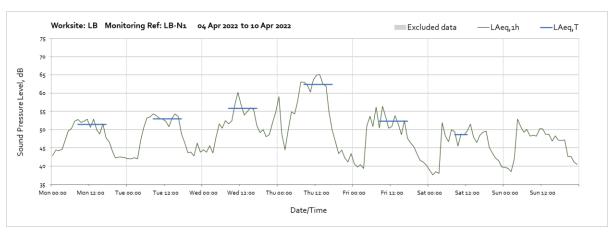
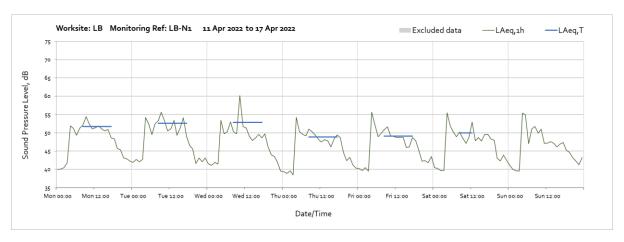
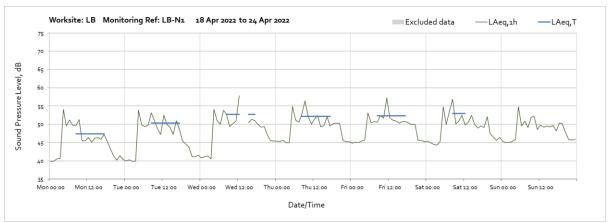
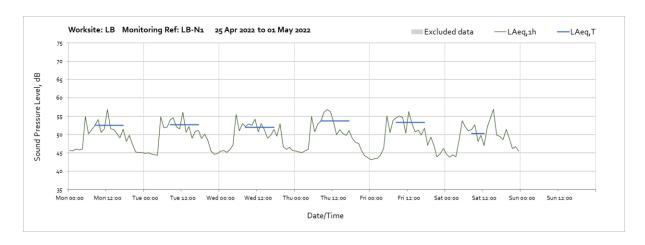
Worksite: LB - Monitoring Ref: LB-N1

Note: Missing data between 13:00 and 15:00 on 20^{th} April was due to disconnection of noise monitor from the server.

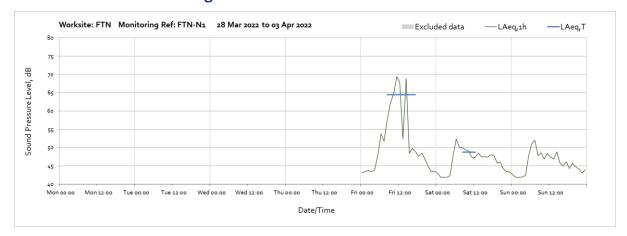
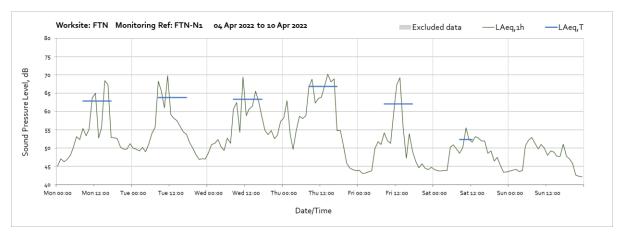
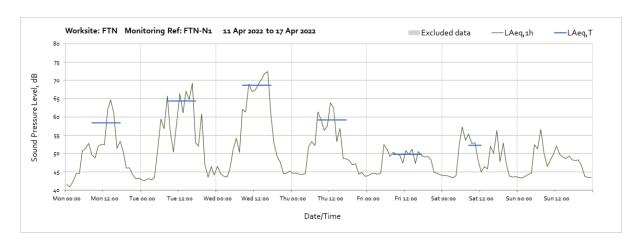
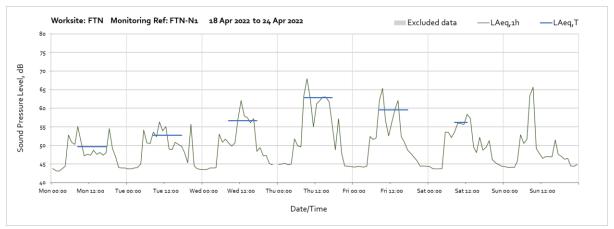
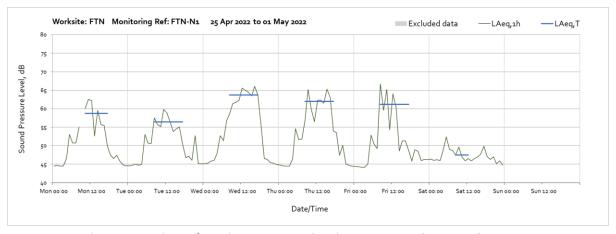
Worksite: FTN - Monitoring Ref: FTN-N1

Note: Missing data on Wednesday 20th April at 23:00 was due disconnection of monitor from server.

Note: Missing data on Monday 25th April at 09:00 was due disconnection of monitor from server.

- 2.2.6 Two exceedances of the LOAEL during the weekday daytime period were recorded at monitoring location ref.: FTN-N1 during April 2022.
- 2.2.7 No exceedances of the SOAEL were recorded due to HS2 construction works at any of the monitoring locations during April 2022.

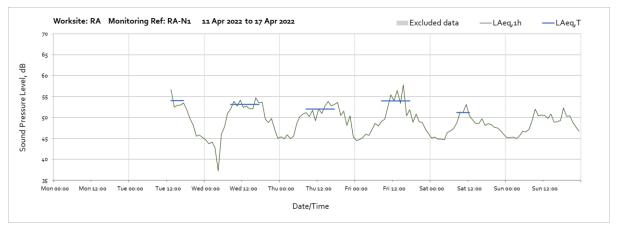
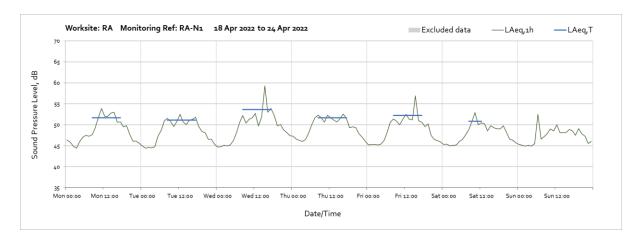
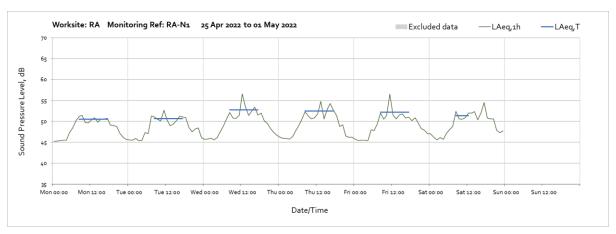
Worksite: RA - Monitoring Ref: RA-N1

Note: The monitor was installed on Tuesday 12th May at 13:00.
