Construction noise and vibration Monthly Report – May 2022

London Borough of Hillingdon

Non-Technical Summary

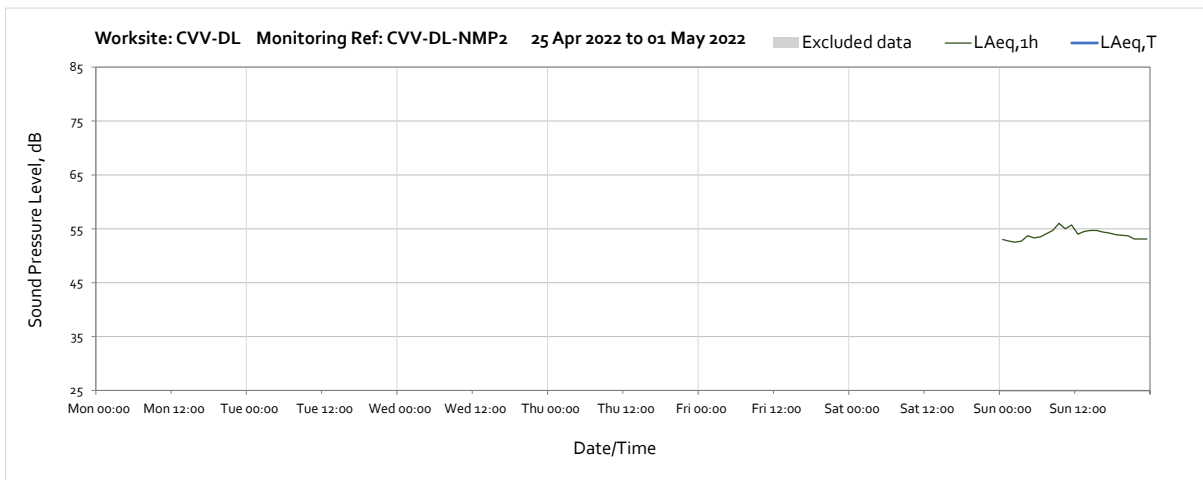
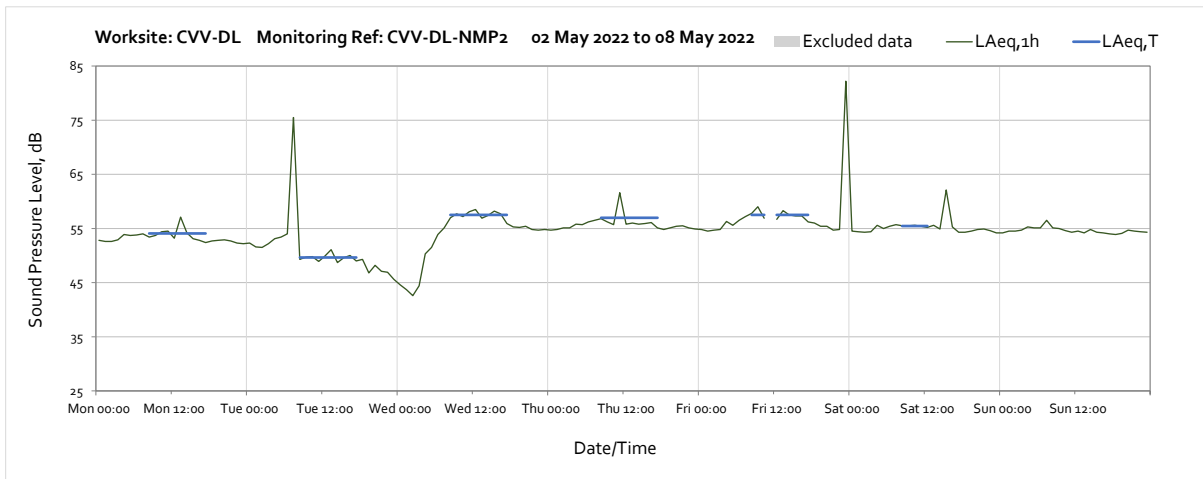
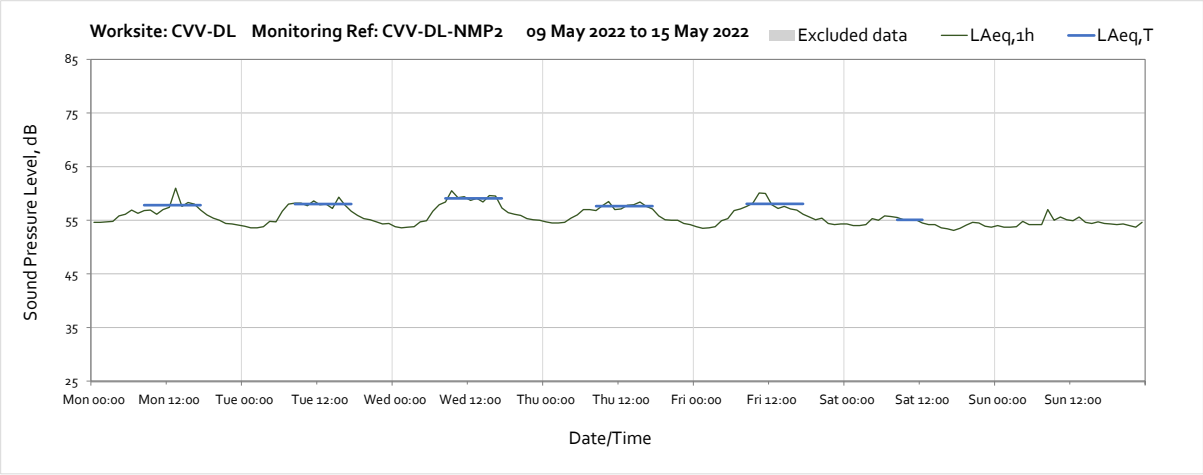
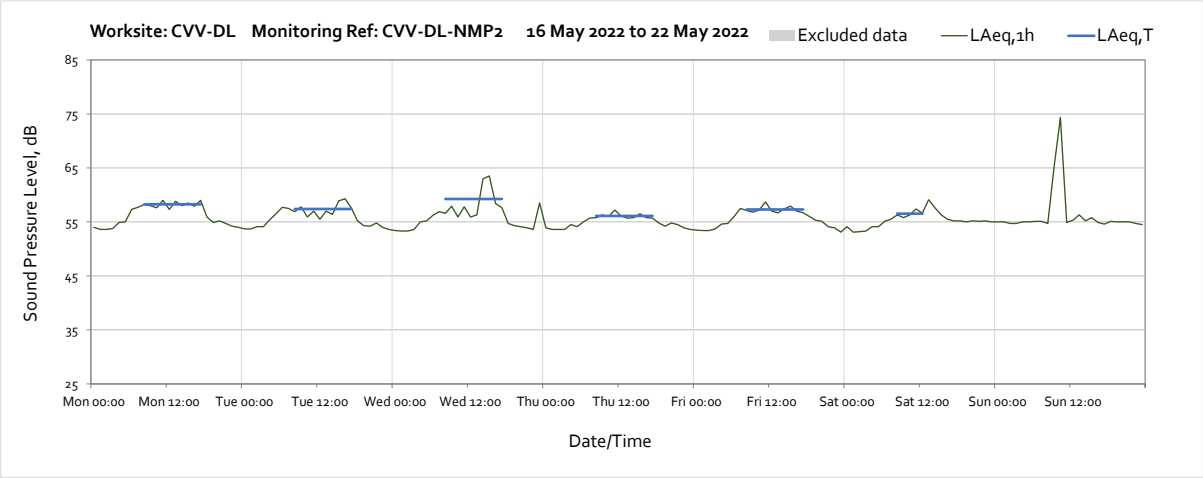
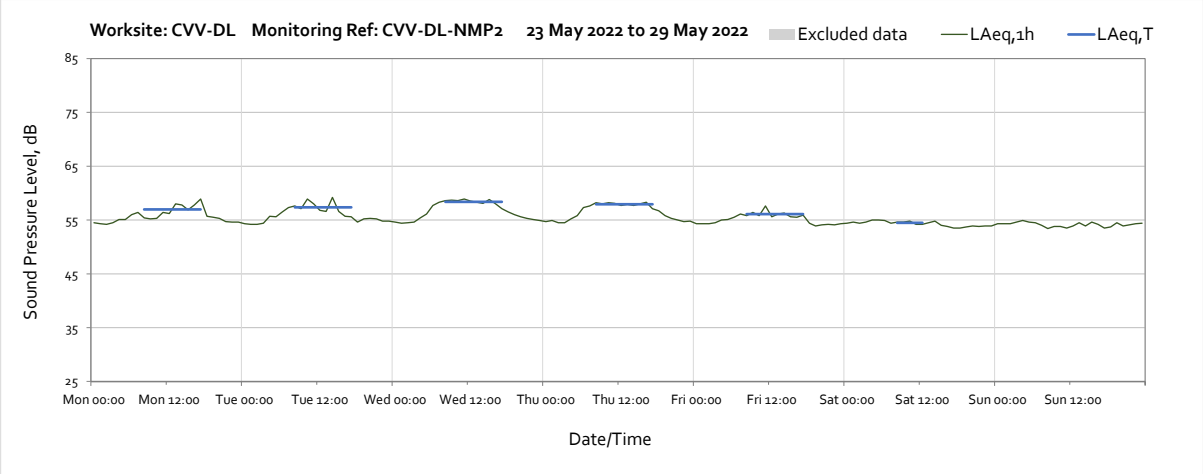
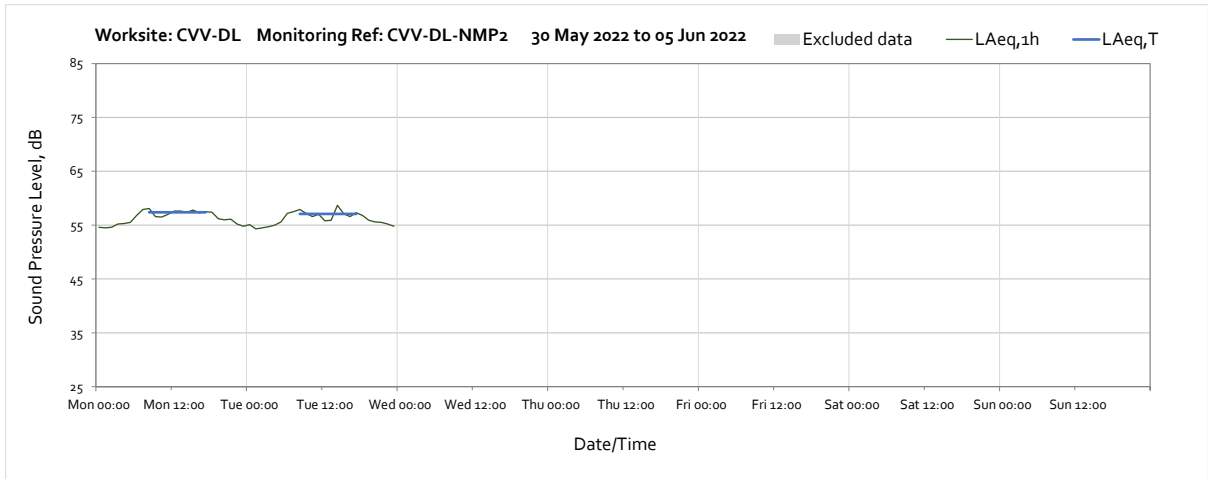
Monitoring Ref: CVV-DL-NMP2

Worksite: Colne Valley Viaduct Dews Lane (CVV-DL)

Note: Missing data at 11:00 on Friday 6th May 2022 were due to field calibration.

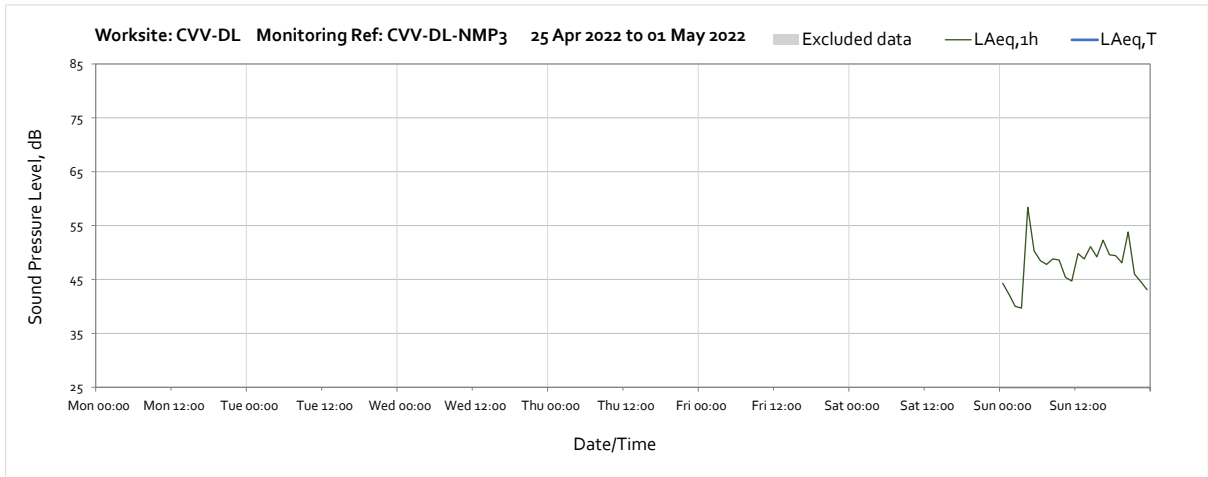
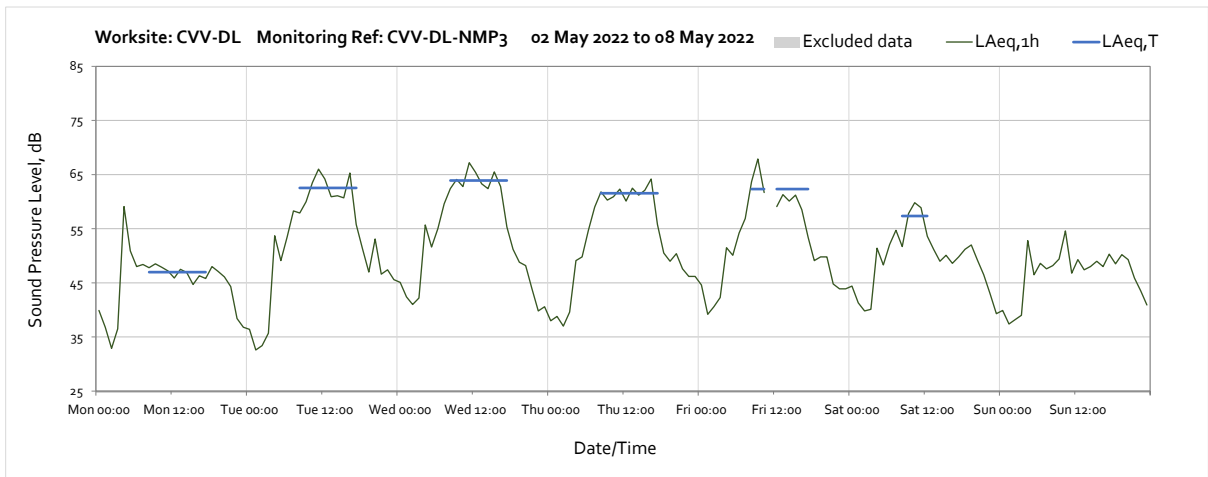
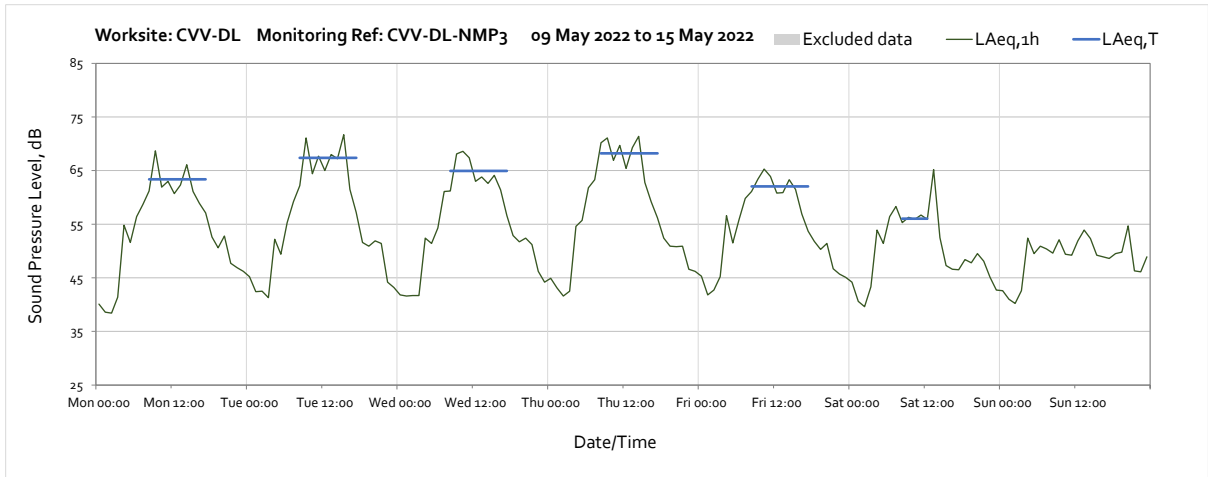
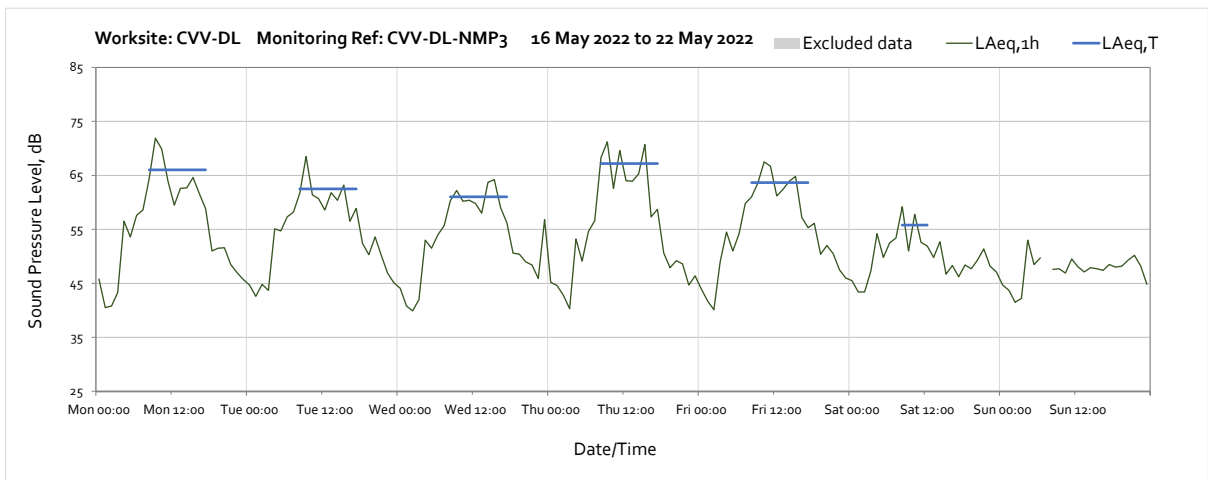
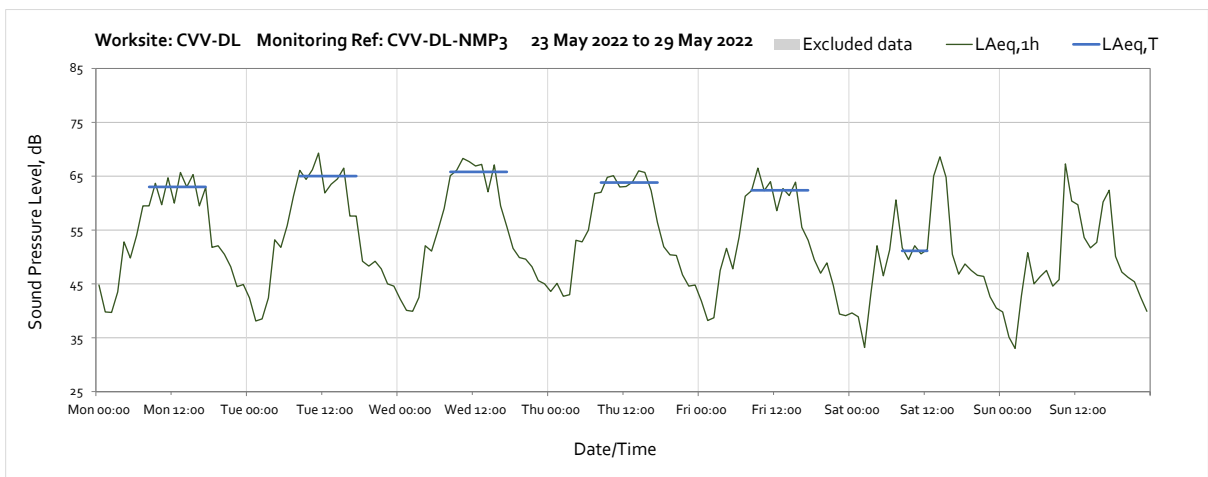
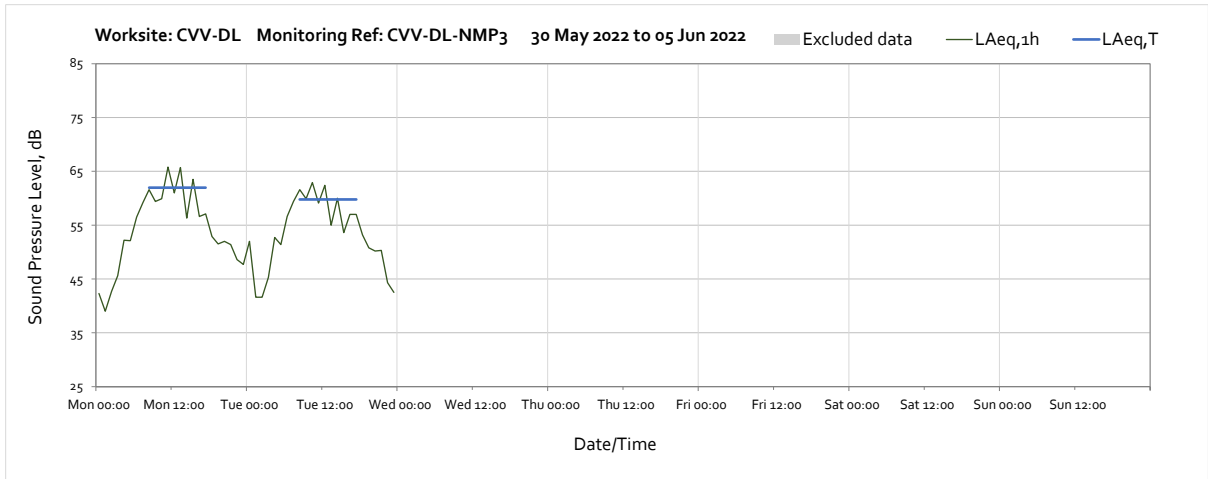
Monitoring Ref: CVV-DL-NMP3

Worksite: Colne Valley Viaduct Dews Lane (CVV-DL)

Note: Missing data at 11:00 on Friday 6th May 2022 were due to field calibration.

Note: Missing data at 07:00 on Sunday 22nd May 2022 were due to monitor settings update.

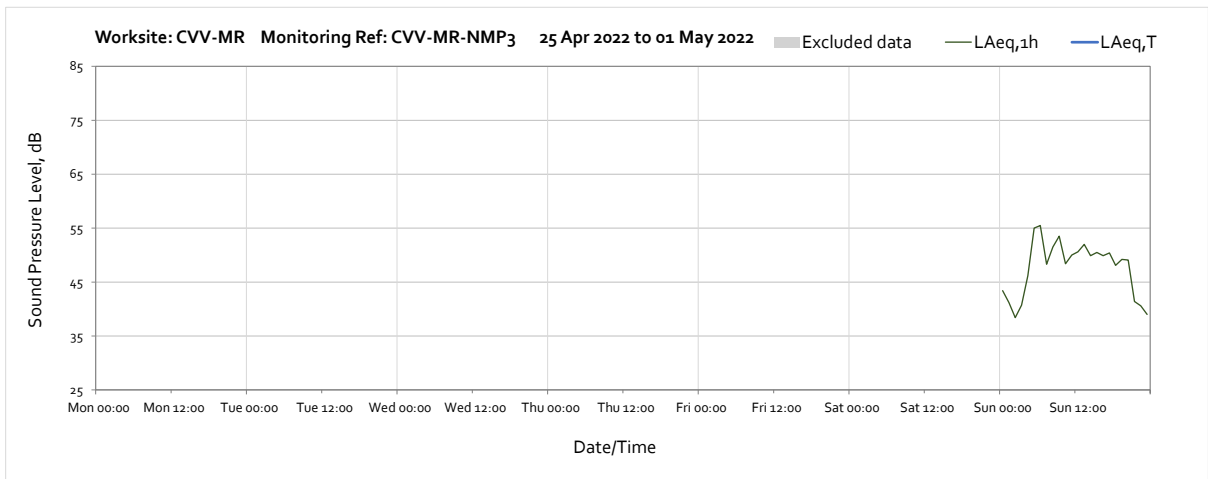
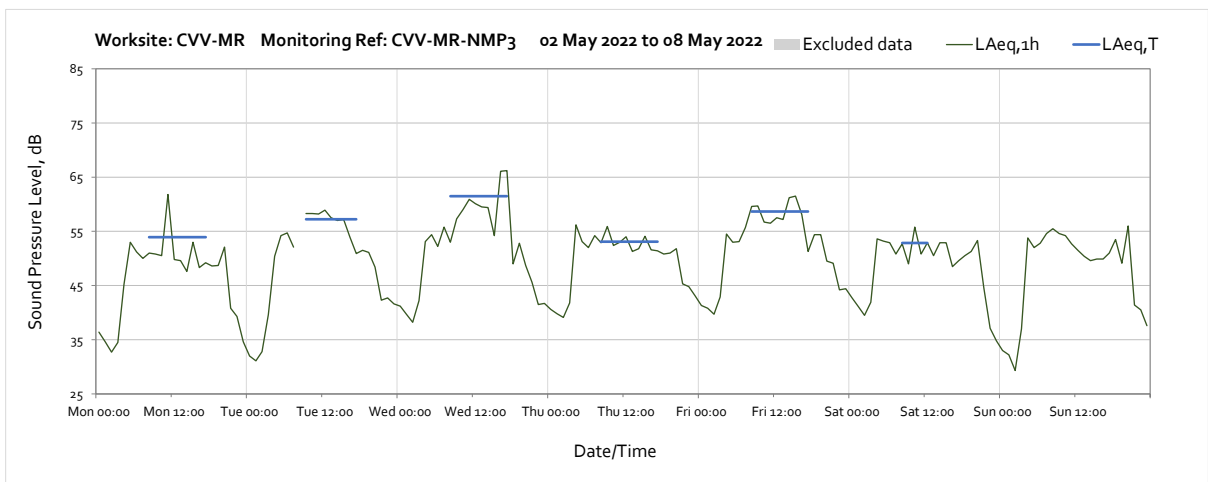
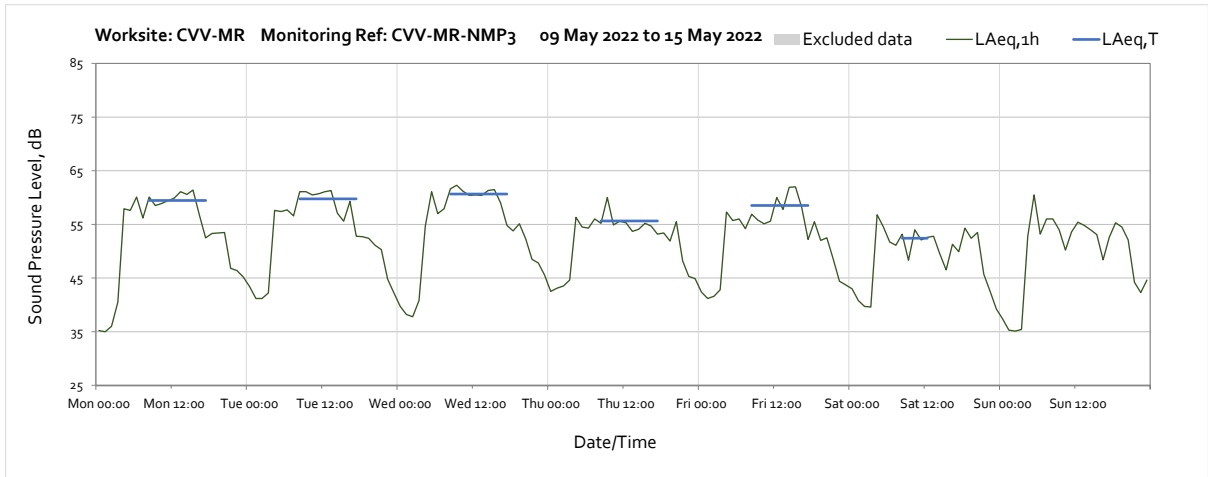
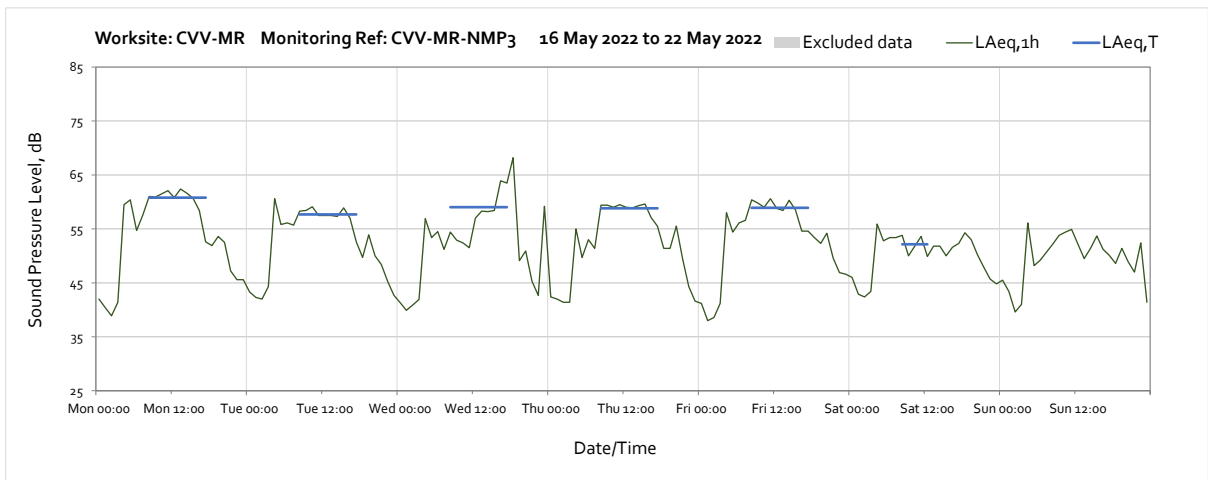
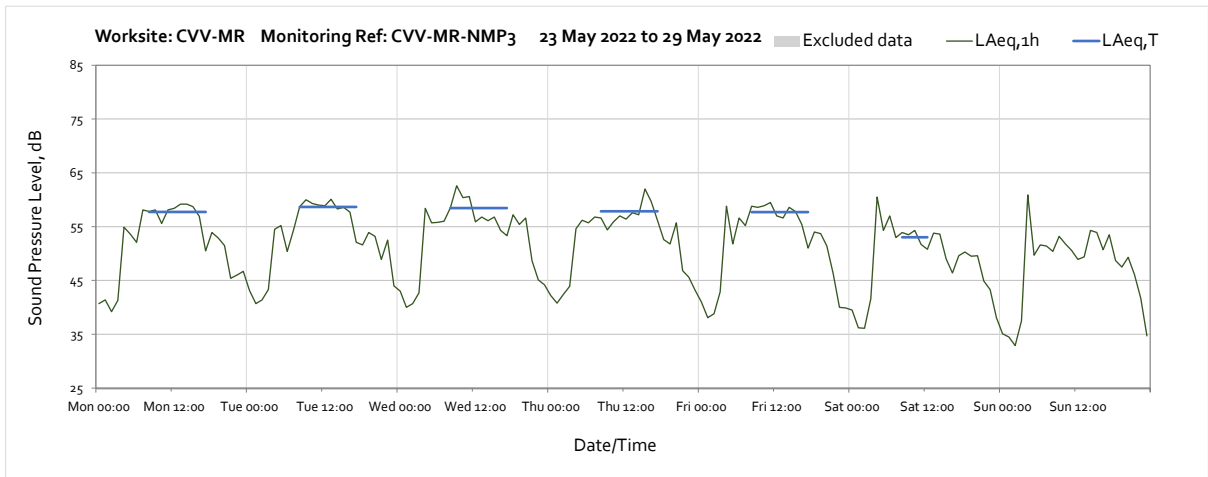
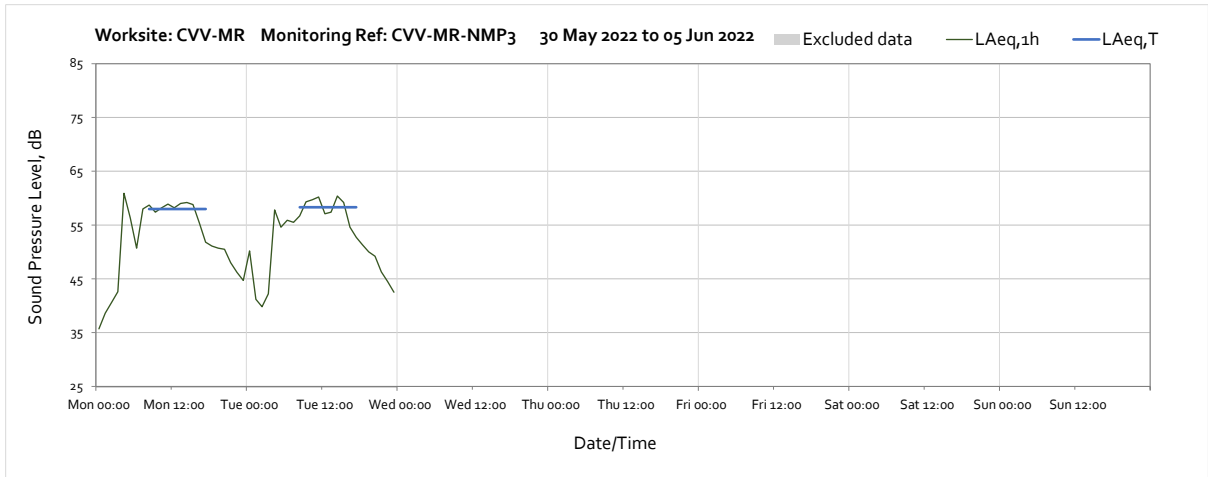
Monitoring Ref: CVV-MR-NMP3

Worksite: Colne Valley Viaduct Moorhall Road (CVV-MR)

Note: Missing data at 08:00 on Tuesday 3rd May 2022 were due to monitor settings update.

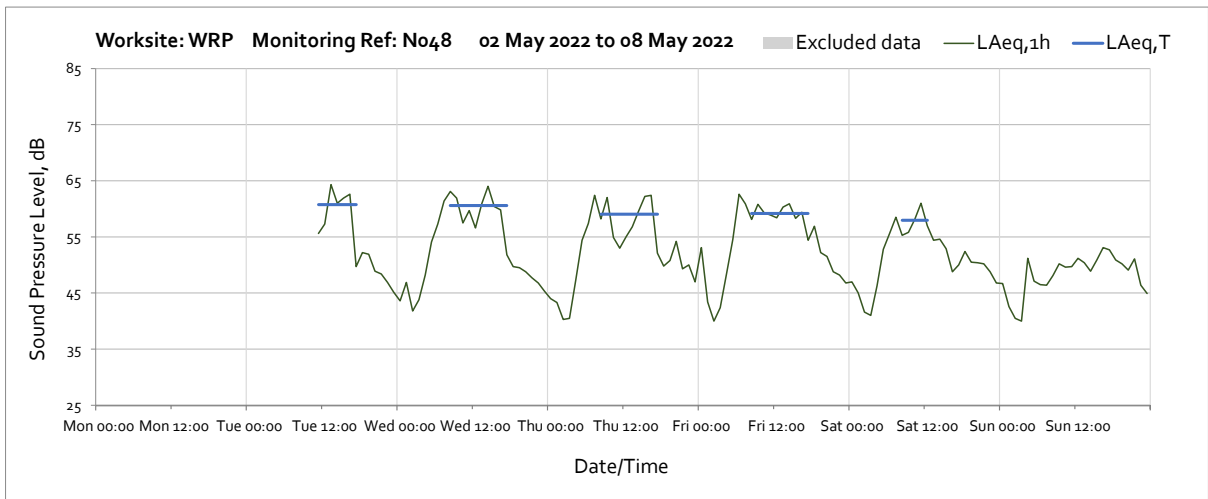
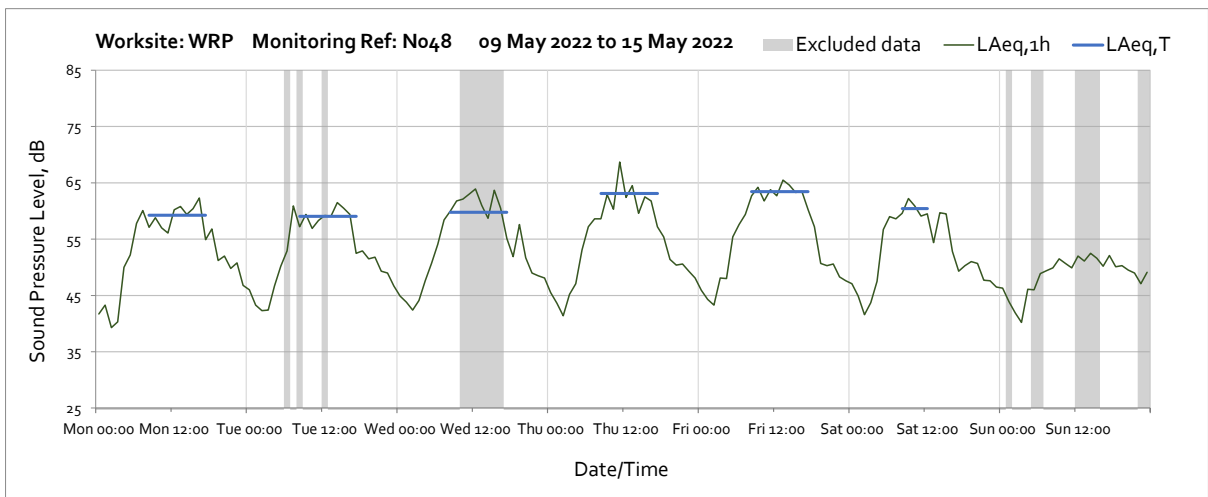
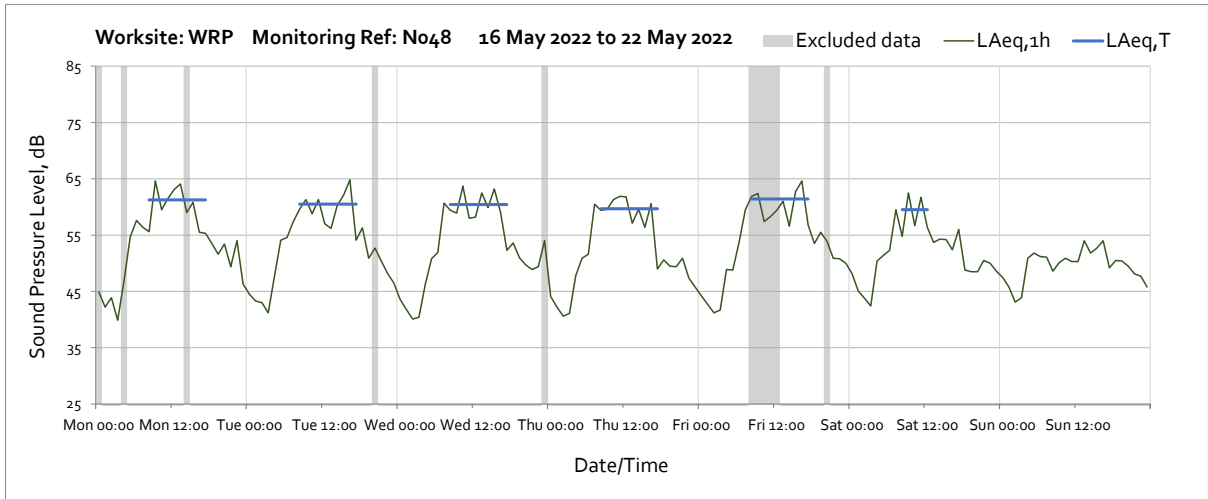
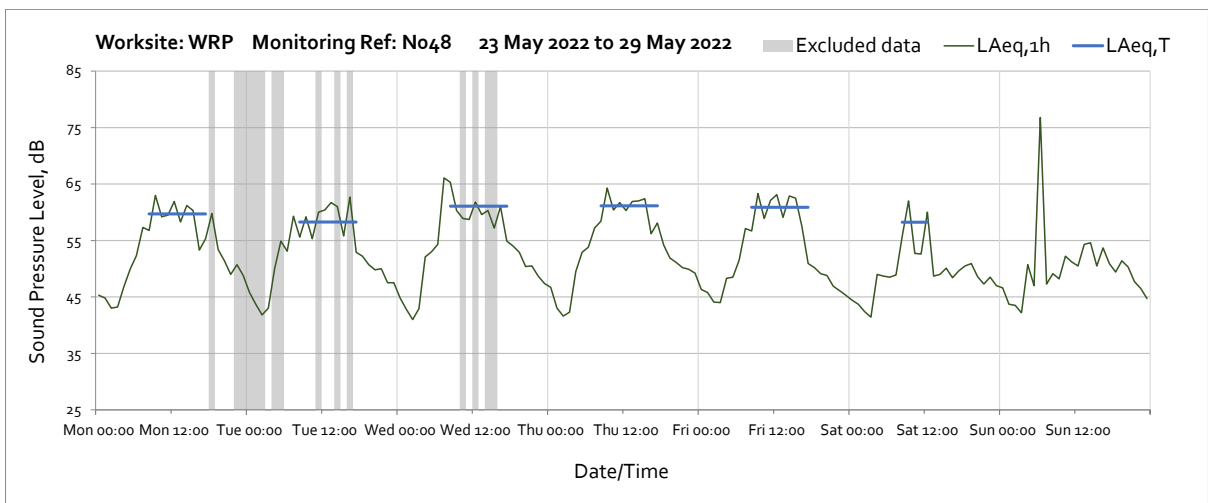
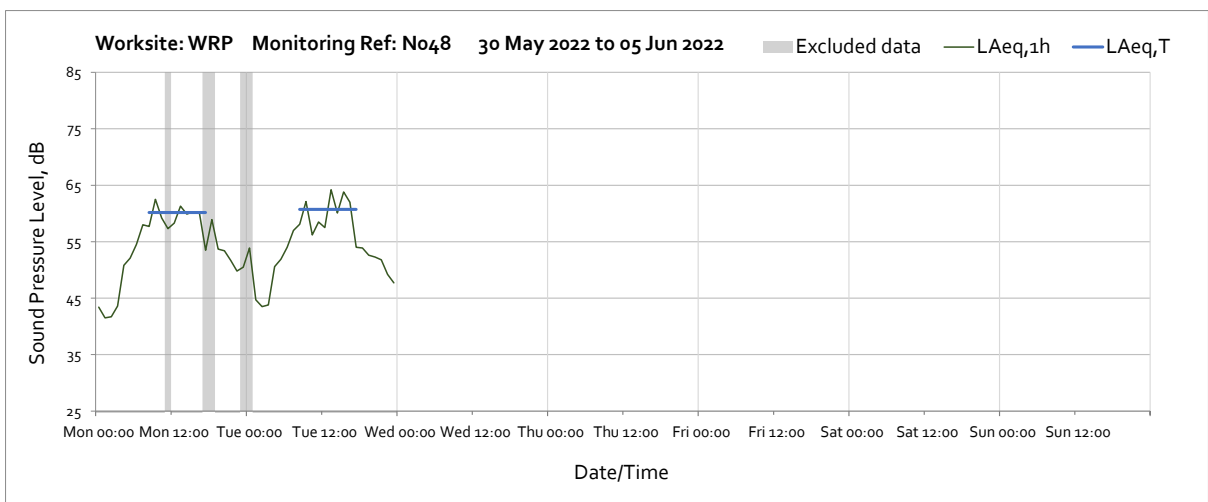
Worksite: West Ruislip Portal (WRP) - Monitoring Ref: N048

Note: Missing data between 00:00 on Sunday 1st May and 11:00 on Tuesday 3rd May were due to loss of battery power at the monitoring station.

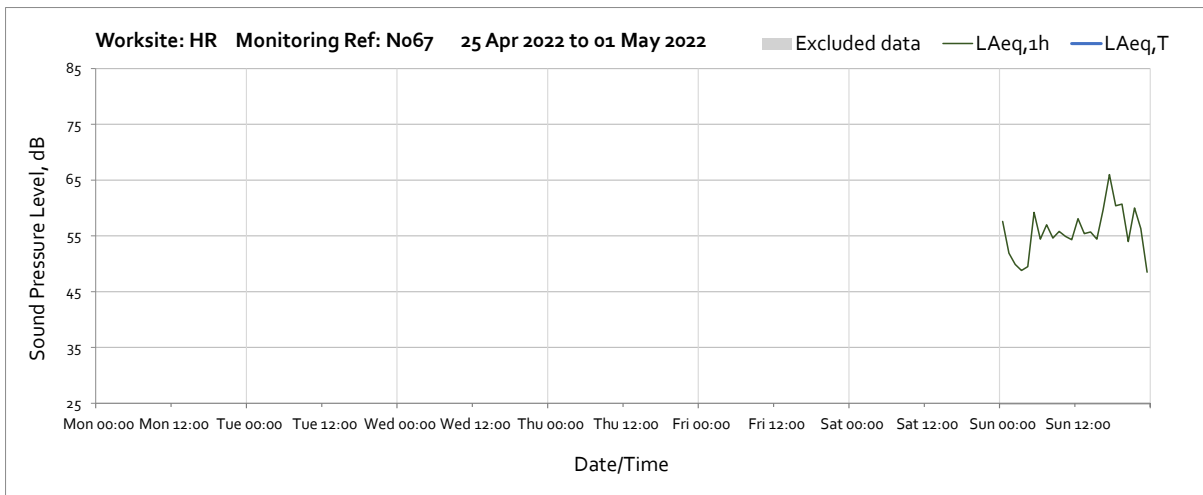
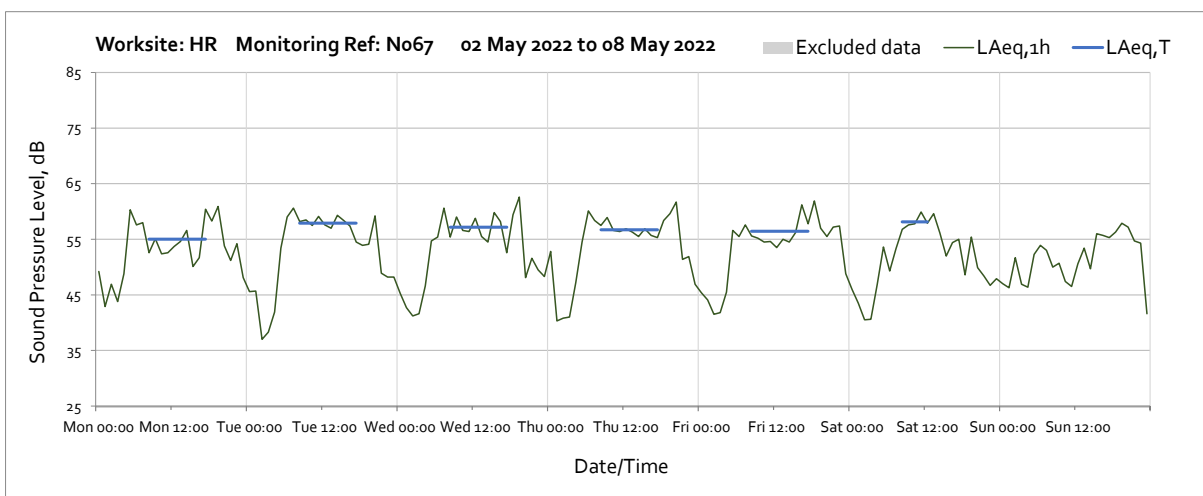
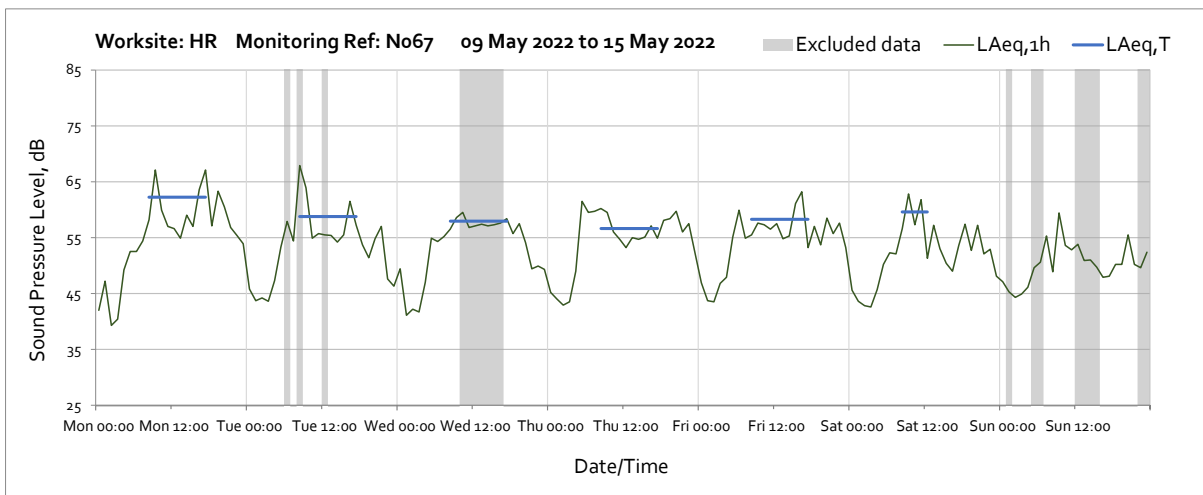
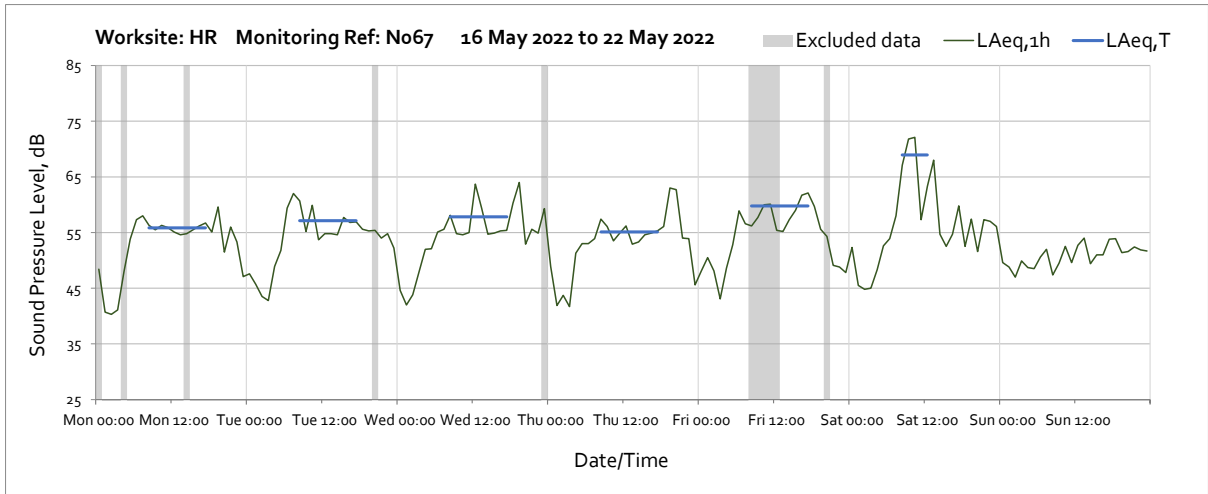
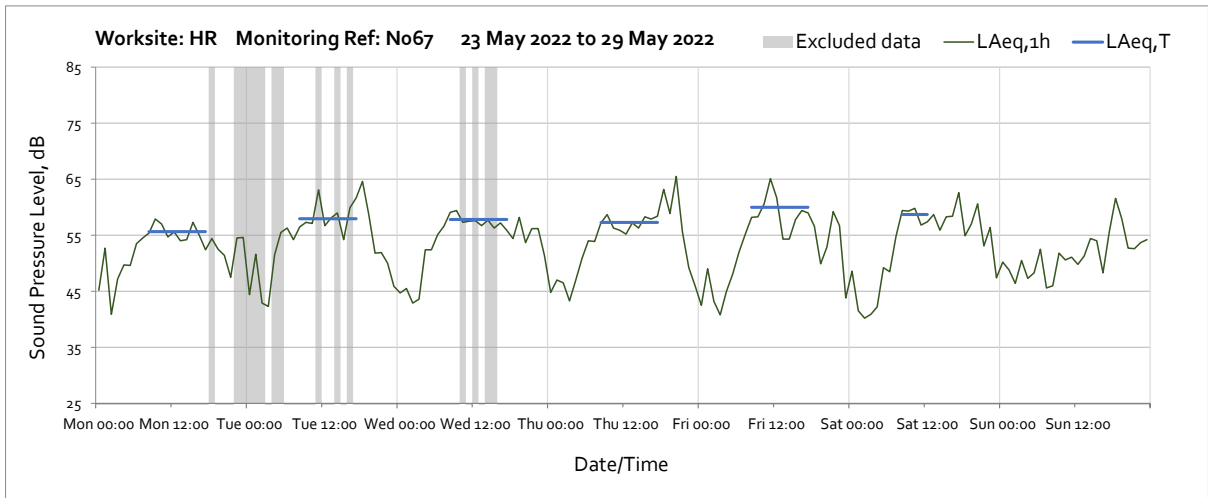
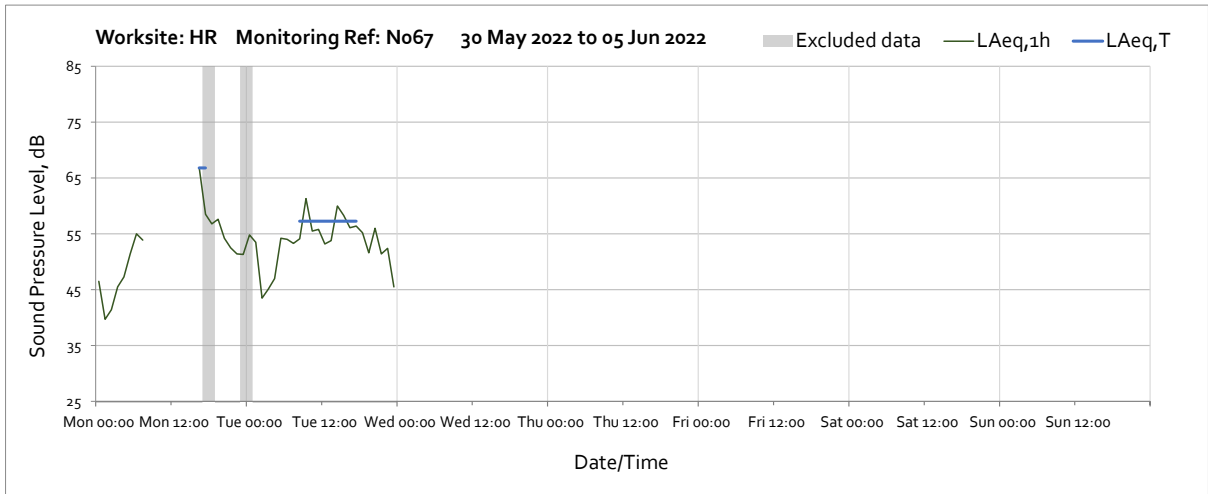
Worksite: Harvil Road (HR) – Monitoring Ref: N067

Note: Missing data between 08:00 and 16:00 on Monday 30th May were due to loss of battery power at the monitoring station.

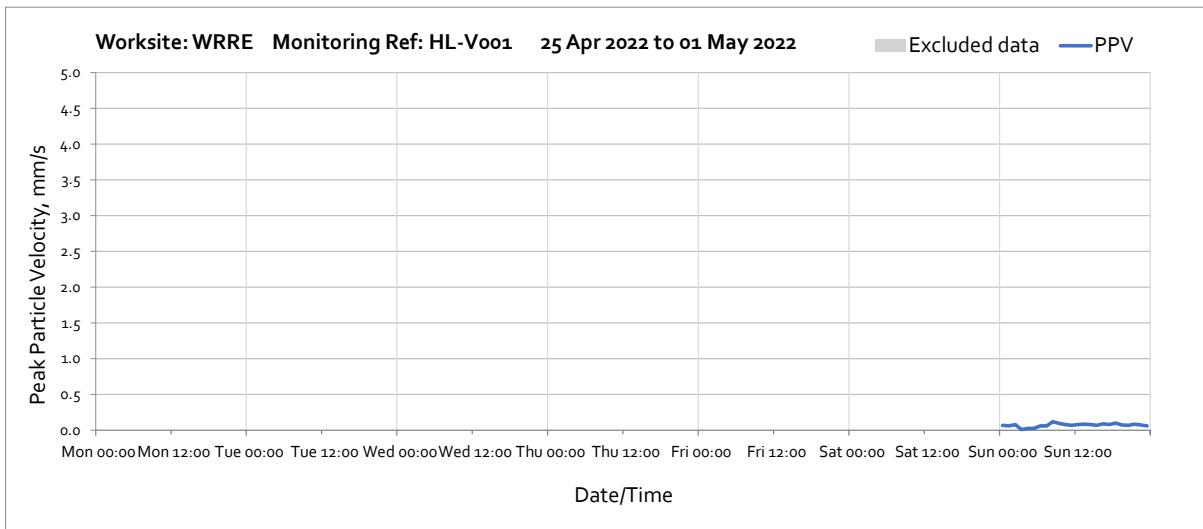
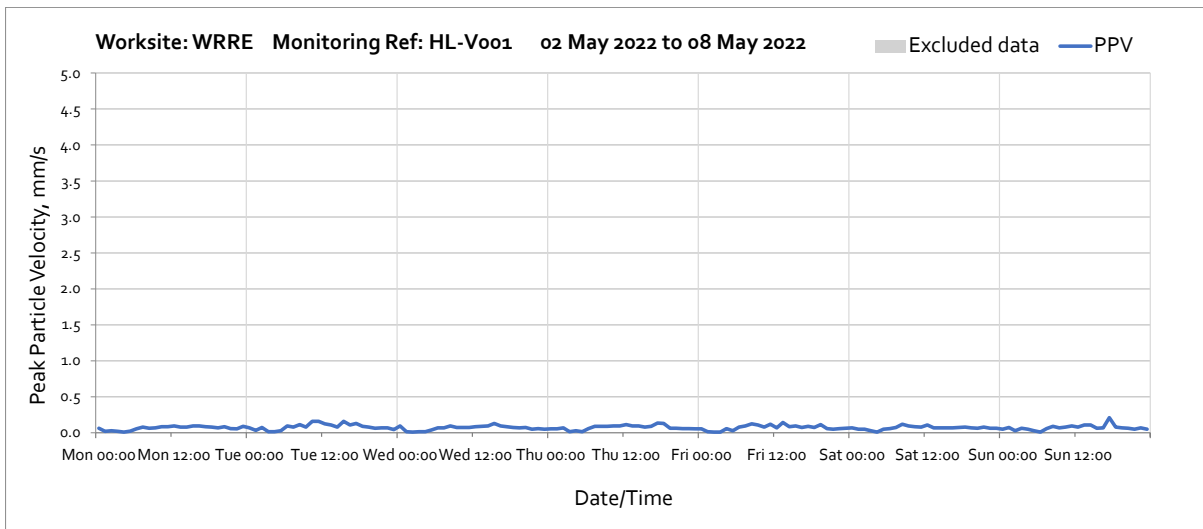
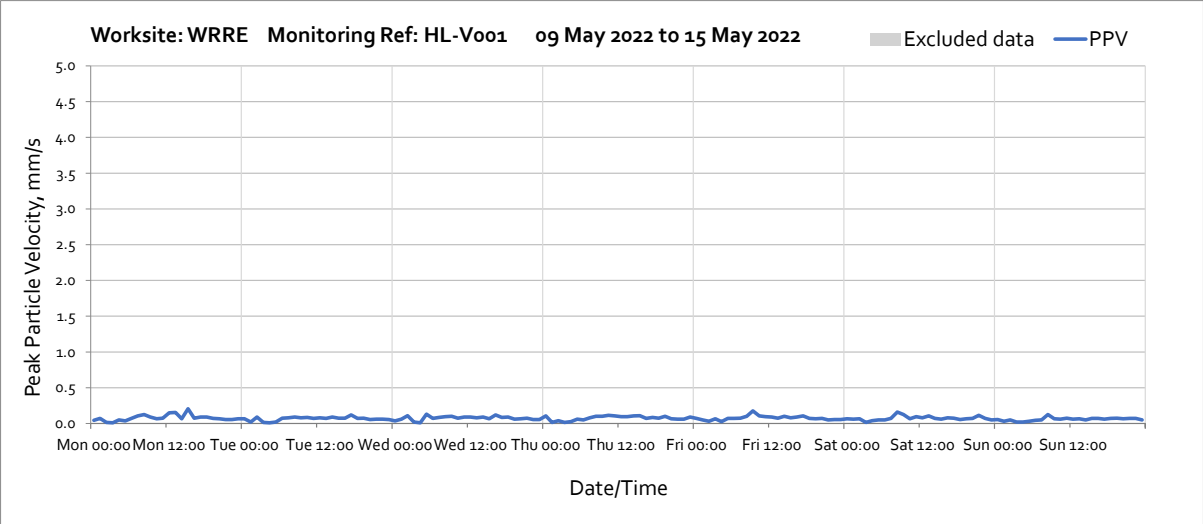
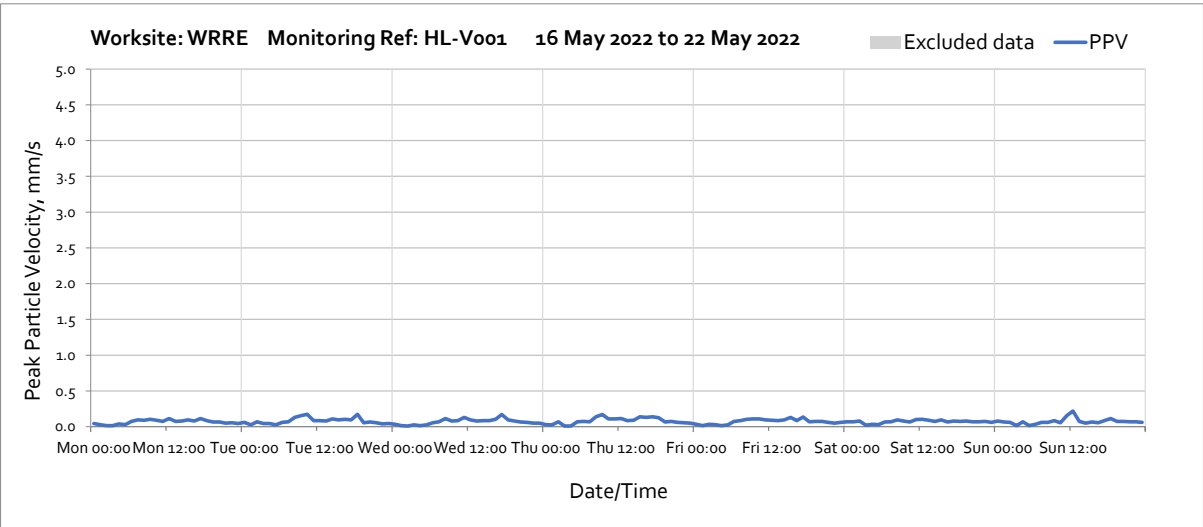
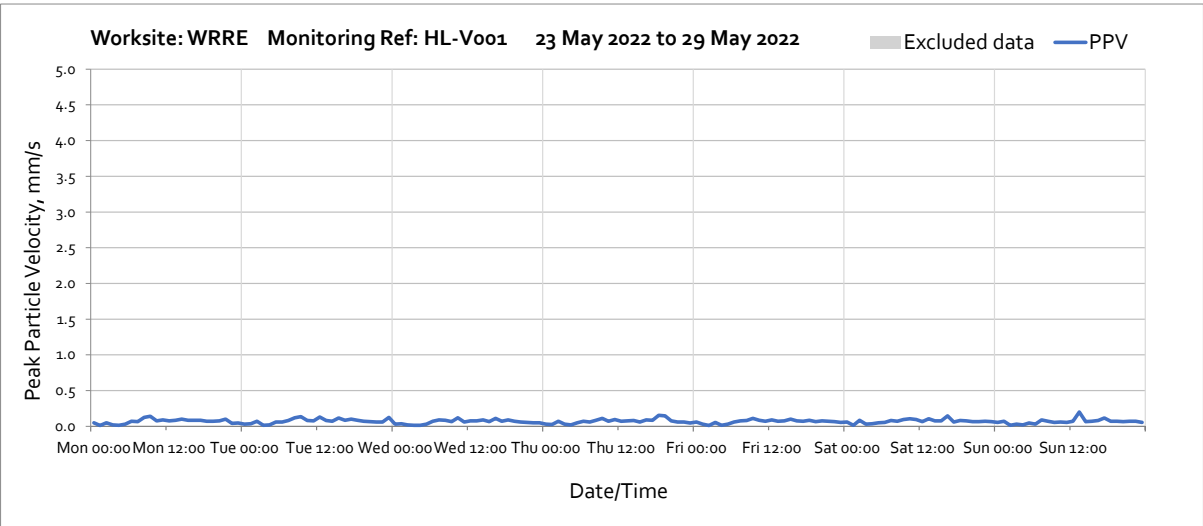
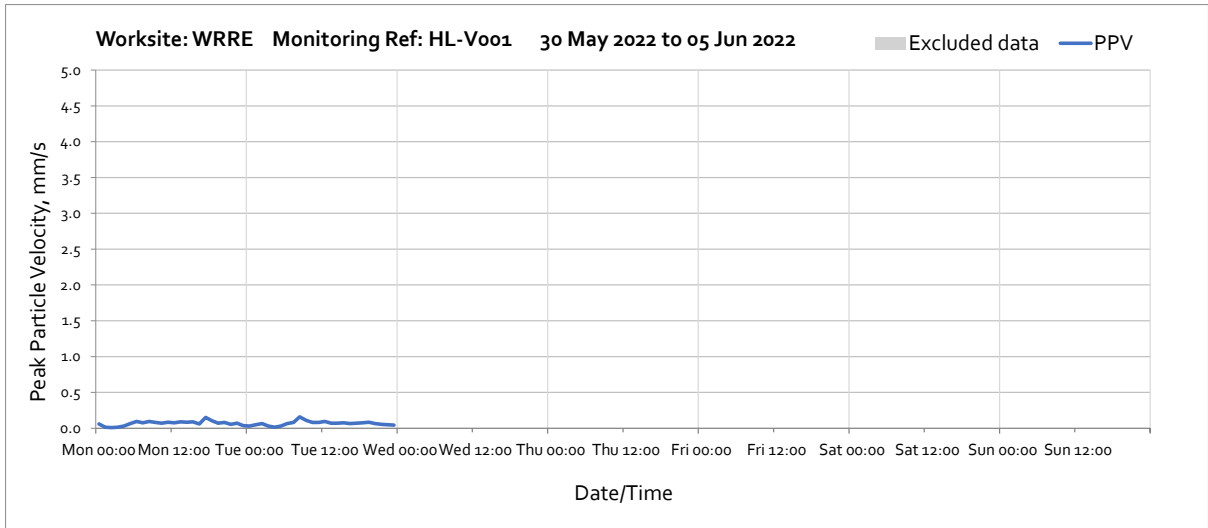
Worksite: West Ruislip Retained Embankment (WRRE) – Monitoring Ref: HL-V001

The following graphs show the hourly measured peak particle velocity PPV recorded during the monitoring period. The graphs show the highest PPV of the three orthogonal axis x, y and z. Where high values of PPV were caused by local interference with the vibration monitor, which are not representative of HS2 construction works, these values have been greyed out in the following charts and have been excluded to calculate values in Table 4 of the main report.
