Construction noise and vibration Monthly Report – May 2022

London Borough of Hillingdon

Non-Technical Summary

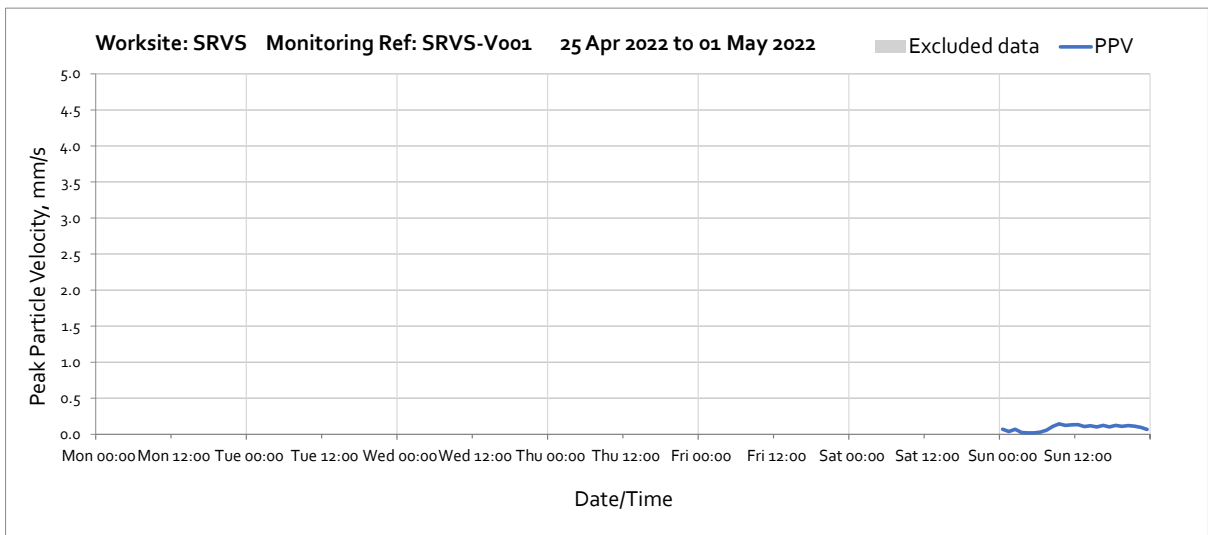
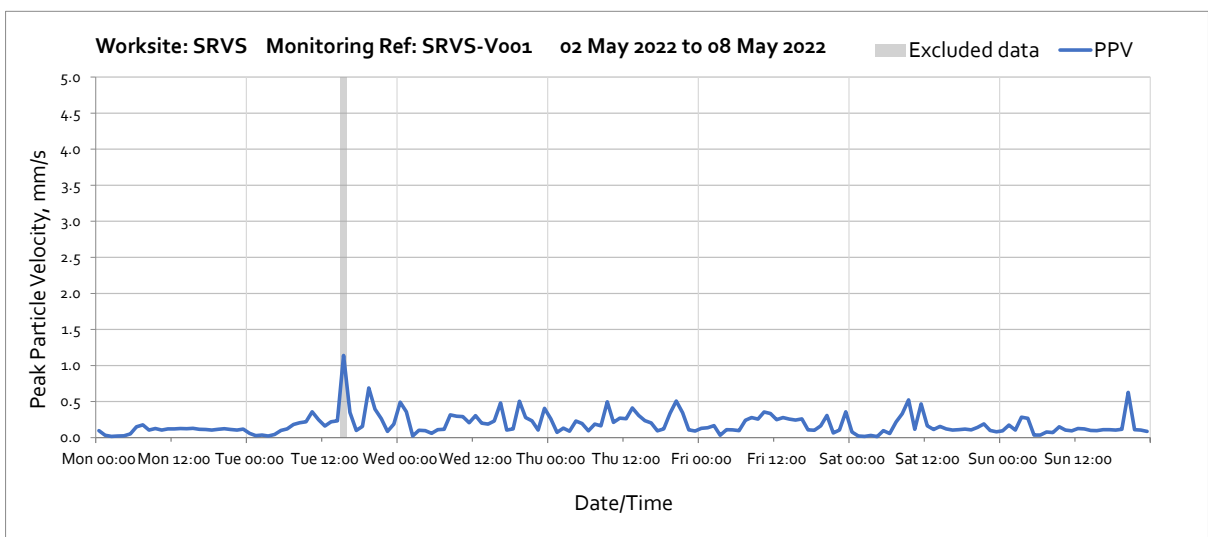
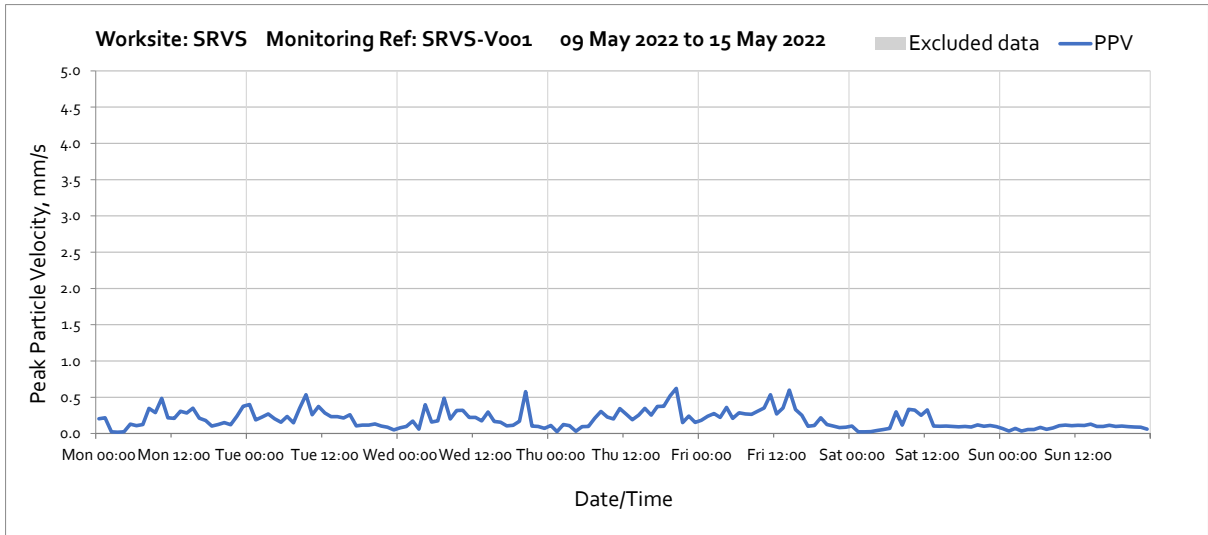
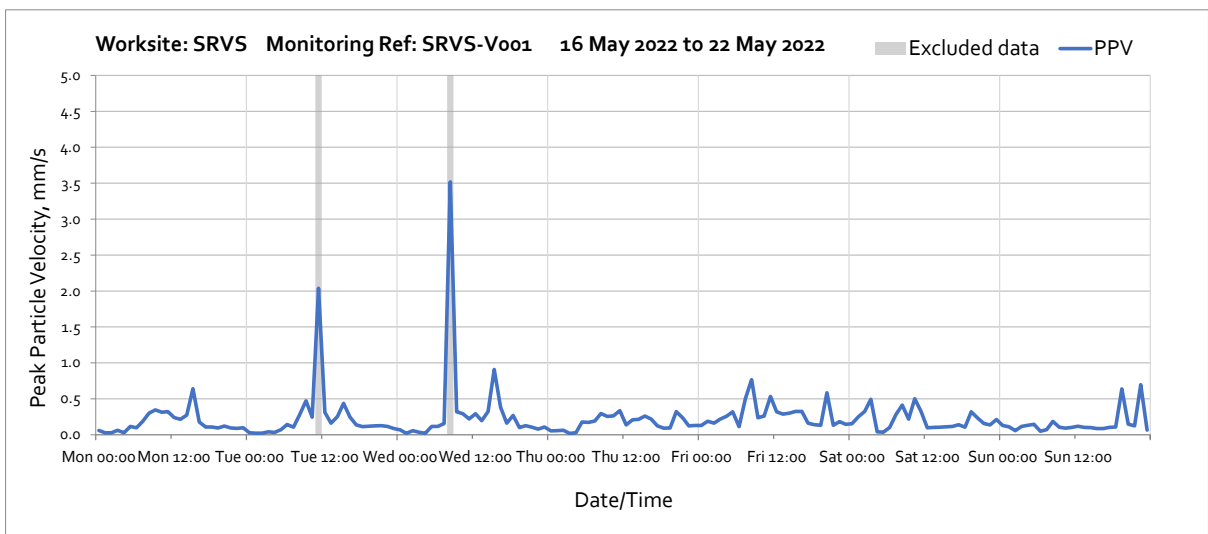
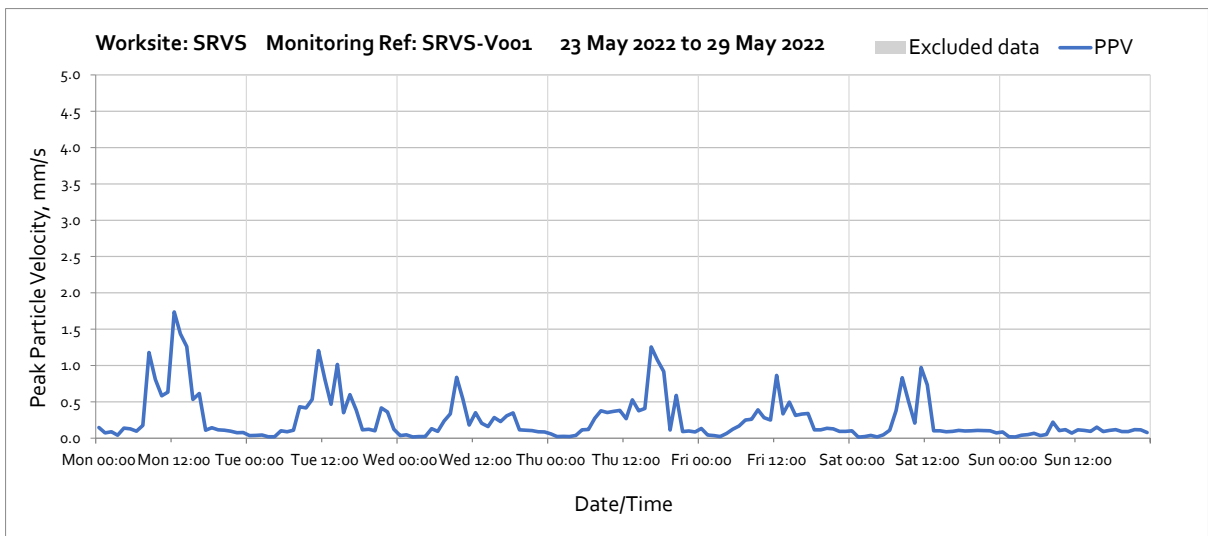
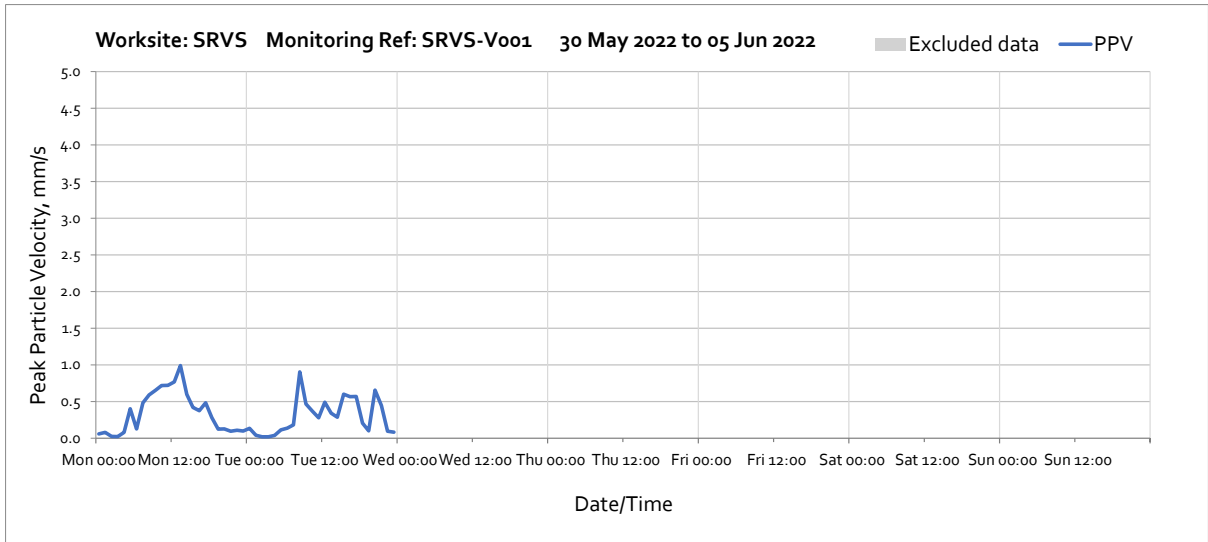
Worksite: South Ruislip Ventilation Shaft (SRVS) – Monitoring Ref: SRVS-V001

Note: High vibration levels measured at 15:00 on Tuesday 3rd May were due to local disturbance at the monitoring location and not representative of HS2 vibration levels at the receptor.

Note: High vibration levels measured at 11:00 on Tuesday 17th May and at 08:00 on Wednesday 18th May were due to local disturbance at the monitoring location and not representative of HS2 vibration levels at the receptor.
