June 2022

Air Quality and Dust Monitoring Monthly Report - June 2022

West Northamptonshire District Council

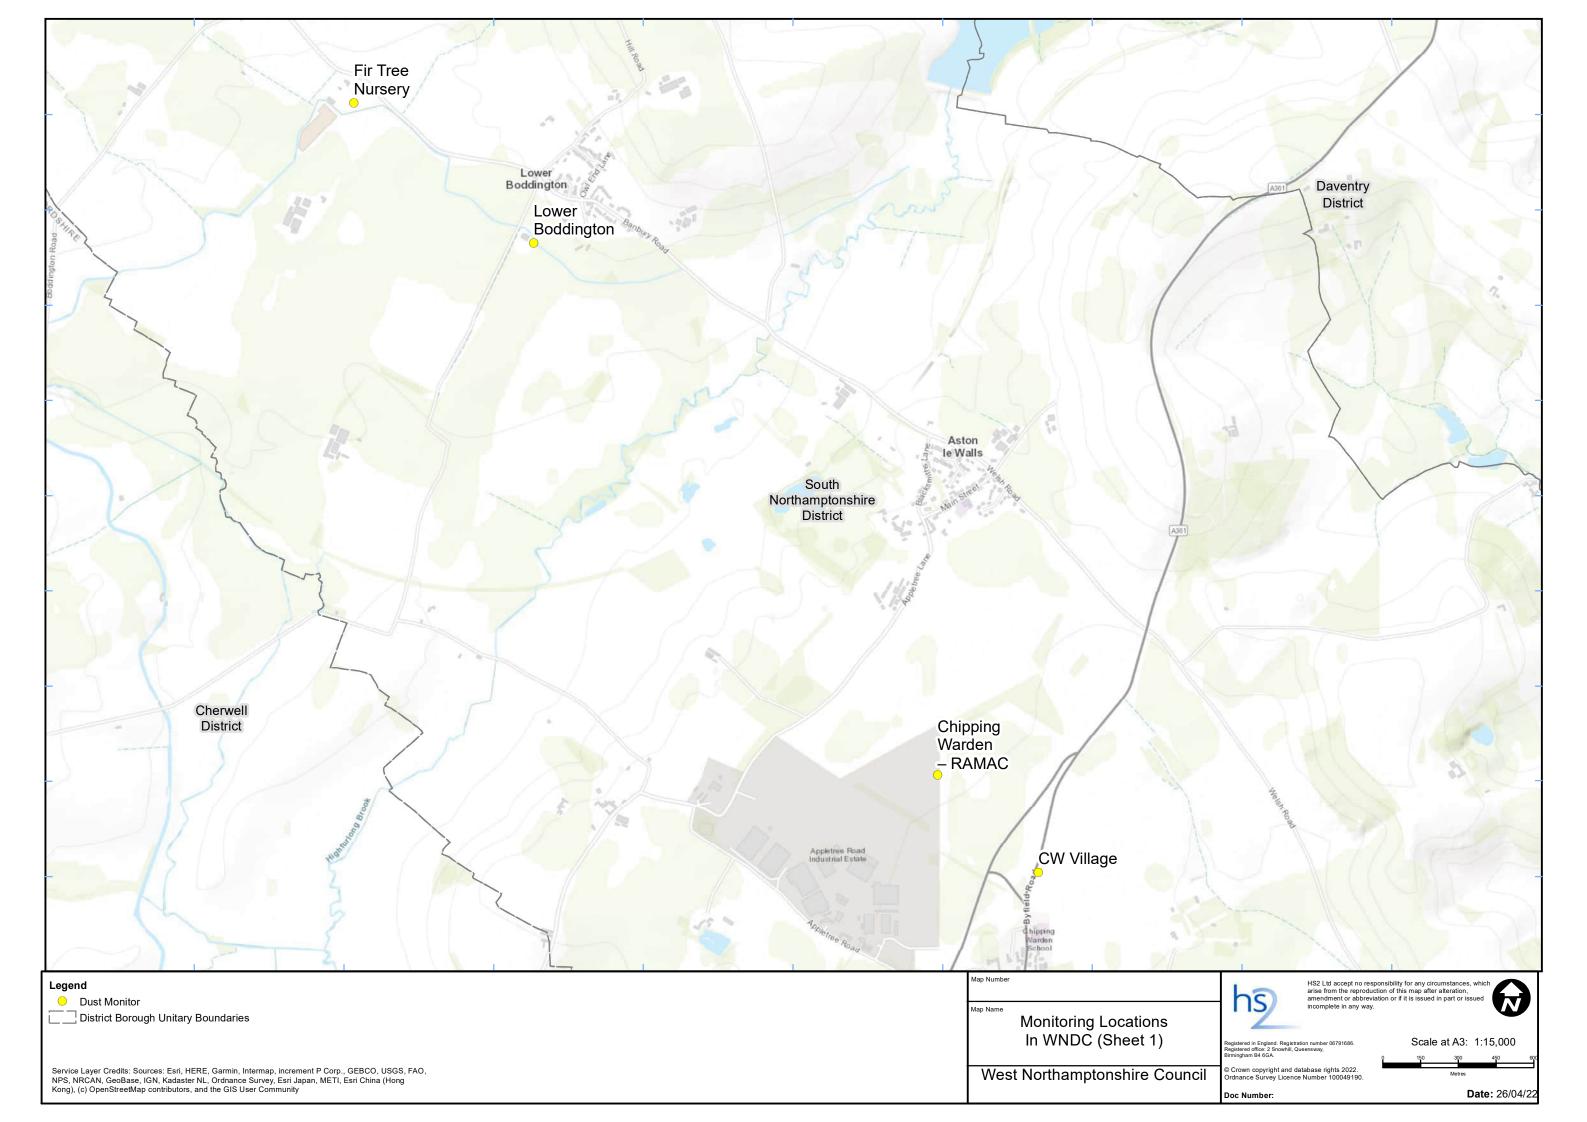
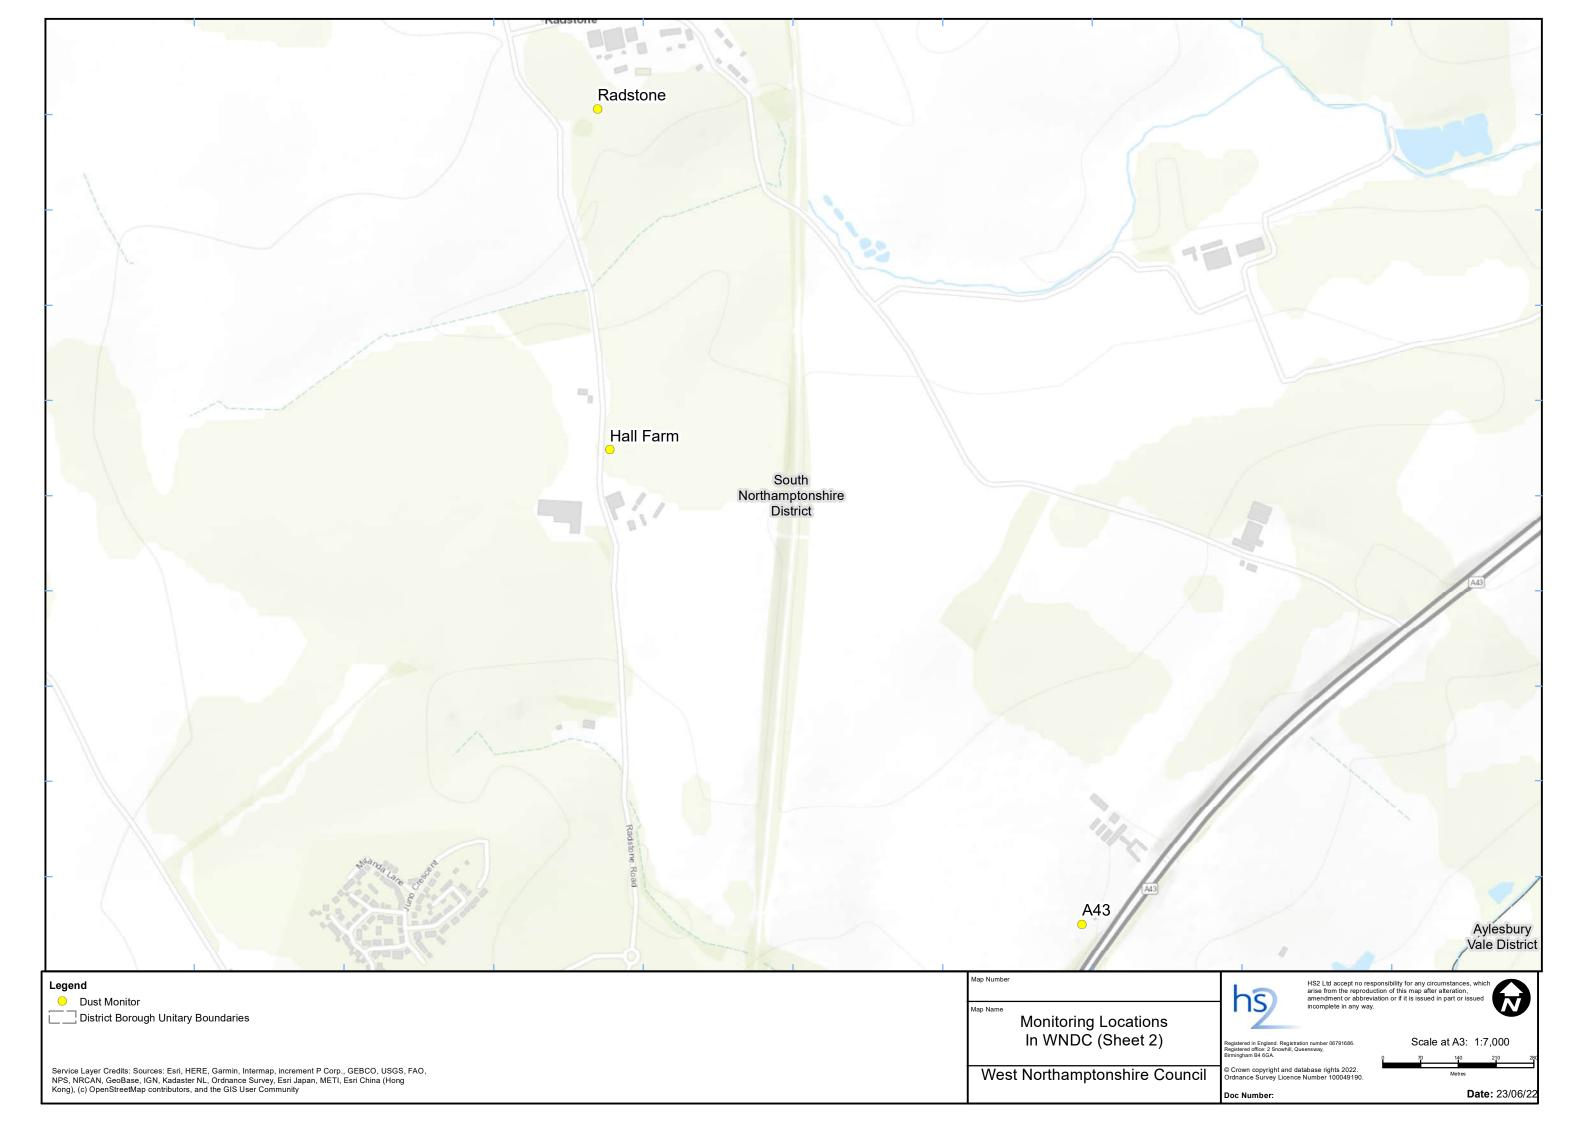
Figure 1 and 2: Worksite and monitoring locations within the WNDC

- 1.1.2 Figures 1 and 2 in Appendix A presents the current worksites together with the dust monitoring locations for June 2022.
- 1.1.3 This summary should be read in conjunction with the overview monitoring report available from www.gov.uk/government/collections/monitoring-the-environmental-effects-of-hs2, which highlights: the applicable standards and guidance, as well as the air quality and dust monitoring methodologies to be implemented by nominated undertakers throughout construction.

- 1.1.4 The current worksites, as presented in Appendix A, Figures 1 and 2, include:

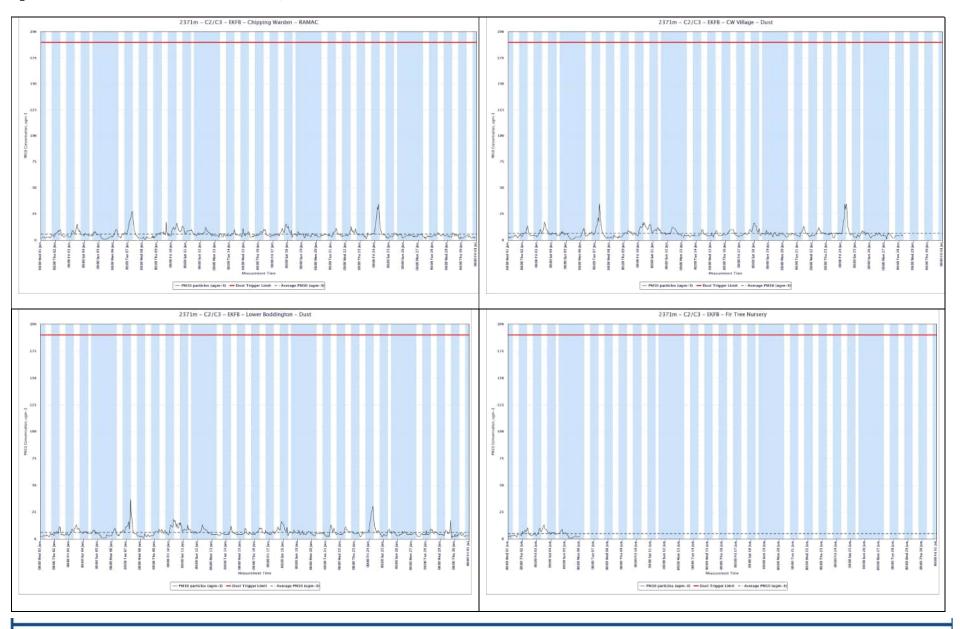
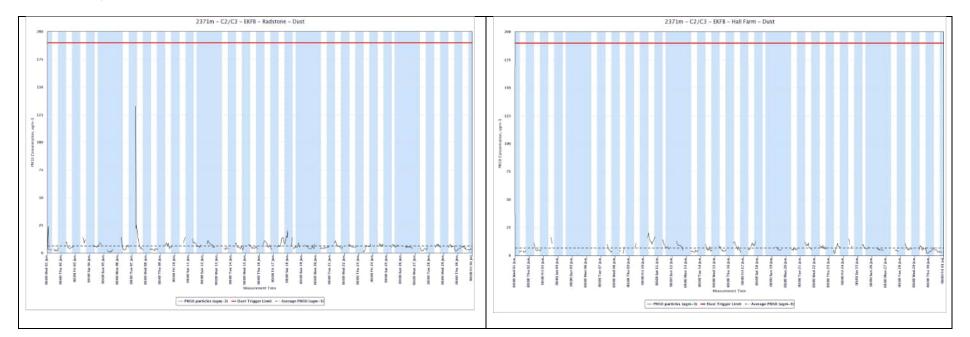
Figure 3: Continuous dust 1-hour mean indicative PM₁₀ concentration for all monitors

- Water Management
- Established of site access road
- Stockpiling
- Topsoil stripping and material movement
- 1.1.5 Dust monitoring locations and results are presented in Appendix B, Table 1, together with line charts of monthly data from the dust monitors presented in Figure 3. All continuous dust monitoring is undertaken using indicative monitors. Despite being Environment Agency (MCERTS) certified, indicative monitors carry a higher level of uncertainty than reference monitors, and therefore cannot be strictly compared with Air Quality Standards for human health and the environment. The purpose of the monitoring undertaken is to ensure the effectiveness of the on-site mitigation.

- 1.1.6 Six (6) dust monitors are installed around the worksites, where works are underway. These sites returned a medium dust risk rating.
- 1.1.7 The trigger level for PM₁₀ concentrations of 190 μg/m³, over a 1-hour period, in accordance with the updated guidance document 'Guidance on Monitoring in the Vicinity of Demolition and Construction Sites (October 2018)' has been applied.

- 1.1.8 No (0) trigger alerts were recorded in the monitoring period (June 2022).
- 1.1.9 Data capture was below 90% for multiple monitors due to loose connections and damage to a controller box due to water ingress.
