August 2022

## **Construction Noise and Vibration Monthly Report – June 2022**

**Cherwell District Council**

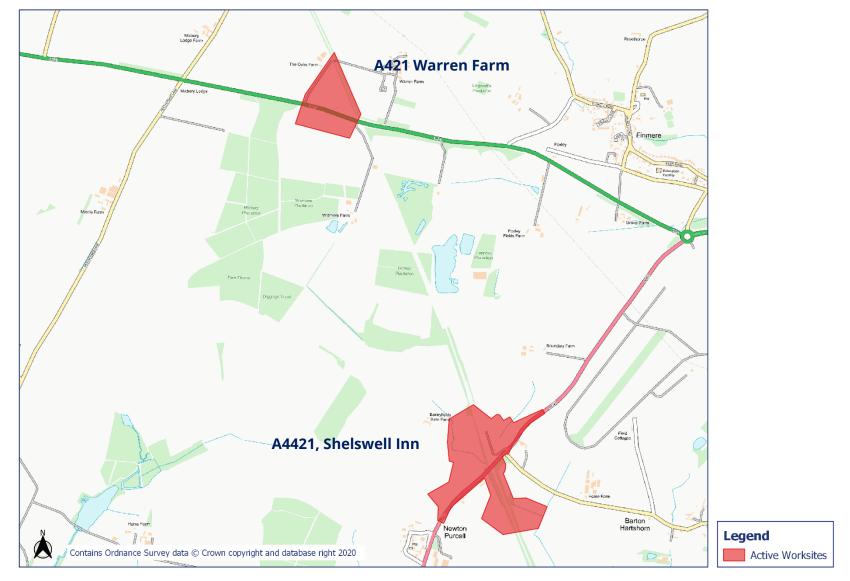
### **HS2** Worksite Identification Plan - Overview

- 1.1.3 Construction sites in the local authority area where monitoring was undertaken during this period include:
  - A421 Warren Farm worksite ref.: A421-N1 (see Works Identification Plan 1 in Appendix A), where the following work activities were undertaken:

- Formation of embankment.
    - Vegetation clearance.
  - A4421 North, Shelswell Inn, worksite ref.: NPF-N1 (see Works Identification Plan 1 in Appendix A), where the following work activities were undertaken:

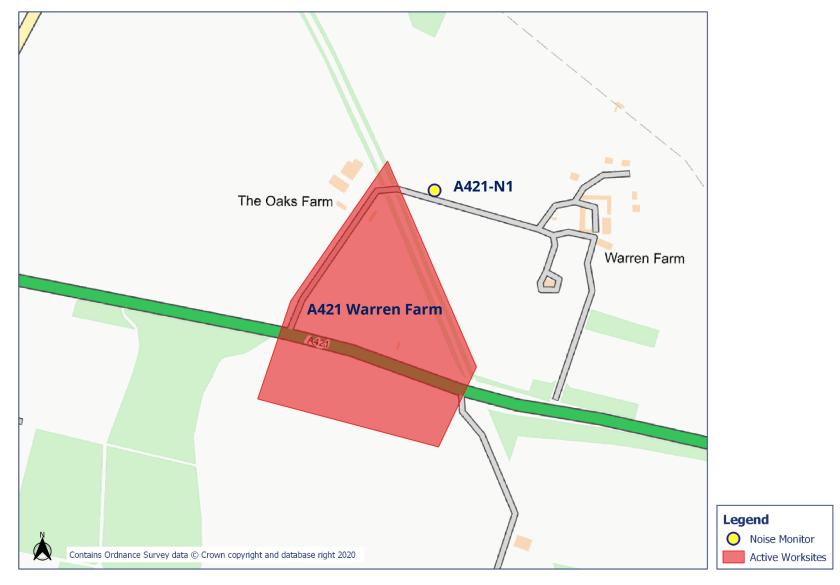
### **HS2** Noise and Vibration Monitoring Plan - 1

- 1.2.1 Two monitoring installations were present during June in the CDC area. Table 2 summarises the position of noise monitoring installations within the CDC area in June 2022.
- 1.2.2 Monitoring location A421-N1 was offline throughout the month due to power supply issues. A replacement power module due for installation has been delayed and the matter is currently being pursued.
- 1.2.3 Maps showing the position of noise monitoring installations are presented in Appendix B.

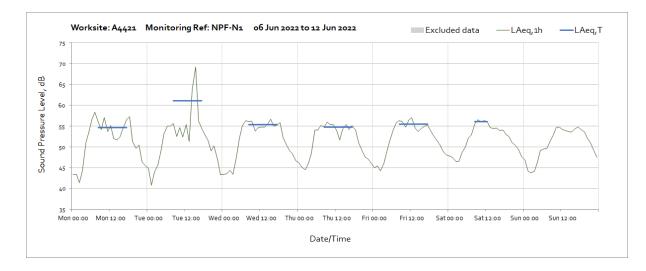
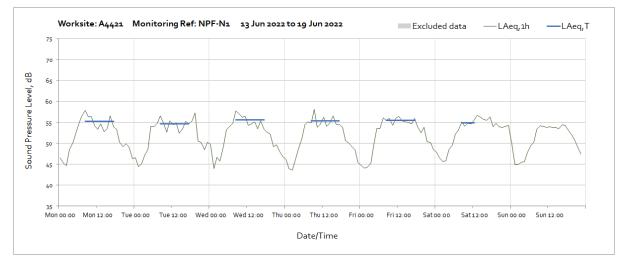
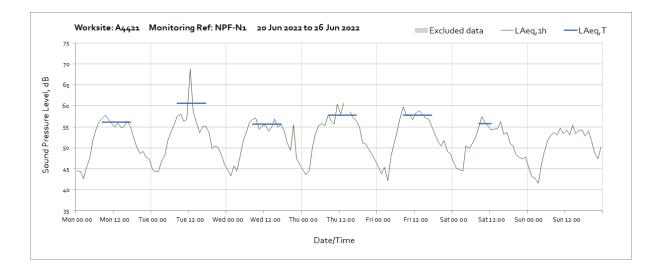
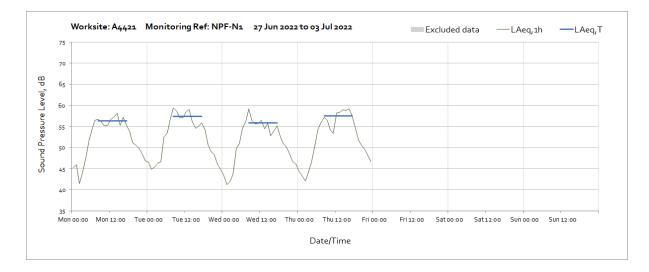
#### Worksite: A4421 - Monitoring Ref: NPF-N1

The following graphs show the hourly measured ambient noise level  $L_{Aeq,1h}$  and, where relevant, the averaged noise level  $L_{Aeq,T}$  values, where the time period T is as specified in Table 1 of HS2 Information Paper E23. Periods with adversely weather affected noise levels are greyed out and have been excluded from the calculation of the  $L_{Aeq,T}$  values in Table 3 of the main report.

Note: Missing data for the period 23:00 to midnight on 19 June is due to the data period rounding cut off after automatic system check.

Note: Missing data for the period 14:00 to 15:00 on 23 June was due to remote monitor maintenance.
