Construction Noise and Vibration Monthly Report – May 2022

Warwick District Council

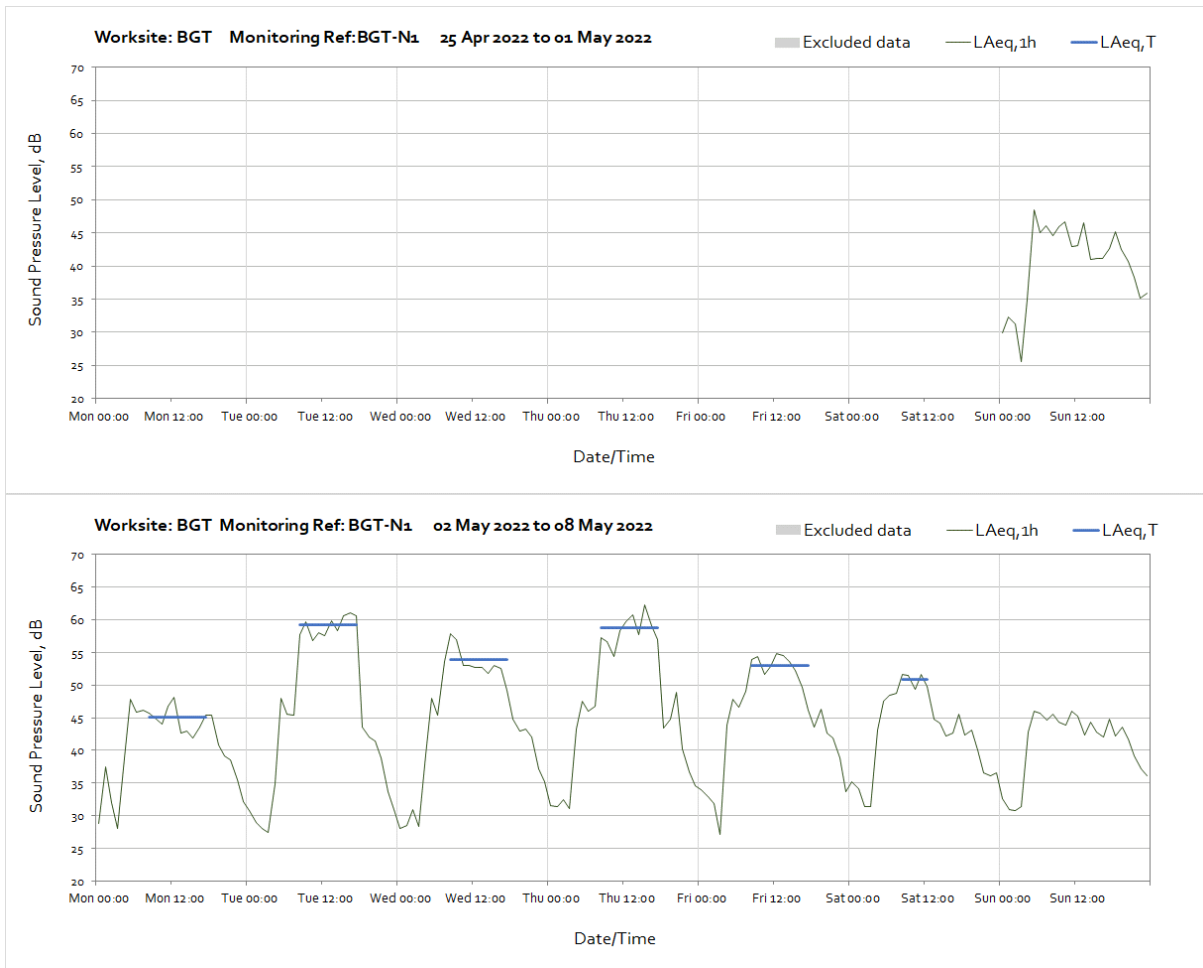
Worksite: BGT - Monitoring Ref: BGT-N1

The following graphs show the hourly measured ambient noise level $L_{Aeq,1h}$ and, where relevant, the averaged noise level $L_{Aeq,T}$ values, where the time period T is as specified in Table 1 of HS2 Information Paper E23. Periods with adversely weather affected noise levels are greyed out and have been excluded from the calculation of the $L_{Aeq,T}$ values in Table 3 of the main report.

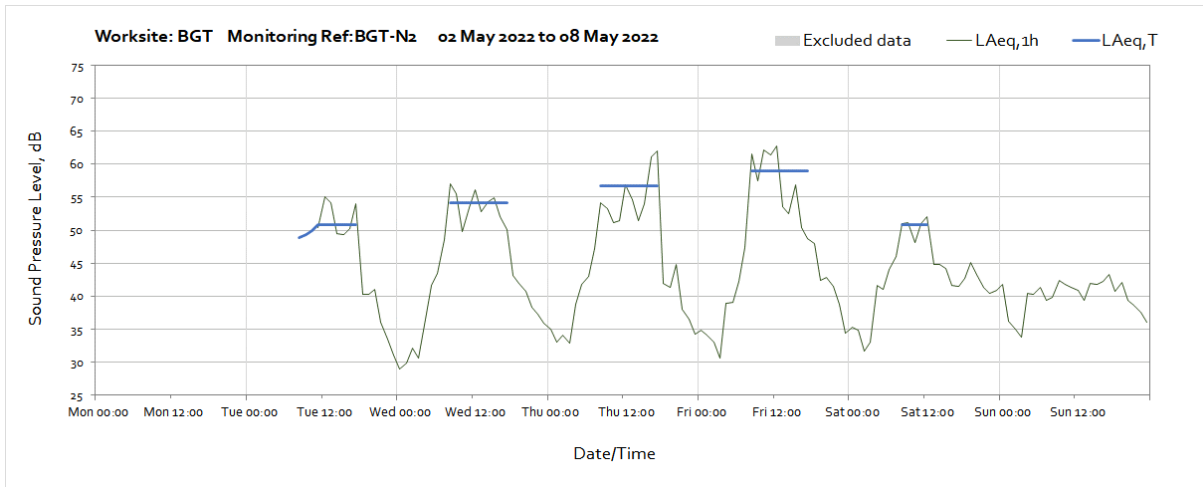
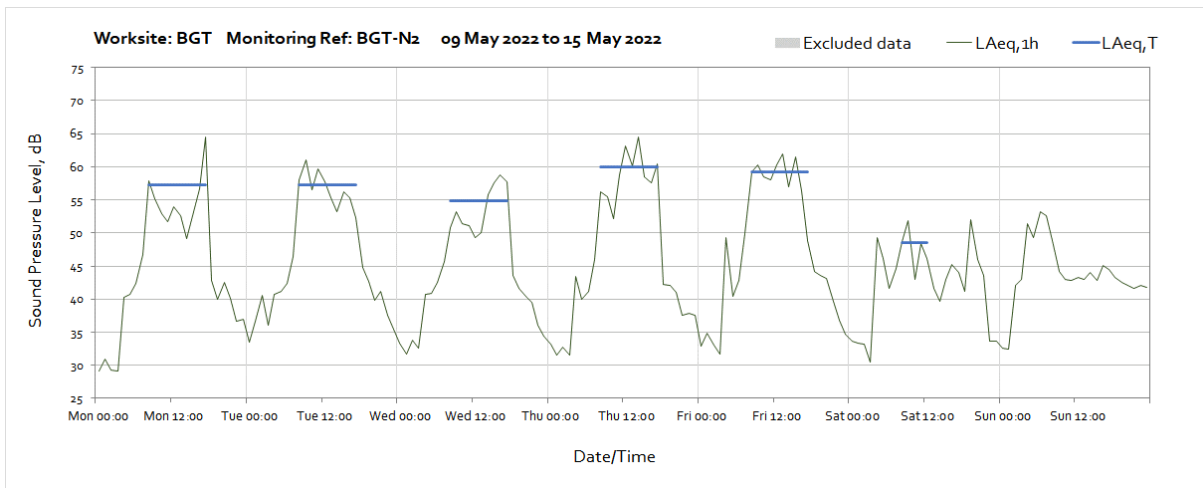
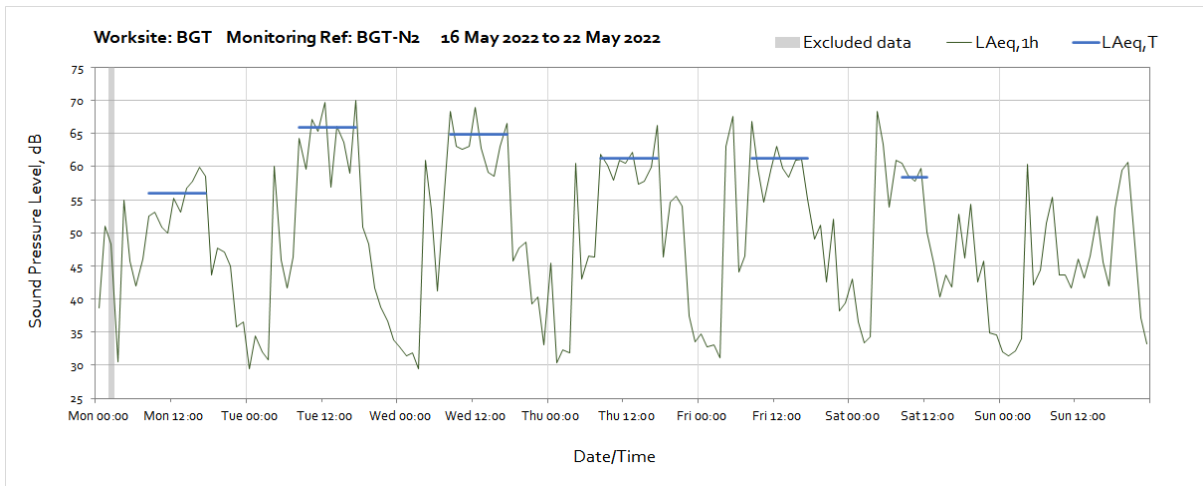
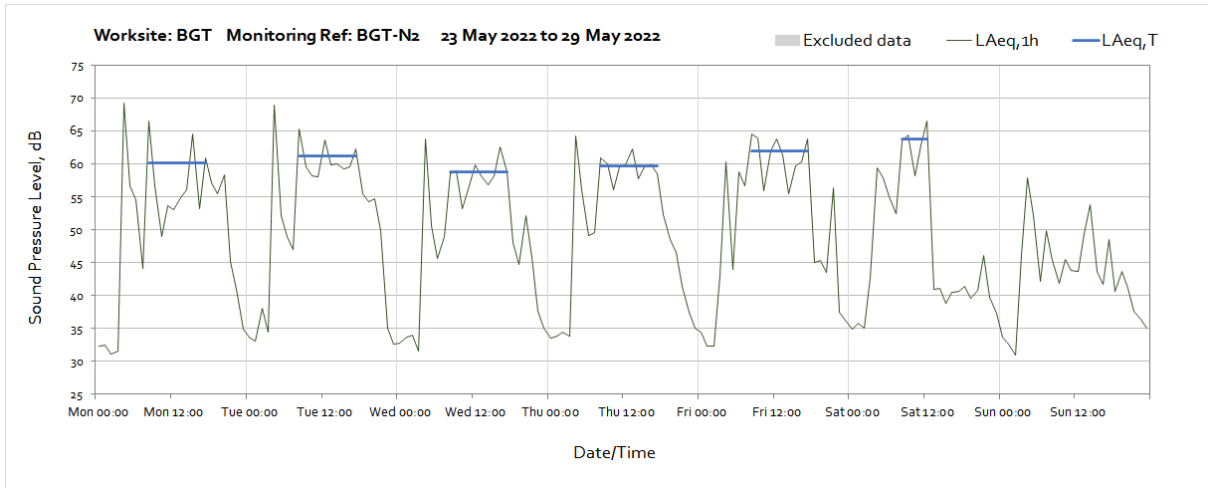
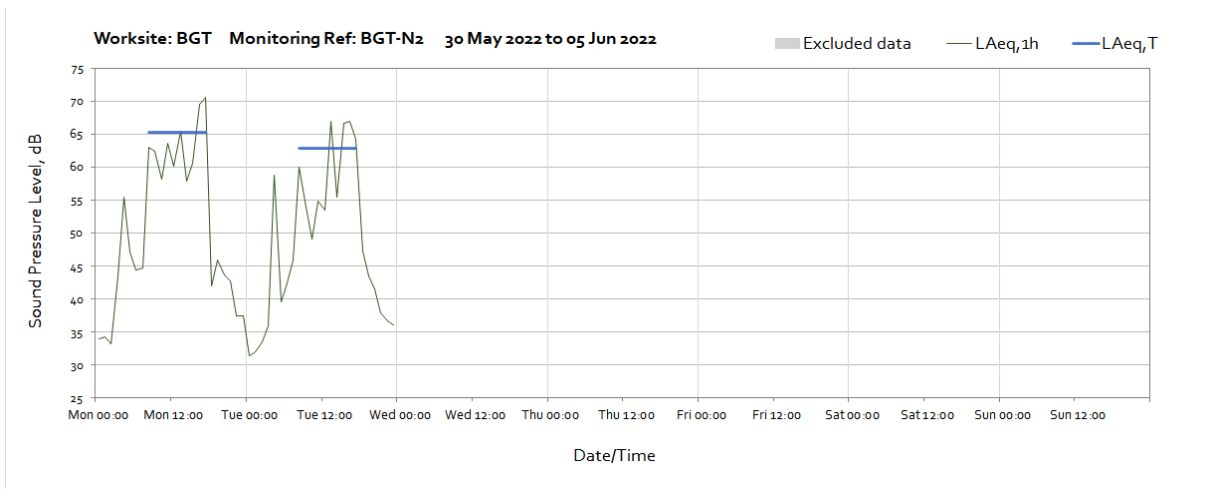
Worksite: BGT - Monitoring Ref: BGT-N2

Note: Missing data from the beginning of the month until Tuesday 9th May 2022 at 11:00 was due to a power supply issue.

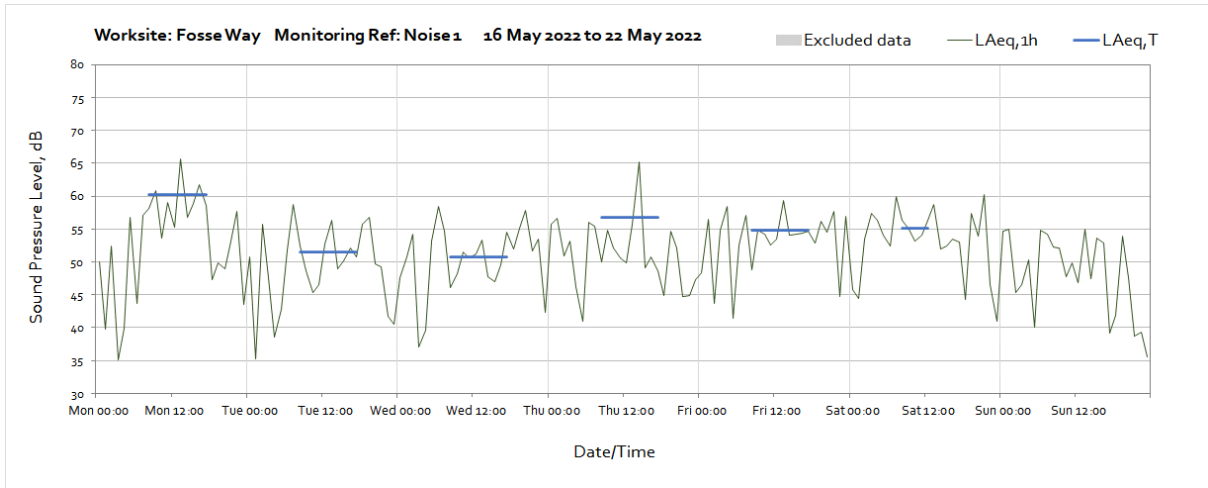
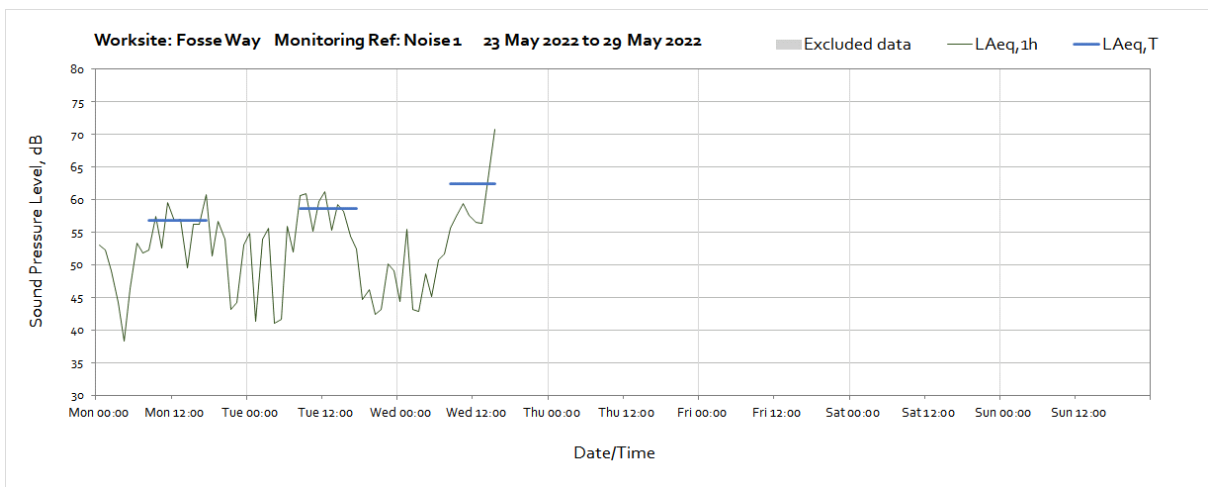
Worksite: FD – Monitoring Ref: FD-N1

2.2.8 Three (3) exceedances of the SOAEL at monitoring locations ref.: FD-N1 and FD-N2 were due to HS2 construction works during May 2022.

Note: Missing date from Wednesday 25th May 2022 to the end of the month was due to the temporary removal of the noise monitor while fencing at the installation area was modified. Monitoring will be reinstalled at a later date.

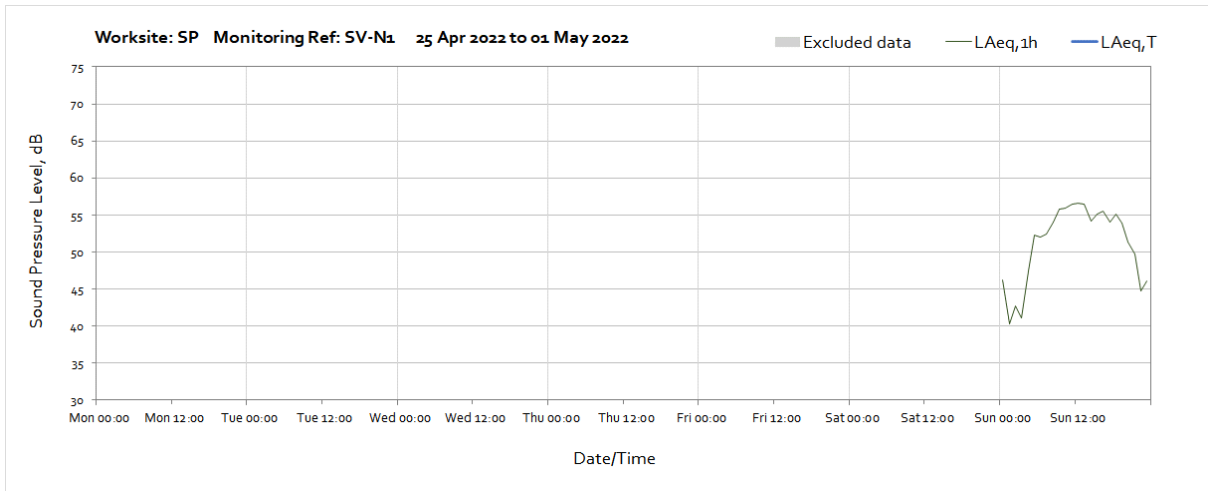
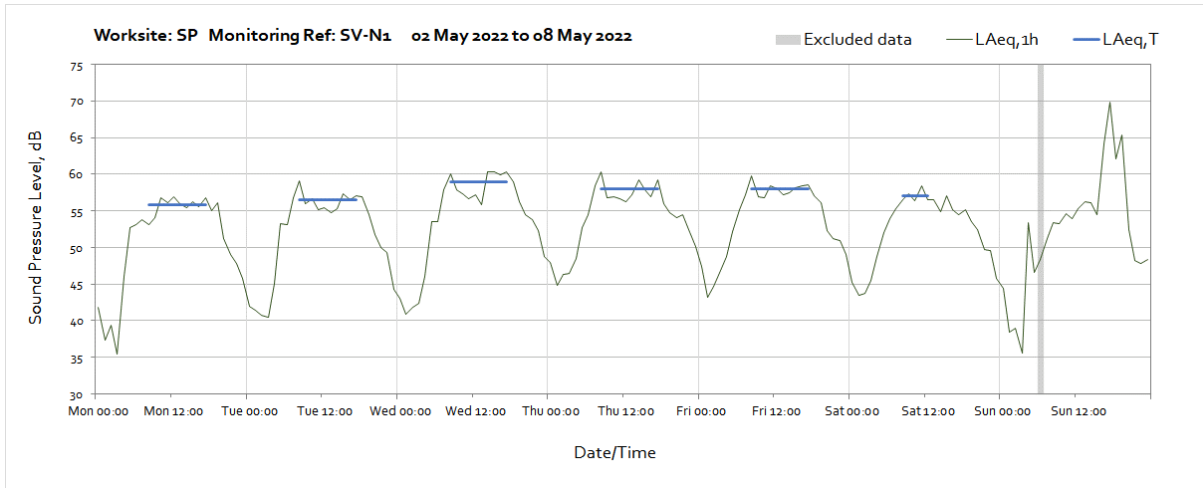
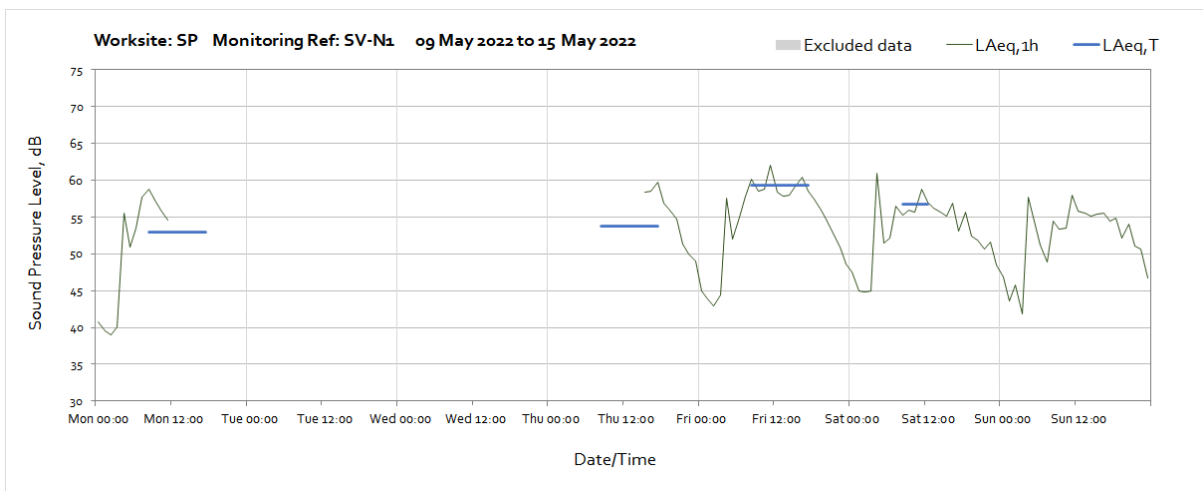
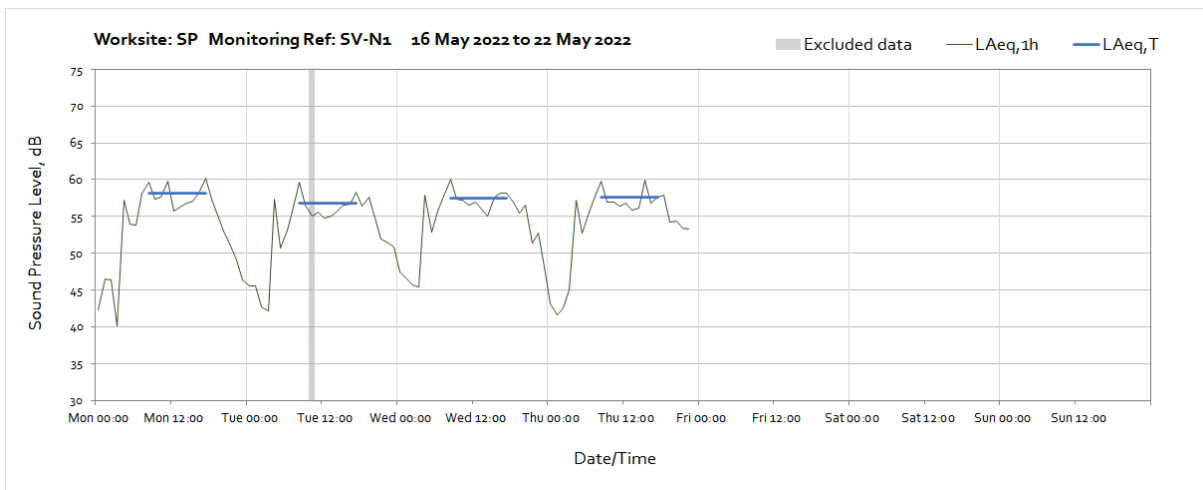
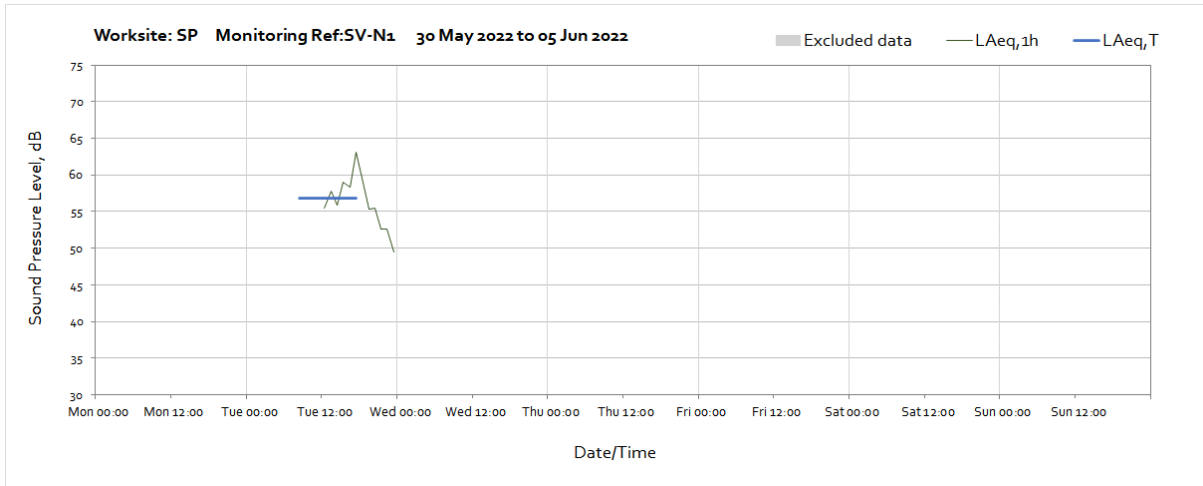
Worksite: SV – Monitoring Ref: SV-N1

Note: Missing data between Monday 9th May 2022 at 12:00 and Thursday 12th May 2022 at 15:00 was due to a power supply issue.

Note: Missing date between Thursday 19th May 2022 at 23:00 and Tuesday 31st May 2022 at 12:00 was due to a power supply issue.

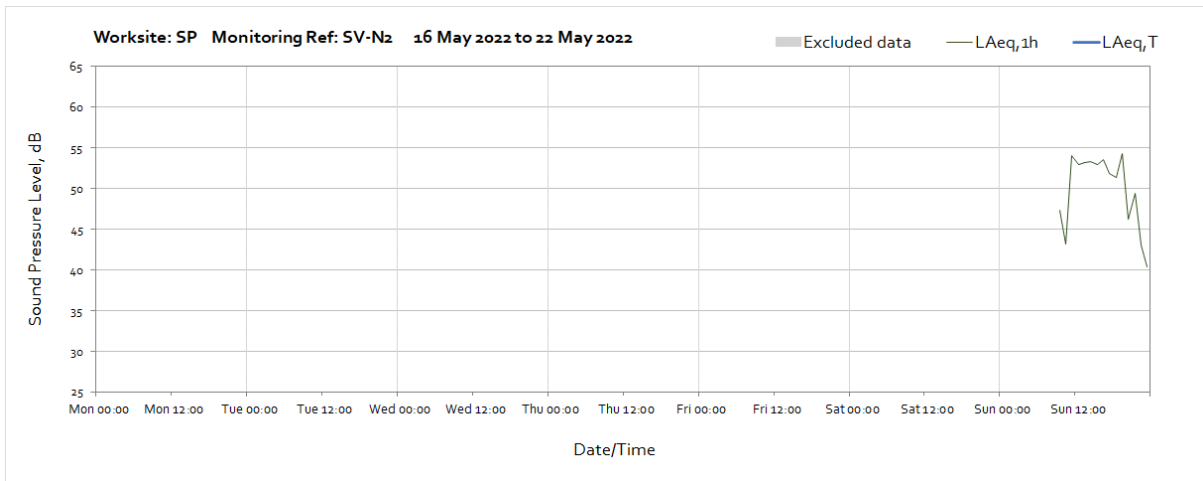
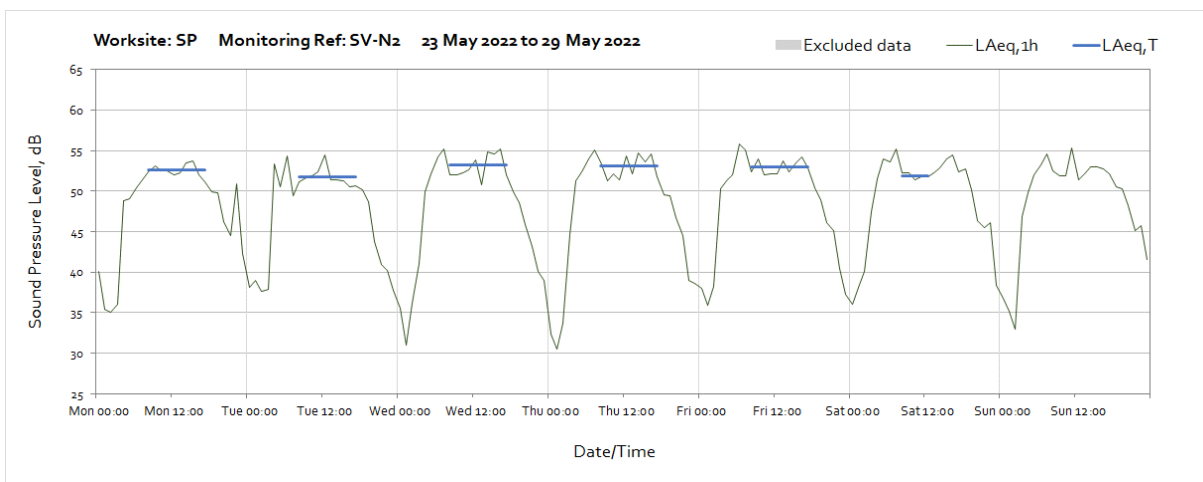
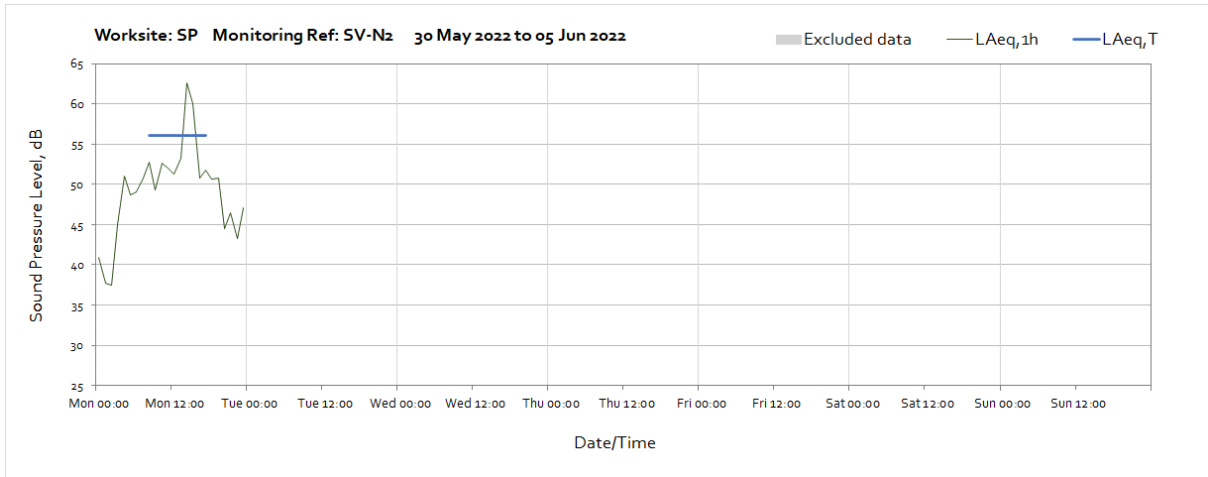
Worksite: SV – Monitoring Ref: SV-N2

Note: Missing date from the beginning of the month to Sunday 22nd May 2022 was due to a monitor fault.

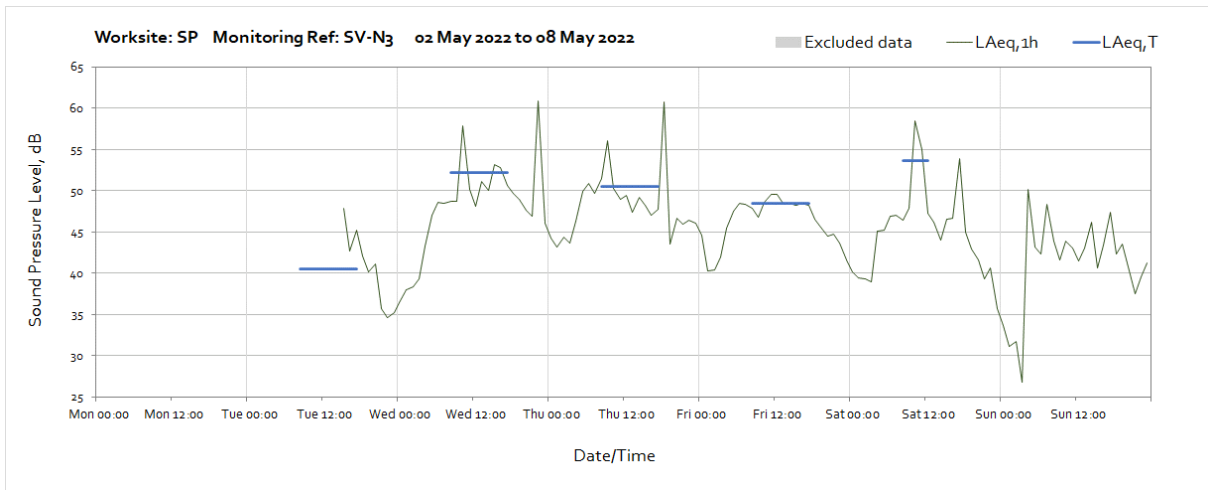
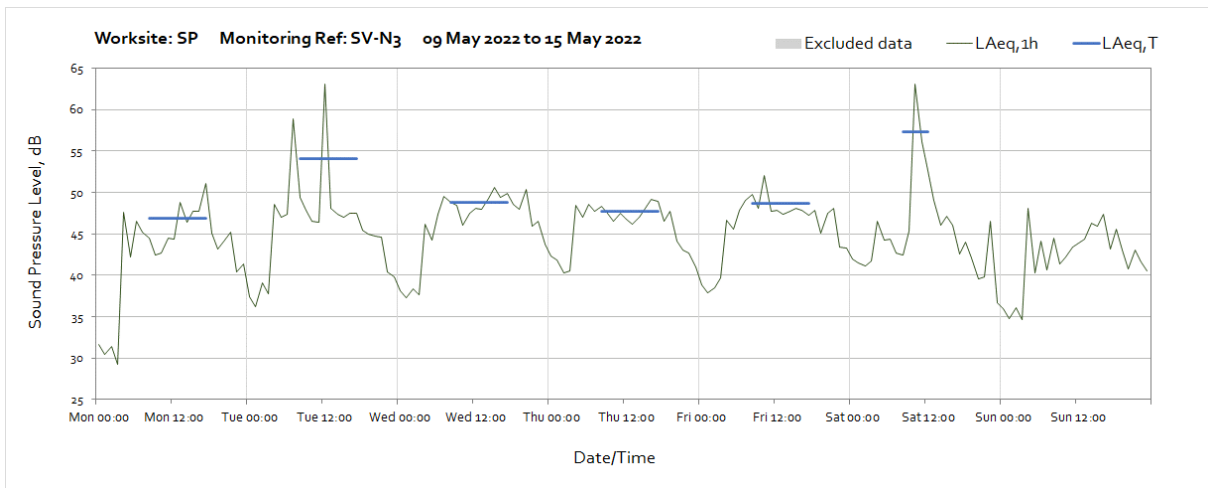
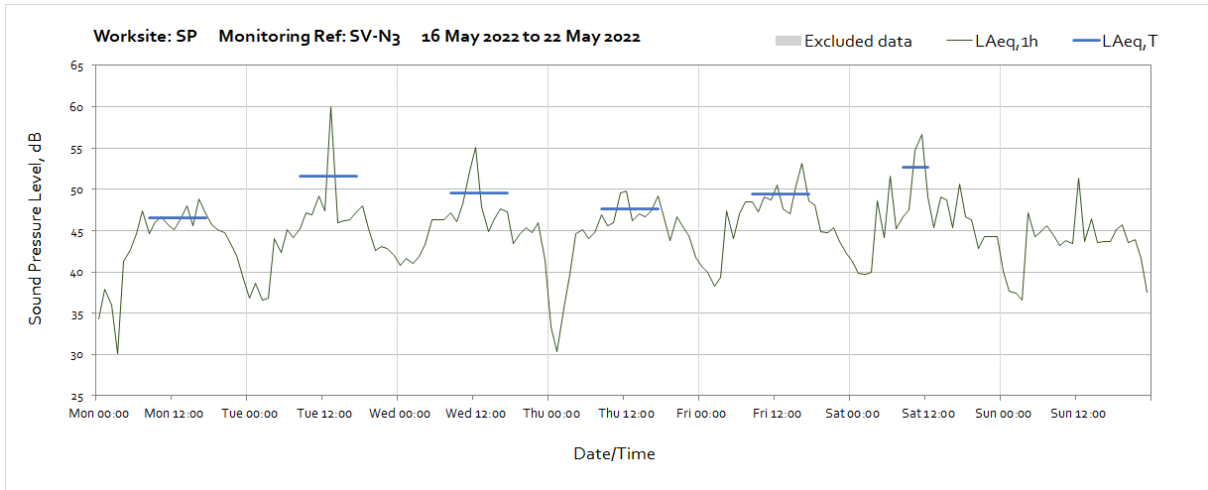
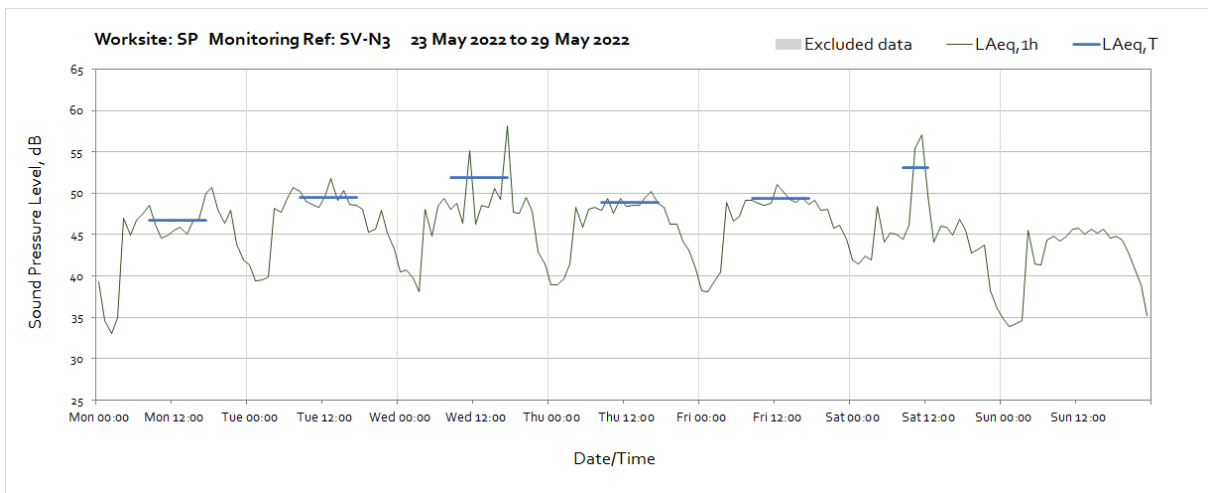
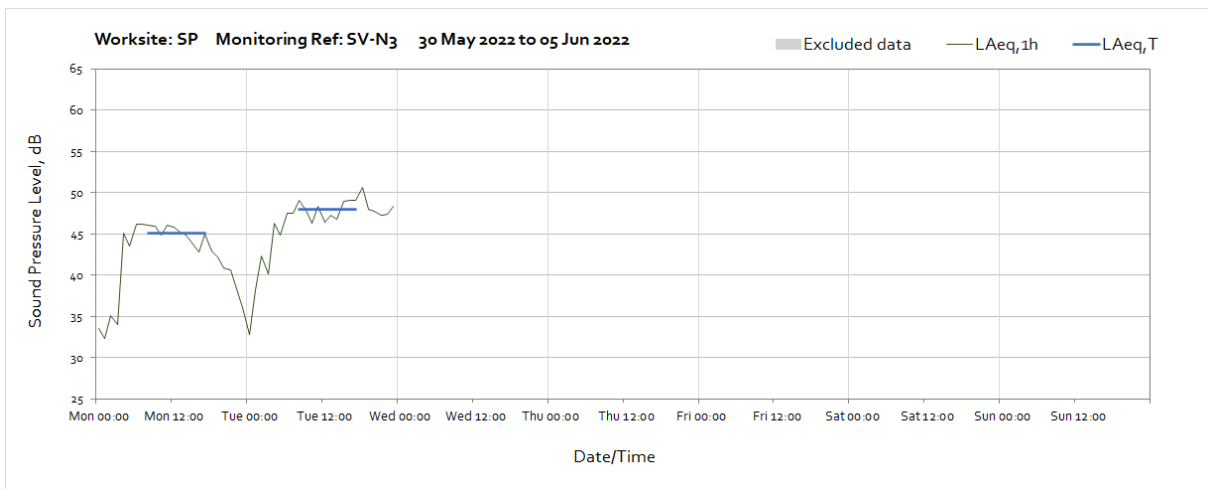
Worksite: SV – Monitoring Ref: SV-N3

Note: Missing data between the beginning of the month and Tuesday 3rd May 2022 was due to a monitor fault.

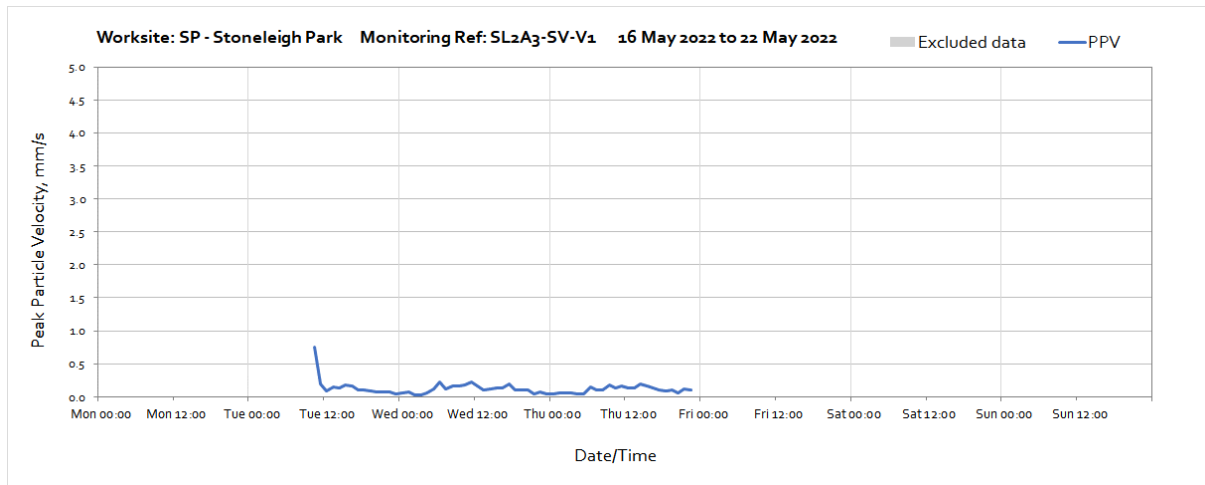
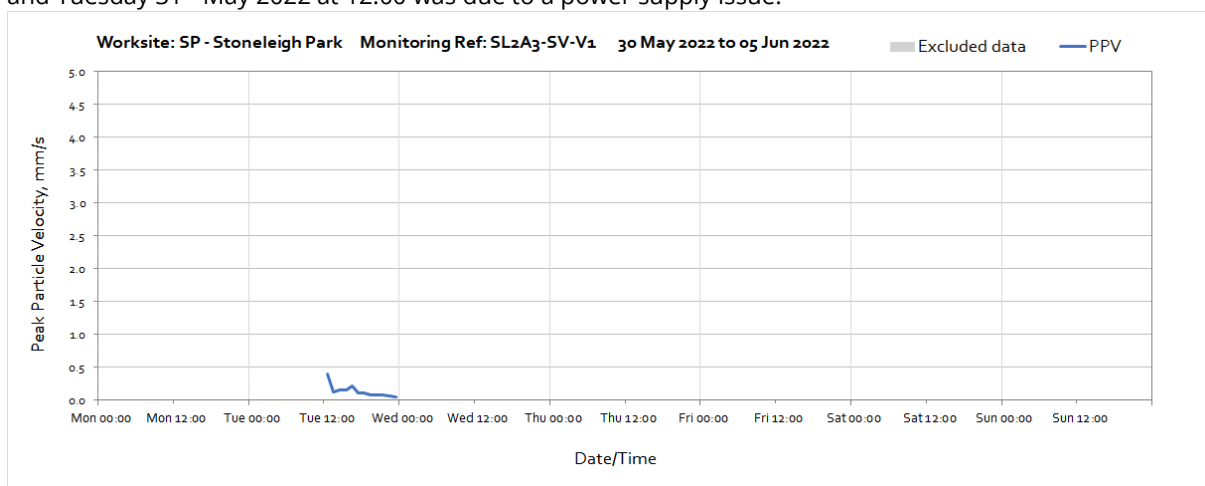
Worksite: SV – Monitoring Ref: SV-V1

The following graphs show the hourly measured peak particle velocity PPV recorded during the monitoring period. The graphs show the resultant PPV due to vibration components on three orthogonal axes x, y and z. Where resultant PPV data is not available (monitors V039 and V043), the highest vibration component in either of the three axes is presented for each 1hr measurement period respectively. Where high values of PPV were caused by local interference with the vibration monitor, which are not representative of HS2 construction works, these values have been greyed out in the following charts and have been excluded to calculate values in Table 4 of the main report.

Note: Monitor installed on Tuesday 17th May 2022. Missing data between Thursday 19th May 2022 at 23:00 and Tuesday 31st May 2022 at 12:00 was due to a power supply issue.

Note: Missing data between Thursday 19th May 2022 at 23:00 and Tuesday 31st May 2022 at 12:00 was due to a power supply issue.
