July 2022

Air Quality and Dust Monitoring Monthly Report - July 2022

City of Westminster

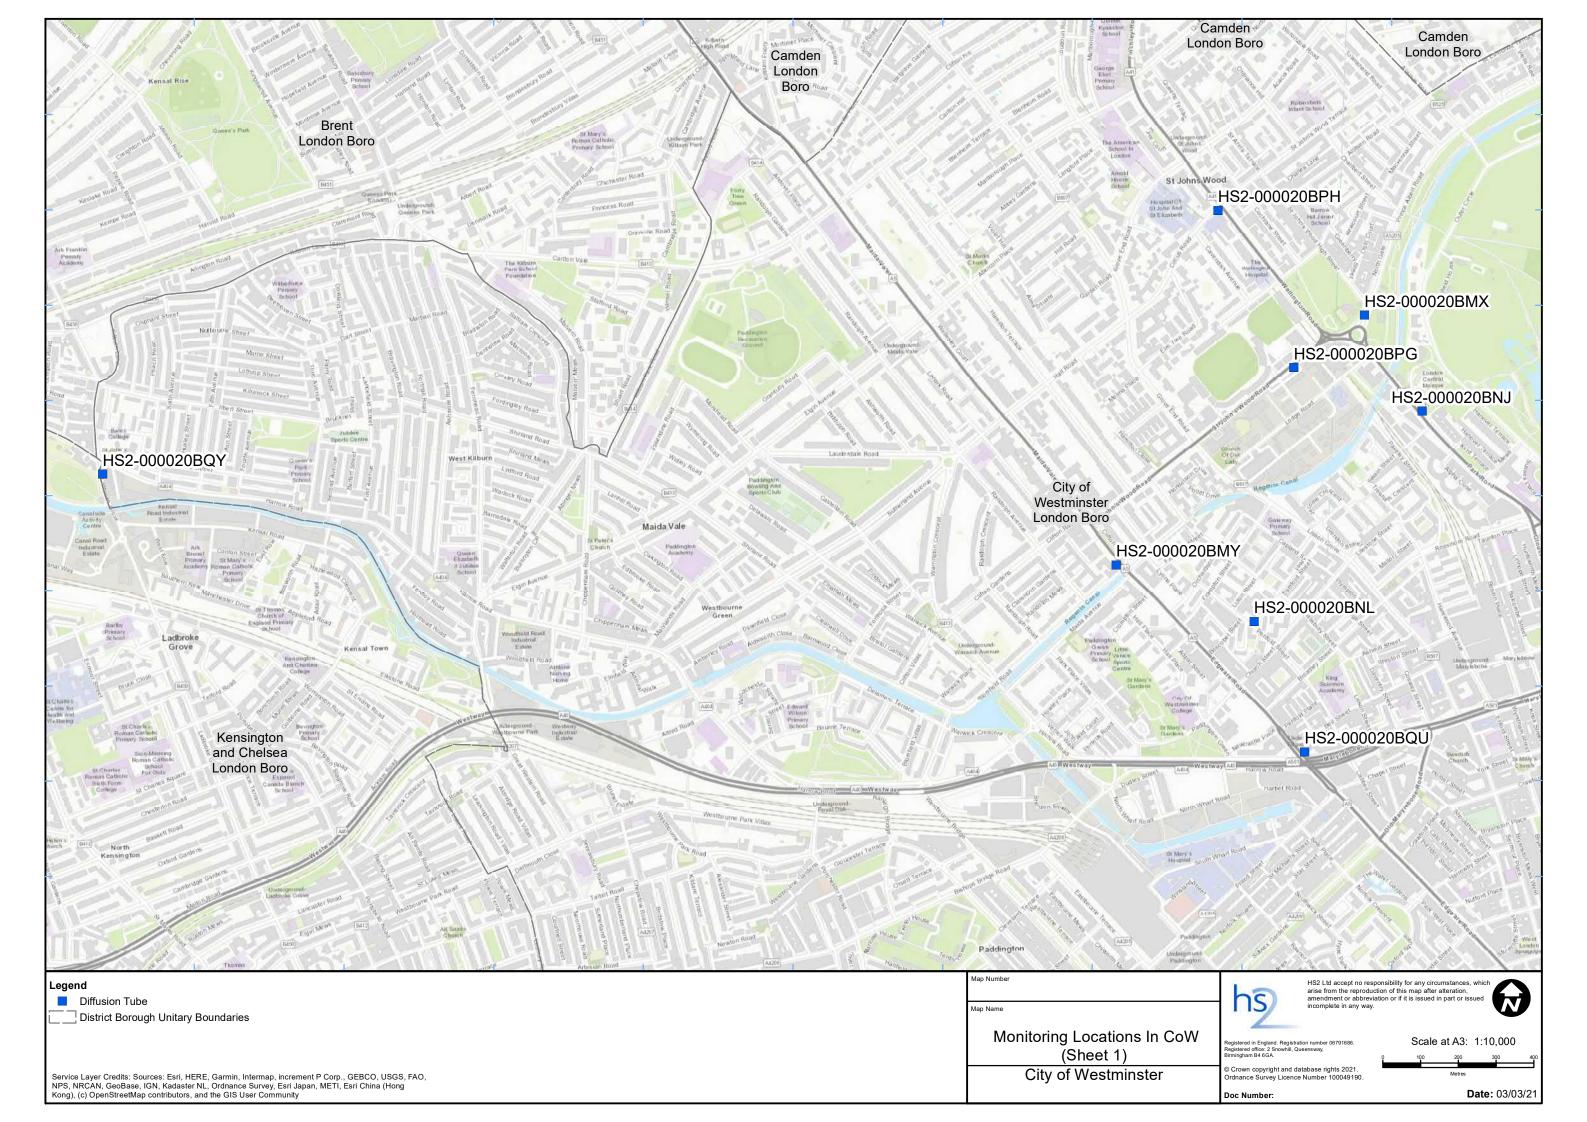
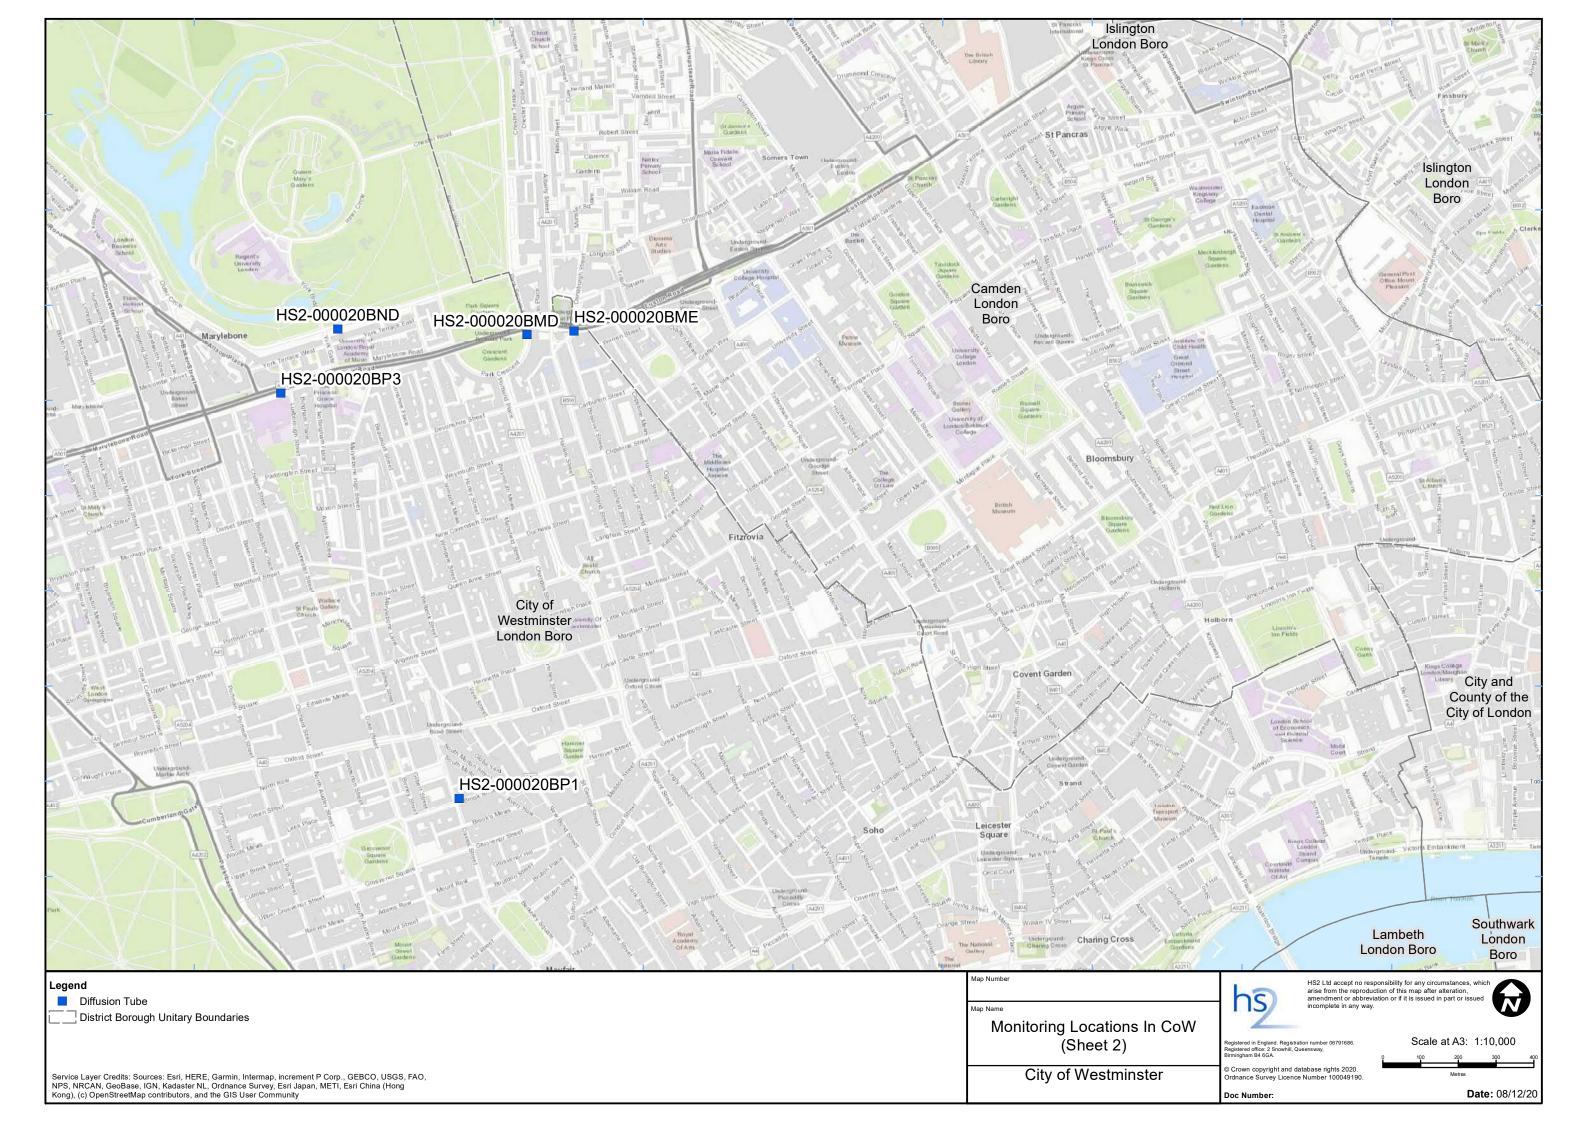
Figure 1 and Figure 2: Current monitoring locations within the COW

- 1.1.2 Figure 1 and Figure 2 in Appendix A indicate the current air quality monitoring locations.
- 1.1.3 This summary should be read in conjunction with the overview monitoring report available from www.gov.uk/government/collections/monitoring-the-environmental-effects-of-hs2, which highlights: the applicable standards and guidance, as well as the air quality and dust monitoring methodologies to be implemented by nominated undertakers throughout construction.

- 1.1.4 There are no current worksites located within the CoW. Therefore, no dust monitoring has been carried out.
- 1.1.5 Diffusion tube monitoring of Nitrogen Dioxide (NO₂) was undertaken at thirteen (13) locations around highways within the CoW as part of the management of air quality where significant effects may occur as a result of the scheme.
