## **Construction Noise and Vibration Monthly Report – July 2022**

**London Borough of Ealing**

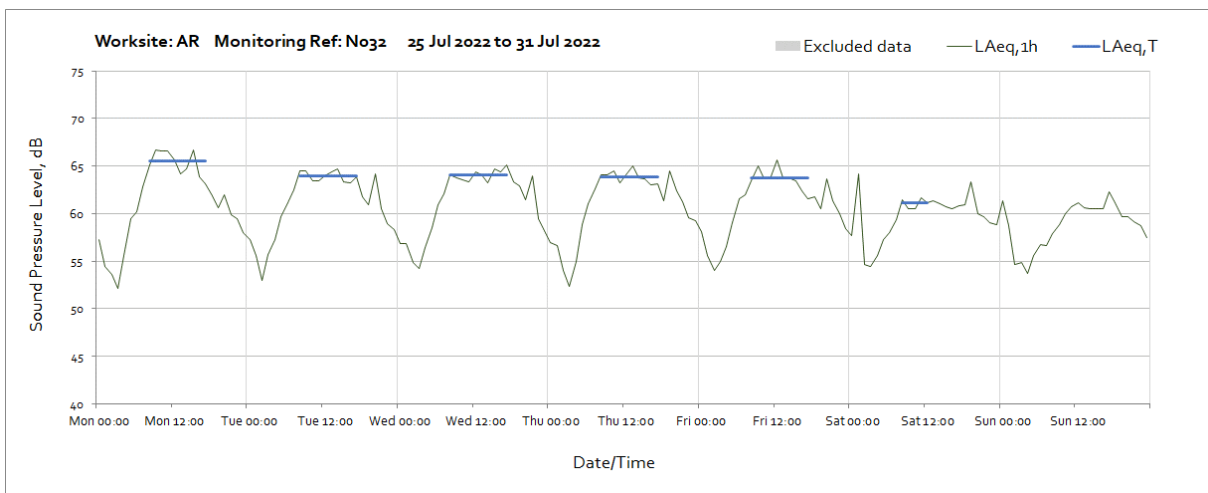
### Worksite: Atlas Road worksite (AR) – Monitoring Ref: N032

The following graphs show the hourly measured ambient noise level  $L_{Aeq,1h}$  and, where relevant, the averaged noise level  $L_{Aeq,T}$  values, where the time period T is as specified in Table 1 of HS2 Information Paper E23. Periods with adversely weather affected noise levels are greyed out and have been excluded from the calculation of the  $L_{Aeq,T}$  values in Table 3 of the main report.

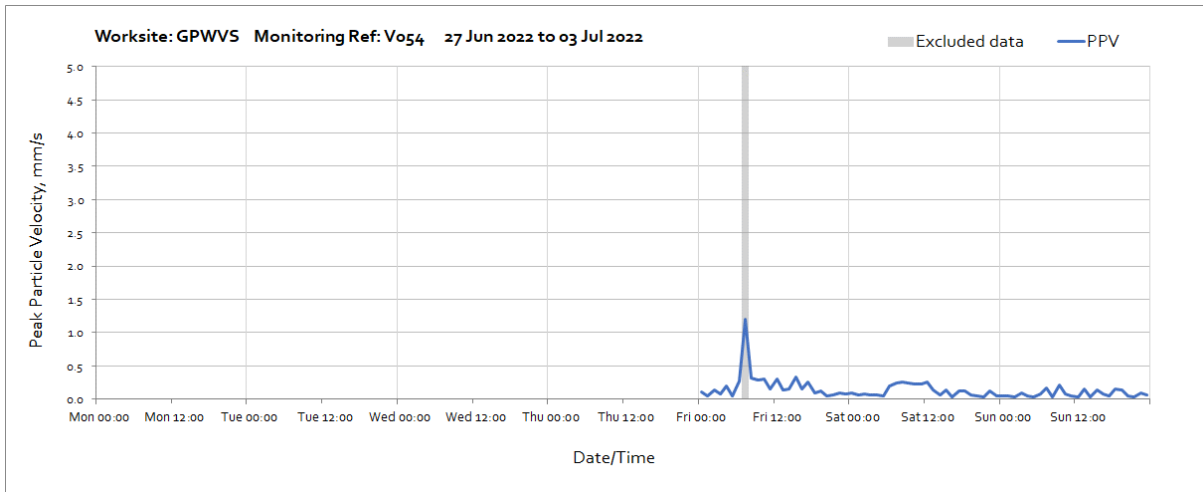
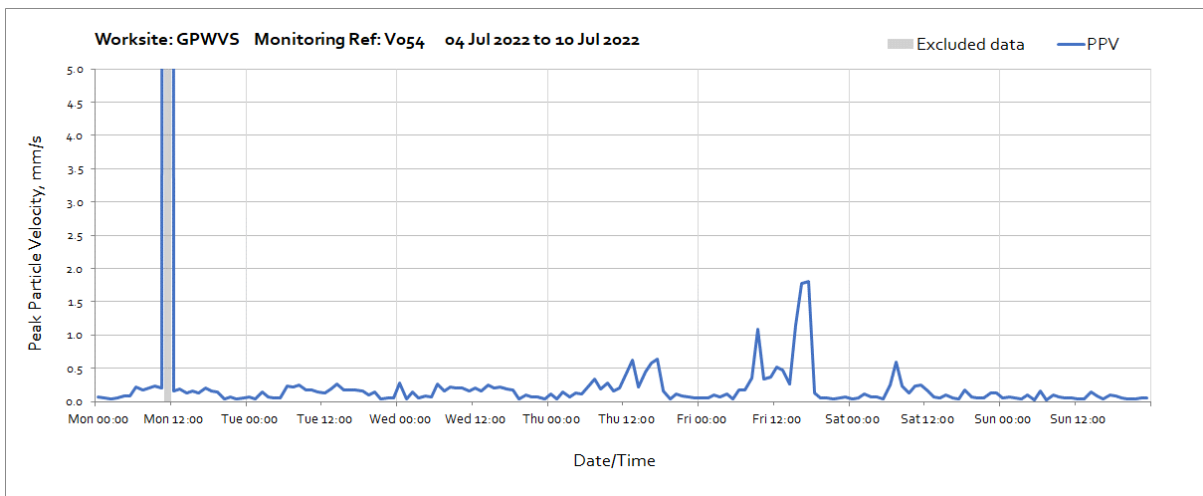
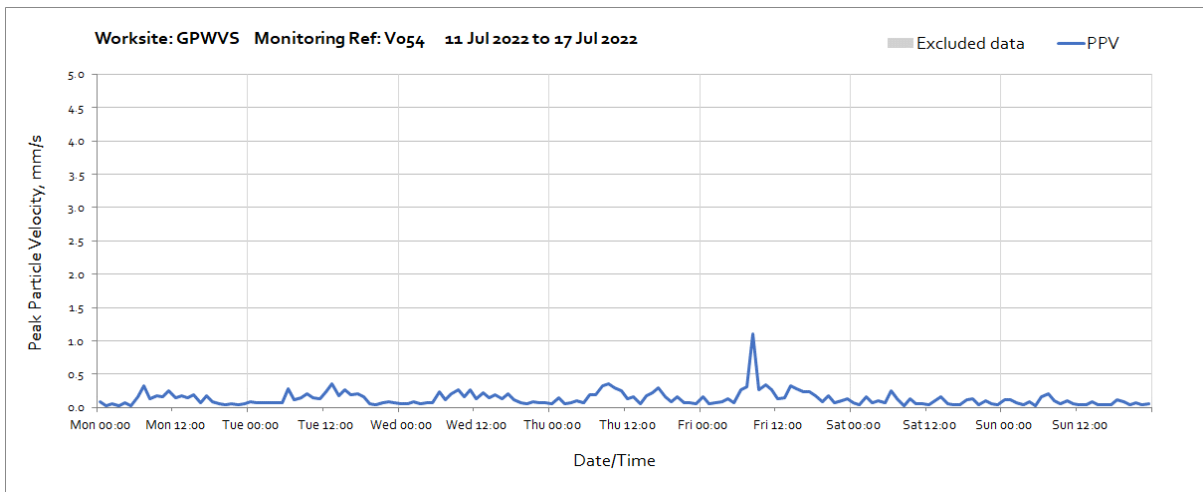
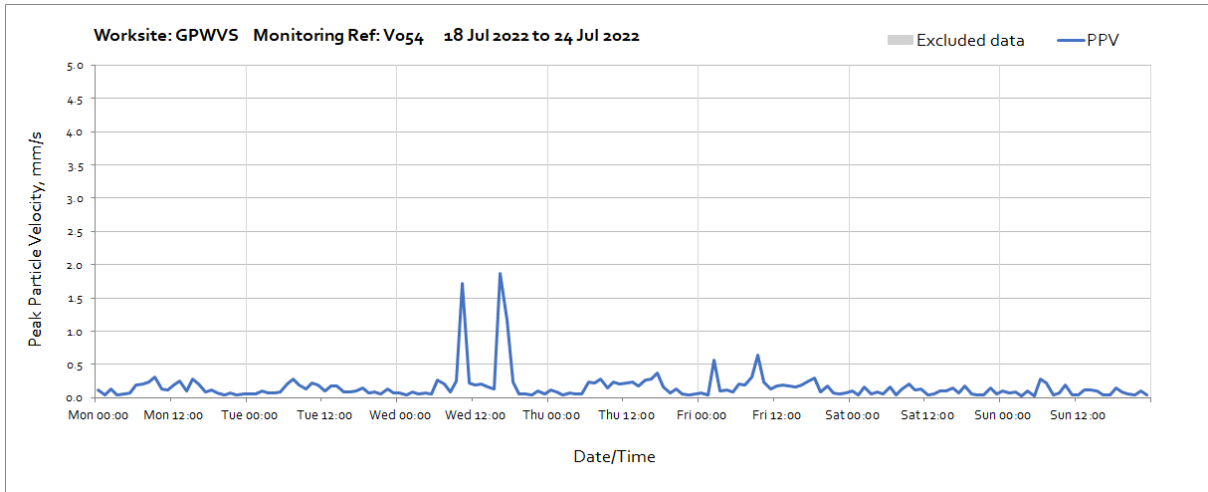
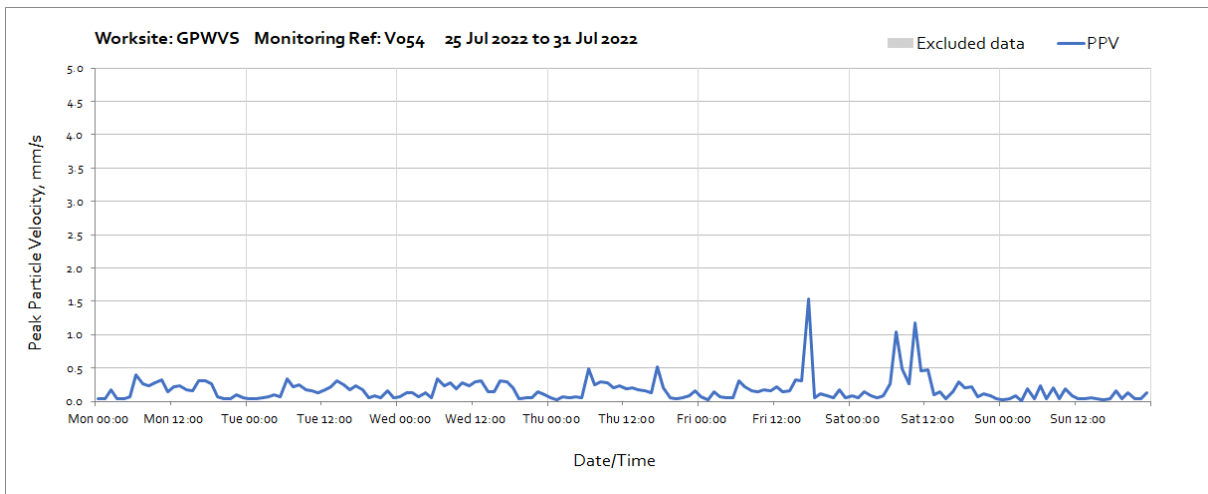
## Worksite: Green Park Way Vent Shaft (GPWVS) - Monitoring Ref: V054

The following graphs show the hourly measured peak particle velocity PPV recorded during the monitoring period. The graphs show the highest PPV of the three orthogonal axis x, y and z. Where high values of PPV were caused by local interference with the vibration monitor, which are not representative of HS2 construction works, these values have been greyed out in the following charts and have been excluded to calculate values in Table 4 of the main report.
