# HS2

September 2022

## **Construction Noise and Vibration Monthly Report – July 2022**

**North Warwickshire Borough Council**

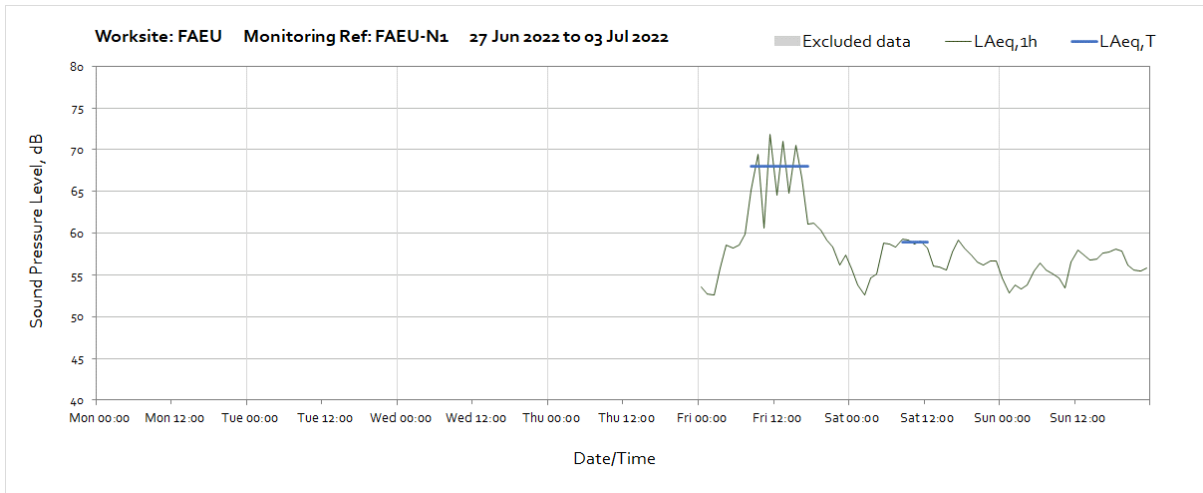
### Worksite: FAEU – Monitoring Ref: FAEU-N1

The following graphs show the hourly measured ambient noise level  $L_{Aeq,1h}$  and, where relevant, the averaged noise level  $L_{Aeq,T}$  values, where the time period T is as specified in Table 1 of HS2 Information Paper E23. Periods with adversely weather affected noise levels are greyed out and have been excluded from the calculation of the  $L_{Aeq,T}$  values in Table 3 of the main report.:

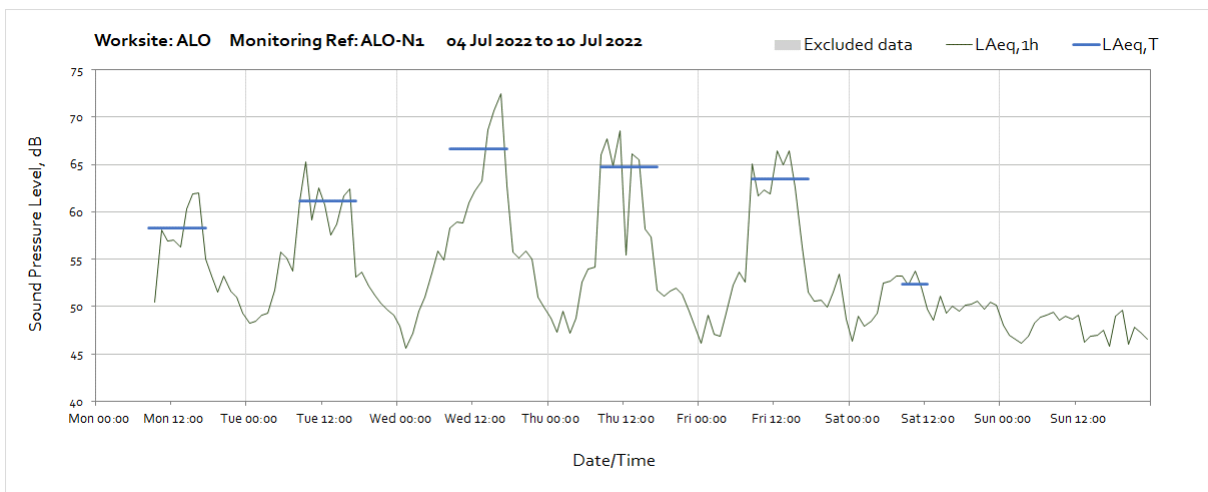
**Worksite: ALO – Monitoring Ref: ALO-N1**

Note: Missing data from 21:00 on Friday 1<sup>st</sup> July until 09:00 on Monday 4<sup>th</sup> July was due to a firmware error within the monitoring station.

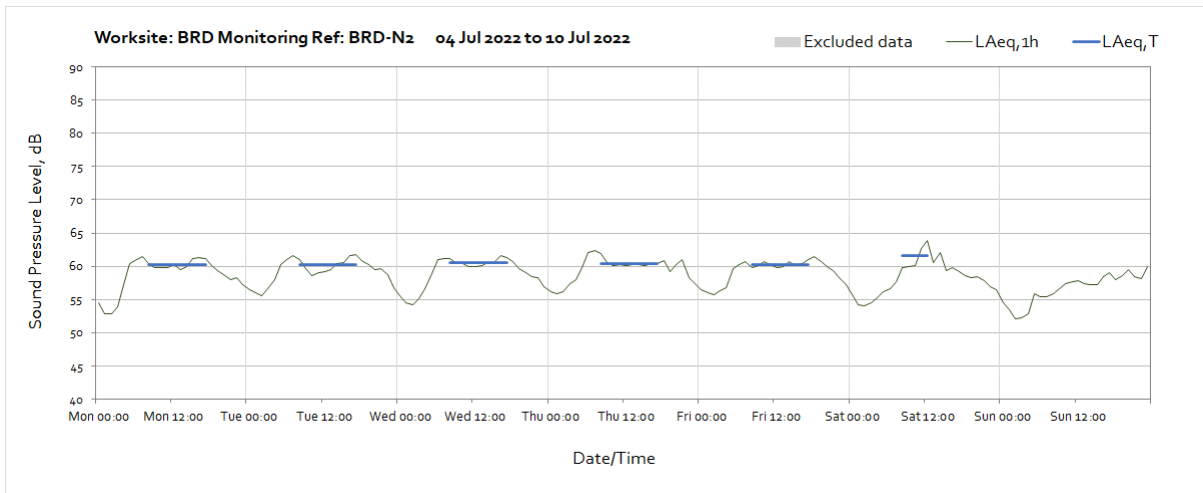
## Worksite: BRD - Monitoring Ref: BRD-N2

Note: Missing data Friday 26<sup>th</sup> at 1700 due to an intermittent power issue.

2.2.8 Two (2) exceedances of SOAEL were recorded at monitoring location ref.: BRD-N2 and monitoring location ref.: BFCV-N1 due to HS2 construction works during July 2022.

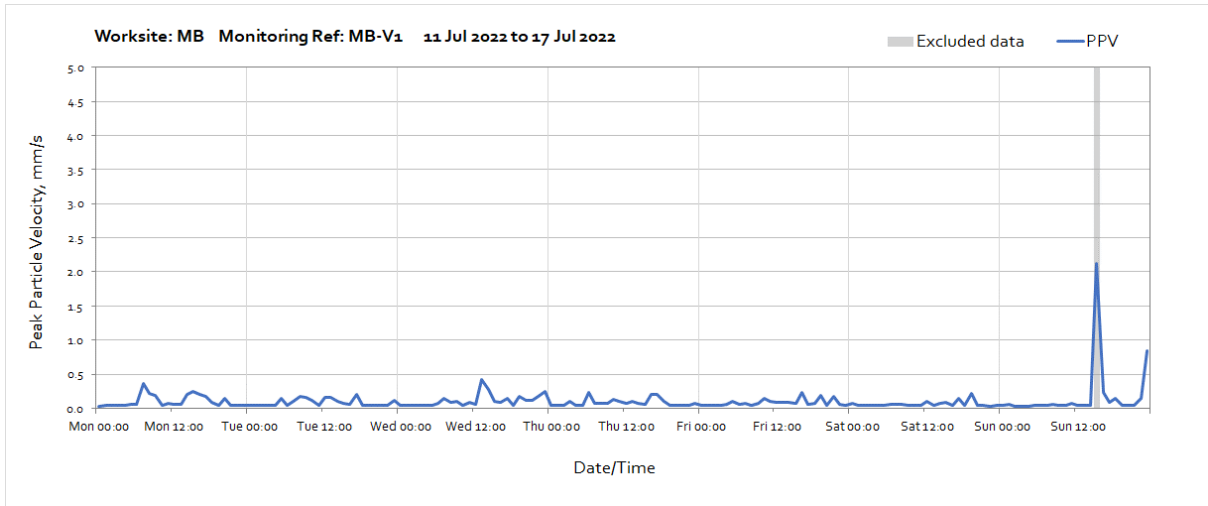
### Worksite: MB - Monitoring Ref: MB-V1

The following graphs show the hourly measured peak particle velocity PPV recorded during the monitoring period. The graphs show the highest PPV of the three orthogonal axes x, y and z. Where high values of PPV were caused by local interference with the vibration monitor, which are not representative of HS2 construction works, these values have been greyed out in the following charts and have been excluded to calculate values in Table 4 of the main report.

Note: Missing data 0900 Thursday 28<sup>th</sup> July was due to an intermittent issue with the meter.
