## **Construction Noise and Vibration Monthly Report – July 2022**

**West Northamptonshire District Council**

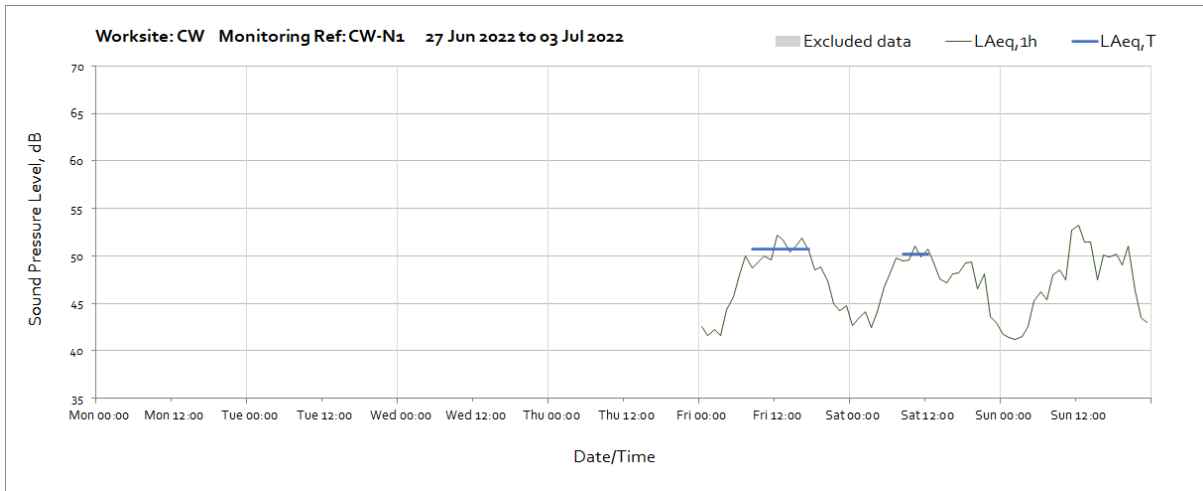
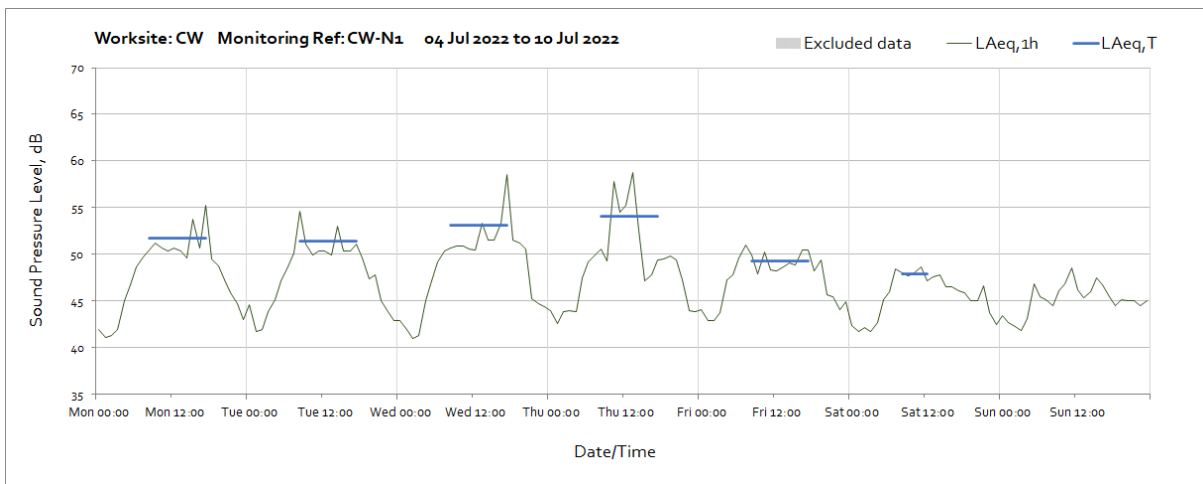
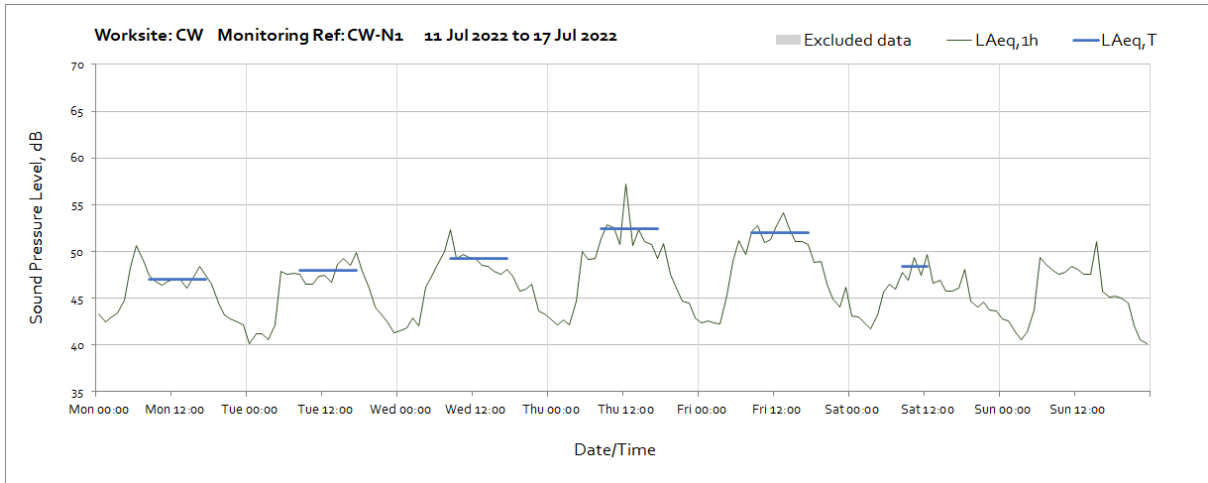
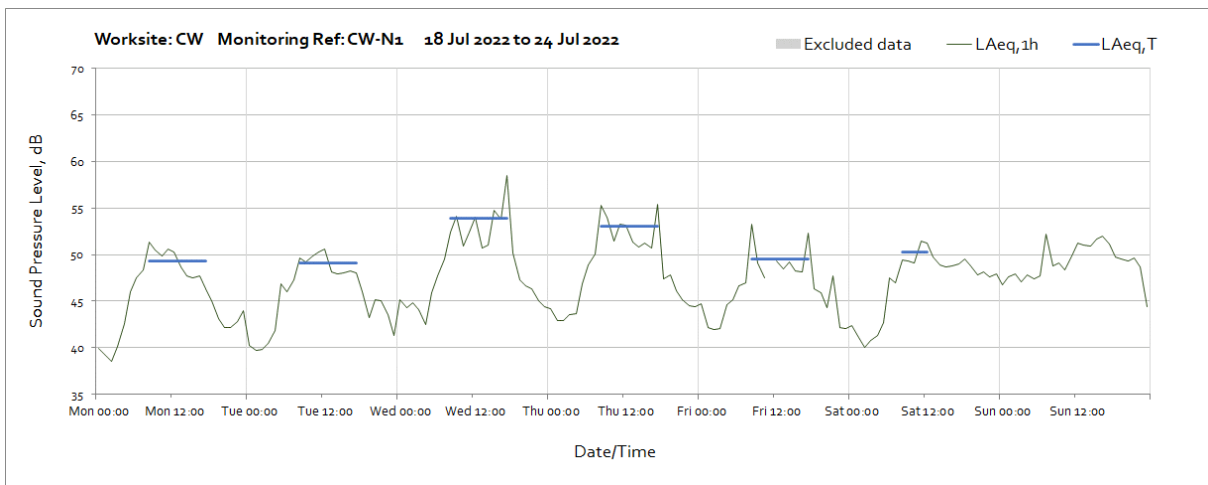
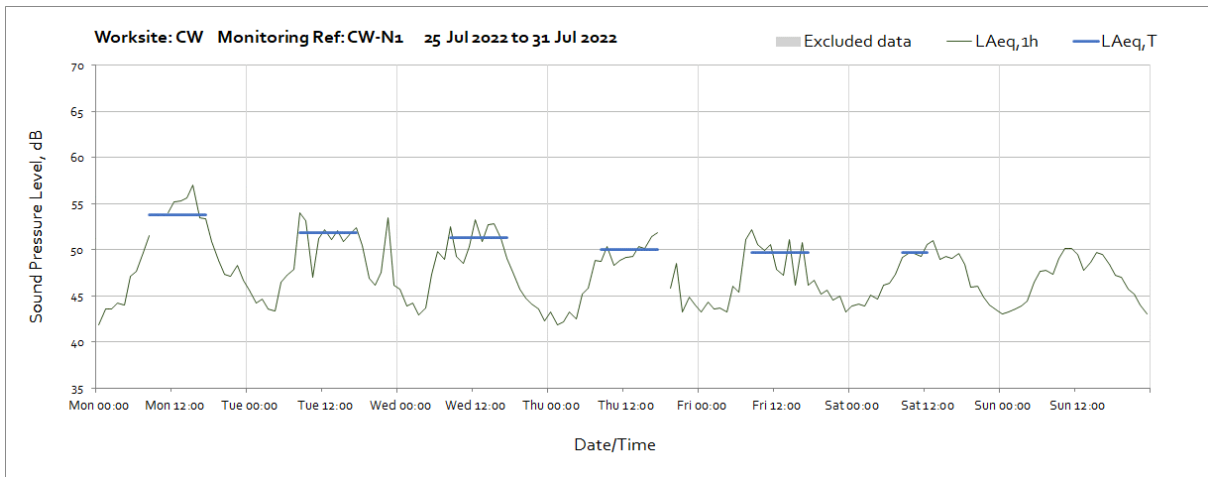
### Worksite: CW – Monitoring Ref: CW-N1

The following graphs show the hourly measured ambient noise level  $L_{Aeq,1h}$  and, where relevant, the averaged noise level  $L_{Aeq,T}$  values, where the time period T is as specified in Table 1 of HS2 Information Paper E23. Periods with adversely weather affected noise levels are greyed out and have been excluded from the calculation of the  $L_{Aeq,T}$  values in Table 3 of the main report.

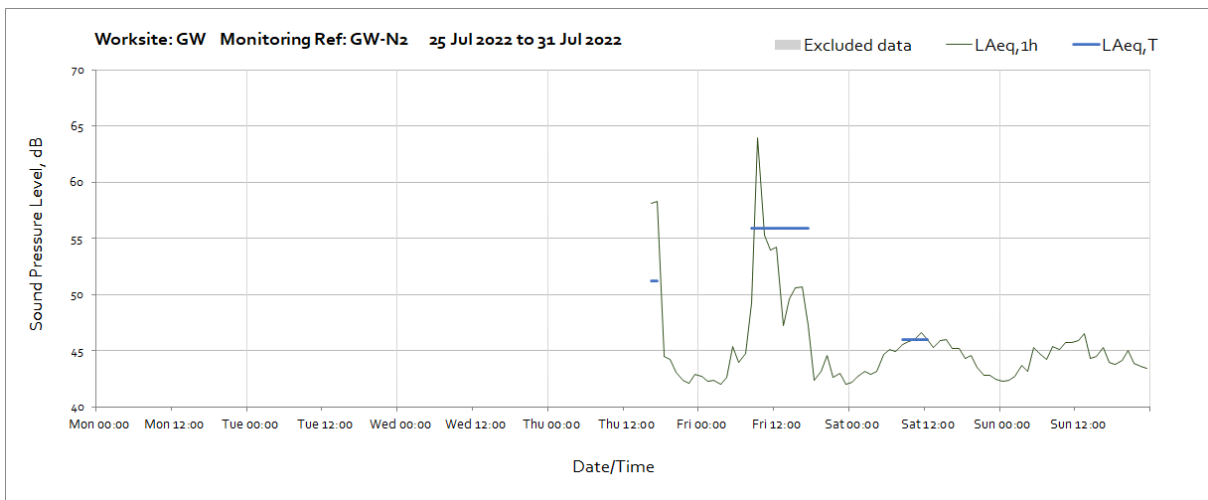
**Worksite: GW - Monitoring Ref: GW-N2**

Note: Monitor installed on 28<sup>th</sup> July 2022.
