Air Quality and Dust Monitoring Monthly Report - August 2022

West Northamptonshire District Council

Air Quality and Dust Monitoring Summary Report, August 2022 West Northamptonshire Council

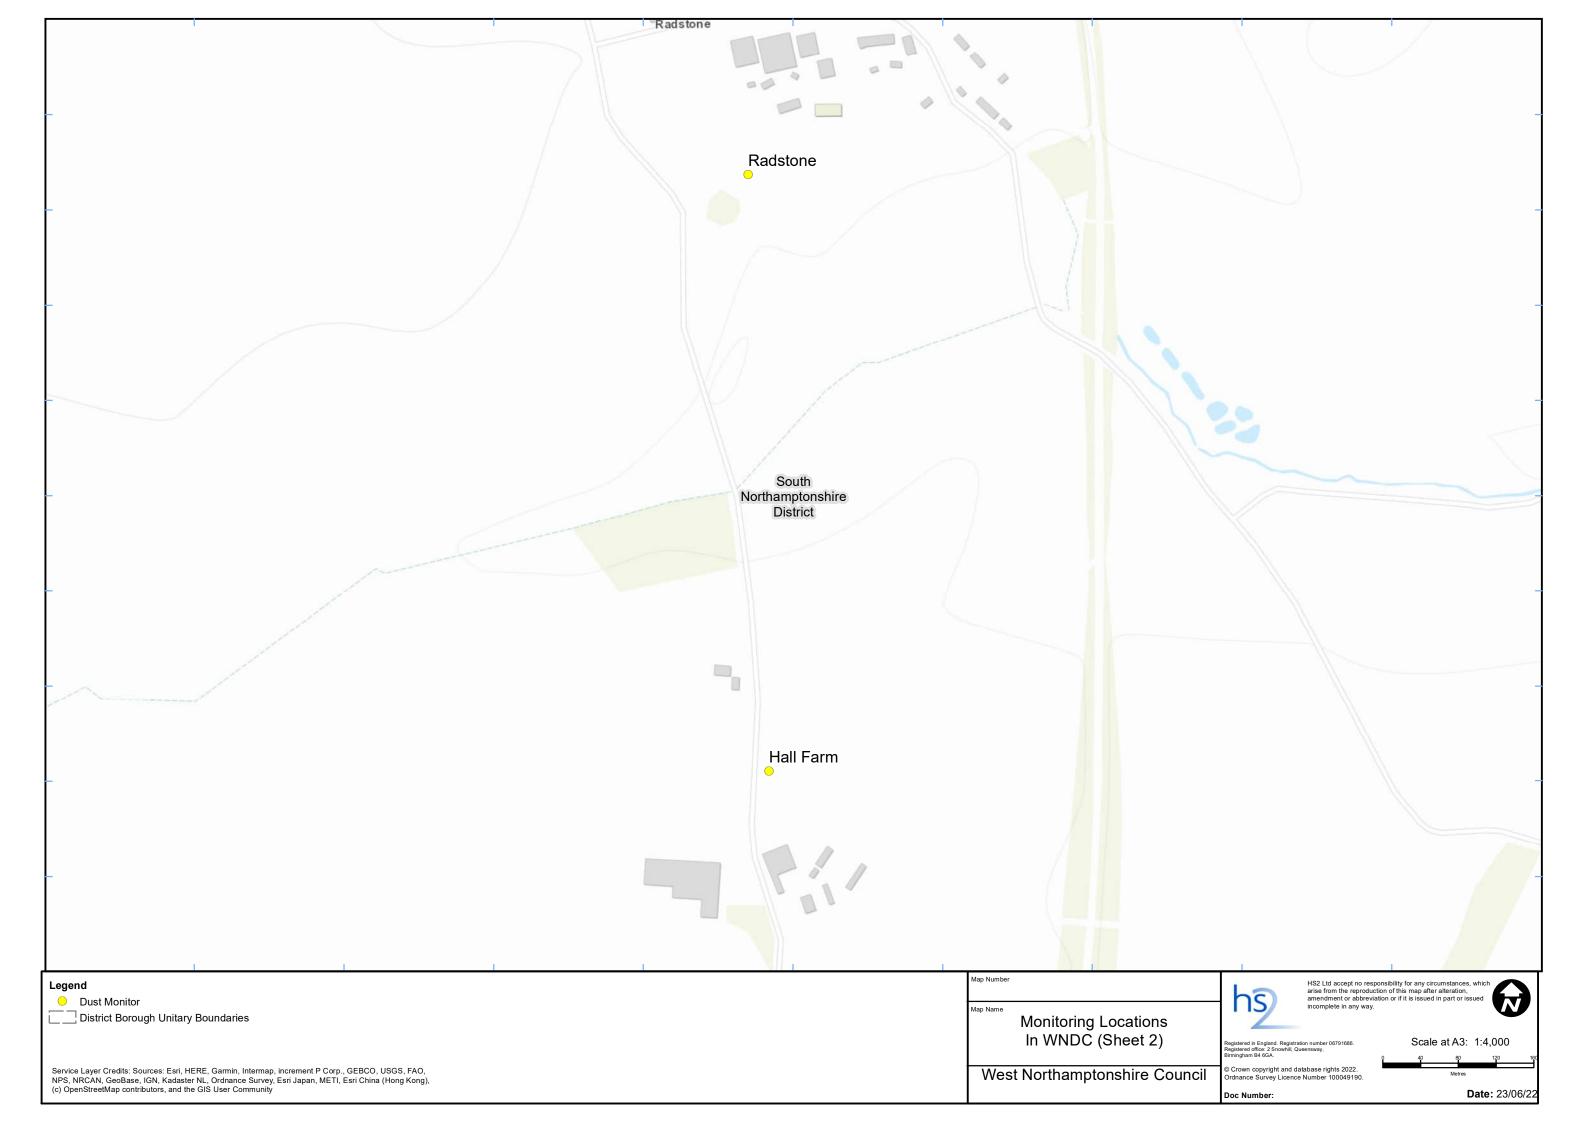
Figure 1 and 2: Worksite and Monitoring locations during August 2022 – Chipping Warden – RAMAC & CW Village - Dust

- 1.1.2 Figures 1 and 2 in Appendix A present the current worksites together with the dust monitoring locations for August 2022.
- 1.1.3 This summary should be read in conjunction with the overview monitoring report available from www.gov.uk/government/collections/monitoring-the-environmental-effects-of-hs2, which highlights: the applicable standards and guidance, as well as the air quality and dust monitoring methodologies to be implemented by nominated undertakers throughout construction.

- 1.1.4 The current worksites, as presented in Appendix A, Figures 1 and 2, include:

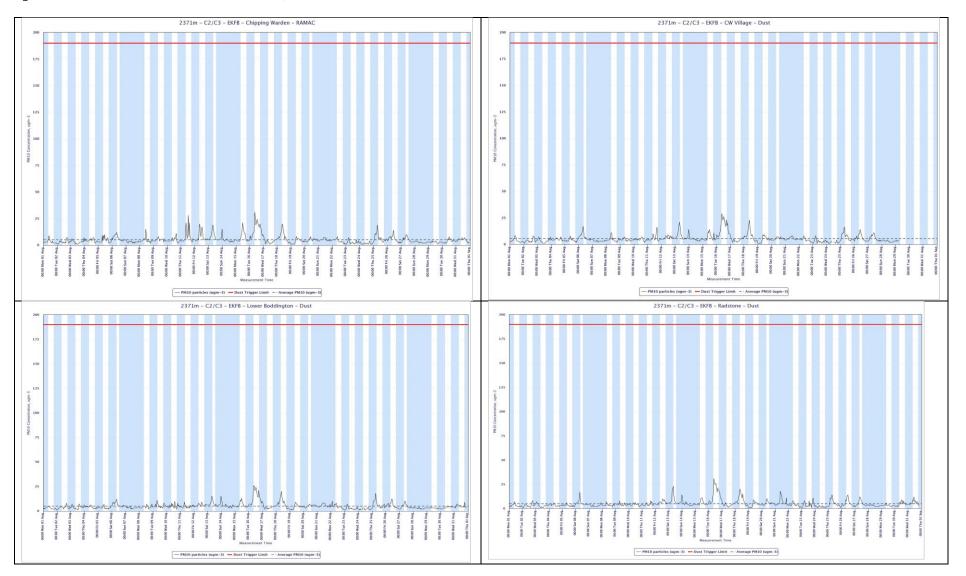
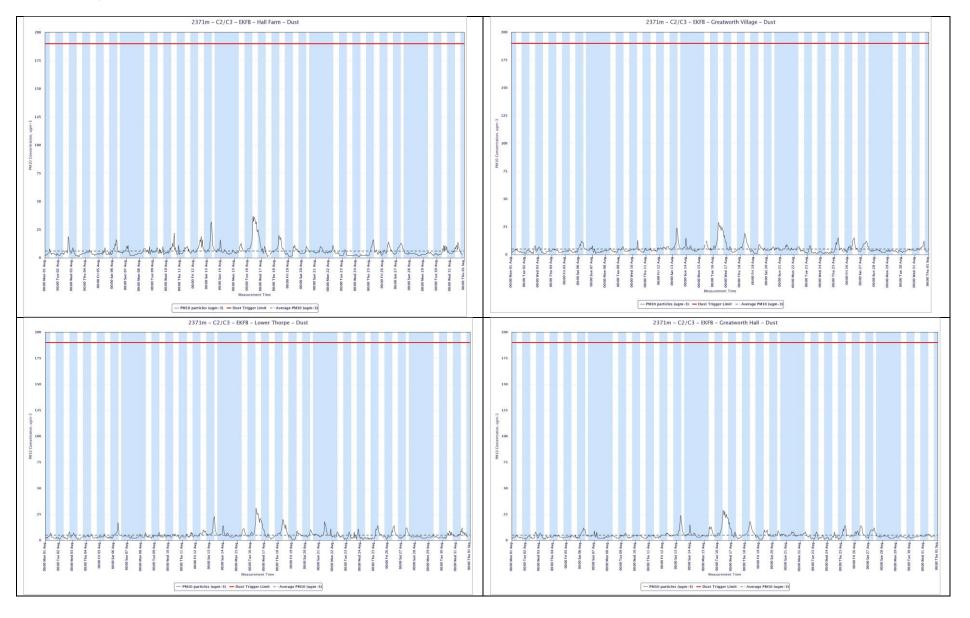
Figure 3: Continuous dust 1-hour mean indicative PM₁₀ concentration for all monitors

- 1.1.6 The trigger level for PM₁₀ concentrations of 190 μg/m³, over a 1-hour period, in accordance with the updated guidance document 'Guidance on Monitoring in the Vicinity of Demolition and Construction Sites (October 2018)' has been applied.
- 1.1.7 No (0) trigger alerts were recorded during the monitoring period (August 2022).
- 1.1.8 Data capture was below 90% at the Fire Tree Nursery monitor for the month of August 2022 as a result of damage to the controller box caused by water ingress.
- 1.1.9 There were no (0) complaints received during the reporting period.
