## **Construction Noise and Vibration Monthly Report – August 2022**

**London Borough of Ealing**

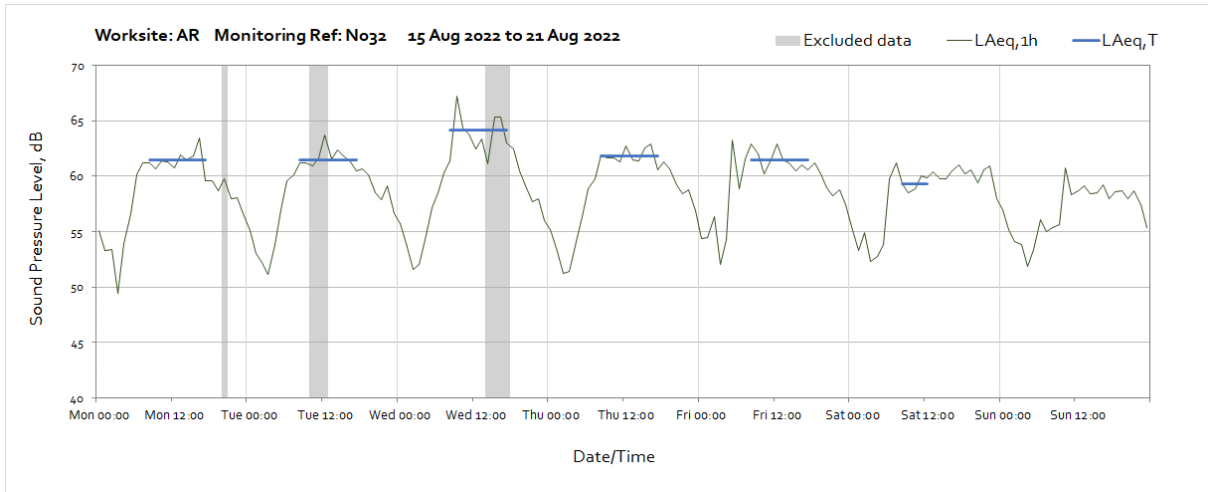
### Worksite: Atlas Road worksite (AR) – Monitoring Ref: N032

The following graphs show the hourly measured ambient noise level  $L_{Aeq,1h}$  and, where relevant, the averaged noise level  $L_{Aeq,T}$  values, where the time period T is as specified in Table 1 of HS2 Information Paper E23. Periods with adversely weather affected noise levels are greyed out and have been excluded from the calculation of the  $L_{Aeq,T}$  values in Table 3 of the main report.

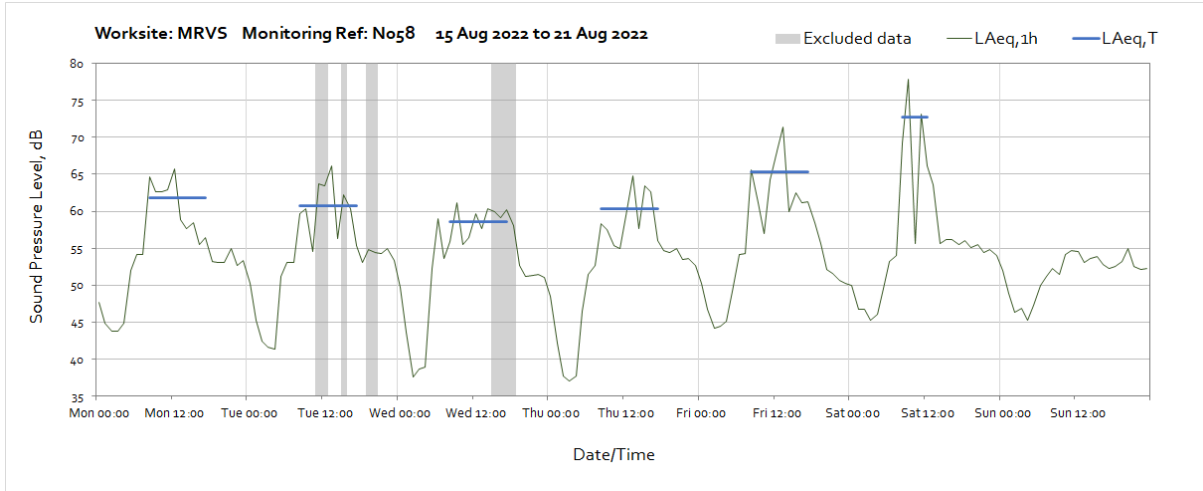
**Worksite: Mandeville Road Ventilation Shaft (MRVS) – Monitoring Ref: N058**

Note: Missing data between 00:01 on Saturday 27<sup>th</sup> August and 10:00 on Tuesday 30<sup>th</sup> August was due to loss of continuous power at the monitoring station.

2.2.2 Seven (7) exceedances of the SOAEL was recorded due to HS2 construction works during August 2022. The exceedance occurred at the noise monitors N033 and N049 during two and three weekday daytime periods respectively. At the noise monitor N041 the exceedance accrued during one night-time periods and at the noise monitor N058 during one Saturday daytime periods.

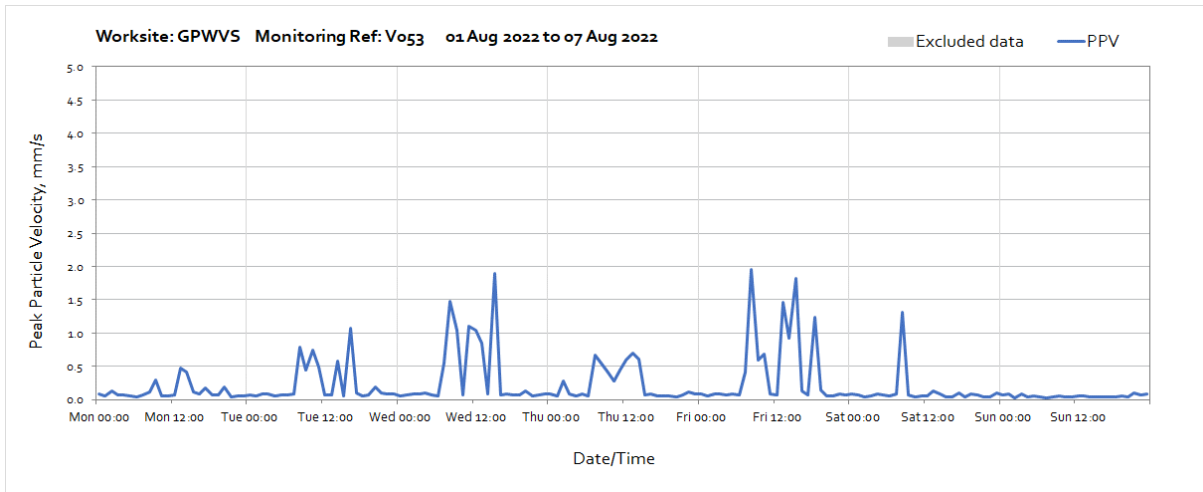
## Worksite: Green Park Way Vent Shaft (GPWVS) – Monitoring Ref: V053

The following graphs show the hourly measured peak particle velocity PPV recorded during the monitoring period. The graphs show the highest PPV of the three orthogonal axis x, y and z. Where high values of PPV were caused by local interference with the vibration monitor, which are not representative of HS2 construction works, these values have been greyed out in the following charts and have been excluded to calculate values in Table 4 of the main report.

Note: Missing data between 09:00 on Wednesday 10<sup>th</sup> August and 14:00 on Thursday 11<sup>th</sup> August was due to loss of power at the monitoring station.
