# **Construction Noise and Vibration Monthly Report – August 2022**

**West Northamptonshire District Council**

### **Non-Technical Summary**

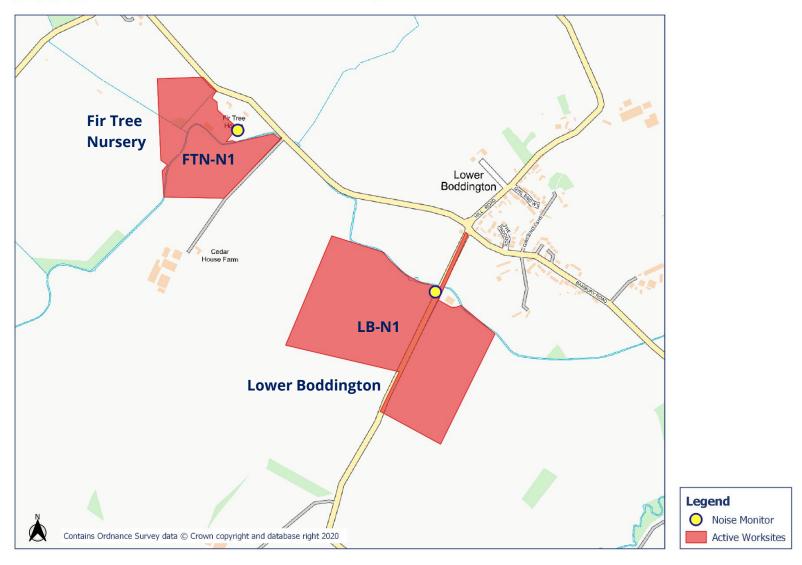
#### **Noise Monitoring Plan - 1**

Table 2 summarises the position of noise monitoring installations within the WNDC area in August 2022.
- 1.2.2 No data was recorded in August 2022 at Fir Tree Nursery, worksite ref.: FTN due to damage of the monitor. No data was recorded in August 2022 at Chipping Warden, worksite ref.: CW due to a SIM card malfunction within the monitor.
- 1.2.3 Maps showing the position of noise monitoring installations are presented in Appendix B.

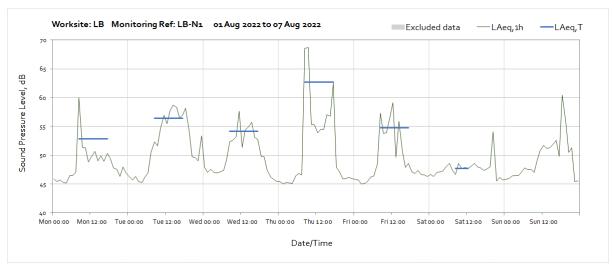
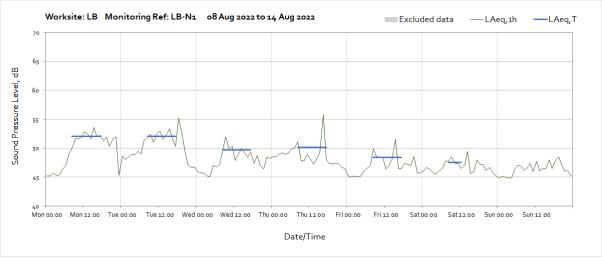
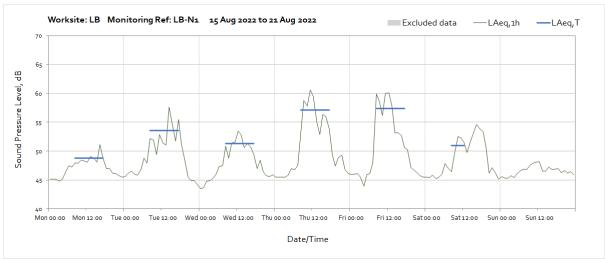
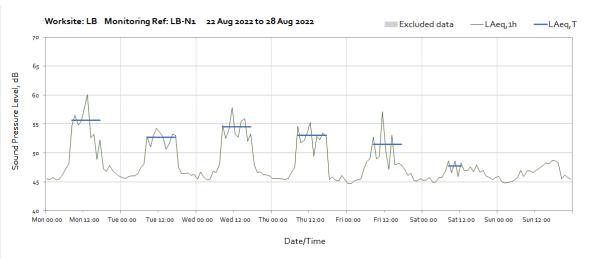
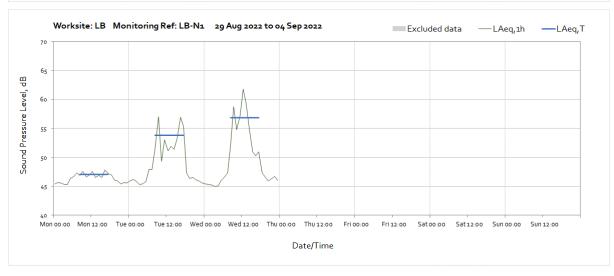
#### Worksite: LB - Monitoring Ref: LB-N1

The following graphs show the hourly measured ambient noise level  $L_{Aeq,1h}$  and, where relevant, the averaged noise level  $L_{Aeq,T}$  values, where the time period T is as specified in Table 1 of HS2 Information Paper E23. Periods with adversely weather affected noise levels are greyed out and have been excluded from the calculation of the  $L_{Aeq,T}$  values in Table 3 of the main report.

Worksite Reference	Measurement Reference	Site Address	Free-Field or Façade Measurement	Weekday Average L <sub>Aeq,T</sub> (Highest Day L <sub>Aeq,T</sub> )			Saturday Average L <sub>Aeq,T</sub> (Highest Day L <sub>Aeq,T</sub> )				Sunday / Public Holiday Average L <sub>Aeq,T</sub> (Highest Day L <sub>Aeq,T</sub> )				
				0700 - 0800	0800 - 1800	1800 - 1900	1900 - 2200	2200 - 0700	0700 - 0800	0800 - 1300	1300 - 1400	1400 - 2200	2200 - 0700	0700 - 2200	2200 - 0700
LB	LB-N1	Lower Boddington, West Northamptonshire	Free-field	47.4	46.4	47.3	48.5	48.0	48.9	45.8	48.6	45.8	47.4	46.4	47.3

Worksite Reference	Measurement Reference	Site Address	Day (Weekday, Saturday, Sunday, Night)	Time period	Number of exceedances of LOAEL	Number of exceedances of SOAEL
LB	LB-N1	Lower Boddington, West Northamptonshire	Weekday	0800-1800	1	No exceedances
RA	RA-N1	Radstone Road, Brackley	Weekday	0800-1800	4	No exceedances
	HF-N1	Hall Farm, Brackley	Weekday Saturday	0800-1800 1400-2200	1 1	No exceedances
LT	LT-N1	Thorpe Mandeville, Banbury	Weekday	0800-1800	4	No exceedances
GW	GW-N1	Helmdon Road, Greatworth	All days	All periods	No exceedances	No exceedances
	GW-N2	Greatworth Hall, Greatworth	Weekday	0800-1800	8	No exceedances

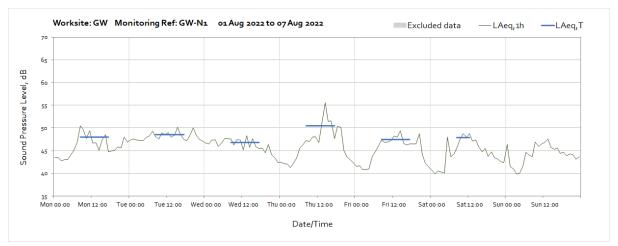
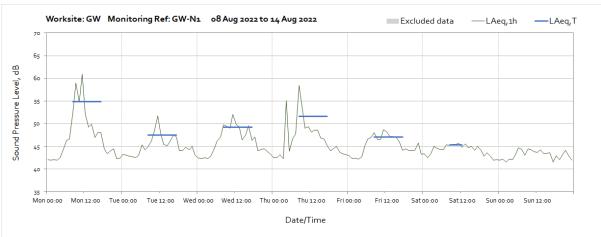
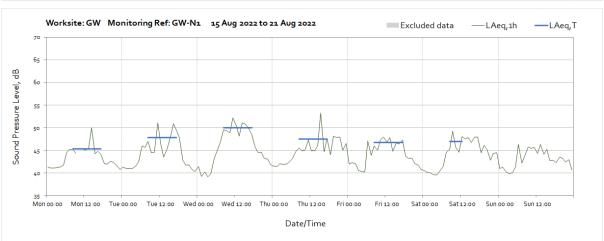
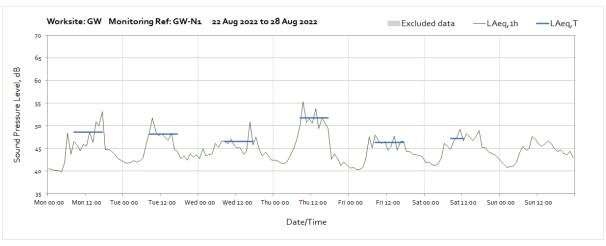
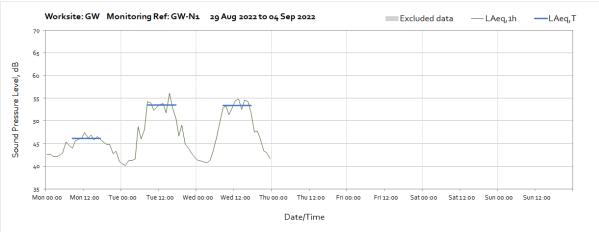
#### Worksite: GW - Monitoring Ref: GW-N1

Note: Missing data at 10:00 on 15<sup>th</sup> August was due to maintenance of the monitor.

(52.4)	(46.9)	(41.0)	(44.3)	(46.4)	(48.6)	(46.3)	(44.9)	(41.9)	(52.4)	(46.9)	(41.0)
GW	GW-N1	Helmdon Road, Greatworth	Free-field	44.8	43.4	44.9	46.8	47.1	45.5	42.6	44.7	42.8	44.8	43.4	44.9
