Construction Noise and Vibration Monthly Report – September 2022

Stratford-on-Avon District Council

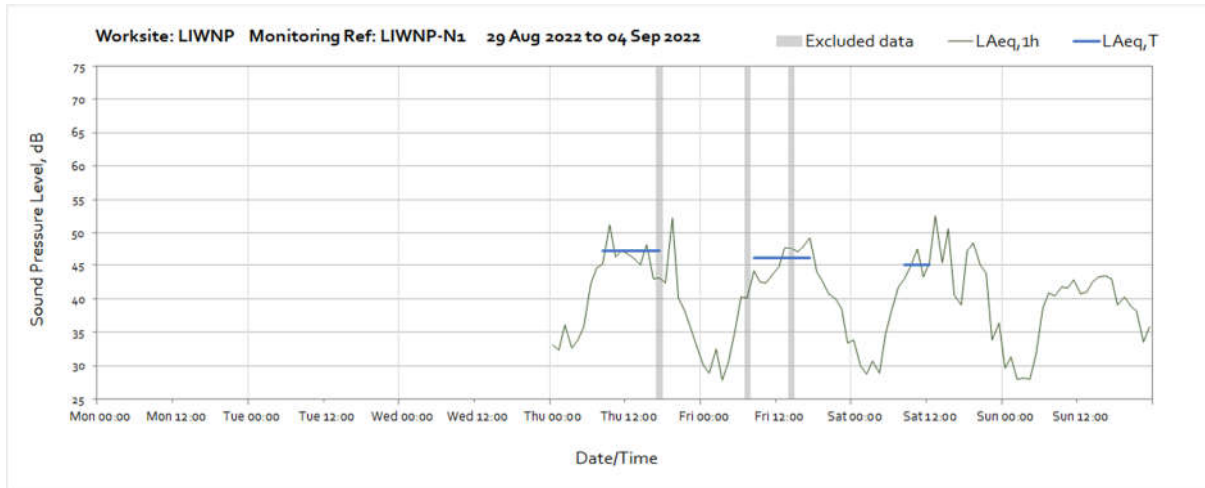
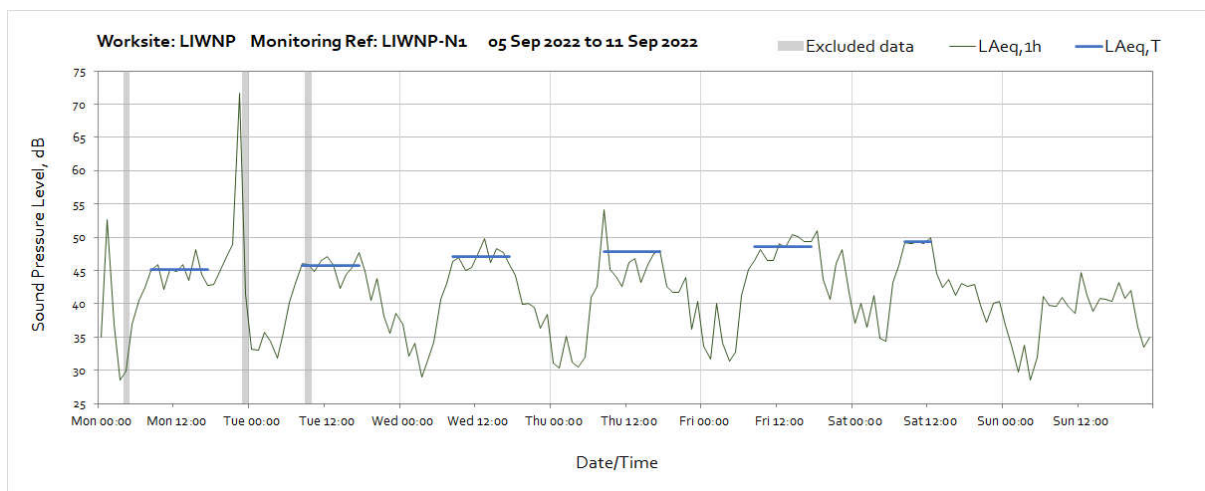
Worksite: LIWNP Monitoring Ref: LIWNP-N1

The following graphs show the hourly measured ambient noise level $L_{Aeq,1h}$ and, where relevant, the averaged noise level $L_{Aeq,T}$ values, where the time period T is as specified in Table 1 of HS2 Information Paper E23. Periods with adversely weather affected noise levels are greyed out and have been excluded from the calculation of the $L_{Aeq,T}$ values in Table 3 of the main report.

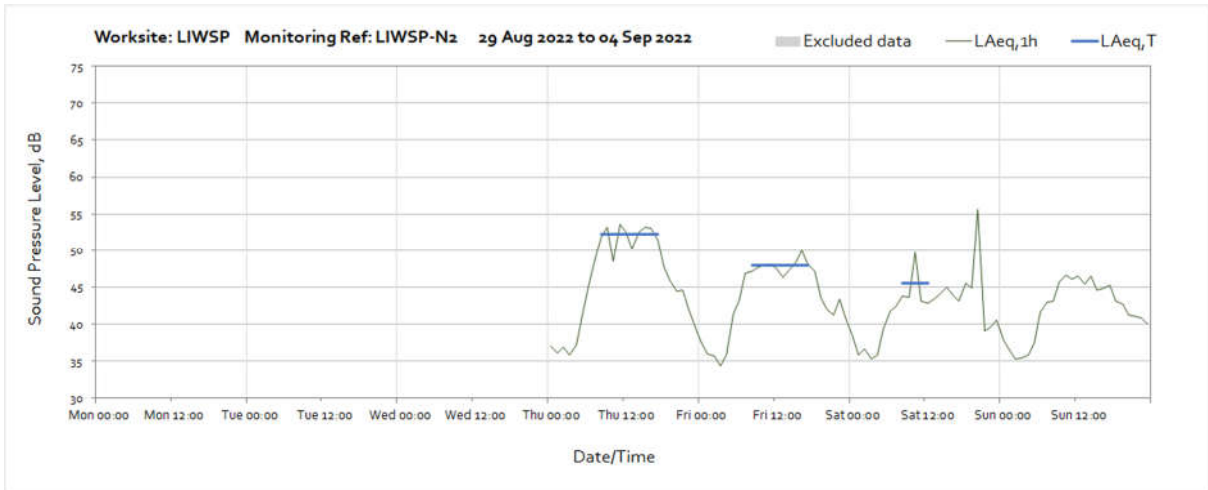
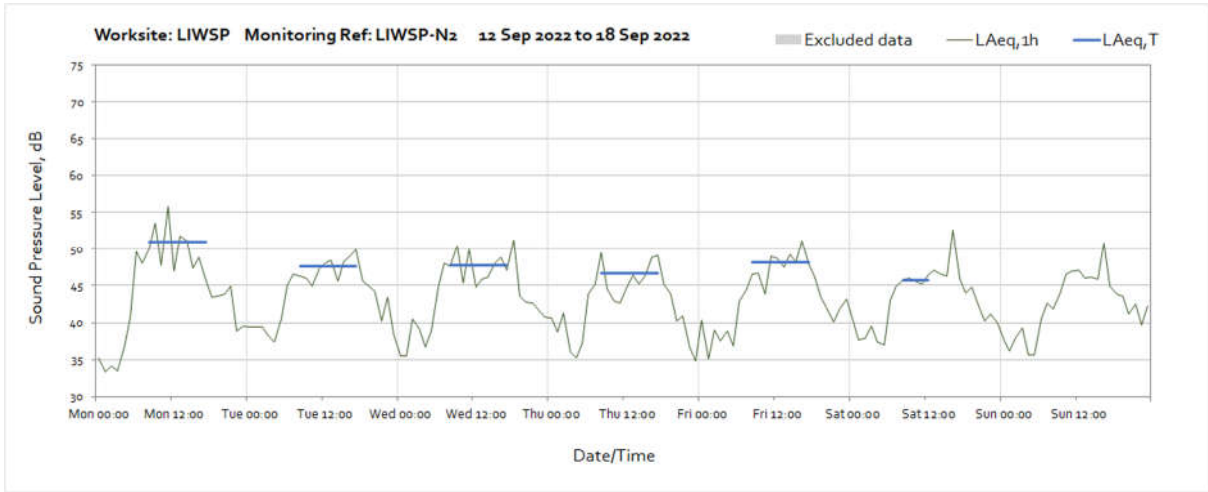
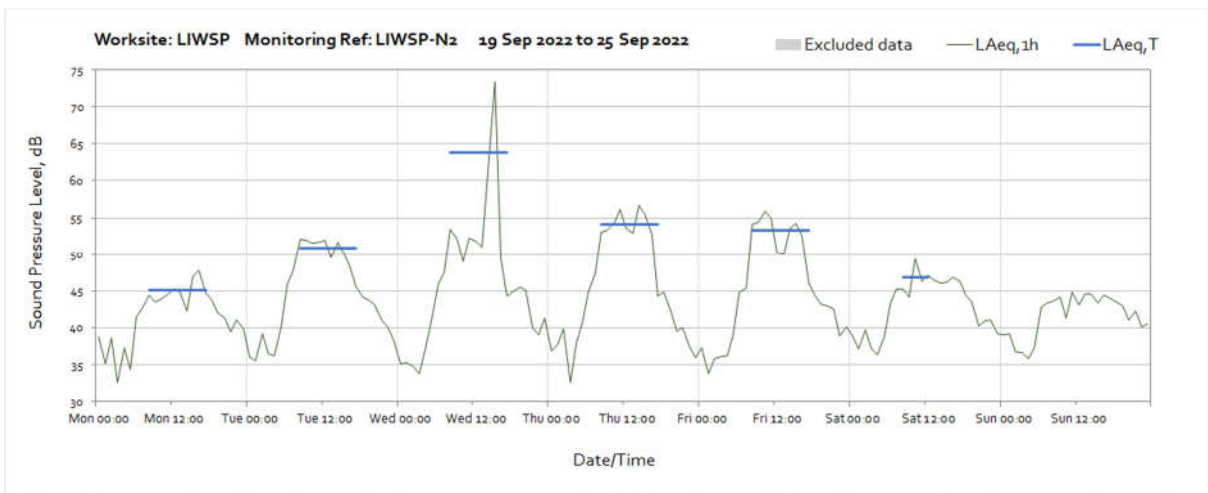
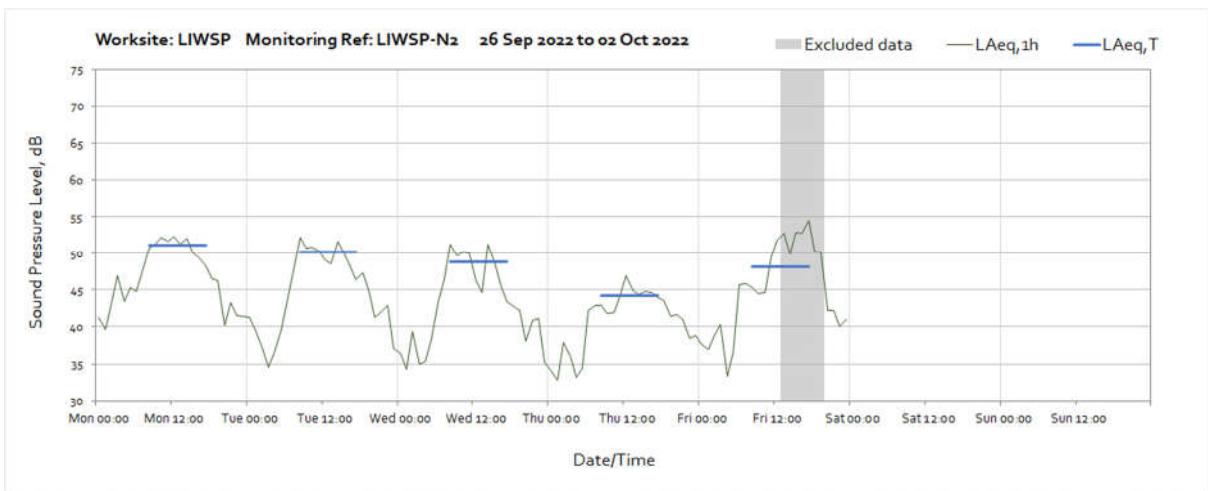
Worksite: LIWSP Monitoring Ref: LIWSP-N2

2.2.6 There was two exceedances of the LOAEL at monitoring locations LIWSP-N2 and HF-N1 during the month of September 2022.

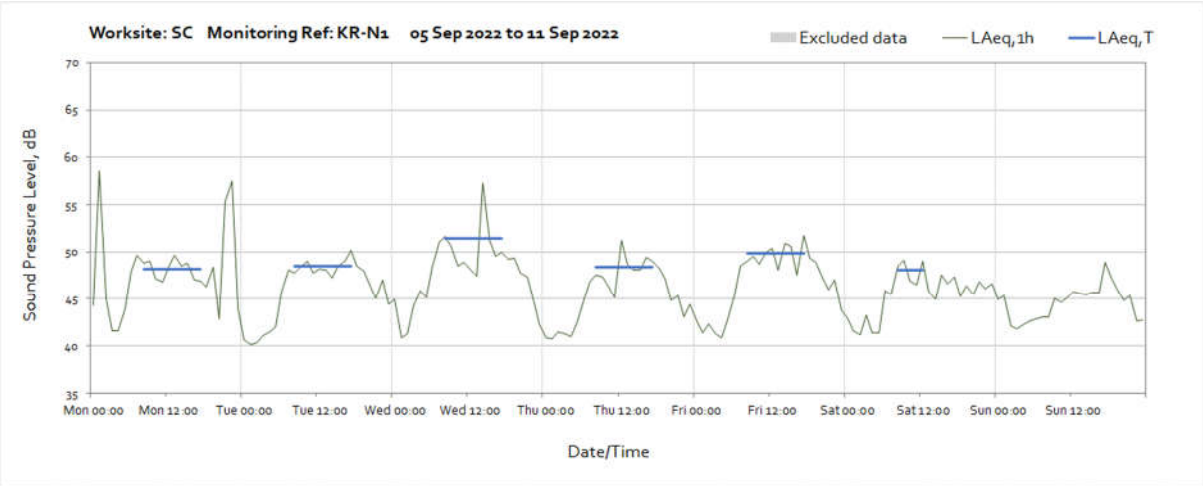
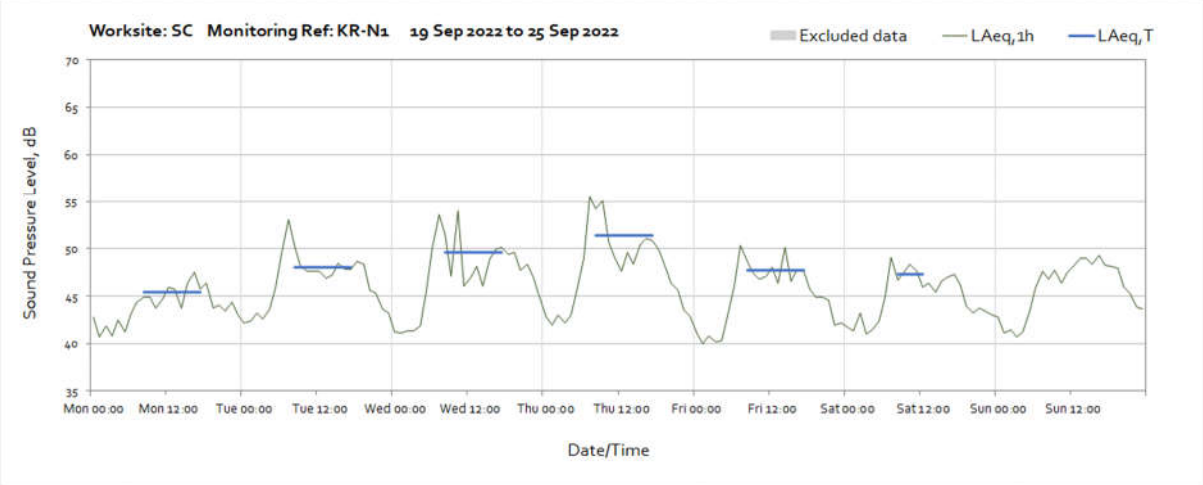
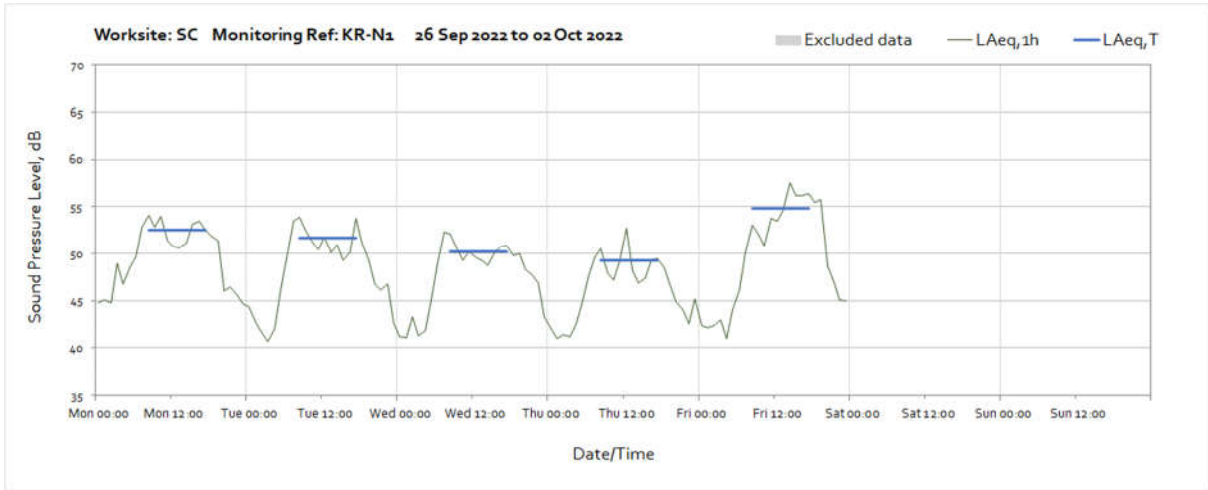
Worksite: KR Monitoring Ref: KR-N1

Note: Missing data between 0800 and 0900 on the 1st September was due to monitor maintenance.

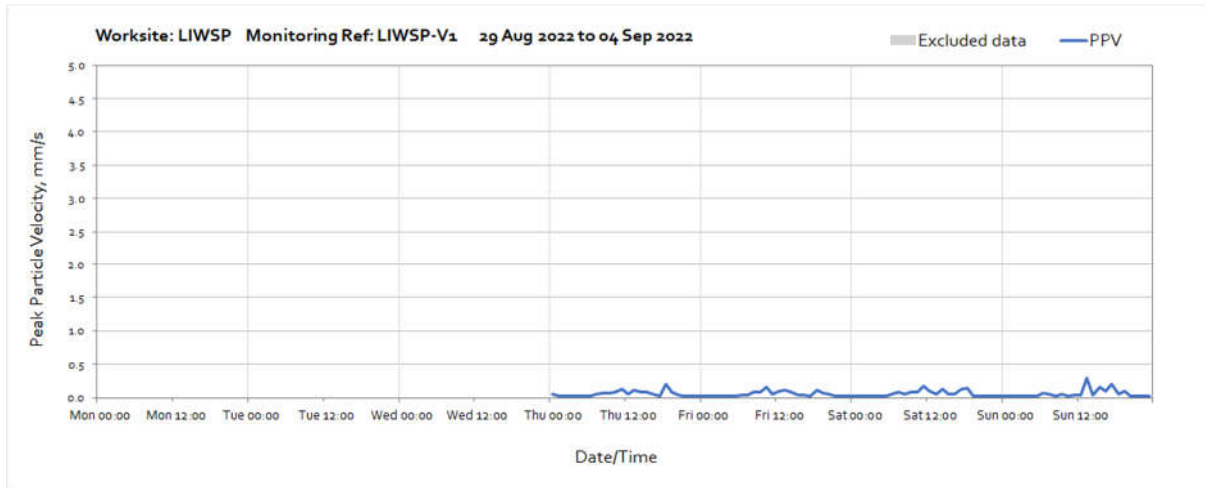
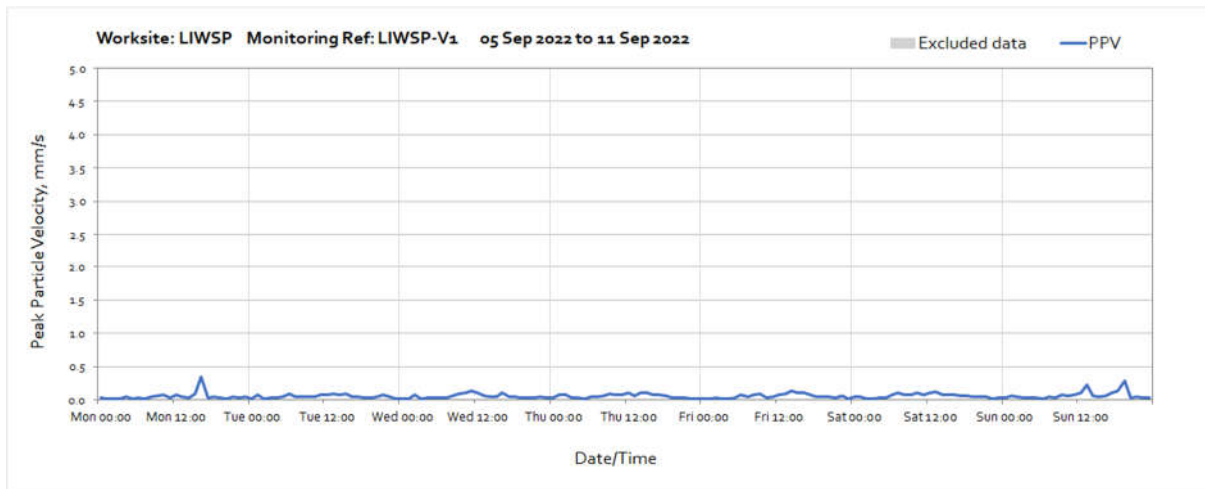
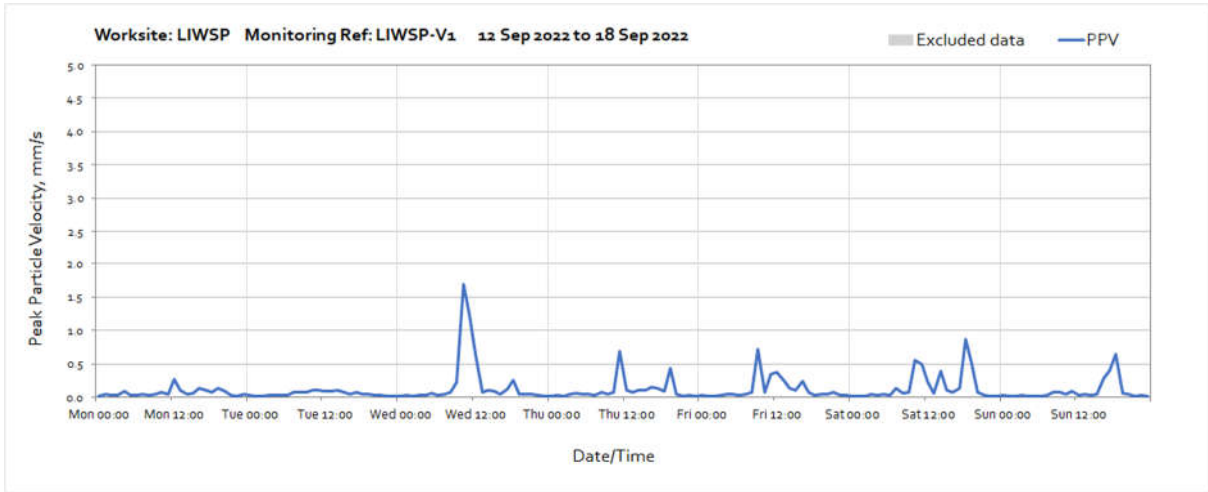
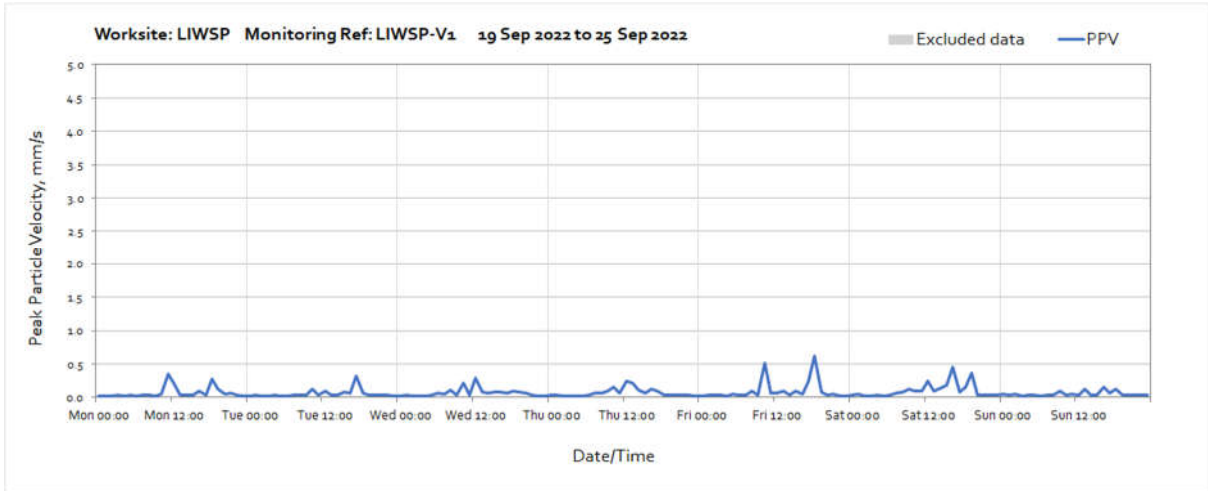
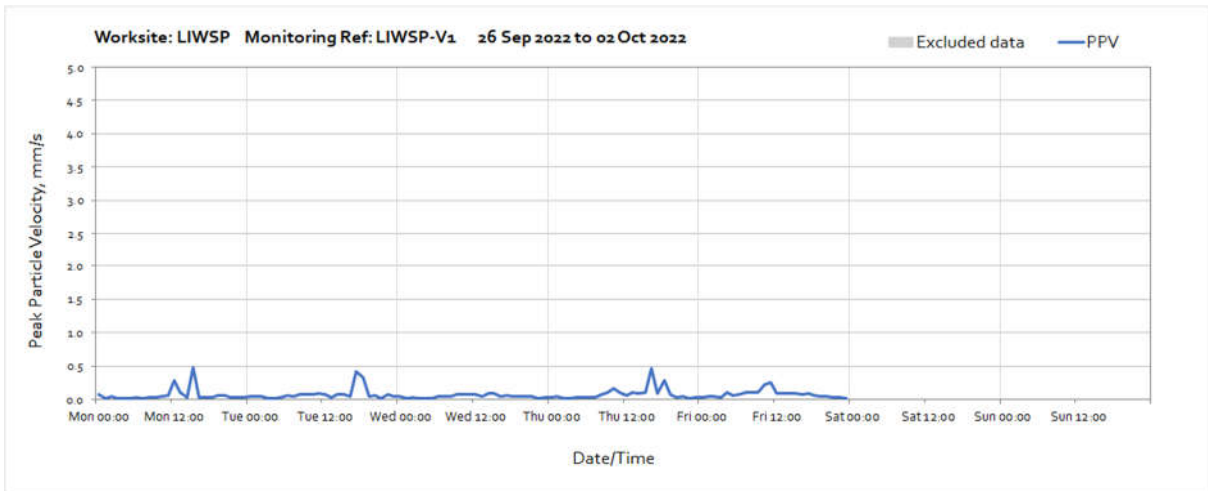
Worksite: LIWSP Monitoring Ref: LIWSP-V1

Worksite Reference	Measurement Reference	Monitor Address	Highest PPV measured in any axis, mm/s
LIWSP - Long Itchington Wood South Portal	LIWSP-V1	Woodside House, Bascote Heath, Southam	2.95 (YX-axis)

The following graphs show the hourly measured peak particle velocity PPV recorded during the monitoring period. The graphs show the highest PPV of the three orthogonal axes x, y and z. Where high values of PPV were caused by local interference with the vibration monitor, which are not representative of HS2 construction works, these values have been greyed out in the following charts and have been excluded to calculate values in Table 4 of the main report.
