Berden Hall Farm Solar Farm

Location of internal viewpoints

Location of external viewpoints

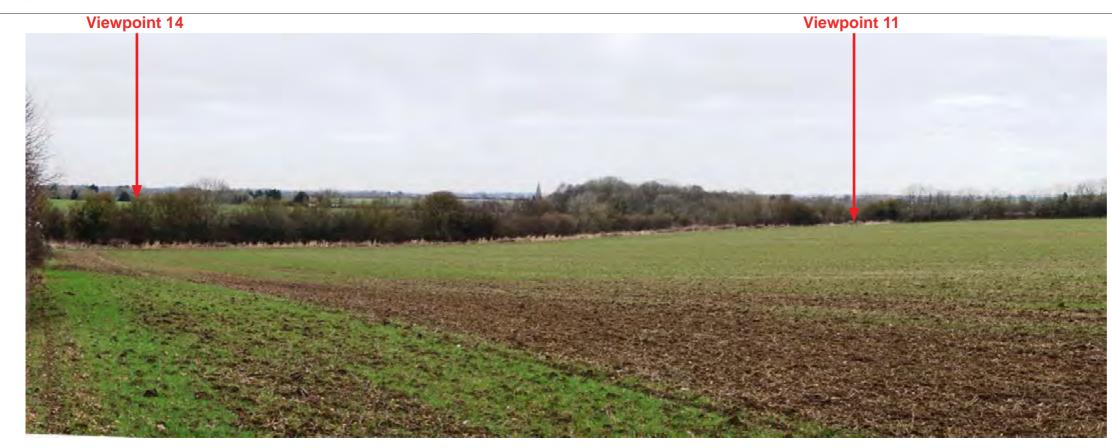
# Photograph A

The first of a series of pans from the driveway to the Pelham Substation. This view is northeast down to the Pelham Road, which is largely obscured by the roadside hedge. Open fields on the ridge further north afford views of the Site (see Viewpoint 14), but the historic cluster of properties at Berden Priory, are screened by topography and a block of woodland at Arnold's Spring. A gap in the roadside hedge cover, along the Pelham Road, allows views into the site (see viewpoint 11).

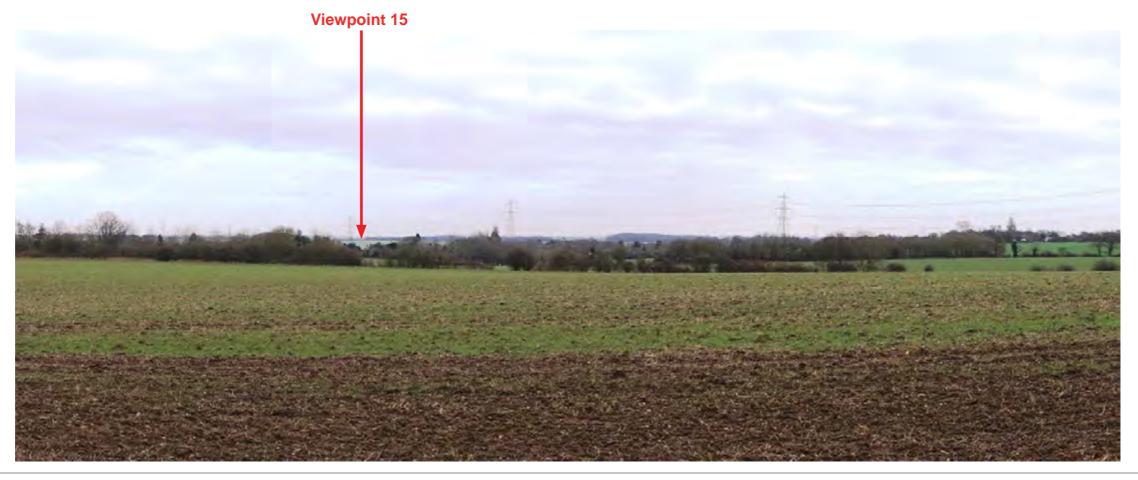
# Photograph B

The pan continuing to the east illustrating the level of enclosing tree cover around the Site. The roofs of a few properties on the edge of Berden are just visible on the right side of the image. The local countryside and the Site is adversely influenced by the overhead transmission lines. There is a long distance view from Chalk Pit Lane to the Northeast (see view 15).

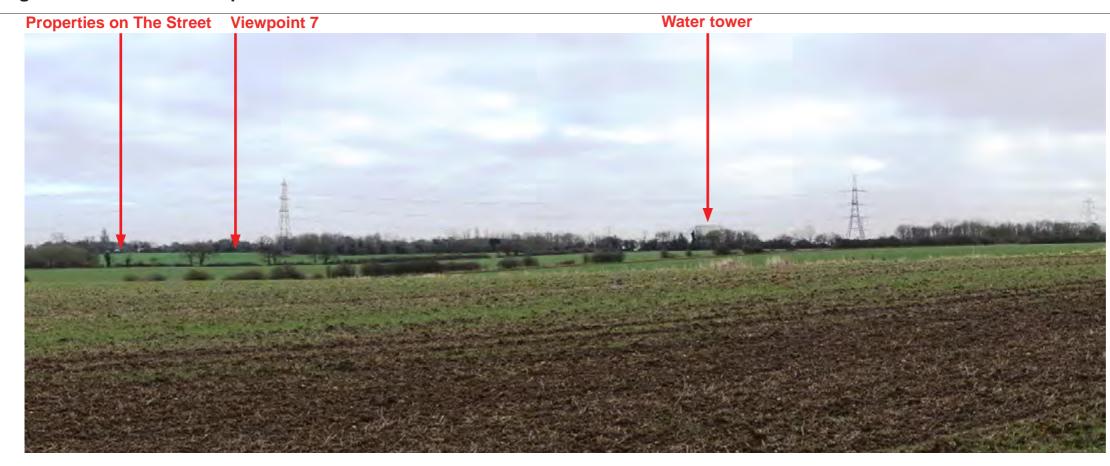
# Photograph C

The pan continuing to the southeast, again illustrating the enclosing tree cover and the adverse landscape and visual influence of the overhead transmission line. The water tower is visible but not the nearby dwellings at its base. The upper parts of residential properties on The Street can just be seen.

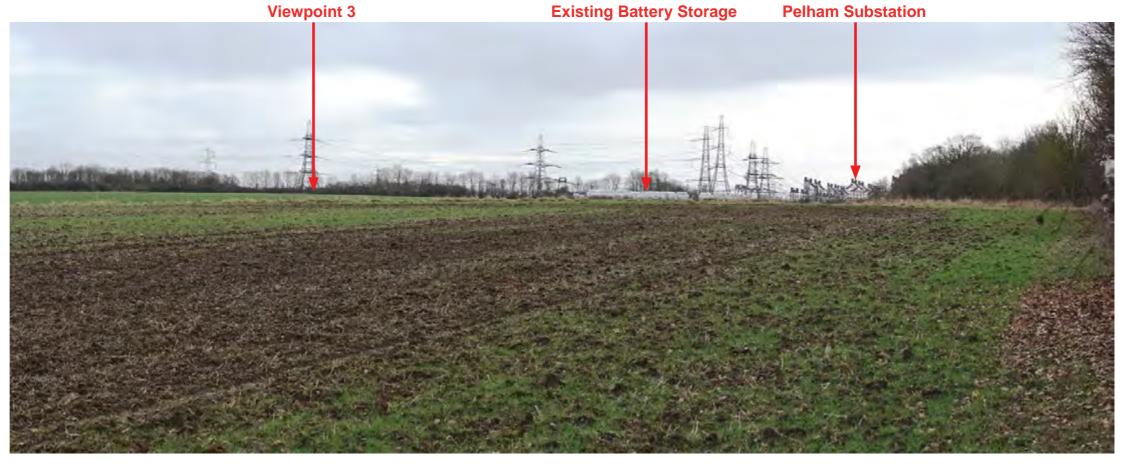
# Photograph D

The pan continuing to the south. The battery electricity storage facility is visible, with the upper section of the Pelham Substation and transmission towers visible beyond. The tree line on the ridge provides visual enclosure to the Site to views from further south. The proposed Pelham Spring solar farm (currently refused) lies on the far side of the ridge, further down the slope, and so the two solar farms will not be inter-visible. Viewpoint 3 is from a public footpath which passes through the Site.

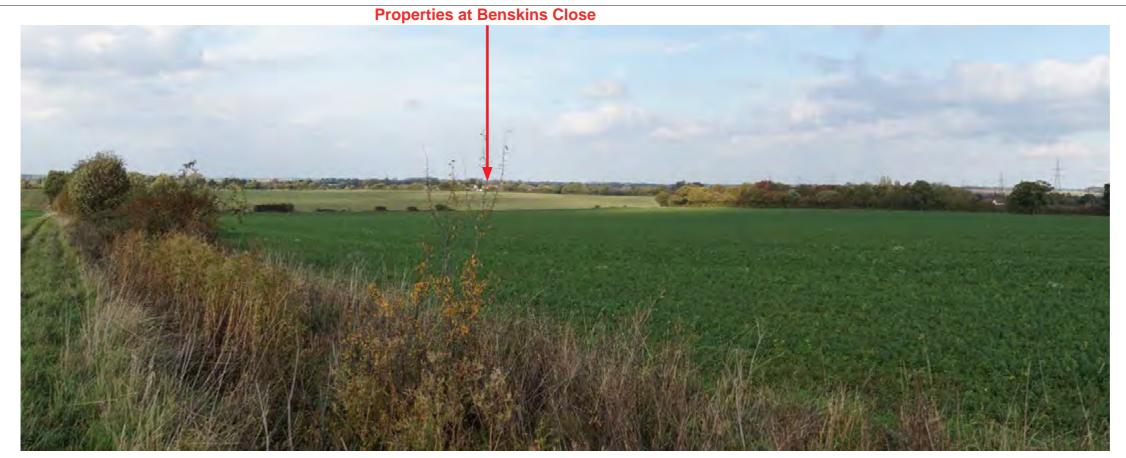
# Photograph E

This is a summer view from PRoW 5/26 looking northeast, illustrating the level of visual enclosure to the Site. It also illustrates the slight dip within the central eastern side of the Site. PRoW 5/22 runs along the hedgeline within the dip.

# Stocking Pelham lies behind the tree line The Pelham Road lies behind the hedgerow Public Footpath

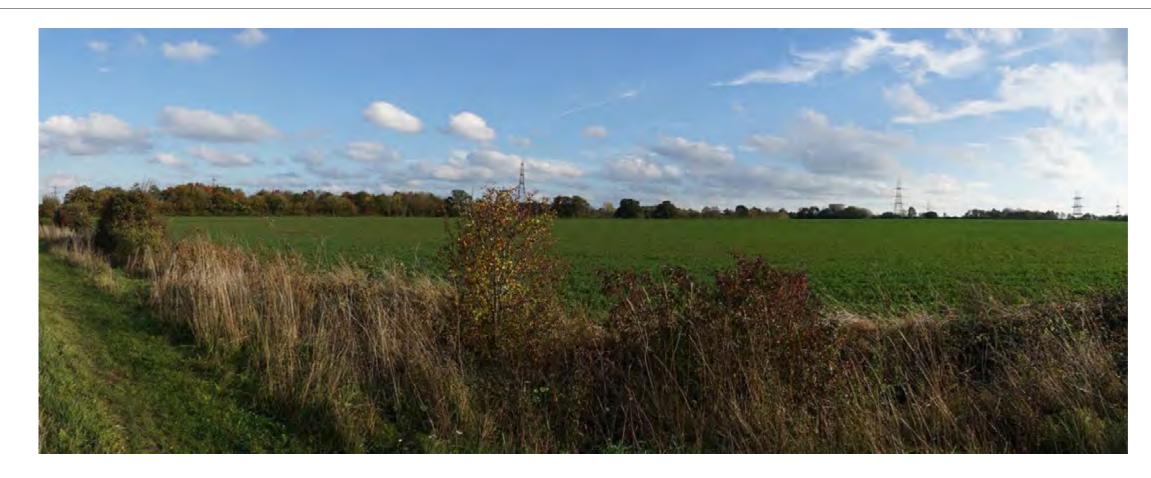
# Photograph F

View from PRoW 5/26 looking northwest across the Site towards Stocking Pelham, which lies screened by the high degree of visual enclosure. The start of the slight dip in the landform in the centre of the Site is visible and continues to the east.

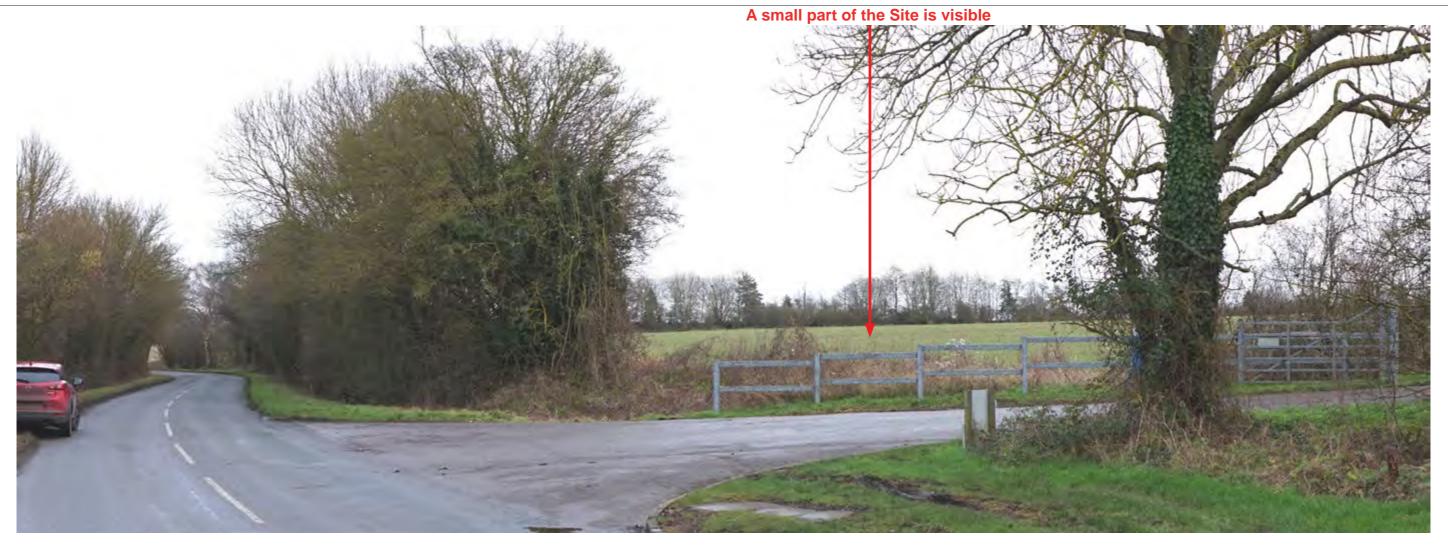
**Direction of view: West**

Distance to nearest site boundary: 32 m

Elevation: 114 m AOD

Grid reference: TL 45676 29421

Date photo was taken: 20.01.2022

## The existing view

This is the first view of the Site when heading east from the village of Stocking Pelham. Prior to this point views are blocked by intervening trees and hedges, even in winter. Part of the Site is visible through a gap in the hedge which runs alongside the access to the Pelham Substation. The Site appears as an open rural field with a hedge on the far side of the field forming the skyline.

# Predicted changes to the view without mitigation

Solar panels will be seen side on through the gap in the hedge and through the perimeter deer fencing, but the first panels will be set 35 m back from the fence.

The sensitivity of users is Medium and the magnitude of change is Medium in winter and summer, resulting in a Moderate adverse impact in winter and summer.

#### Mitigation and assessment of residual impact

It is proposed to plant a native hedge with trees set 2 m out from the deer fence to screen the proposed solar farm. Once established the hedge will be managed at a winter cut height of 3 m and 3 m wide at the base.

Once established the hedge will screen the solar farm from view in summer, resulting in a Negligible impact on visual amenity. In winter it will be possible to glimpse the panels and fencing through the leafless branches (a Low magnitude of change), resulting in an adverse impact of Minor significance.

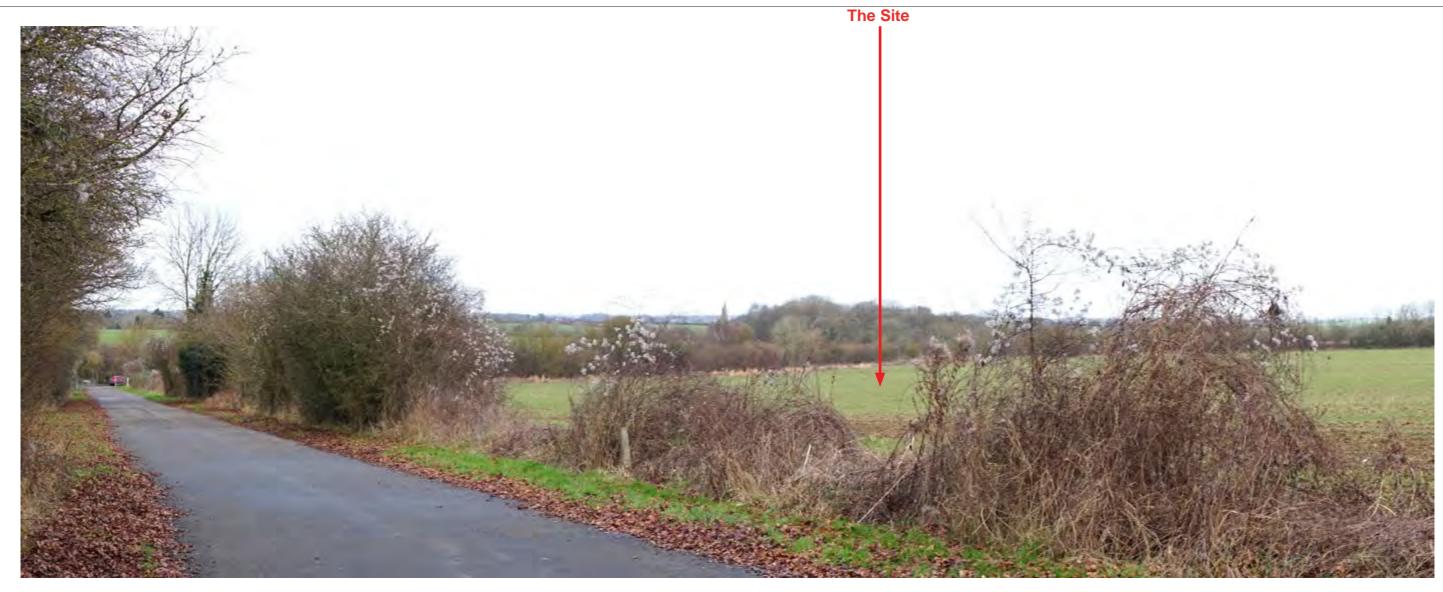
**Direction of view:** Northeast

Distance to nearest site boundary: 5 m

Elevation: 124 m AOD

Grid reference: TL 45708 29178

Date photo was taken: 20.01.2022

#### The existing view

This PRoW heads south from the Pelham Road, along the tarmac access road to the Pelham Substation. A hedge runs along the eastern edge, but several large gaps afford views through to the Site, such as this one. It is a rural view which is curtailed by rising ground and hedge cover to the east and south. There are wider, but not extensive, views over the valley to the north.

#### Predicted changes to the view without mitigation

The solar panels will be visible through the gaps in the hedge, typically set back 15 - 25 m from the exsiting hedge and seen through the deer fencing.

The sensitivity of walkers is High and the magnitude of change is High (when walking sequentially along the PRoW) in winter and Medium in summer, resulting in a Major adverse impact in winter and Moderate – Major in summer.

#### Mitigation and assessment of residual impact

It is proposed to plant a native hedge set 2 m out from the deer fence to screen the proposed solar farm. Once established the hedge will be managed at a winter cut height of 3 m and 3 m wide at the base.

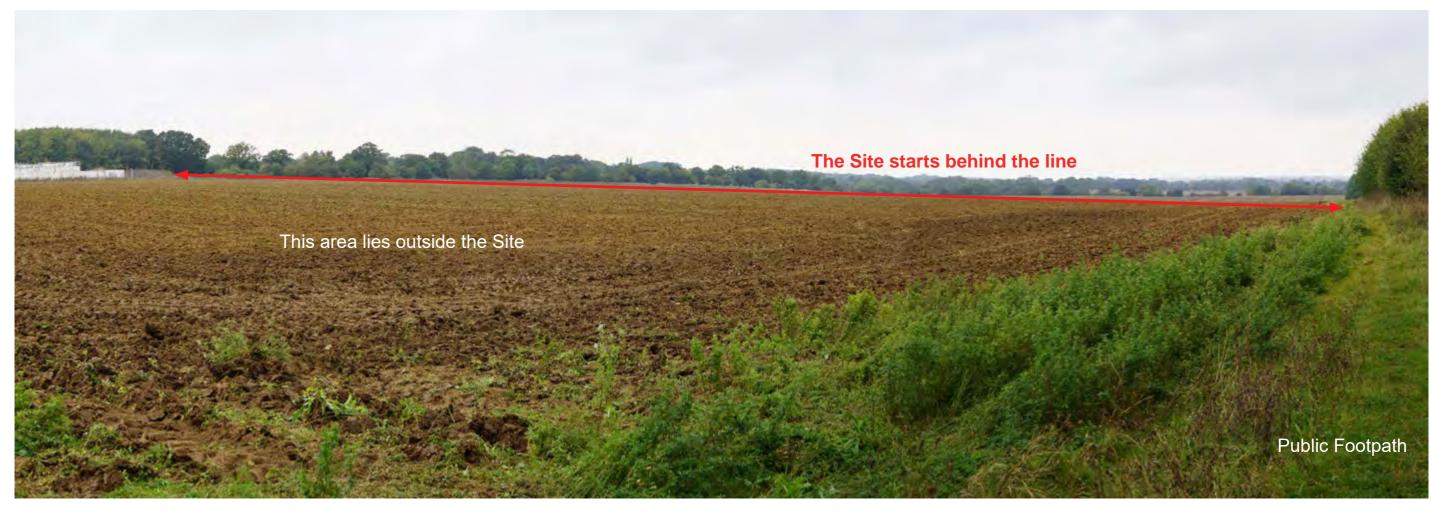
Figure 5.6.3a: View from PRoW 5/26 as it heads north towards the Pelham Road through the Site (Panoramic View)

PRoW 5/27 terminates at the boundary of the substation, joining with PRoW 5/25 which heads east to join with PRoW 5/26. Views towards the Site from PRoW 5/25 are very restricted by a substantial intervening hedgerow, even in winter. PRoW 5/26, however, heads south, first affording clear views over the Site, as at this point, and then it continues through the Site until it meets Ginns Lane.

The solar farm will be visible in the foreground, with the panels facing the viewer when heading north, seen through the deer fence. Walkers will then continue through the solar farm within a corridor flanked to the east by an existing hedge and the deer fence of the proposed solar farm set around 12 m from the hedge.

The sensitivity of walkers is High and the magnitude of change is High in winter and summer resulting in a Major adverse impact on visual amenity.

It is proposed to plant a native hedge set 2 m out from the deer fence to screen the proposed solar farm. Once established the hedge will be managed at a winter cut height of 3 m and 3 m wide at the base, leaving a 7 m wide grass corridor for the PRoW.

Once established the hedge will screen the solar farm from view in summer, resulting in a Minor impact on visual amenity (due mainly to the loss of openness). In winter it will be possible to glimpse the panels and fencing through the leafless branches (a Medium magnitude of change), resulting in an adverse impact of Moderate - Major significance.

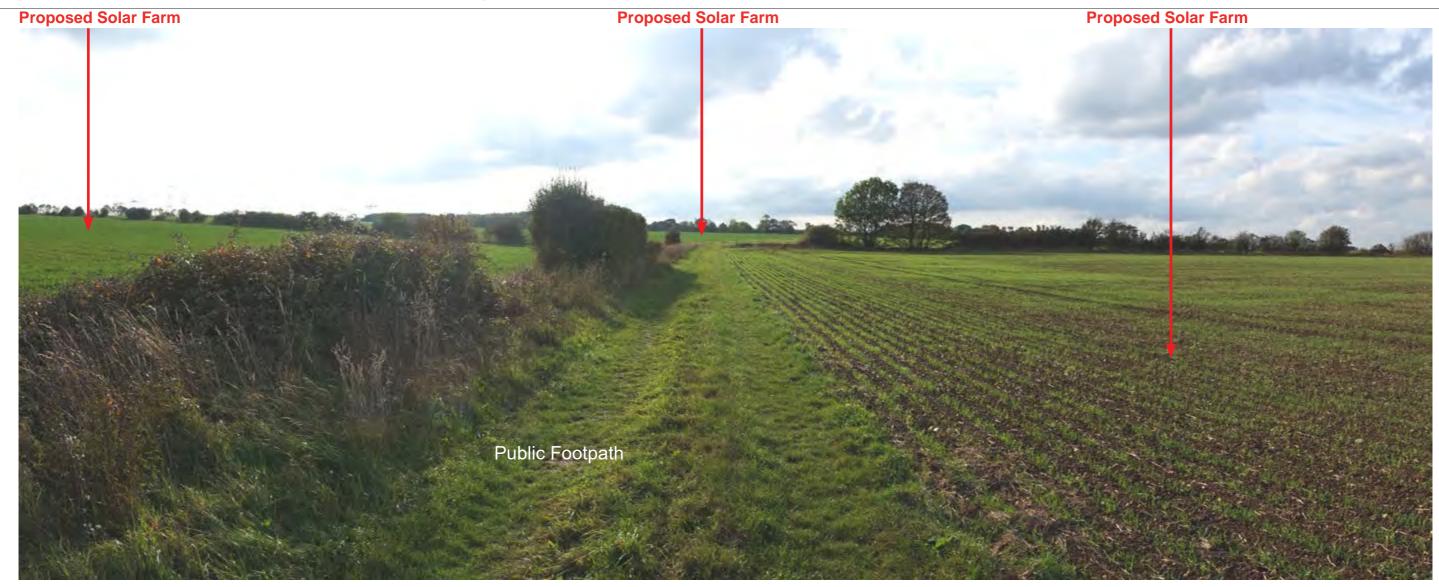
Figure 5.6.5a: View from PRoW 5/21 as it passes through the Site (Panoramic View)

This footpath heads east from PRoW 5/26, passing through the Site. The view has been chosen to illustrate the change in view to walkers as they pass through the Proposed Development.

Solar panels will occupy the field to the left of the existing hedge and within the field in which the footpath runs. Deer fencing will be erected to leave a broad corridor for the existing footpath and hedge. The panels will lie 5 - 10 m beyond the deer fence.

The sensitivity of the viewer is High, and the magnitude of change is High in winter and summer resulting in a Major adverse impact on visual amenity, winter and summer.

It is proposed to plant a native hedge set 2 m out from the deer fence to screen the proposed solar farm. Once established the hedge will be managed at a height of 3 m and 3 m wide at the base, leaving a 7-8 m wide grass corridor for the PRoW.

Once established the hedge will screen the solar farm from view in summer, resulting in a Minor adverse impact on visual amenity (mainly due to the loss of openness). In winter it will be possible to glimpse the panels and fencing through the leafless branches (a Medium magnitude of change), resulting in an adverse impact of Moderate – Major significance.

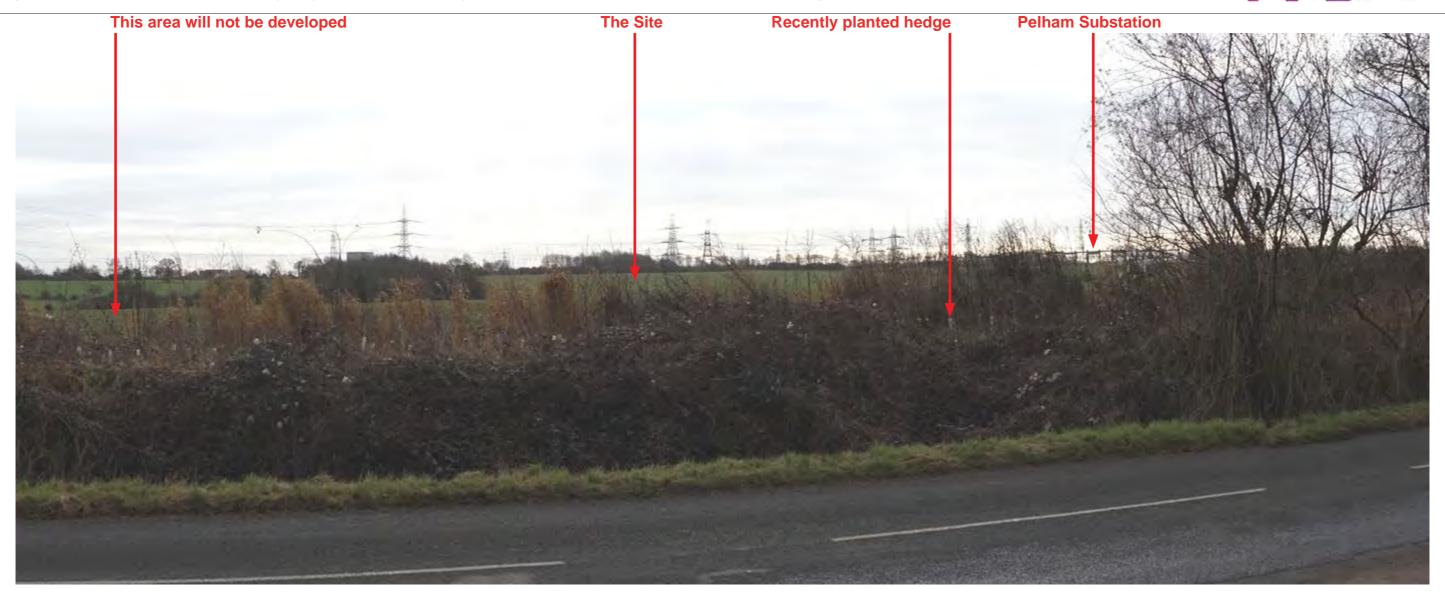
Figure 5.6.9a: View from footway adjacent to dwellings at Benskins Close, on the western edge of Berden (Panoramic View)

The dwellings are single storey and views are limited from within by garden vegetation. The environs afford limited views over the open countryside and the Site. The upper section of the Pelham Substation is visible and the transmission lines which radiate from it. The recently built battery storage facility is also visible, although this will eventually be screened by landscaping.

The proposed solar farm occupy the part of the field which lies to the west of the properties but will stop short of the area of field in front of the properties to maintain their rural outlook. A hedge has recently been planted along Ginns Road (the rabbit guards are just visible in the photograph), and this will screen the remainder of the proposed development from view in summer. In winter it may be possible to glimpse areas of panels through the leafless branches, sensitivity is High and the magnitude of change Low, resulting in an adverse impact of Moderate significance.

A native species hedge will be planted along the eastern boundary of the solar farm to act as a second layer of screening to the hedge recently planted along the road. Once established there will be a Negligible impact on visual amenity, in summer or winter.

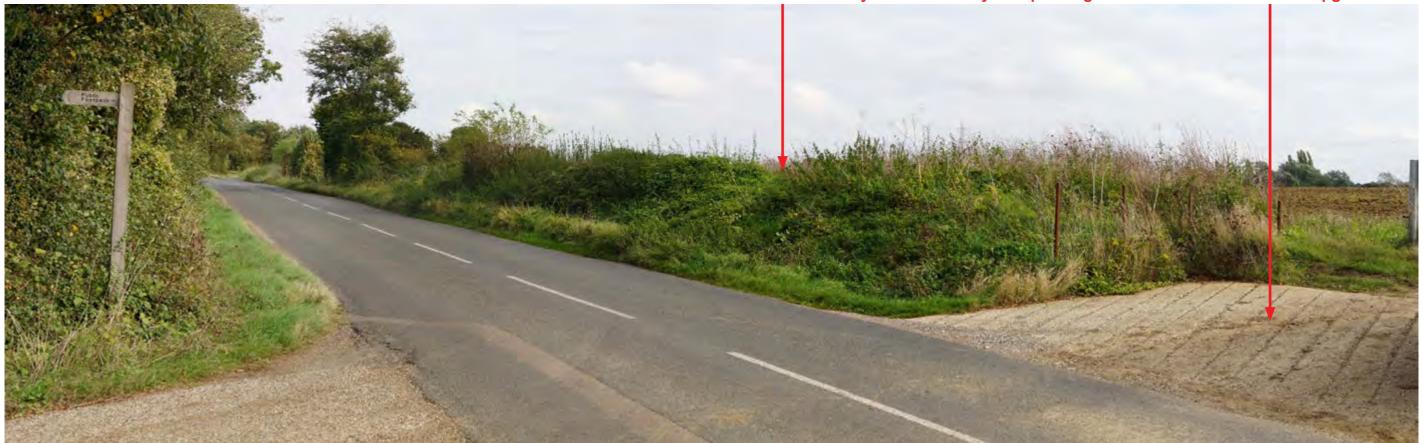
Figure 5.6.10a: View from the Pelham Road (Ginns Road) where it is met by PRoW 5/62, also the location of the existing farm access (Panoramic View)

Panels will be set back in the field and will eventually be screened by new planting

This entrance will be upgraded

To those travelling along Ginns Road, views of the Site are partially restricted by roadside vegetation and a slight bank. But gaps do allow some views to travellers. The landowner has recently planted a hedge alongside the road, which once established will block views of the Site in summer and only allow glimpsed views in winter.

The existing farm access will be retained for agricultural use by the landowner, but it will be upgraded to form the main point of access to the solar farm. The gate will be set 17 m back from the edge of carriageway to allow an HGV to turn in without waiting for the gate to be opened. This 17 m section will have a tarmac or concrete surface. Agricultural vehicles will head east on entering the Site and run parallel to Ginns Road until the open, undeveloped part of the field is reached. A 10 m wide grass corridor will be retained for this purpose (and does not form part of the Site). The deer fencing, forming the northern edge of the solar farm, will be set around 32 m back from the edge of Ginns Road, with the panels between 5 m and 20 m beyond. Construction and maintenance traffic for the solar farm will turn west on passing through the deer fencing.

Once the hedge along Ginns Lane has established it will only be possible to see the solar farm in summer through the remodelled entrance. In winter it will be possible to glimpse the rear edges of the panels through the leafless branches. Sensitivity of road users is Medium and the magnitude of change in summer will be Low and Medium in winter, resulting in a Minor adverse impact in summer and Moderate in summer.

It is proposed to plant a second native hedge in front of the deer proof fence, which will be managed at a height of around 3 m. This will add a second layer of screening to road users which should effectively screen the solar panels from view in winter and summer. The entrance gate has been offset so that the view through the agricultural entrance will be blocked by the proposed hedge.

As a result, the impact on the visual amenity of road users will be Negligible in summer and winter.

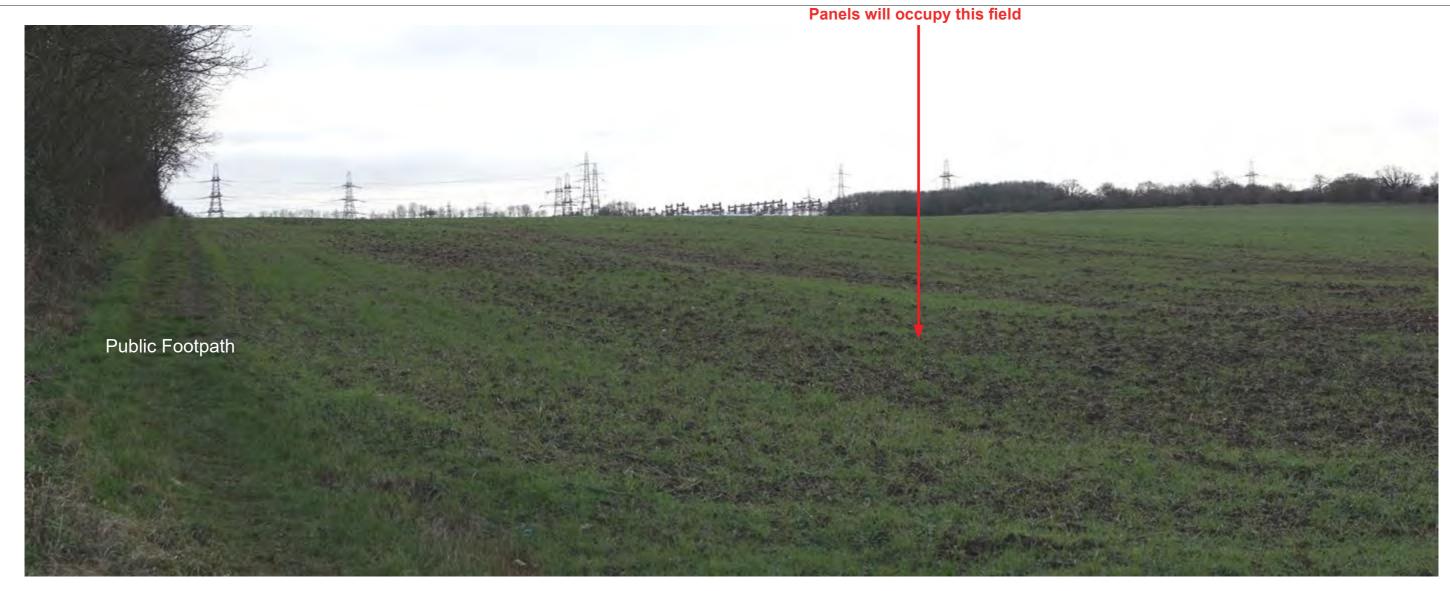
Figure 5.6.12a: View from the start of PRoW 5/26 as it heads north from the Pelham Road (Ginns Road) (Panoramic View)

The footpath runs along the west side of the hedge, through the Site. Currently it is a rural outlook but is substantially adversely influenced by the electrical infrastructure which is clearly visible on the skyline.

A deer fence will be erected 15 m from the existing hedge, with the solar panels visible behind. Panels will also be erected on the east side of the hedge, but this broadens out into a 30 m wide block of woodland which will screen the panels from view. The sensitivity of walkers is High and the magnitude of change High, resulting in an adverse impact of Major significance.

It is proposed to plant a native species hedge in front of the deer fence which, once established at a height of 2.5 m, will screen the proposed solar farm from view in summer, with glimpsed views through the leafless branches in winter. The magnitude of change will reduce to Low in summer and Medium in winter, resulting in a Moderate residual impact in summer and Moderate-Major adverse in winter.
