October 2022

# Air Quality and Dust Monitoring Monthly Report - October 2022

Three Rivers District Council

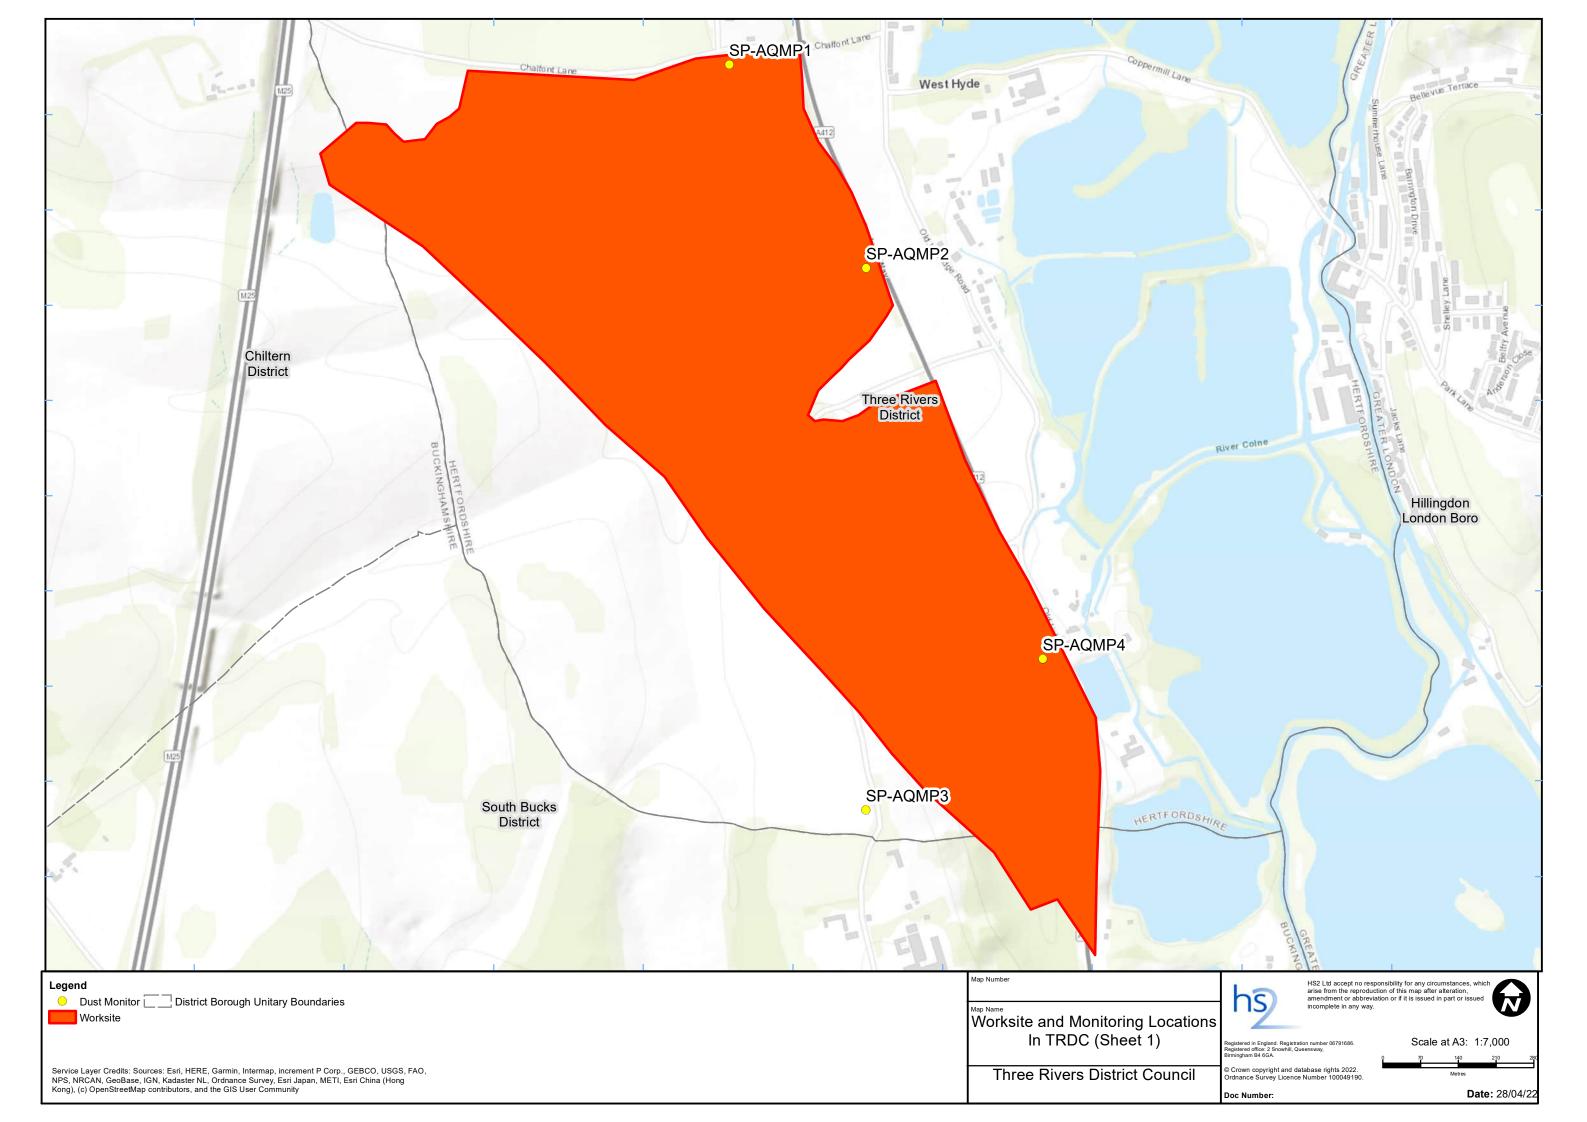
Figure 1: Worksites and monitoring locations within the TRDC

- 1.1.2 Figure 1 in Appendix A indicates the current worksite together with the dust monitoring locations for October 2022.
- 1.1.3 This summary should be read in conjunction with the overview monitoring report available from <a href="www.gov.uk/government/collections/monitoring-the-environmental-effects-of-hs2">www.gov.uk/government/collections/monitoring-the-environmental-effects-of-hs2</a>, which highlights the applicable standards and guidance, as well as the air quality and dust monitoring methodologies to be implemented by nominated undertakers throughout construction.

- 1.1.4 The current phase of works commenced in July 2017 and is currently ongoing. The worksites as presented in Appendix A, Figure 1, include:

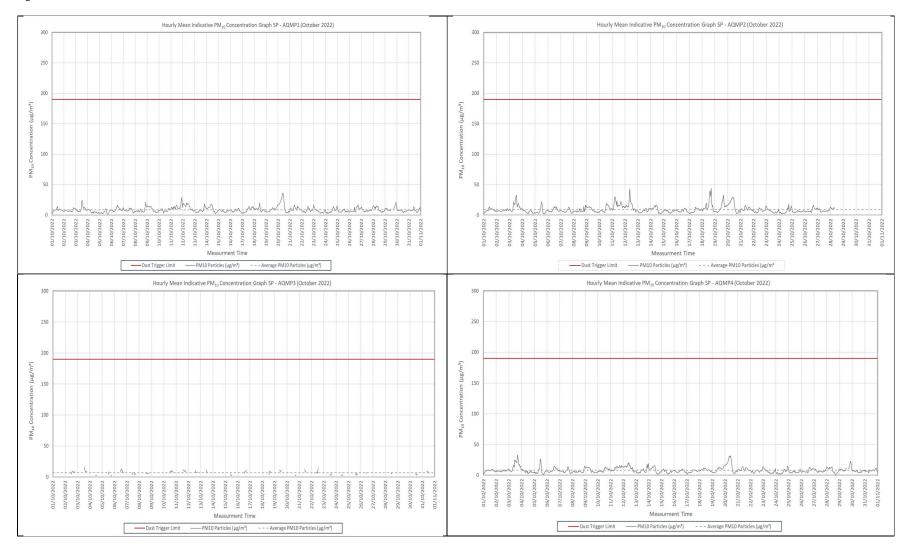
Figure 2: Continuous dust 1-hour mean indicative PM<sub>10</sub> concentration for all monitors

- 1.1.7 The trigger level for PM<sub>10</sub> concentrations of 190 µg/m<sup>3</sup>, measured as a 1-hour mean, in accordance with the updated guidance document '*Guidance on Monitoring in the Vicinity of Demolition and Construction Sites (October 2018)* has been applied.

- 1.1.8 There were no (0) dust trigger alerts recorded during the monitoring period (October 2022).
- 1.1.9 Data capture was below 90% for SP-AQMP2 and SP-AQMP3 monitors due to technical issues, loss of power due to insufficient sunlight/wind and / or issues with data transfer.
