# Air Quality and Dust Monitoring Monthly Report - October 2022

West Northamptonshire District Council

A report prepared by EWCs and MWCCs on behalf of HS2 Ltd.

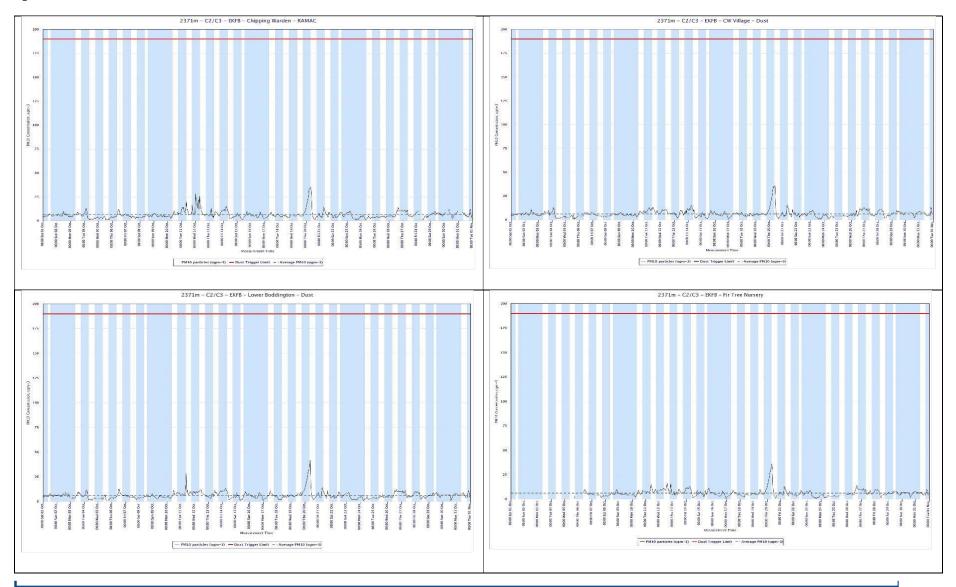
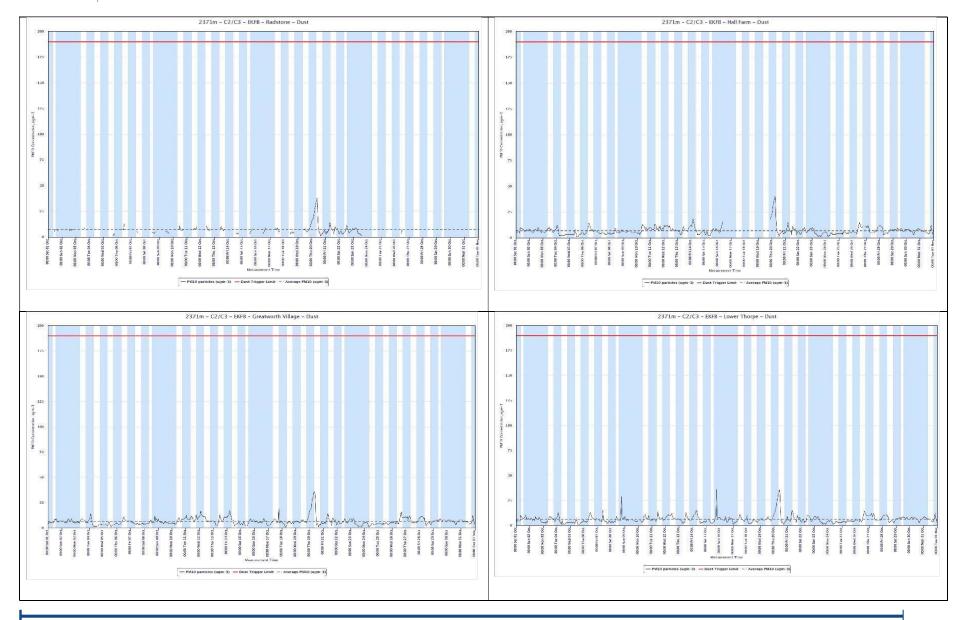
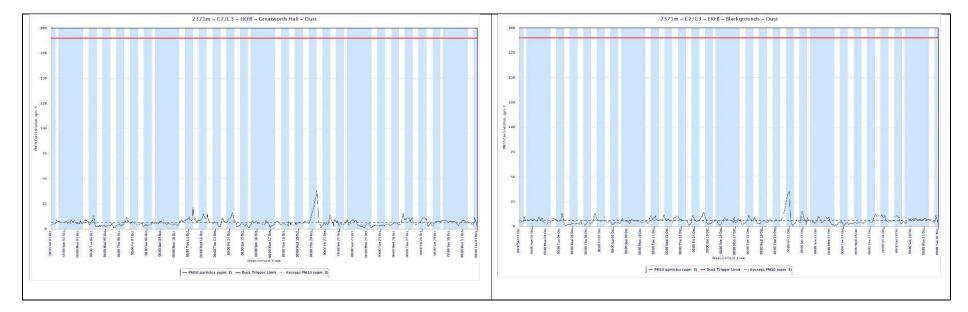
Figure 3: Continuous dust 1-hour mean indicative PM<sub>10</sub> concentration for all dust monitors

- 1.1.6 The trigger level for  $PM_{10}$  concentrations of 190 µg/m³, over a 1-hour period, in accordance with the updated guidance document 'Guidance on Monitoring in the Vicinity of Demolition and Construction Sites (October 2018) has been applied.

- 1.1.9 There were no (0) dust trigger alerts recorded during the monitoring period (October 2022).
- 1.1.10 No (0) complaints were recorded during the reporting period.
