## **Construction noise and vibration Monthly Report – November 2022**

**London Borough of Hillingdon**

This Noise and Vibration Monitoring Report fulfils HS2 Limited's commitment detailed in the Environmental Minimum Requirements (EMRs), Annex 1, Code of Construction Practice, to present the results of noise monitoring carried out within the London Borough of Hillingdon during the month of November 2022.

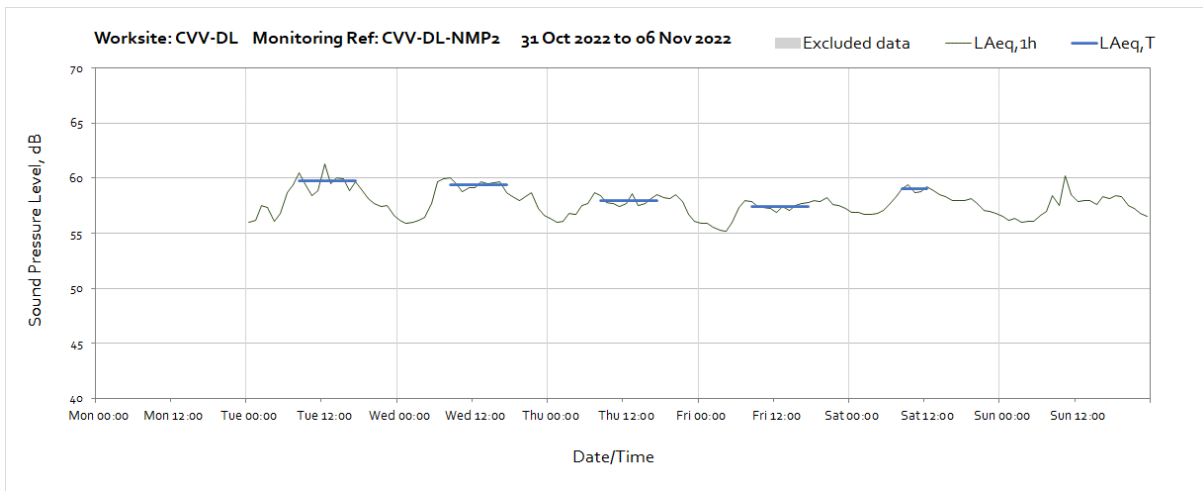
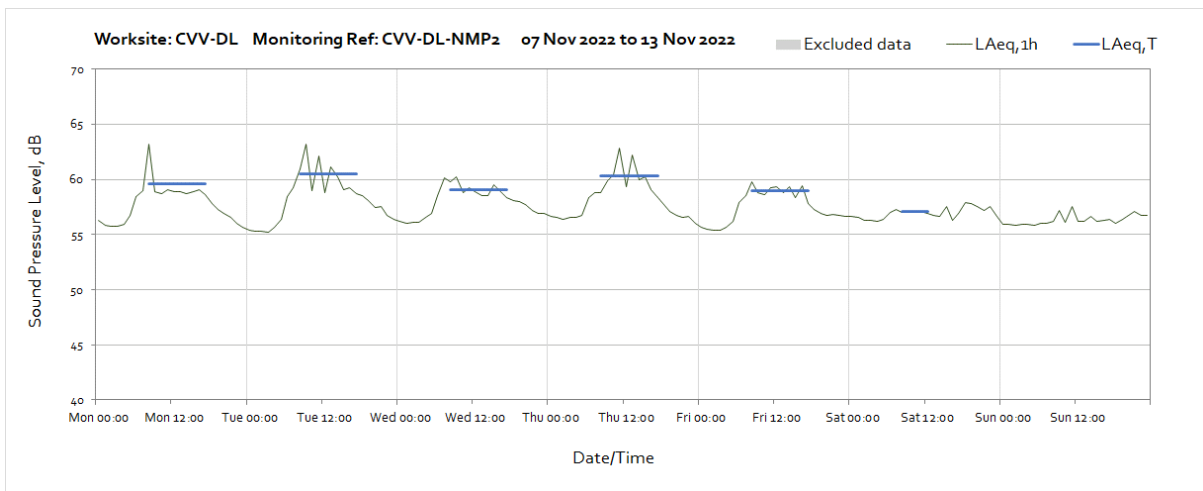
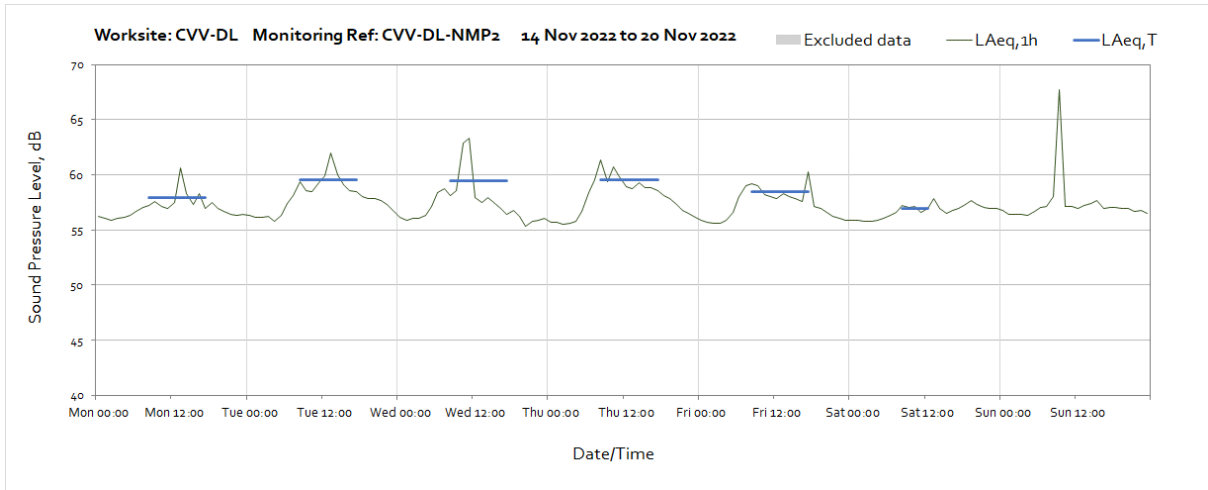
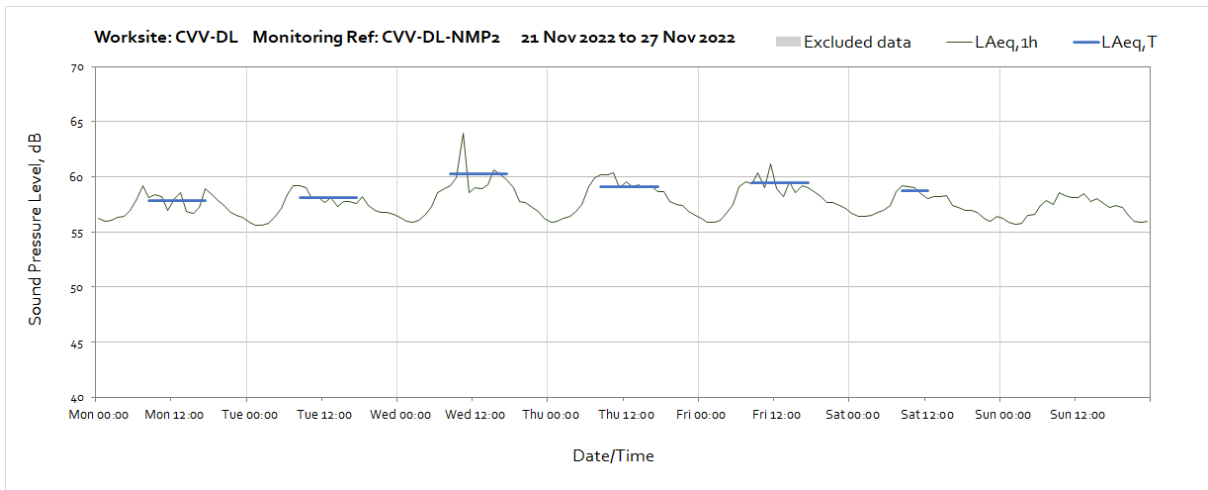
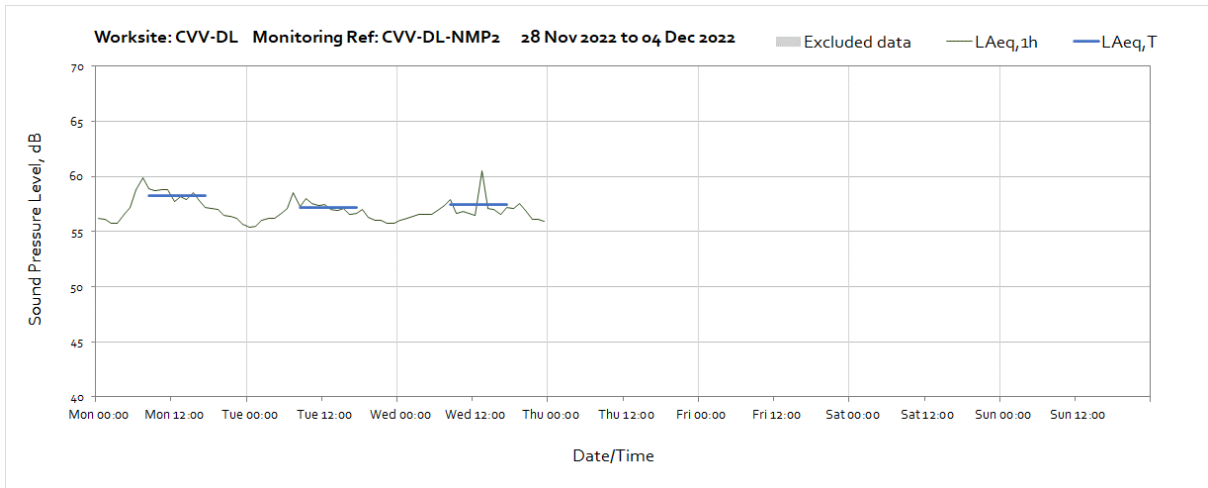
#### Monitoring Ref: CVV-DL-NMP2

The following graphs show the hourly measured ambient noise level  $L_{Aeq,1h}$  and, where relevant, the averaged noise level  $L_{Aeq,T}$  values, where the time period T is as specified in Table 1 of HS2 Information Paper E23. Periods with adversely weather affected noise levels are greyed out and have been excluded from the calculation of the  $L_{Aeq,T}$  values in Table 3 of the main report.

Note: Missing data at 15:00 on Thursday 24<sup>th</sup> November was due to field calibration of the monitor.

2.1.1 Table 3 presents a summary of the measured noise levels at each monitoring location over the reporting period. The  $L_{Aeq,T}$  is presented for each of the relevant time periods averaged over the calendar month, along with the highest single period  $L_{Aeq,T}$  that was found to occur within the month.

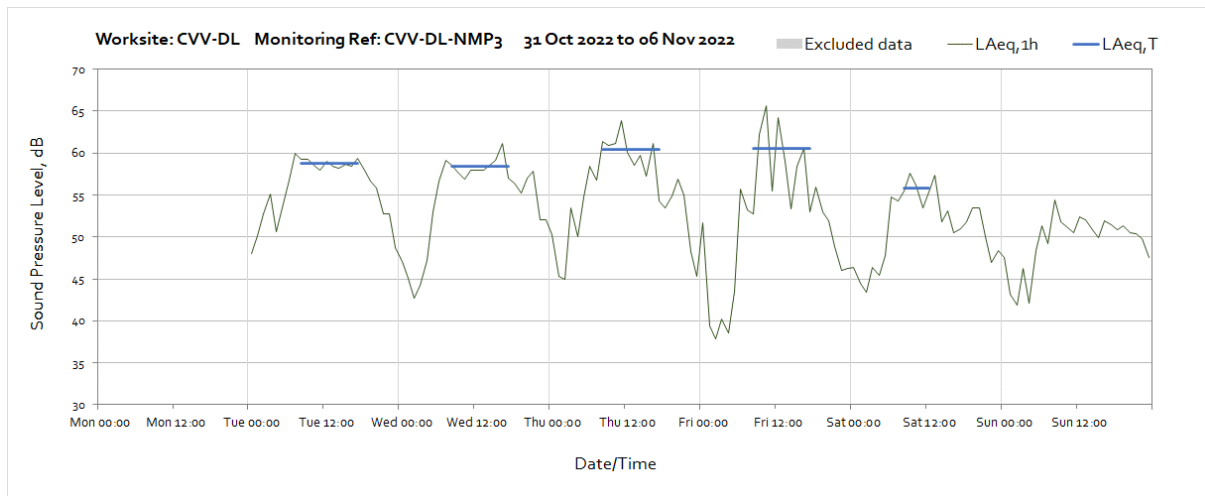
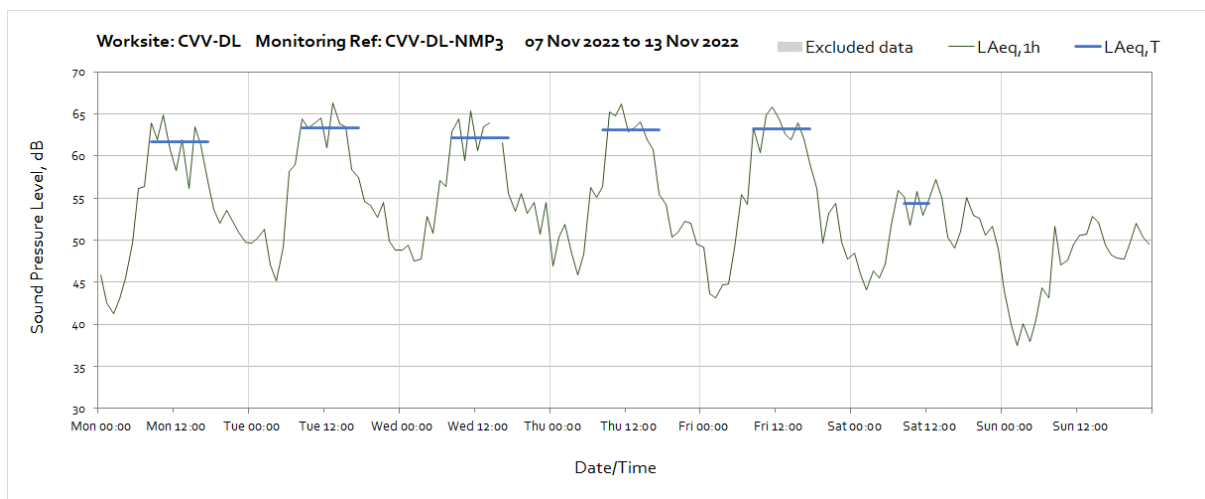
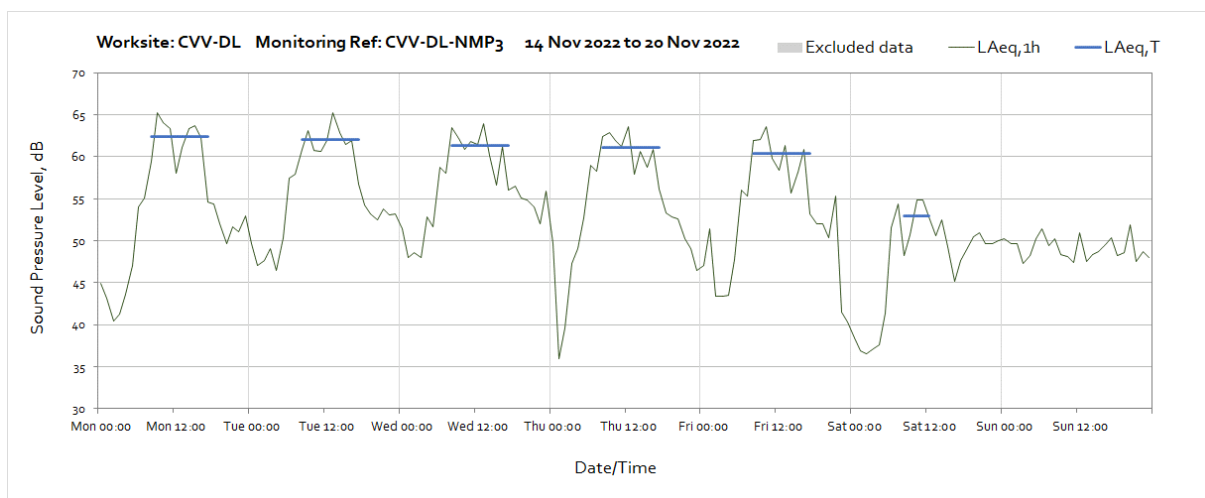
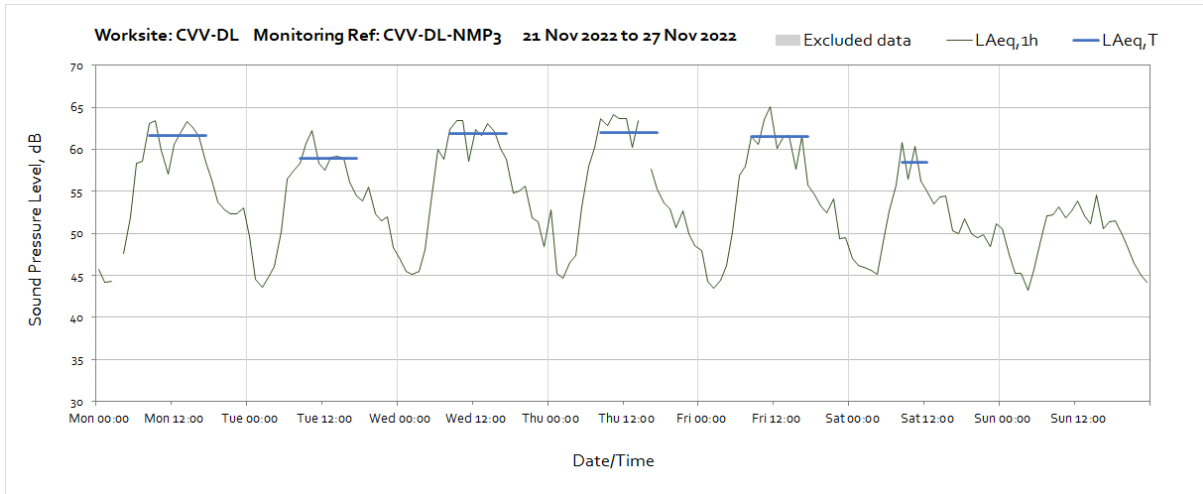
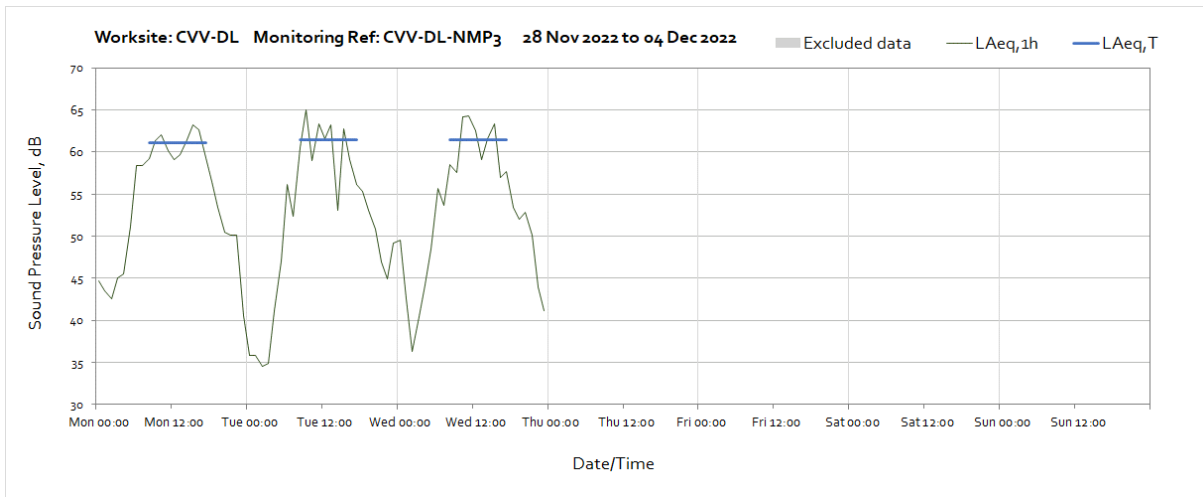
### Monitoring Ref: CVV-DL-NMP3

Note: Missing data at 15:00 on Wednesday 9<sup>th</sup> November was due to noise monitor being replaced for laboratory calibration.

Note: Missing data at 03:00 on Monday 21<sup>st</sup> November was due to monitor setting update. Missing data at 15:00 on Thursday 24<sup>th</sup> November was due to field calibration of the monitor.

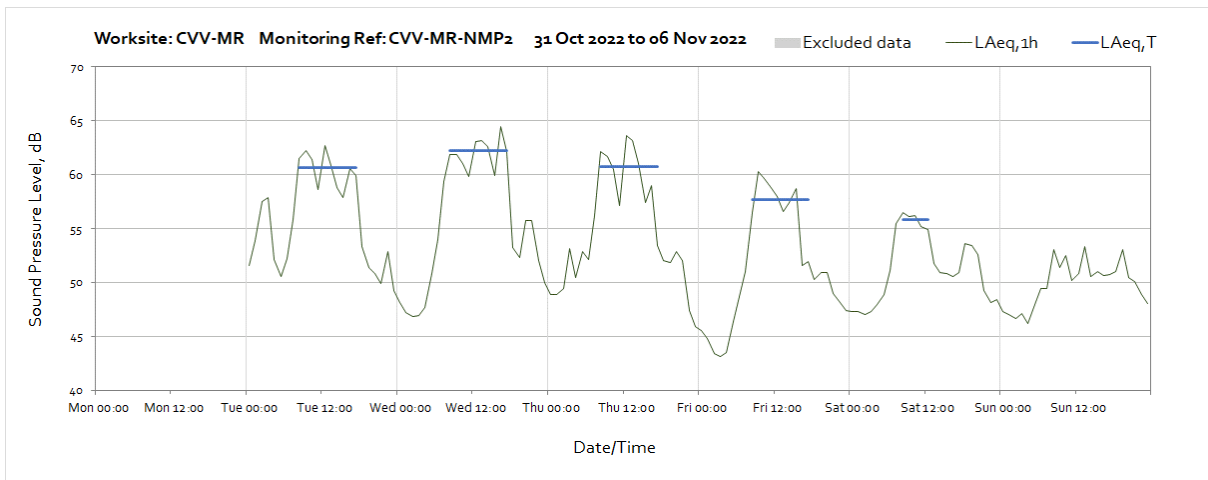
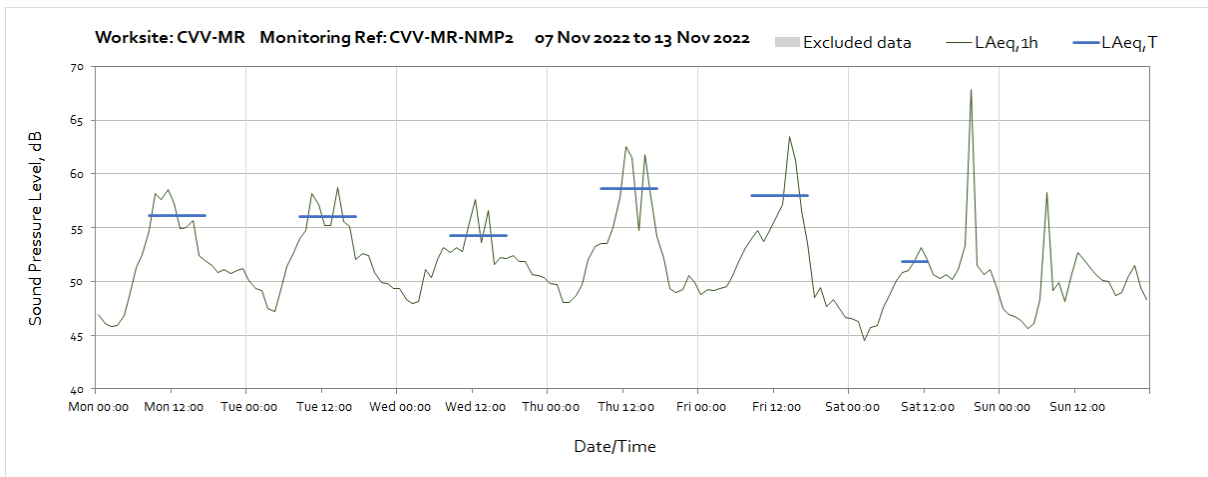
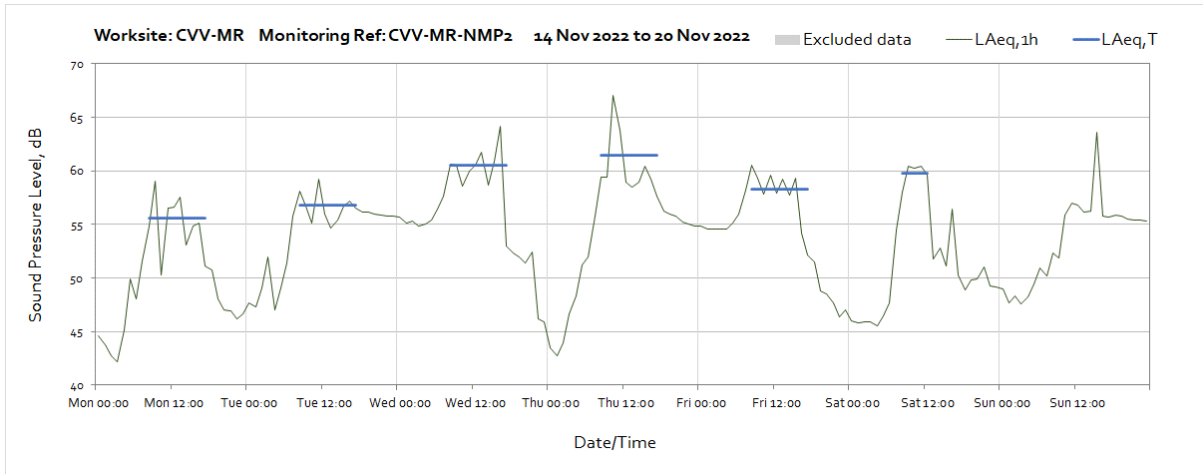
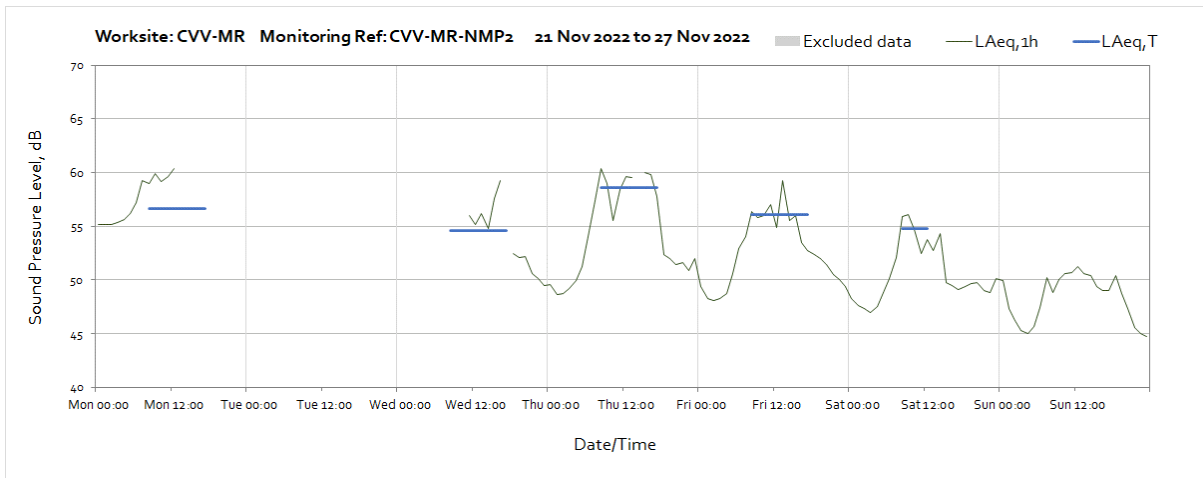
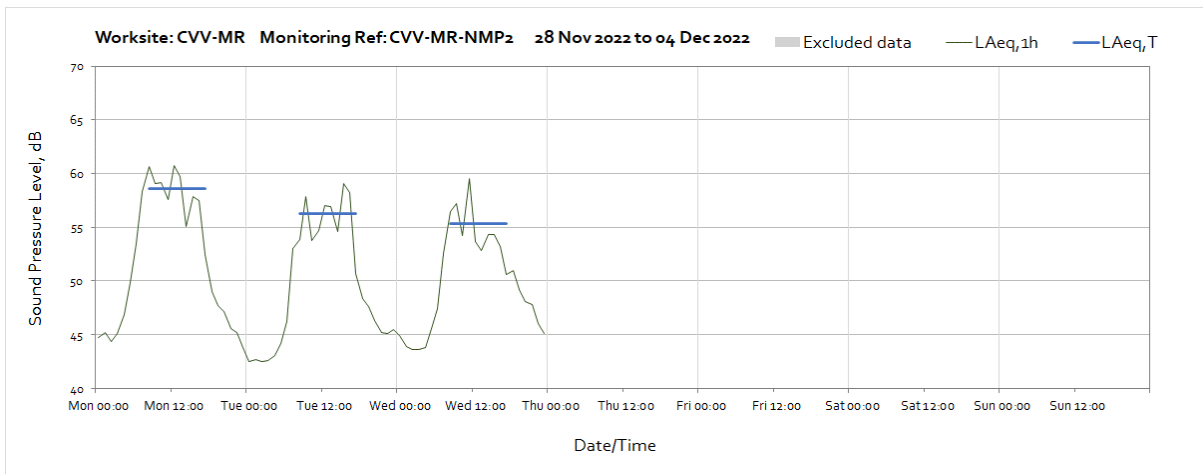
**Monitoring Ref: CVV-MR-NMP2**

Note: Missing data between 13:00 on Monday 21<sup>st</sup> November and 10:00 on Wednesday 23<sup>rd</sup> November was due to loss of power at the monitoring station. Missing data at 17:00 on Wednesday 23<sup>rd</sup> November was due to monitor settings update. Missing data at 14:00 on Thursday 24<sup>th</sup> November was due to field calibration of the monitor.

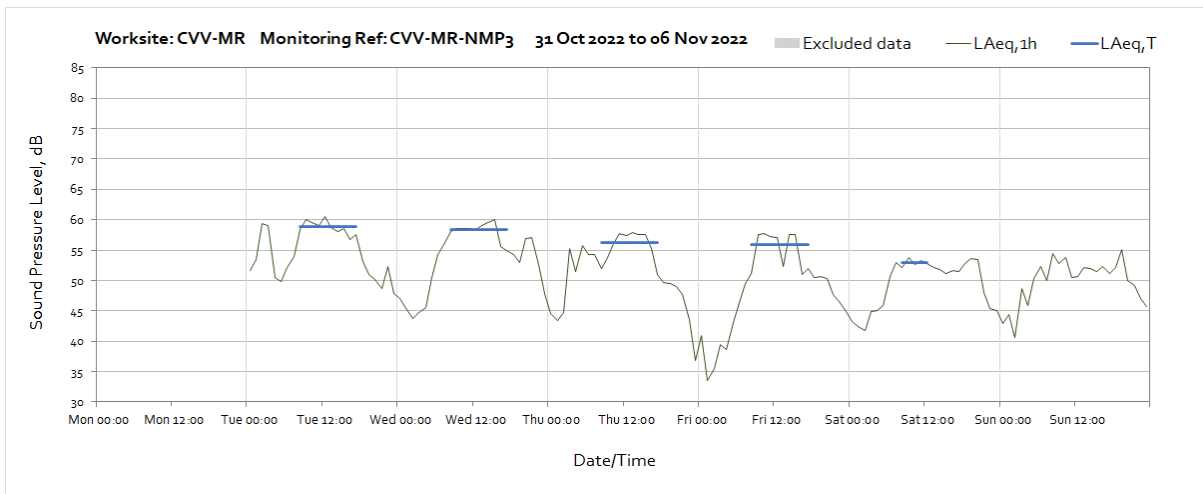
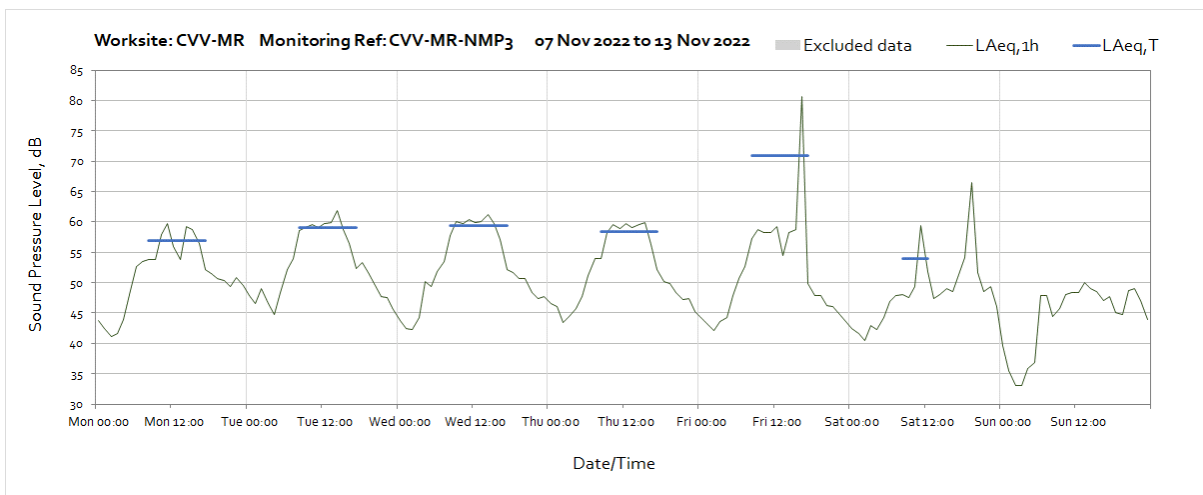
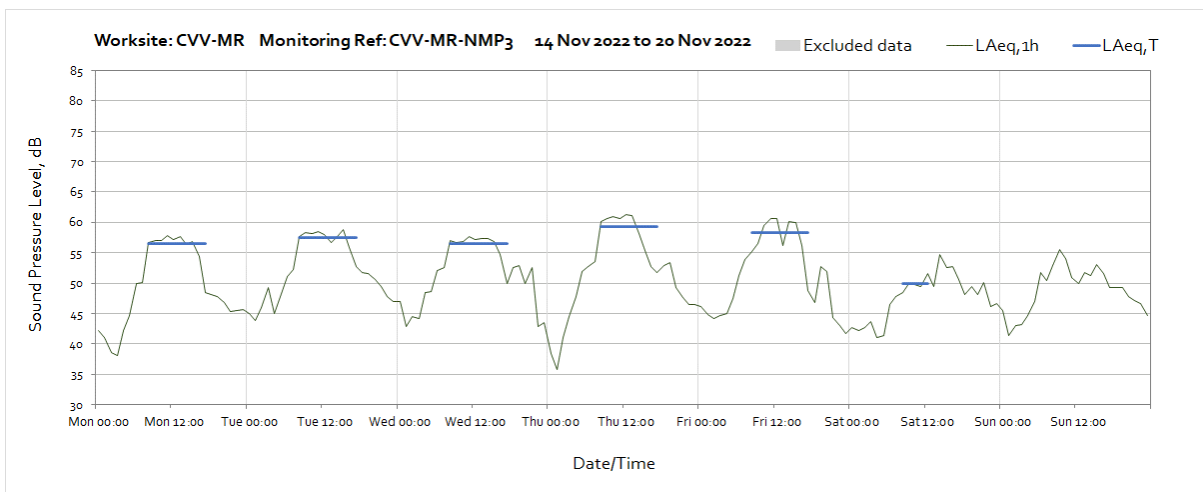
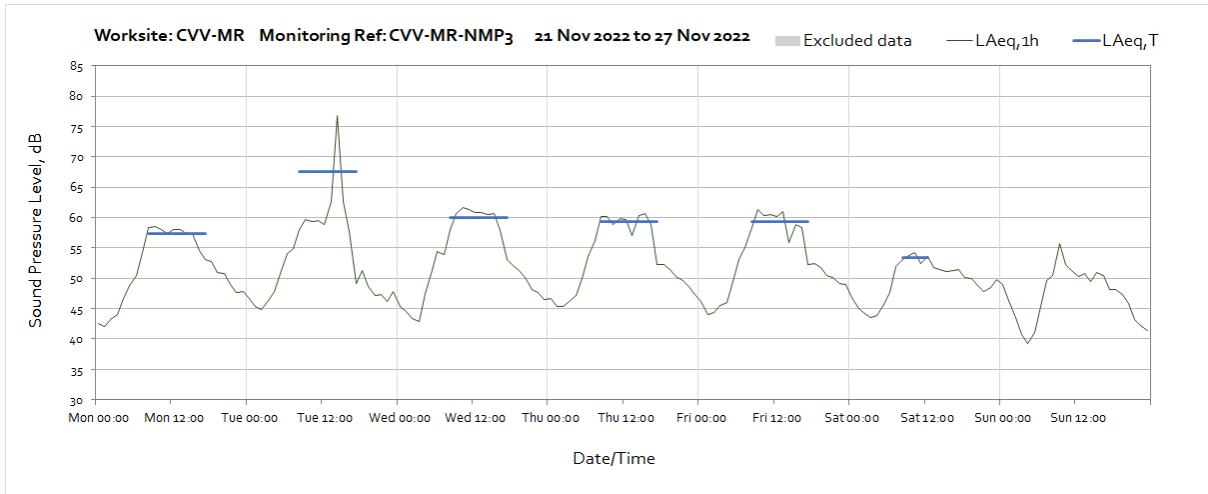
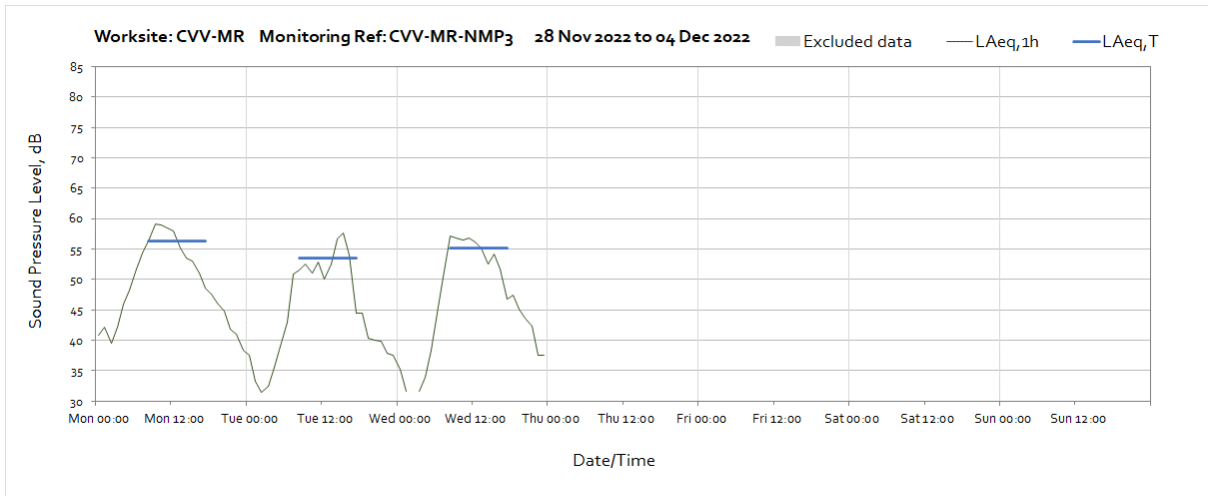
## Monitoring Ref: CVV-MR-NMP3

Note: Missing data at 02:00 on Wednesday 30<sup>th</sup> November was due to monitor settings update.

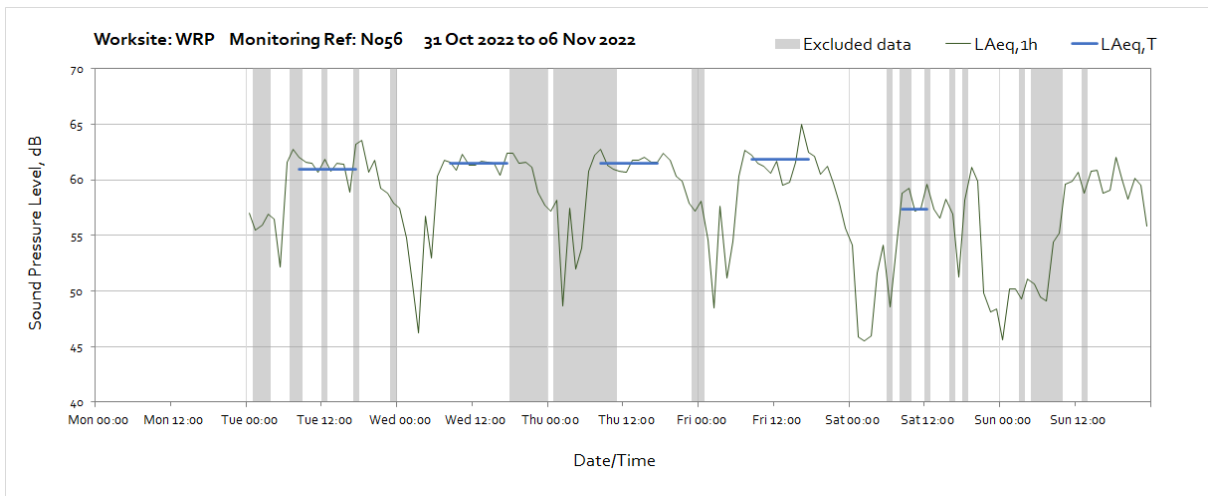
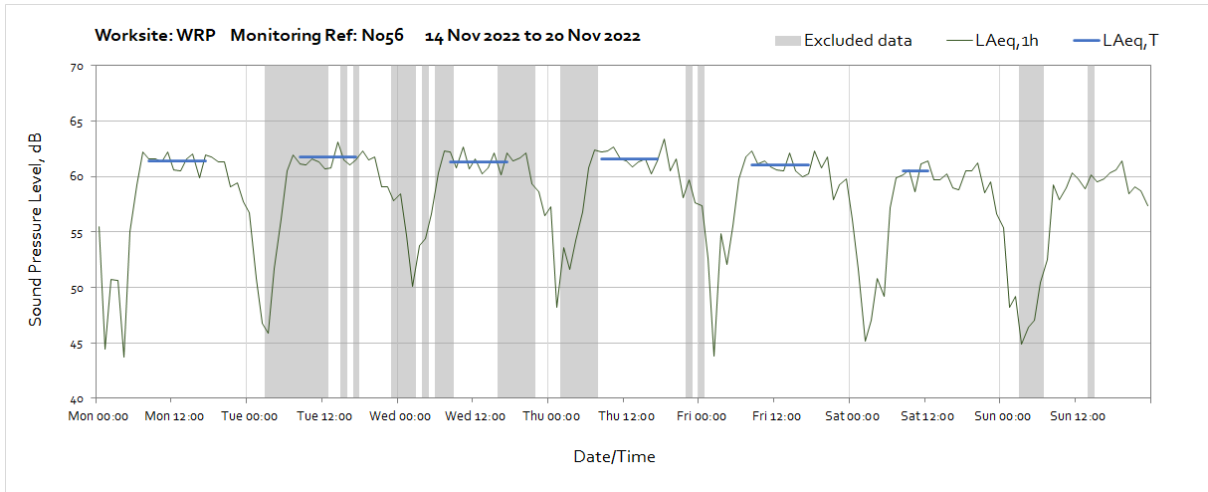
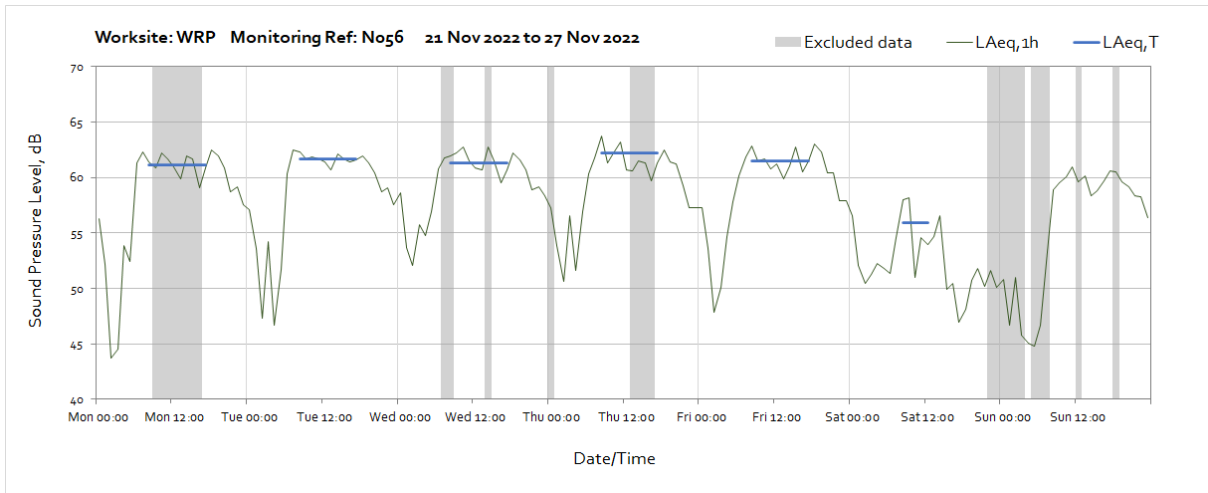
**Worksite: West Ruislip Portal (WRP) – Monitoring Ref: N056**

2.2.8 Four (4) 24-hour periods that experienced an exceedance of the SOAEL were recorded due to HS2 construction works during November 2022. Exceedances occurred at noise monitor N056 during night-time periods.

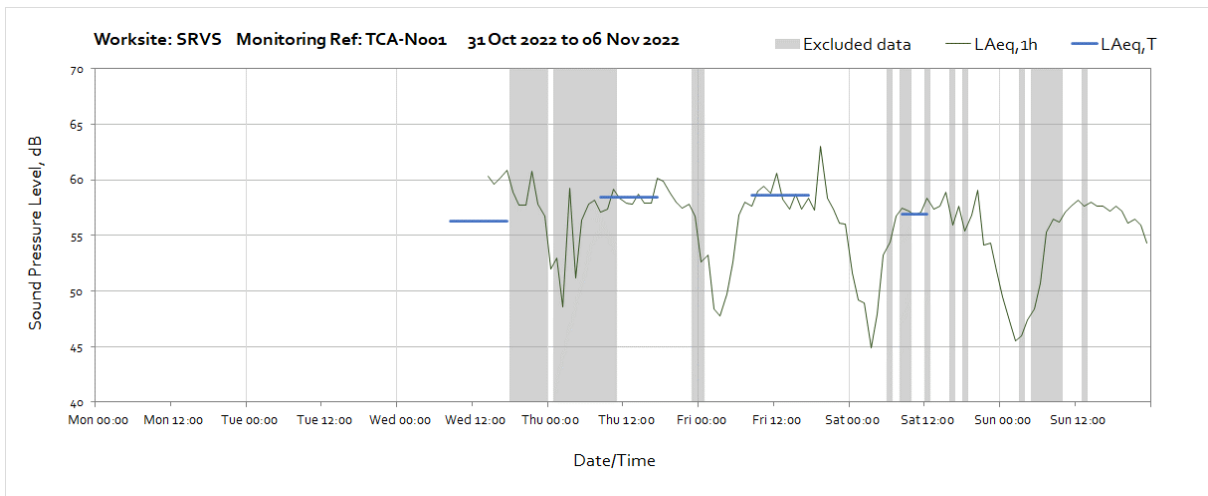
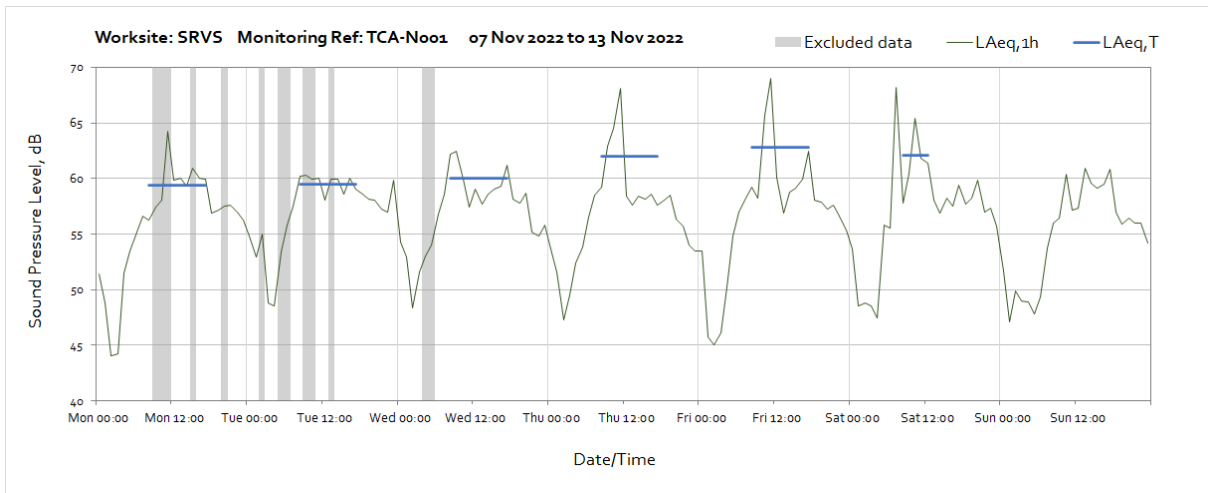
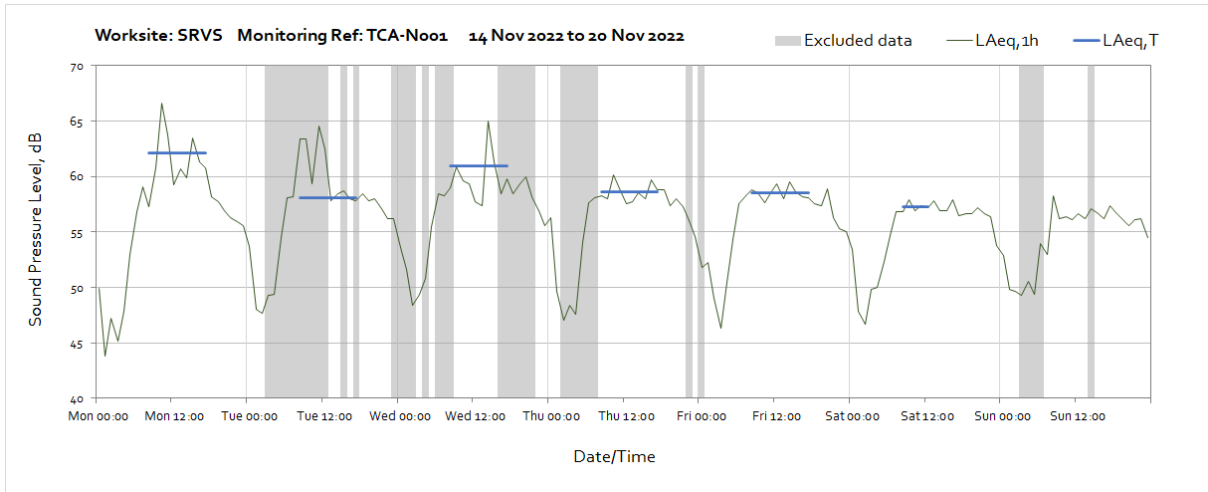
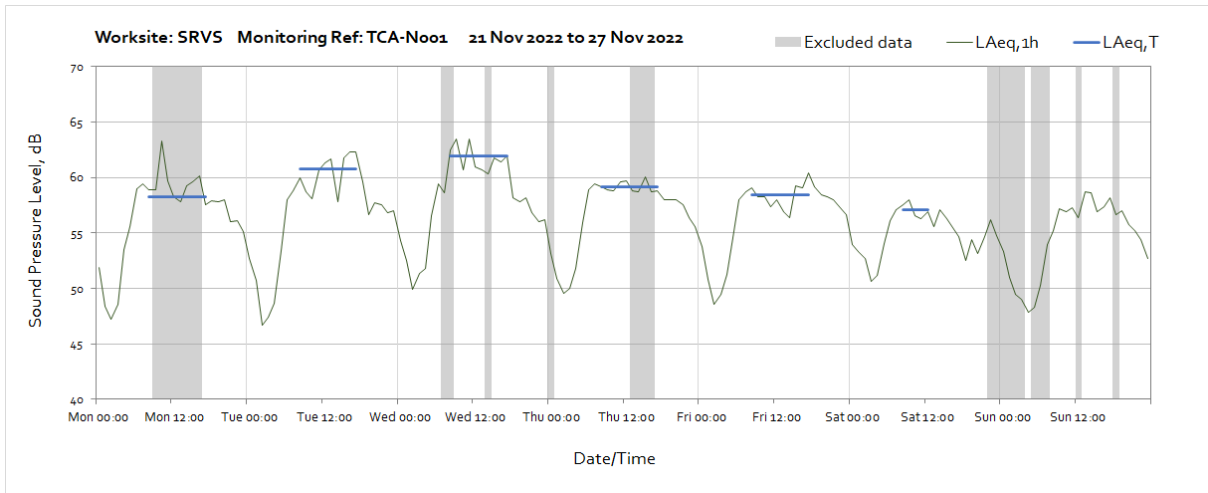
**Worksite: South Ruislip Ventilation Shaft (SRVS) – Monitoring Ref: TCA-N001**

Note: Noise monitor intalled at 14:00 on Wednesday 2<sup>nd</sup> November 2022.

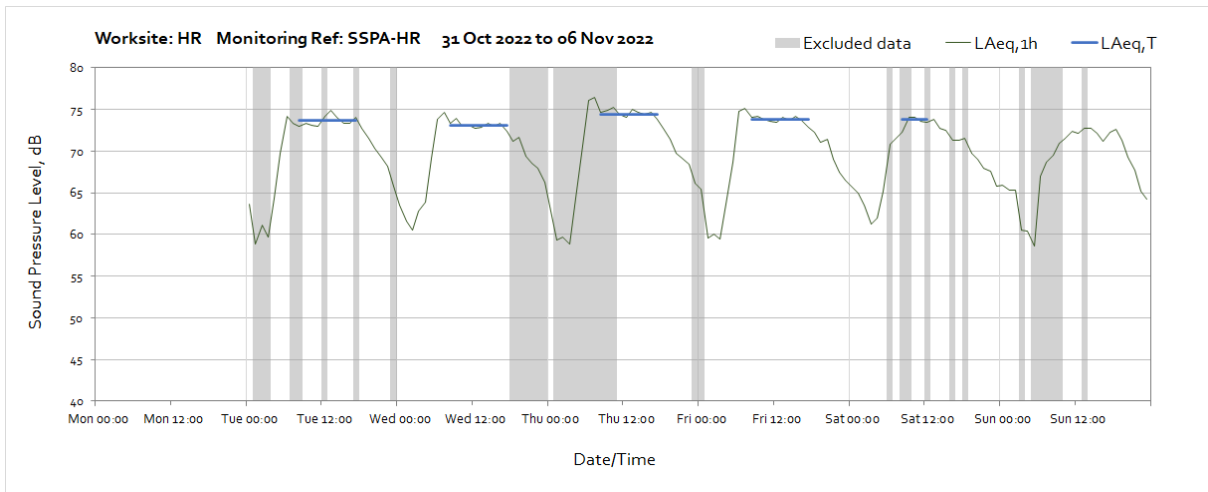
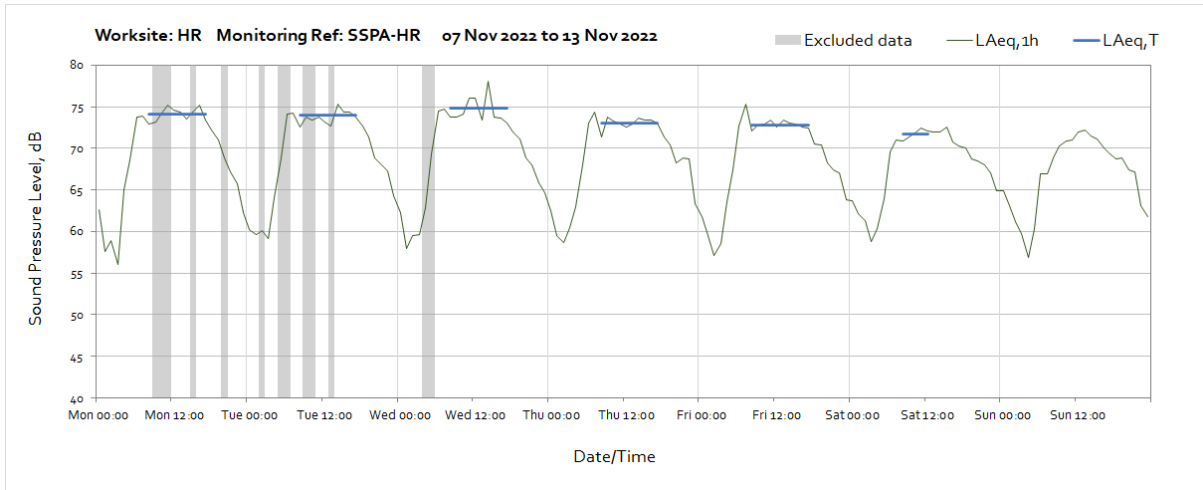
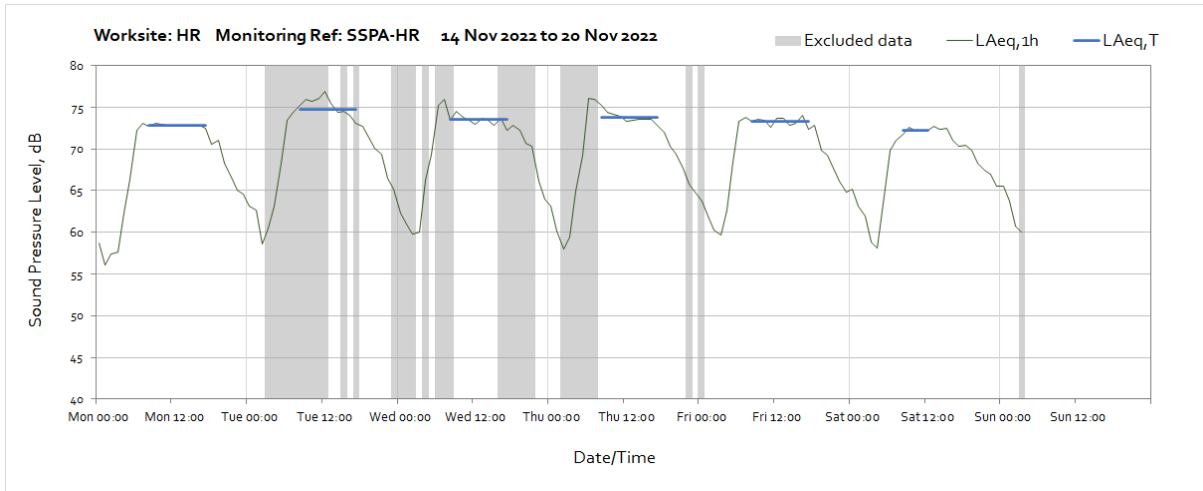
**Worksite: Harvil Road (HR) - Monitoring Ref: SSPA-HR**

Note: Missing data between 04:00 on Sunday 20<sup>th</sup> November to the end of the month was due to loss of battery power at the monitoring station.

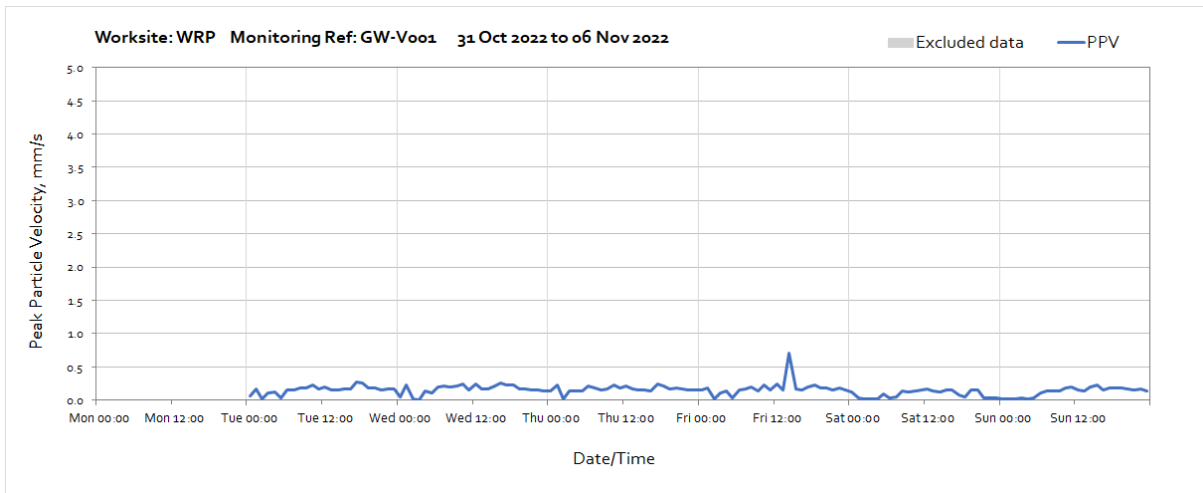
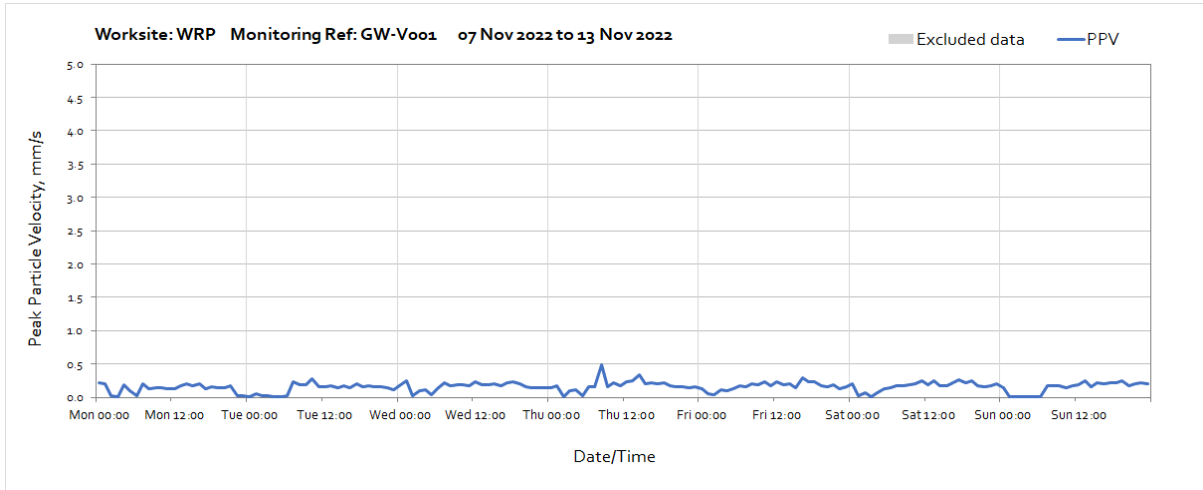
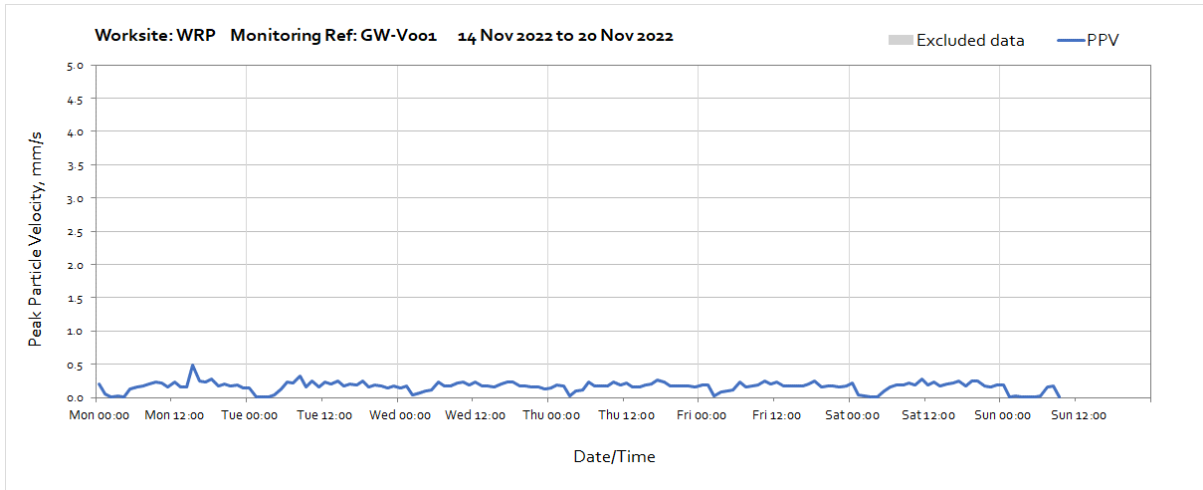
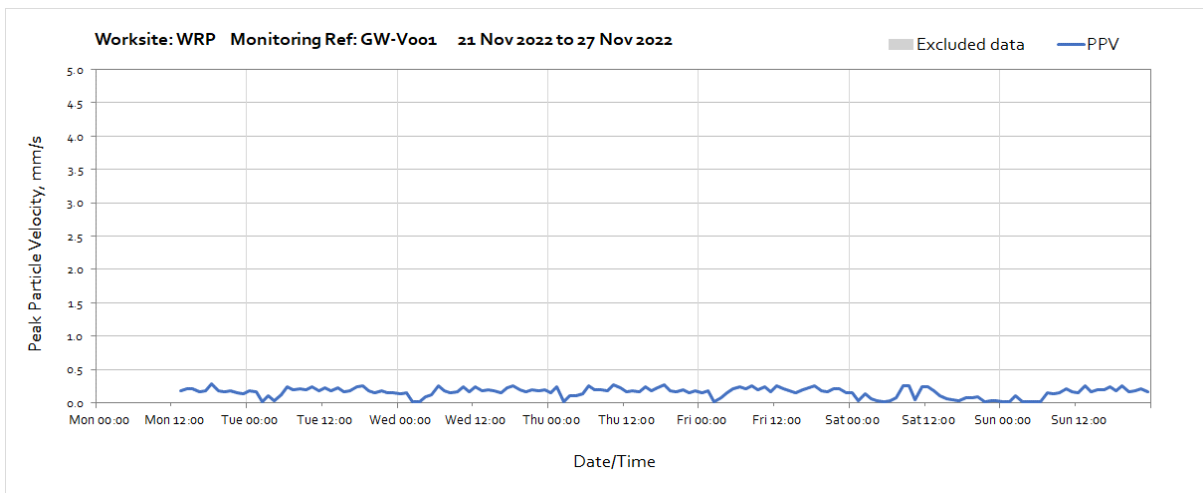
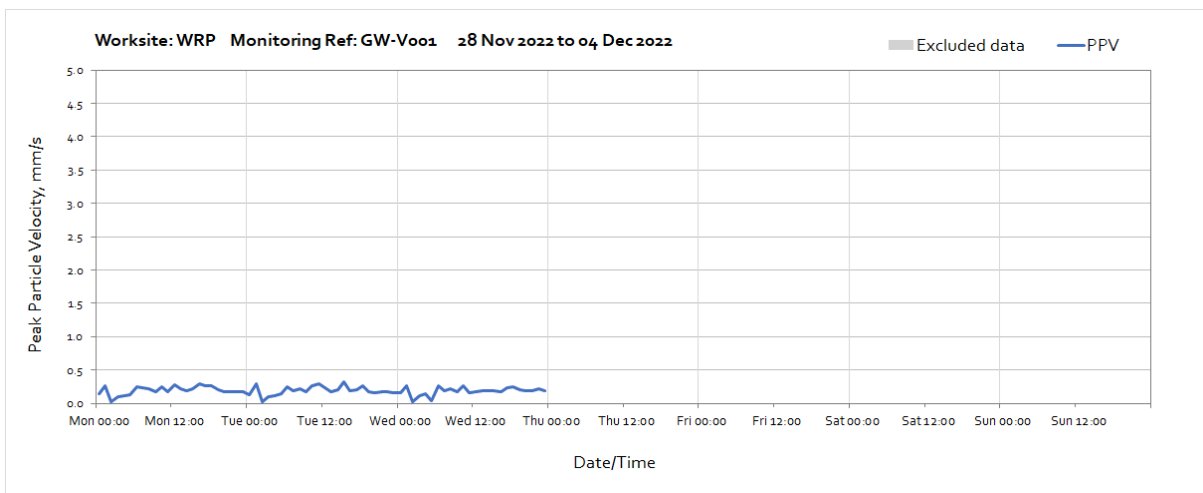
### Worksite: West Ruislip Portal (WRP) – Monitoring Ref: GW-V001

The following graphs show the hourly measured peak particle velocity PPV recorded during the monitoring period. The graphs show the highest PPV of the three orthogonal axis x, y and z. Where high values of PPV were caused by local interference with the vibration monitor, which are not representative of HS2 construction works, these values have been greyed out in the following charts and have been excluded to calculate values in Table 4 of the main report.

Note: Missing data between 10:00 on Sunday 20<sup>th</sup> November and 11:00 on Monday 21<sup>st</sup> November was due to loss of battery power at the monitoring station.

Worksite Reference	Measurement Reference	Monitor Address	Highest PPV measured in any axis, mm/s
WRP	GW-V001	95 The Greenway, Ickenham, Uxbridge	0.71 (Y-axis)
SRVS	SRVS-V001	Braintree Industrial Estate - Building D4	0.89 (Z-axis)
