Construction Noise and Vibration Monthly Report – November 2022

Stratford-on-Avon District Council

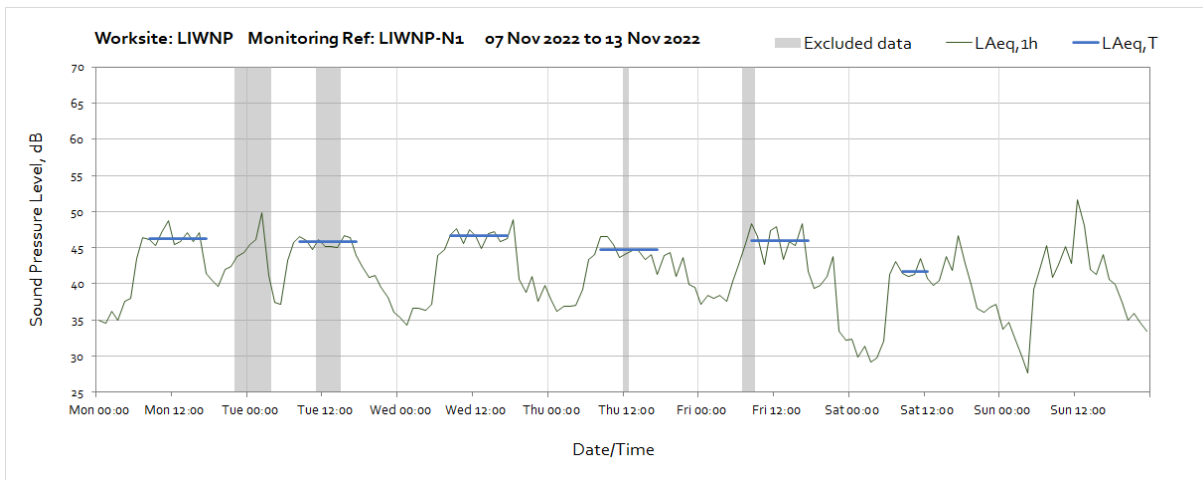
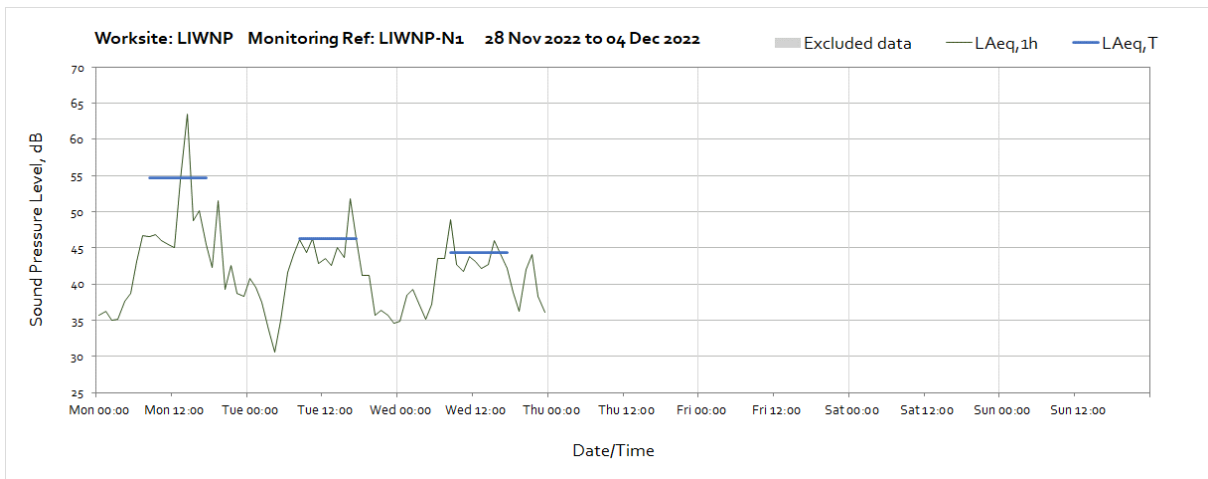
Worksite: LIWNP Monitoring Ref: LIWNP-N1

The following graphs show the hourly measured ambient noise level $L_{Aeq,1h}$ and, where relevant, the averaged noise level $L_{Aeq,T}$ values, where the time period T is as specified in Table 1 of HS2 Information Paper E23. Periods with adversely weather affected noise levels are greyed out and have been excluded from the calculation of the $L_{Aeq,T}$ values in Table 3 of the main report.

2.1.1 Table 3 presents a summary of the measured noise levels at each monitoring location over the reporting period. The $L_{Aeq,T}$ is presented for each of the relevant time periods averaged over the calendar month, along with the highest single period $L_{Aeq,T}$ that was found to occur within the month.

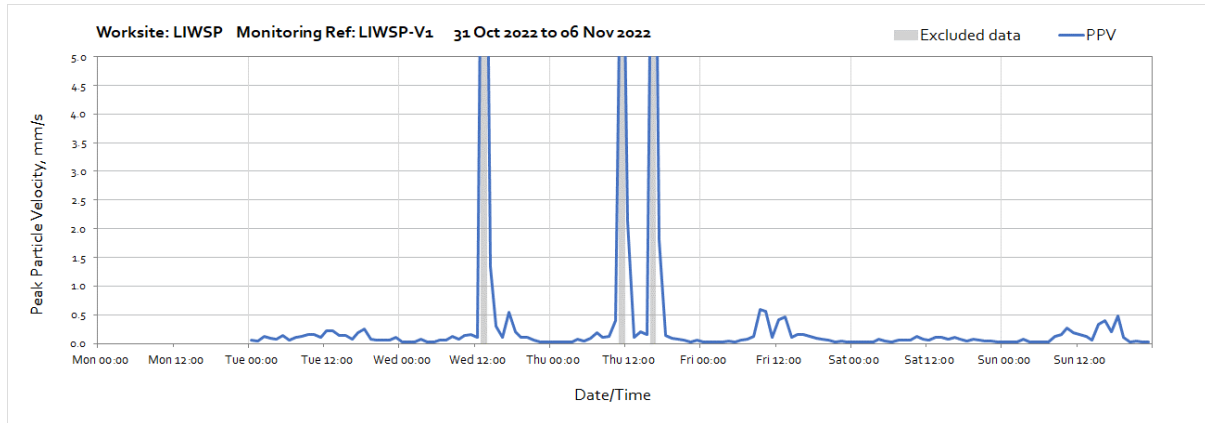
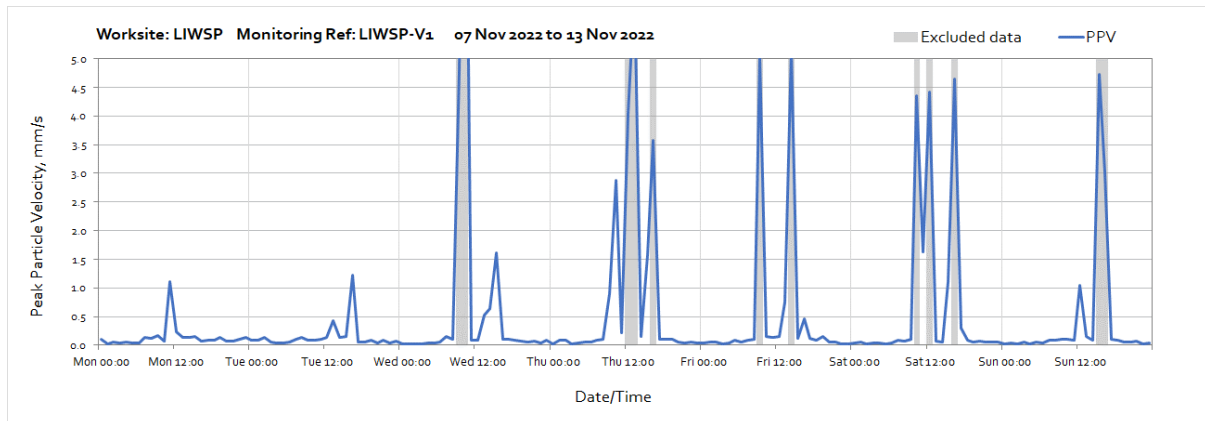
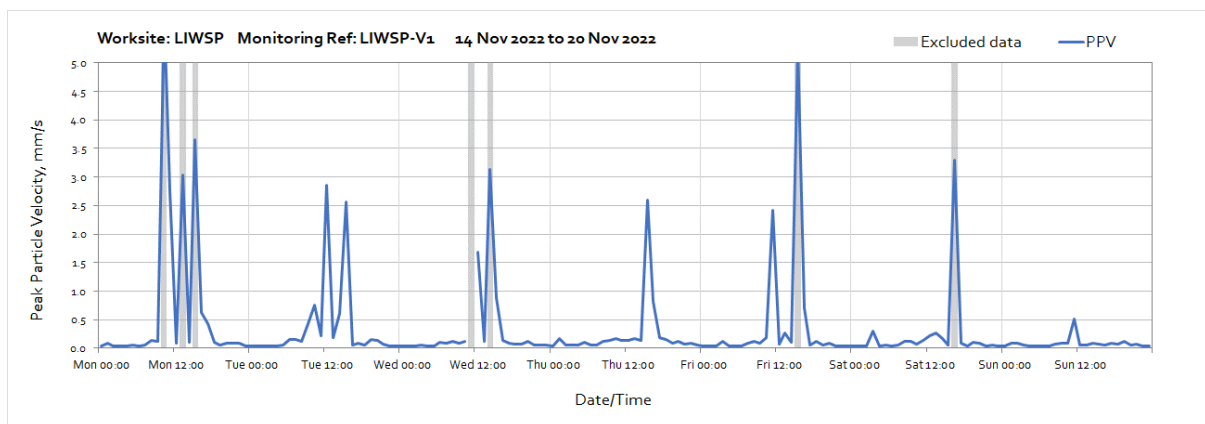
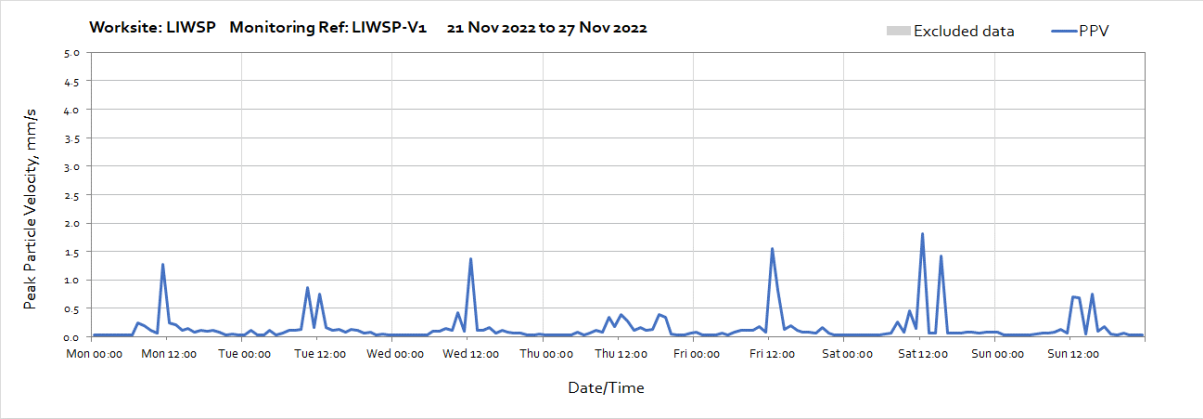
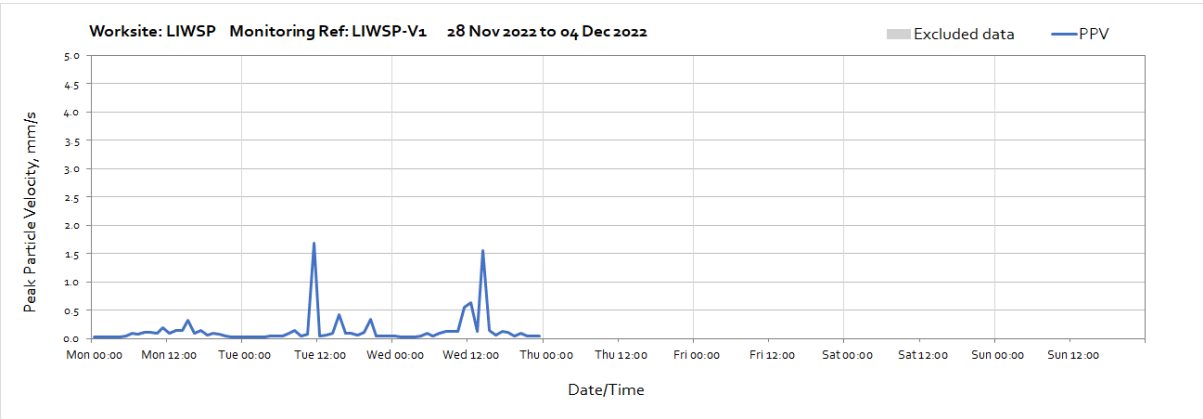
Worksite: LIWSP Monitoring Ref: LIWSP-V1

The following graphs show the hourly measured peak particle velocity PPV recorded during the monitoring period. The graphs show the highest PPV of the three orthogonal axes x, y and z. Where high values of PPV were caused by local interference with the vibration monitor, which are not representative of HS2 construction works, these values have been greyed out in the following charts and have been excluded to calculate values in Table 4 of the main report.

Worksite Reference	Measurement Reference	Monitor Address	Highest PPV measured in any axis, mm/s
LIWSP - Long Itchington Wood South Portal	LIWSP-V1	Woodside House, Bascote Heath, Southam	2.51 (Z-axis)
