Construction Noise and Vibration Monthly Report – November 2022

West Northamptonshire District Council

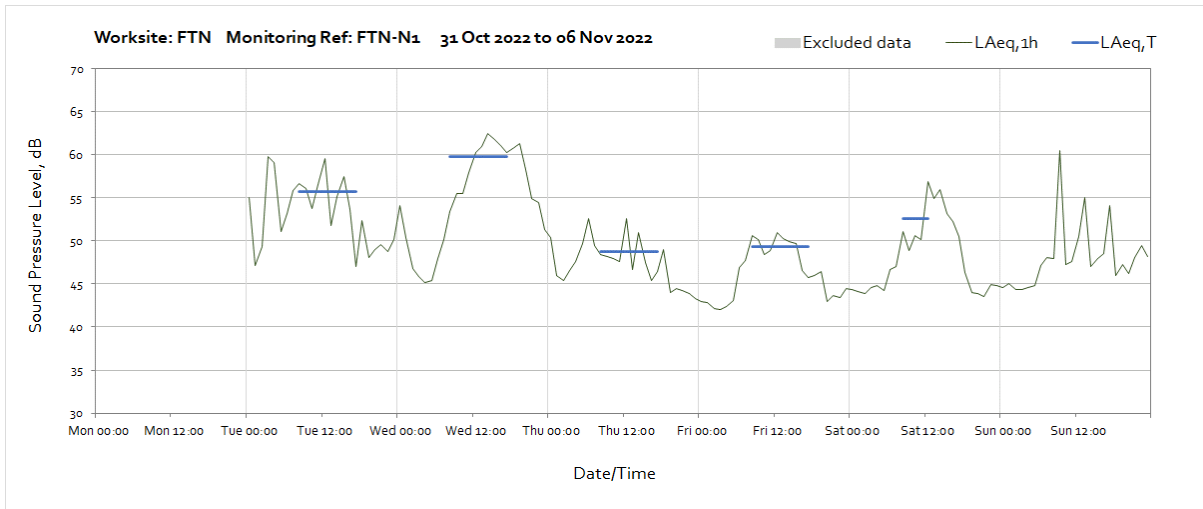
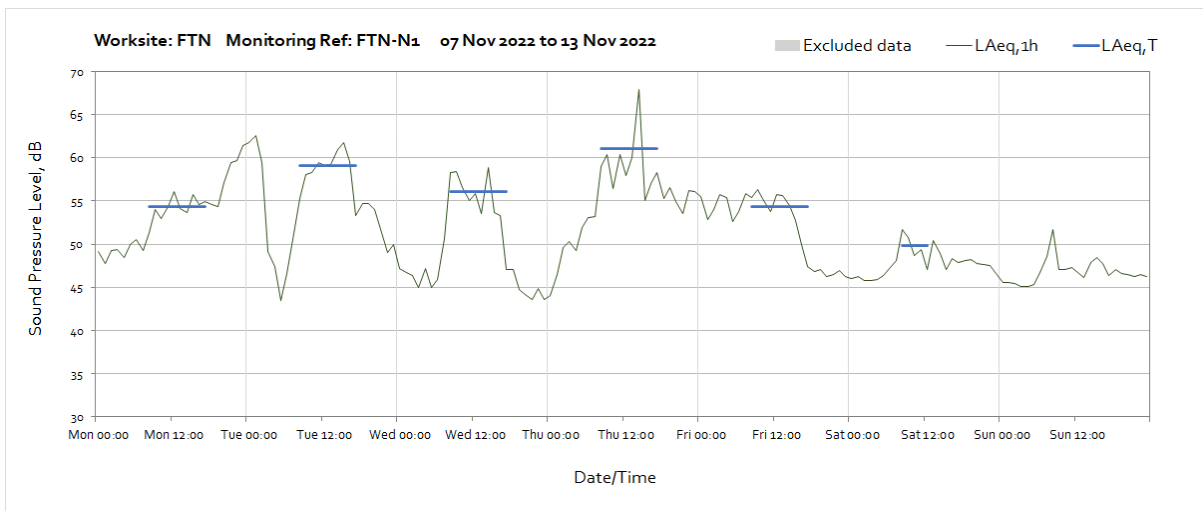
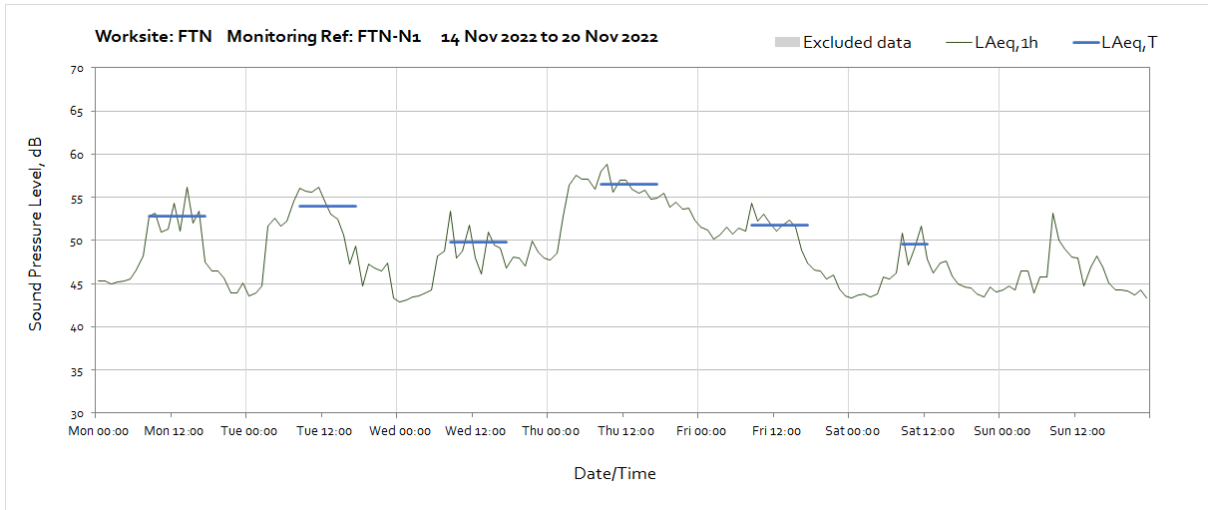
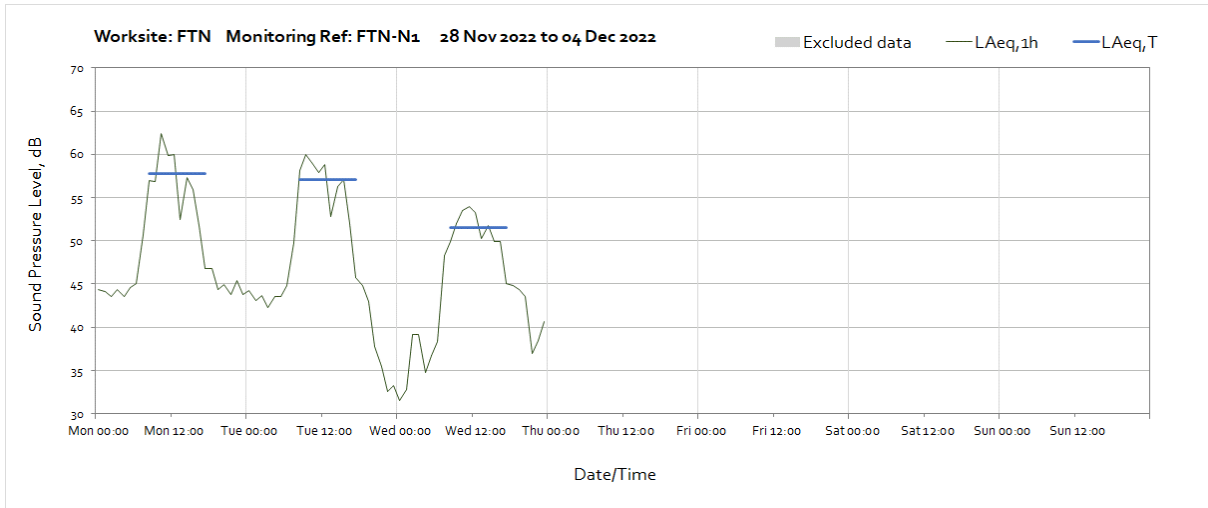
Worksite: FTN – Monitoring Ref: FTN-N1

The following graphs show the hourly measured ambient noise level $L_{Aeq,1h}$ and, where relevant, the averaged noise level $L_{Aeq,T}$ values, where the time period T is as specified in Table 1 of HS2 Information Paper E23. Periods with adversely weather affected noise levels are greyed out and have been excluded from the calculation of the $L_{Aeq,T}$ values in Table 3 of the main report.

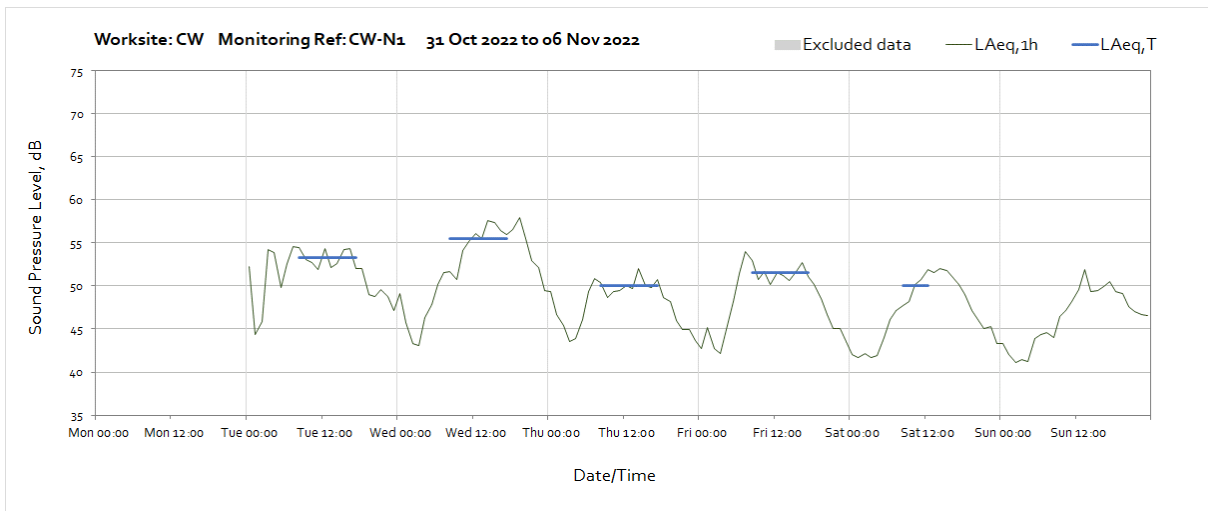
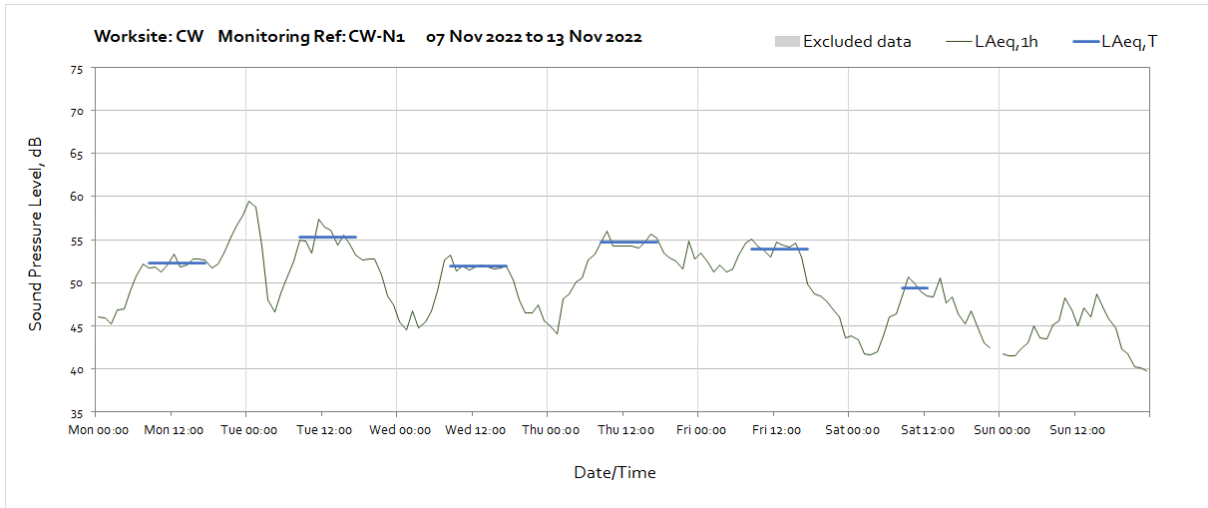
Worksite: CW – Monitoring Ref: CW-N1

Note: Missing data at 23:00 on Saturday 12th November was due to an internal error at the monitoring station.

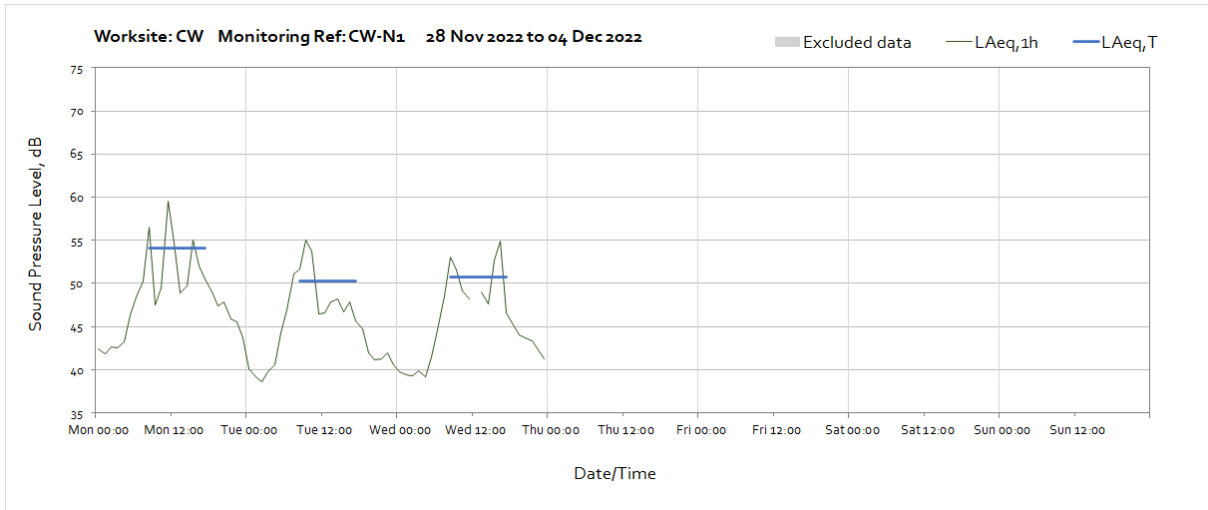
Note: Missing data at 12:00 on Wednesday 30th November was due to maintenance of the monitor.

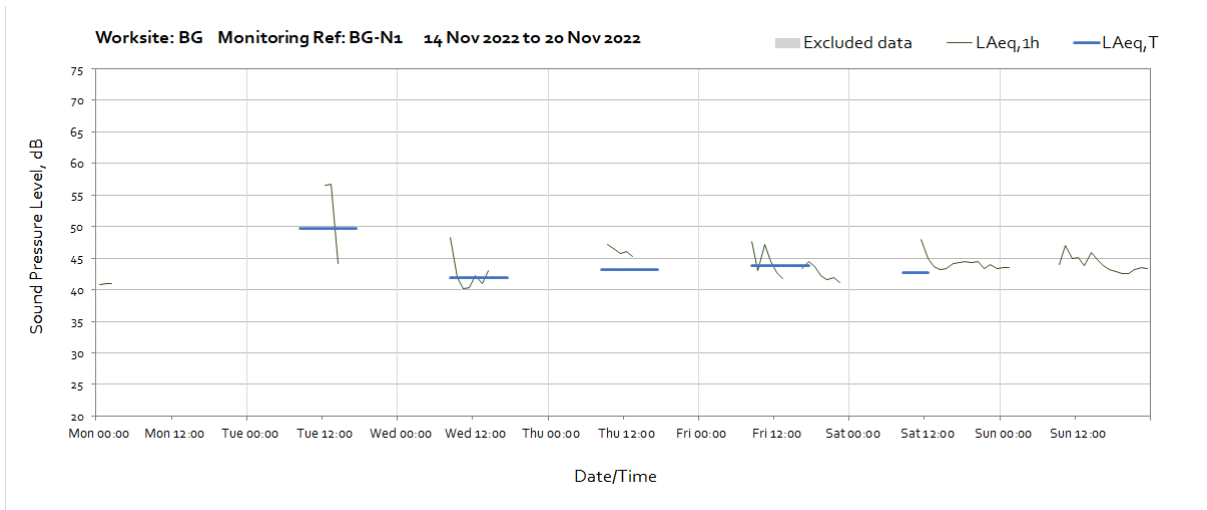
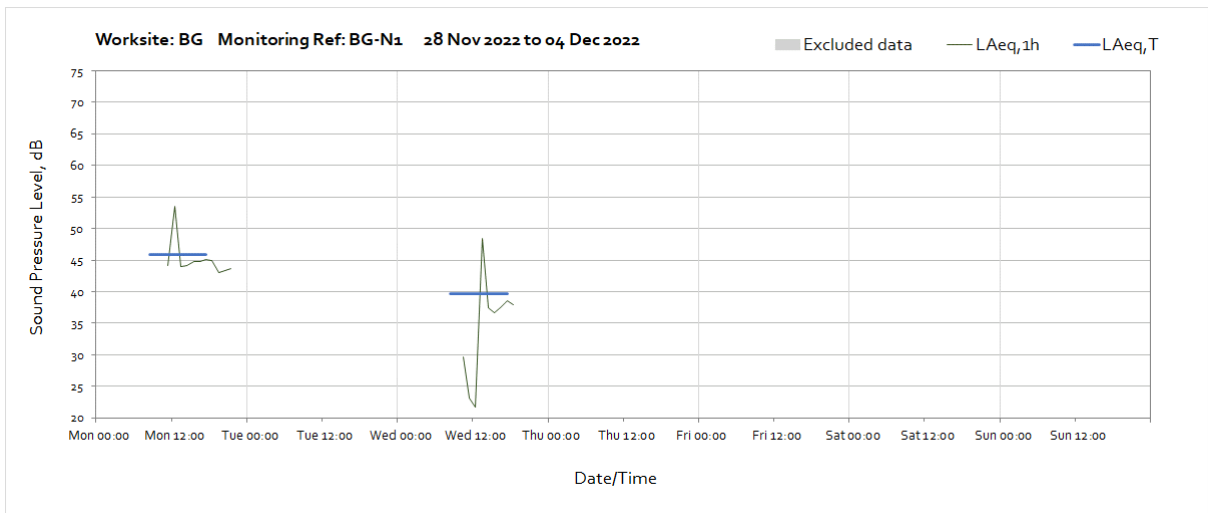
Worksite: BG – Monitoring Ref: BG-N1

Note: Missing data throughout the week was due to a damaged cable leading to loss of power to the monitor, which was subsequently removed for repair in December 2022.
