Ref. FOI 2022/09482

## ATTACHED TO DEED - Hants 331052

## TUNNEL FOUND AT AREA 7 BARTON STACEY TRAINING AREA

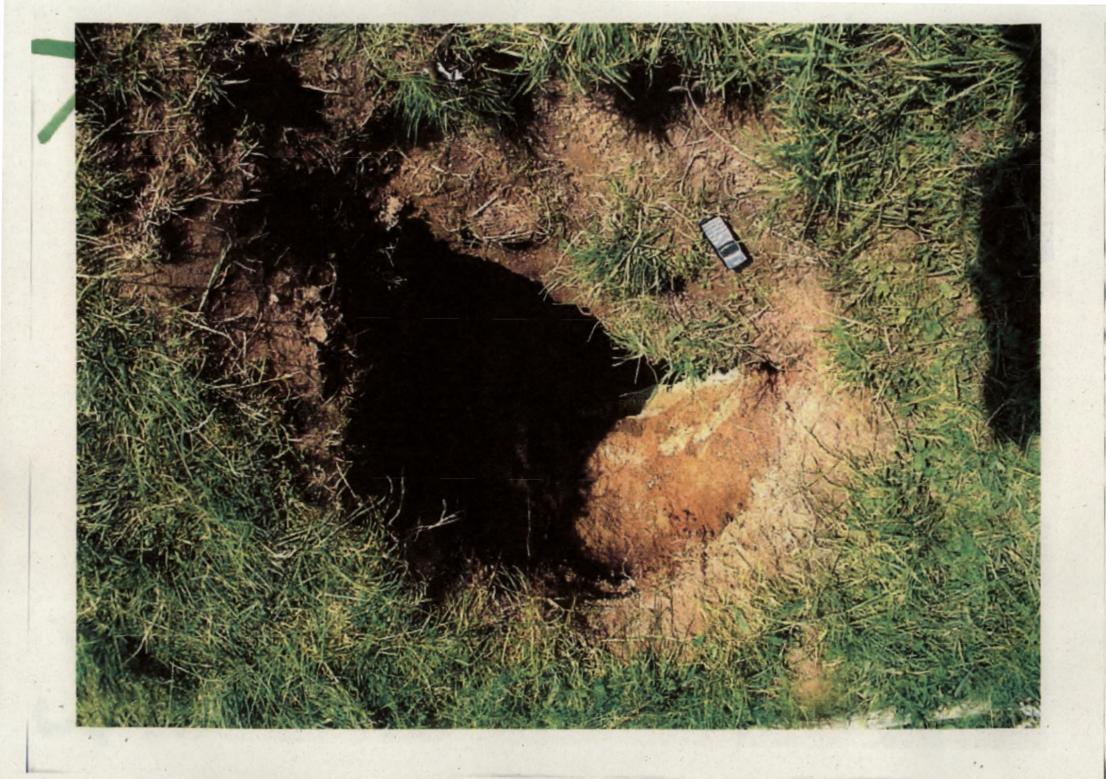
The licensee of the above land reported that a hole had appeared in the middle of his field – see photo 1. This is located at approx. SU 4438.4119

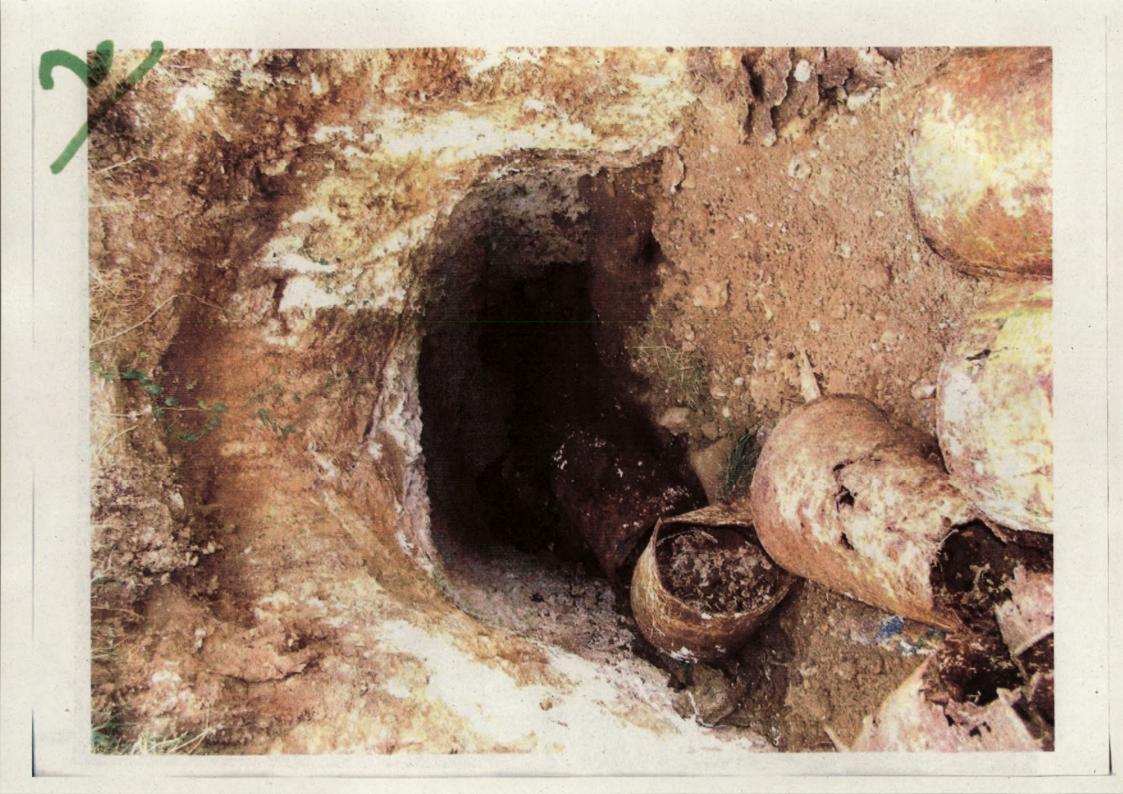
Exploratory excavation was carried out with a mini-digger and the surface removed and a hand-dug shaft running into the chalk appeared, approx 6 feet wide at a 70-60 degree angle – see photo 2. There was no sign in the vicinity of any of the spoil/chalk raised from the shaft. Further excavation revealed that the shaft had been back-filled with large tin drums and builders debris, which were now rusting away and so the ground was subsiding to fill the void – see photo 3 & 4 & 6.

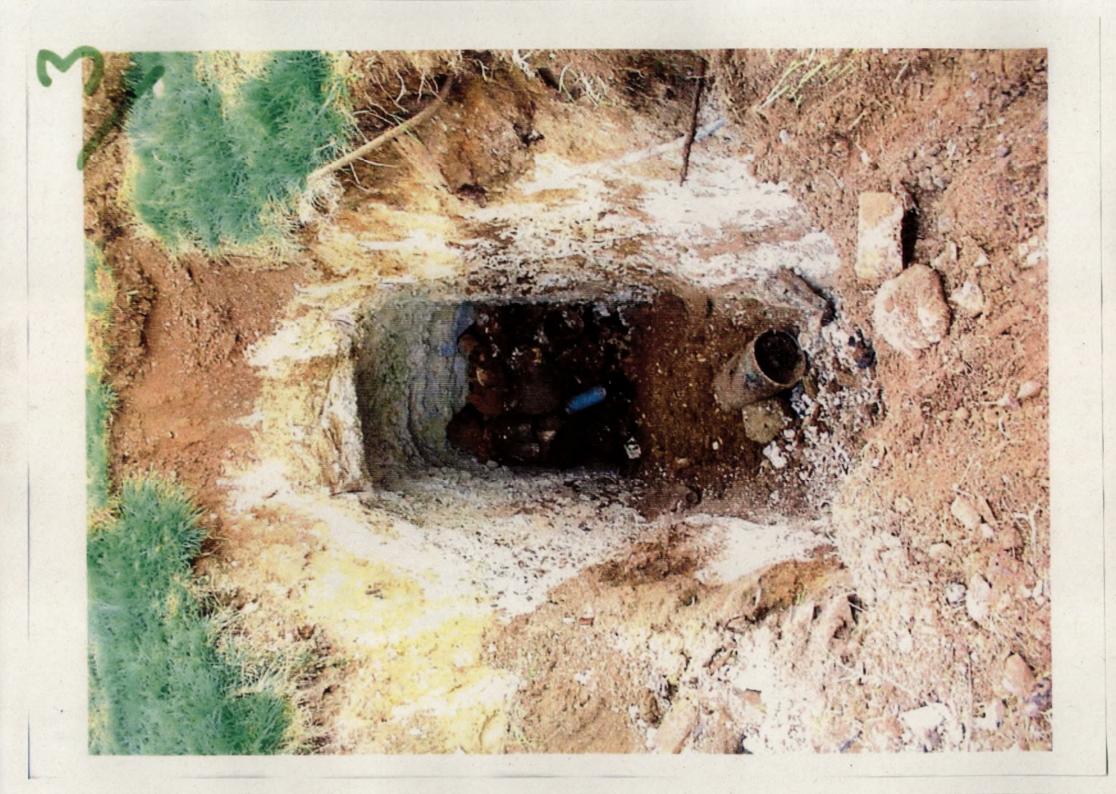
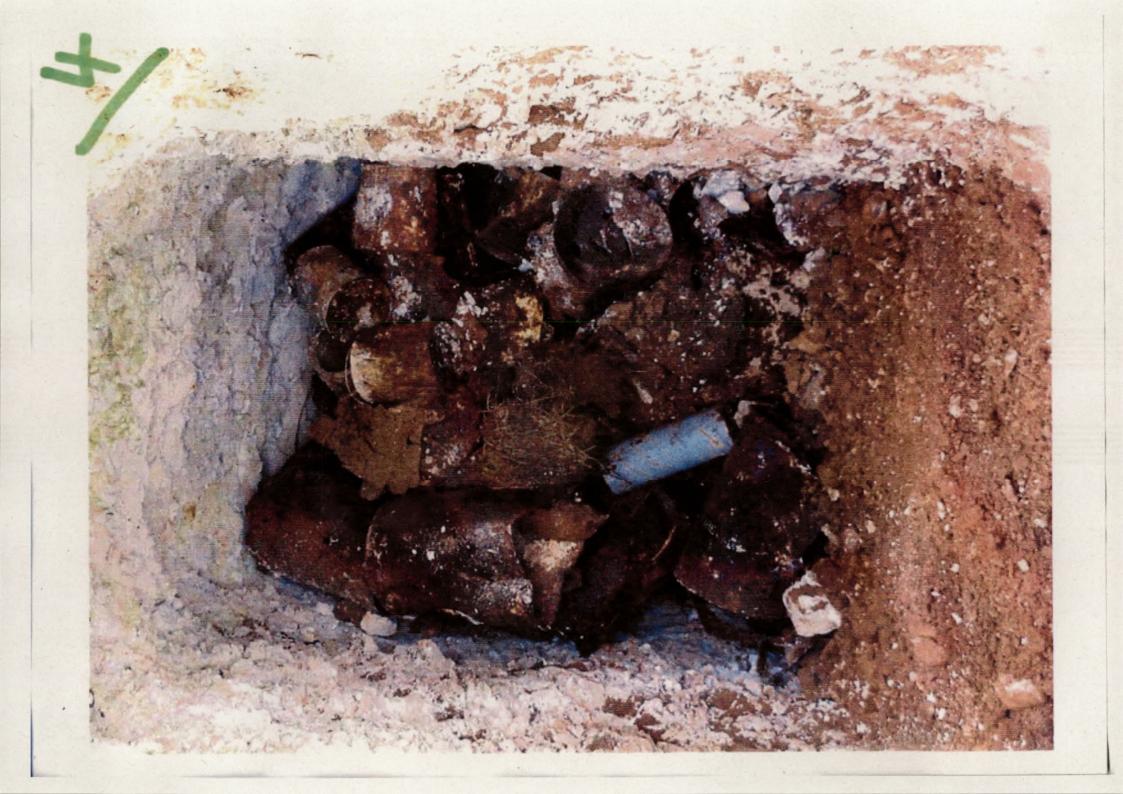
Initially an amount of broken asbestos sheeting was in the debris, so naturally I didn't want to push it back down into the shaft if it was a well, because it could potentially contaminate the aquifers. I also of course had the concern that unknown items could have been buried in War-time that are 'undesirable' but which now can be better disposed of, or rendered harmless, etc. Another consideration was that given the hole was clearly hand dug it could be some sort of archaeological feature (ie. Flint Mine), or even a WW1 / 2 historical construction that would now be of interest and worth preserving (the DE Archaeological Officer was notified at this time- 5 June).

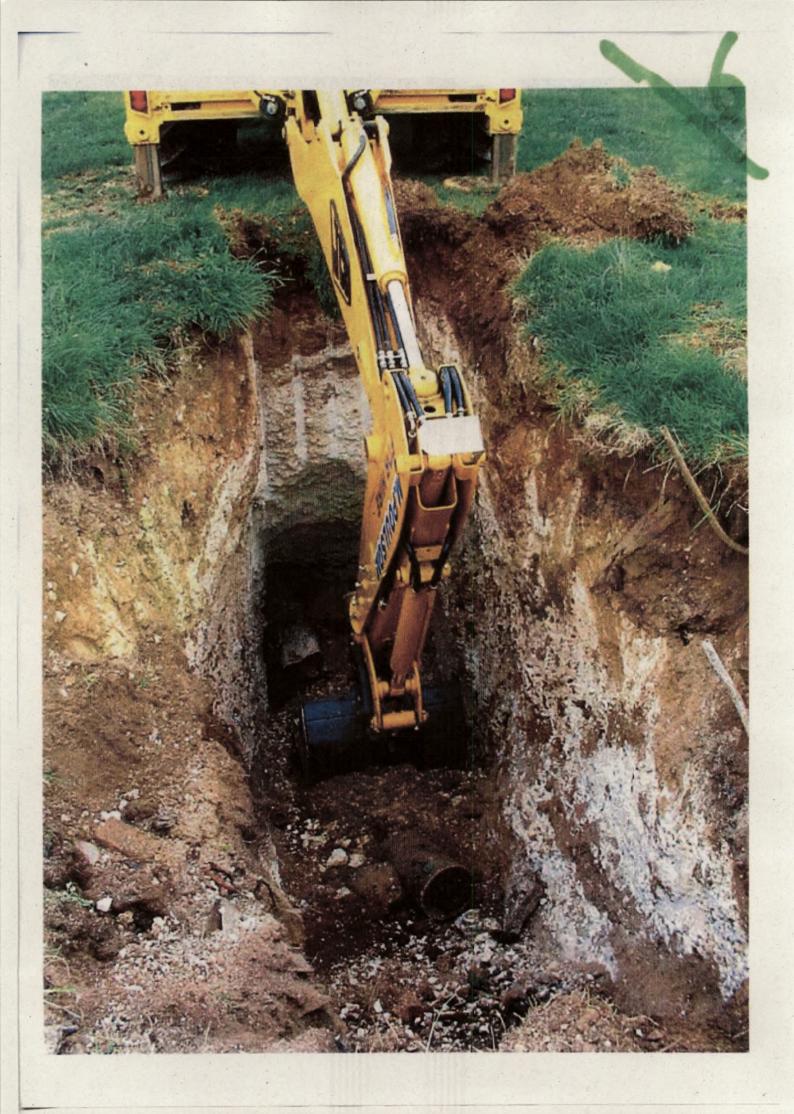
On 9 October 06 a JCB started to excavate the shaft deeper –see photo 6; and when that could reach no deeper a 360 tracked digger continued to its maximum reach. In order to determine that the shaft continued deeper into the ground; and to give an idea of scale I climbed down into the trench – see photo 7.

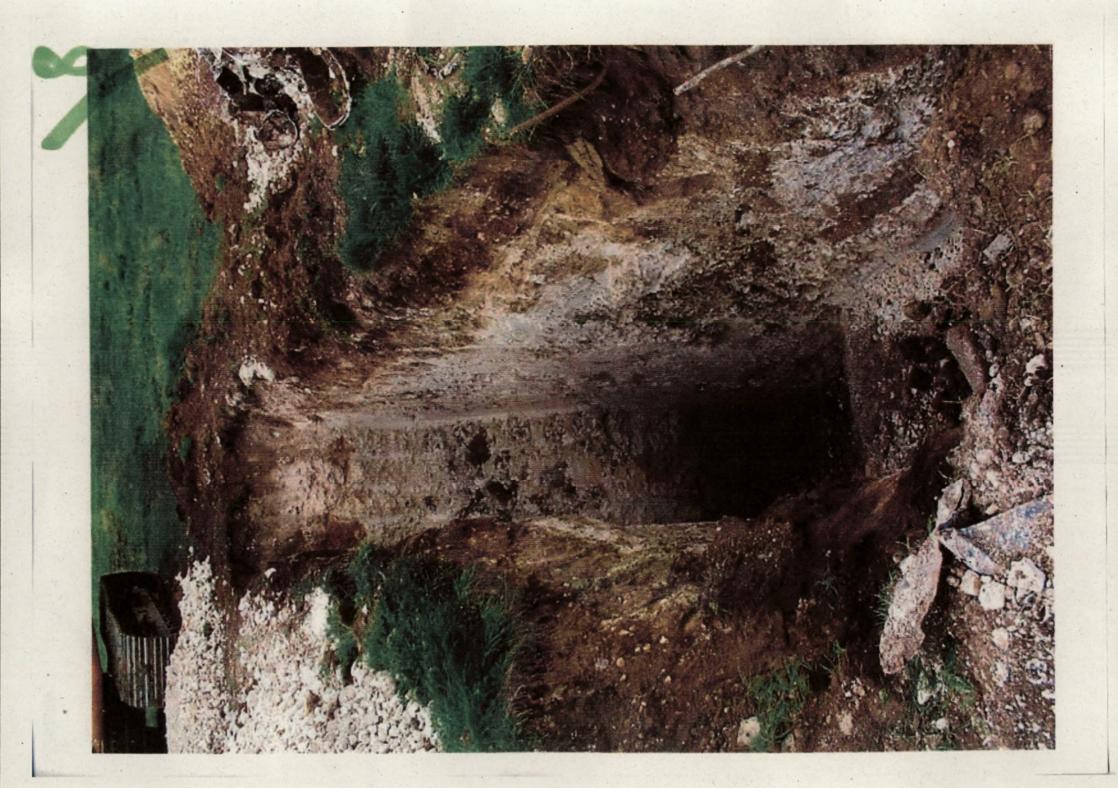
Finally, when the digger could go no deeper I climbed back into the shaft and dug out by hand the soil and debris blocking the shaft – see photo 8. The trench was now about 22 feet deep, and on clearing the entrance to the shaft I then poked a 8 ft pipe into the void and could see that the shaft continued on down into the ground for at least another 10 feet – see photo 9. It appeared that at this location the shaft widened out into a bigger area and a 'roof' to a chamber was evident. This void was stacked full of more metal drums and boxes.

The only way to continue the excavation to determine its depth, origin, contents, etc would now be by hand. I therefore sought advice from DE colleagues given all the variable parameters, plus additional cost would now be incurred, and at the current time there was little evidence that anything noxious was buried there. The main driving force to excavate further now appeared to be curiosity and historical interest.

On further discussion with DTE HQ, and then the local DTE HC Commander, it was determined that we should fill the hole with the debris excavated and import material to make up the deficit.

If in future the land is sold this hole will need to be declared and maybe excavated to ensure nothing untoward exists at the very bottom of the shaft.
