Construction Noise and Vibration Monthly Report – December 2022

Lichfield District Council

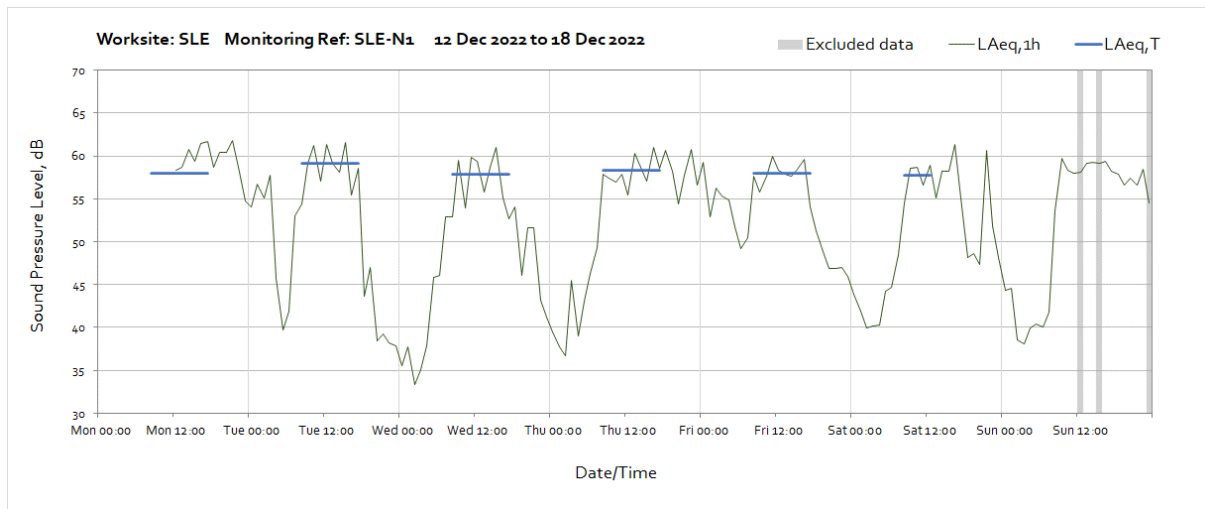
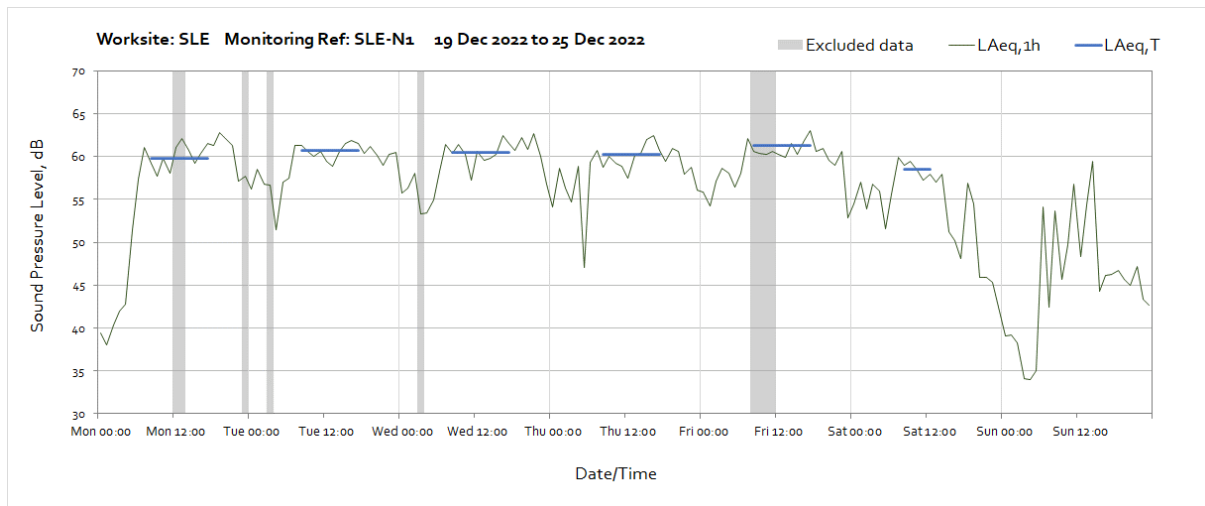
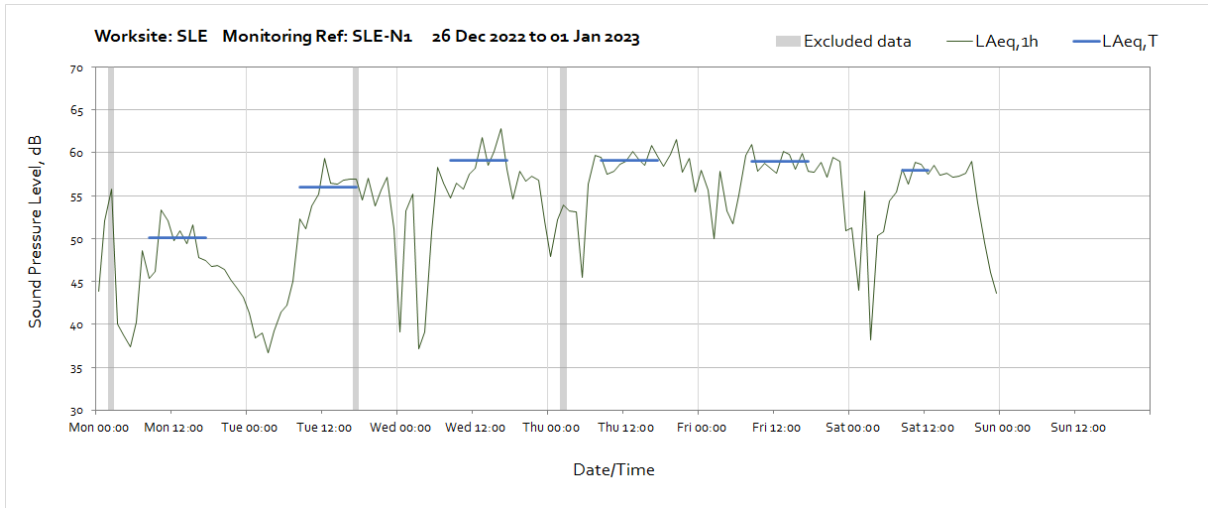
Worksite:SLE - Monitoring Ref: SLE-N1

The following graphs show the hourly measured ambient noise level $L_{Aeq,1h}$ and, where relevant, the averaged noise level $L_{Aeq,T}$ values, where the time period T is as specified in Table 1 of HS2 Information Paper E23. Periods with adversely weather affected noise levels are greyed out and have been excluded from the calculation of the $L_{Aeq,T}$ values in Table 3 of the main report.

Note: Missing data between 00:00 on Thursday 1st December and 12:00 on Monday 12th December was due to loss of power as the solar battery supply was disabled. The batteries were replaced on 12th December.

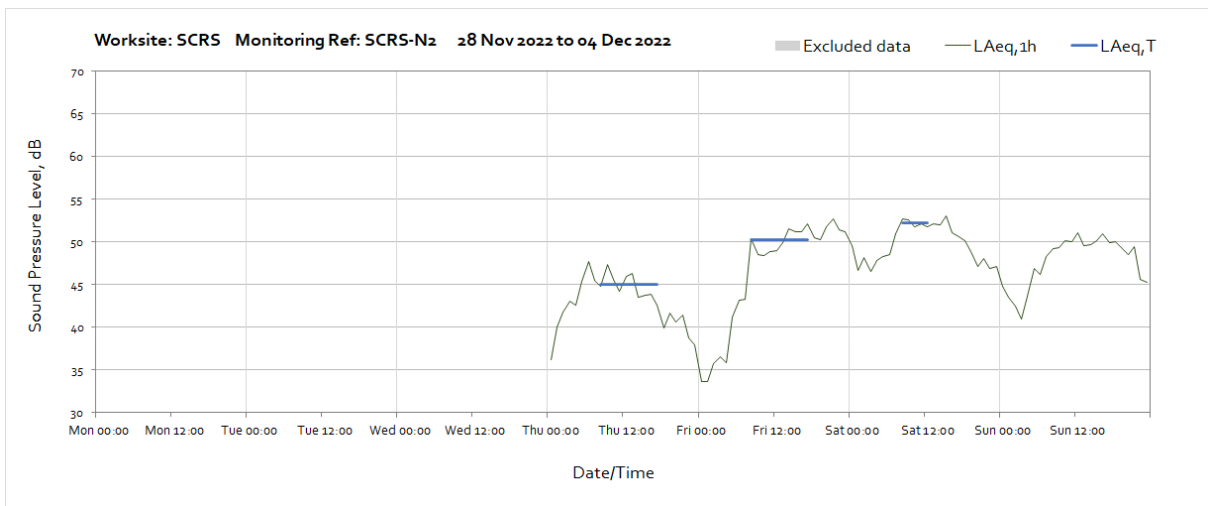
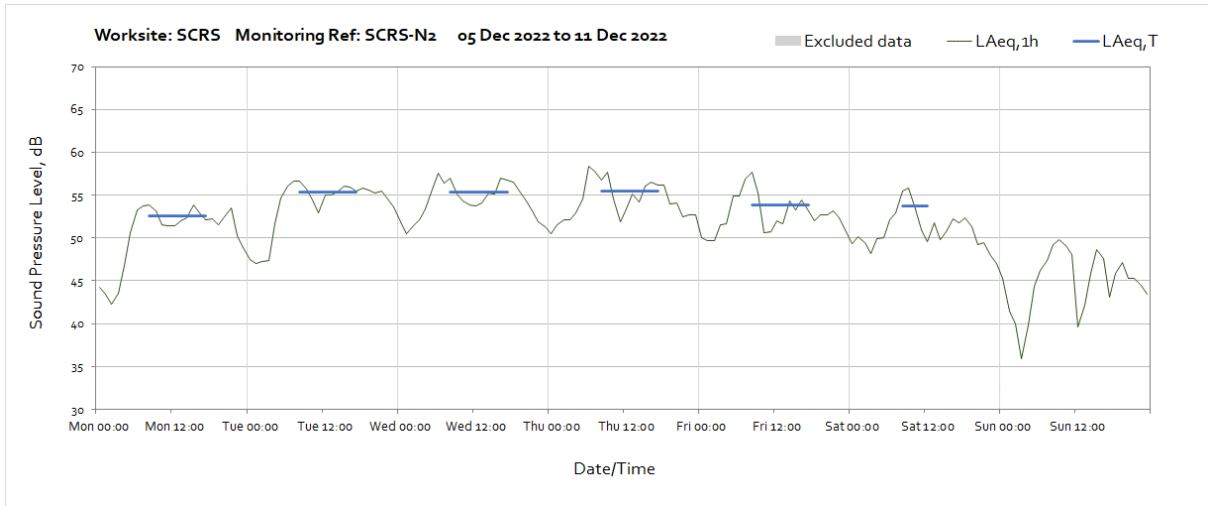
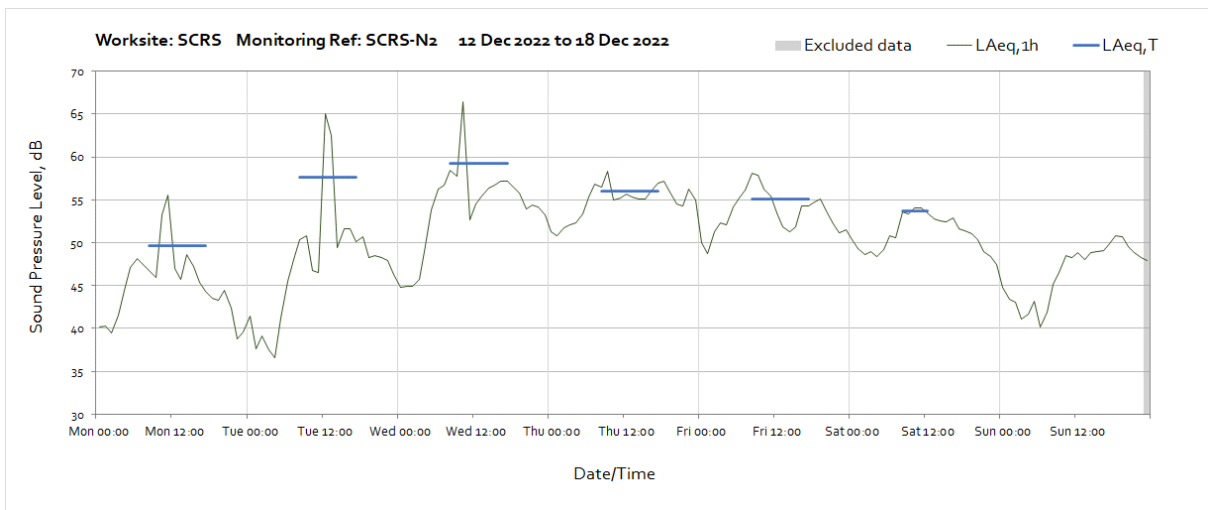
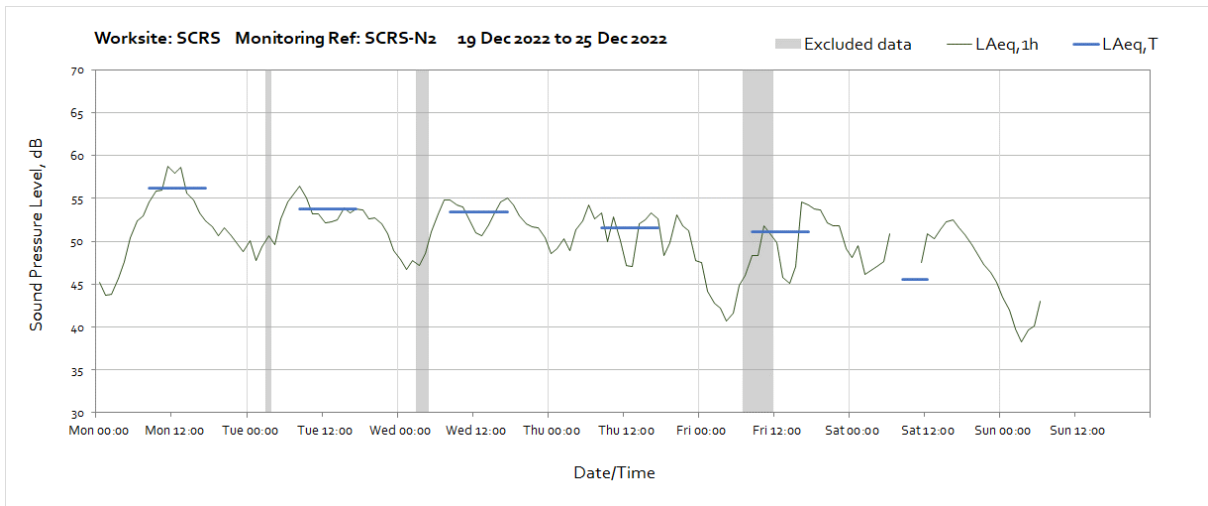
Worksite:SCRS – Monitoring Ref: SCRS-N2

Note: Missing data between 07:00 and 11:00 on Saturday 24th December and from 07:00 on Sunday 25th December till end of the week were due to loss of power to the battery from the solar panel supply.

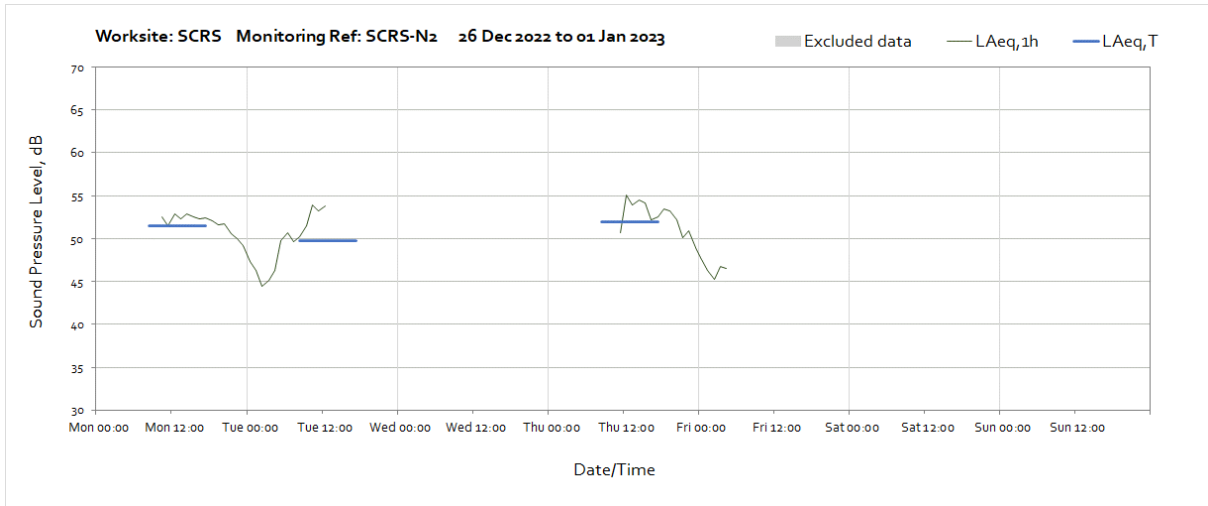
Note: Missing data throughout the week was due to a loss of power to the battery from the solar panels supply.

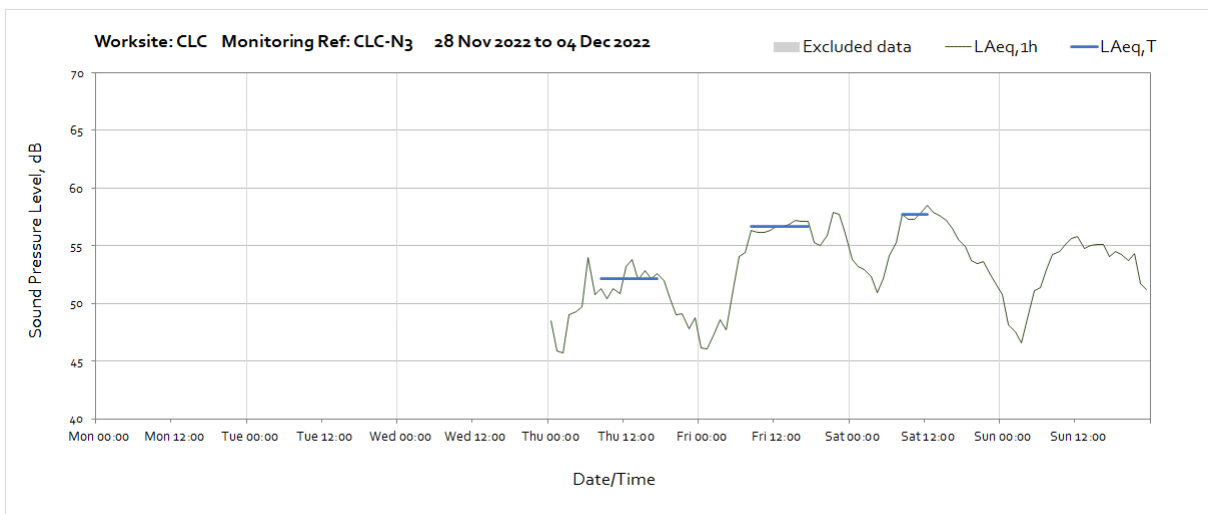
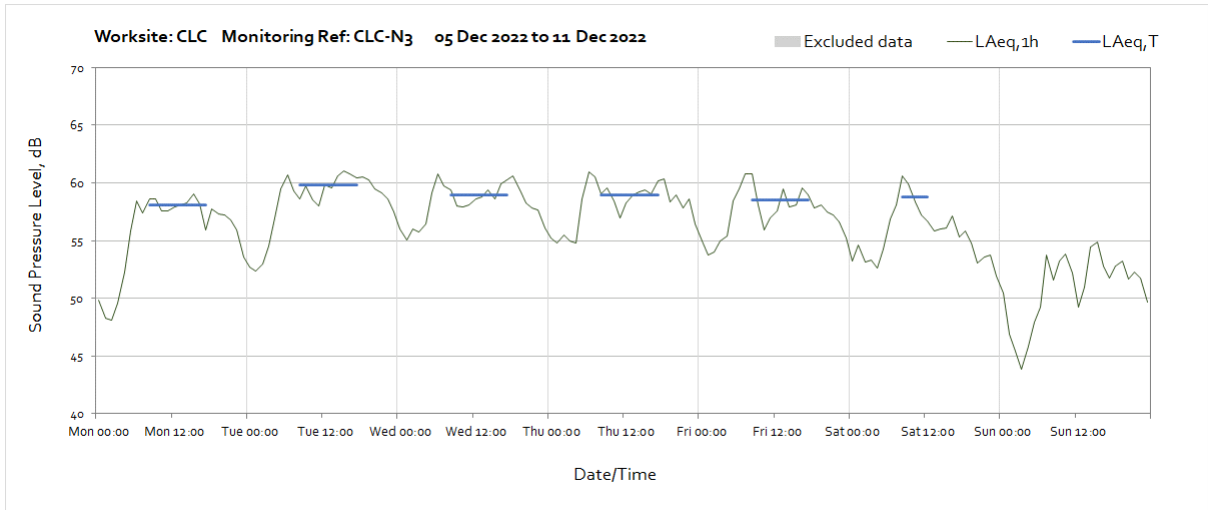
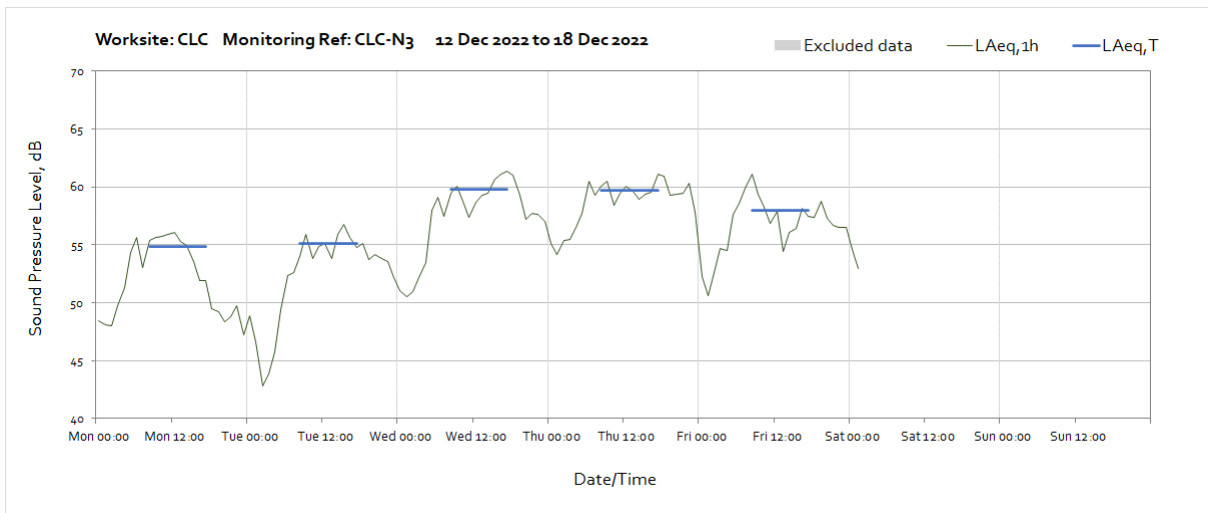
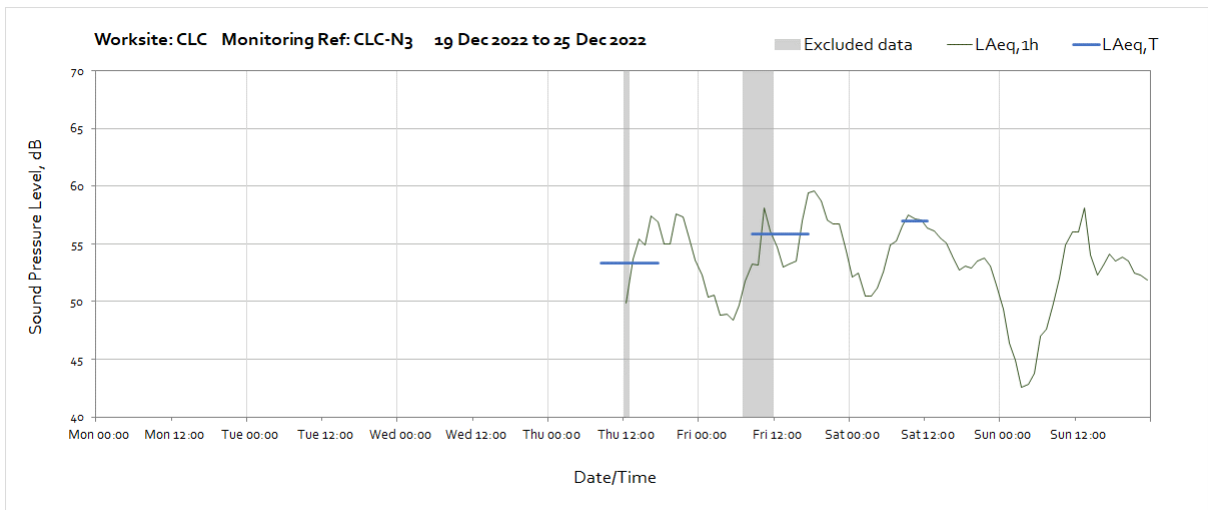
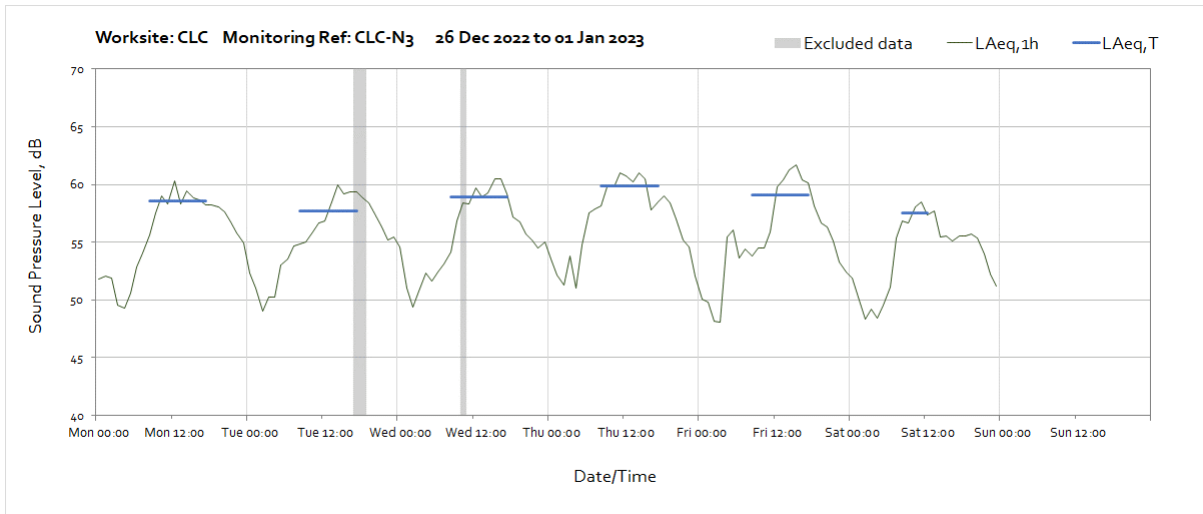
Worksite: CLC - Monitoring Ref: CLC-N3

Note: Missing data from 02:00 on Saturday 17th December till end of the week was due to a loss of power to the monitor.

Note: Missing data till 12:00 on Thursday 22nd December was due to loss of power to the monitor.

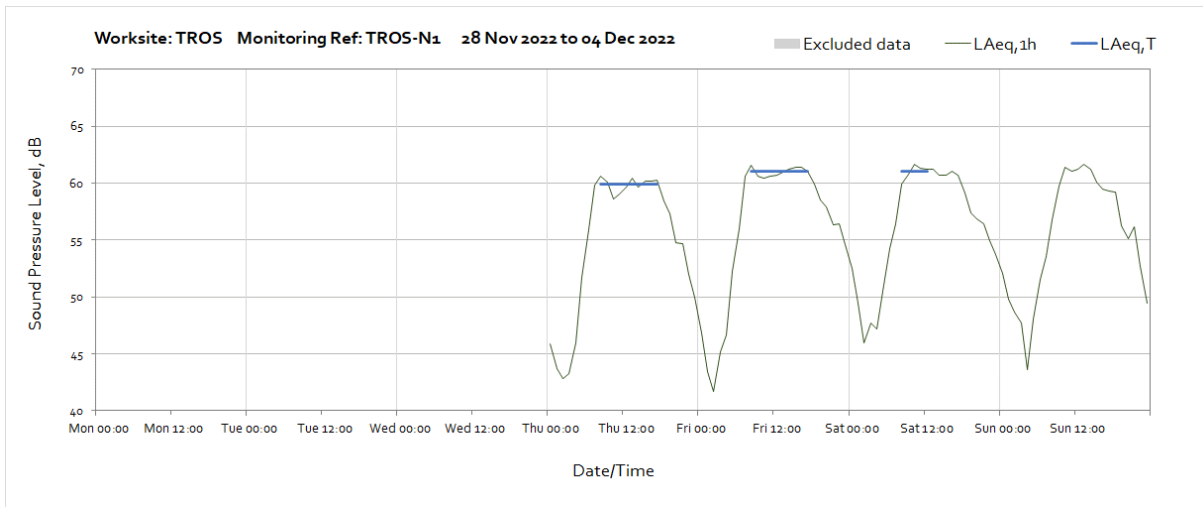
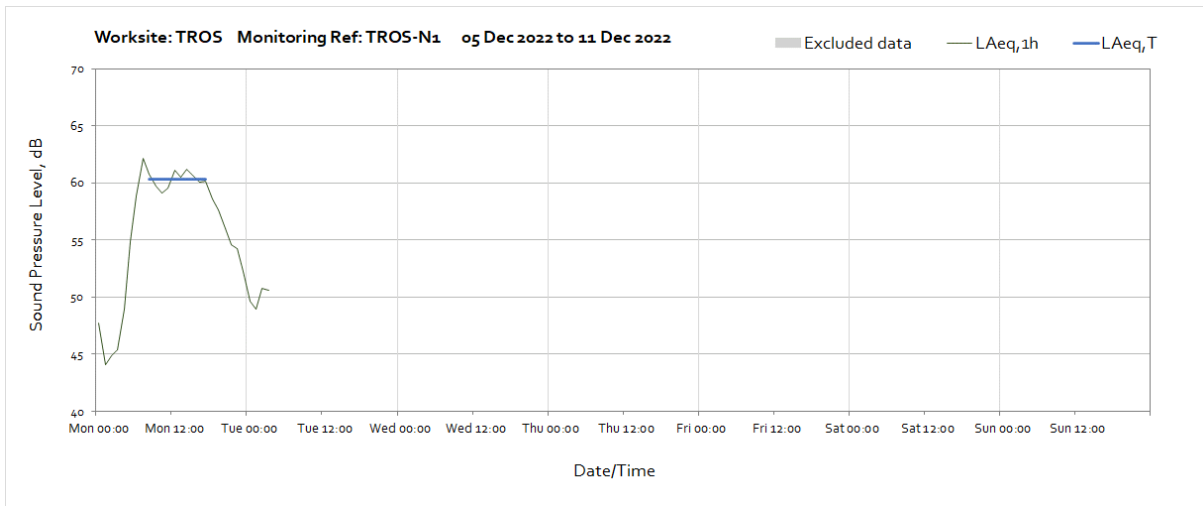
Worksite:TROS – Monitoring Ref: TROS-N1

Note: Missing data from 04:00 on Tuesday 6th December till end of the month was due to loss of power to the monitor as solar battery supply was not able to charge. The batteries were replaced on 22nd December.

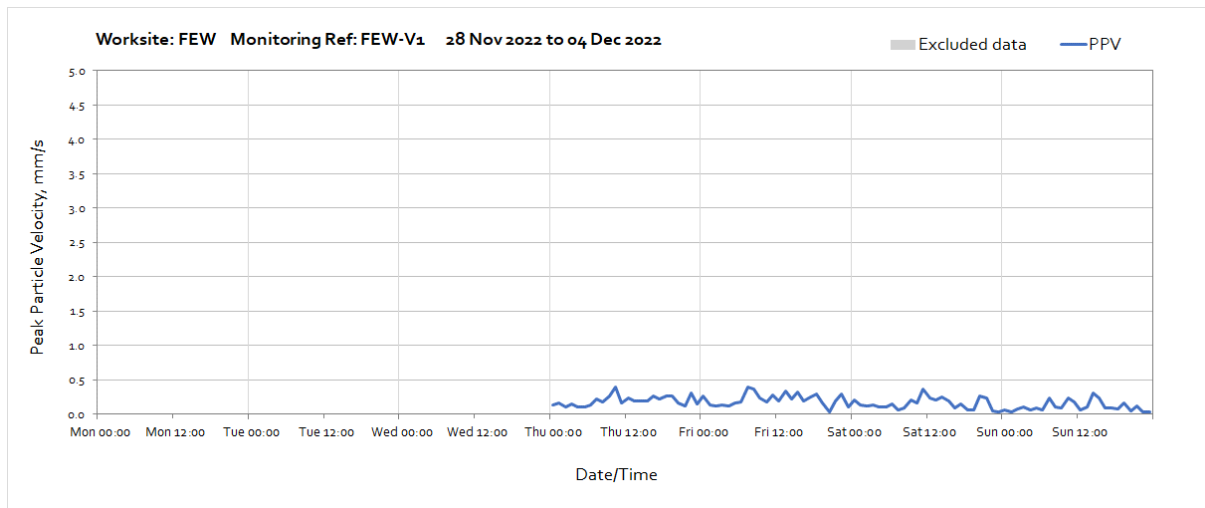
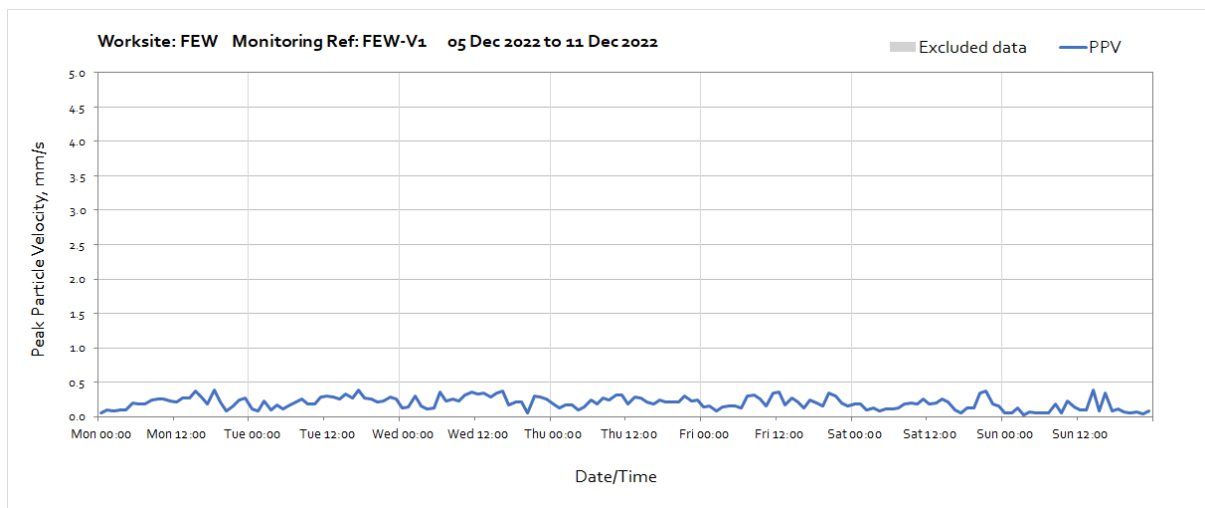
Worksite: FEW – Monitoring Ref: FEW-V1

The following graphs show the hourly measured peak particle velocity PPV recorded during the monitoring period. The graphs show the resultant PPV due to vibration components on three orthogonal axis x, y and z. Where high values of PPV were caused by local interference with the vibration monitor, which are not representative of HS2 construction works, these values have been greyed out in the following charts and have been excluded to calculate values in Table 4 of the main report.
