Construction Noise and Vibration Monthly Report – December 2022

Warwick District Council

Non-Technical Summary

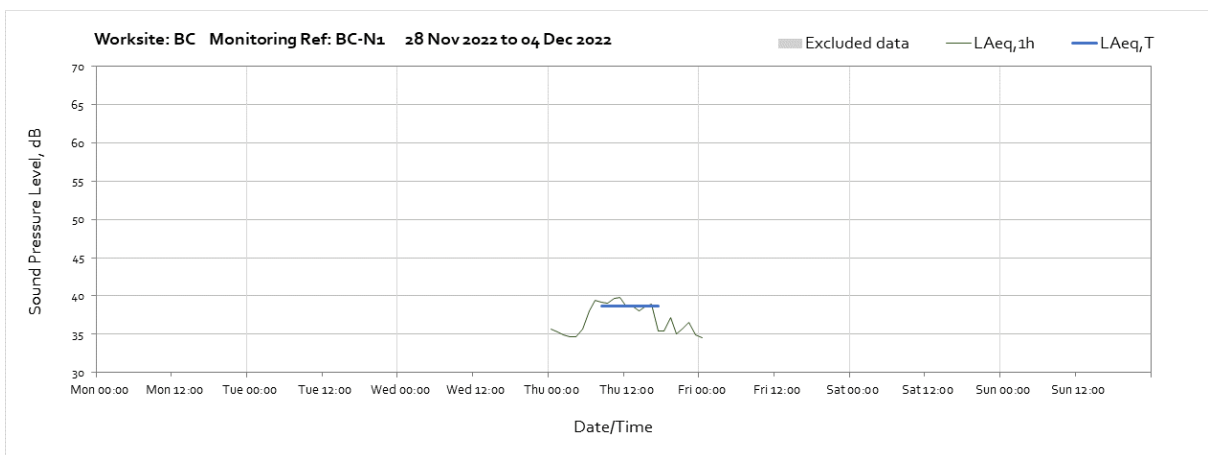
Worksite: BC – Monitoring Ref: BC-N1

Missing data from 1st December onwards due to power supply issues at monitoring location BC-N1.
