Construction Noise and Vibration Monthly Report – December 2022

West Northamptonshire District Council

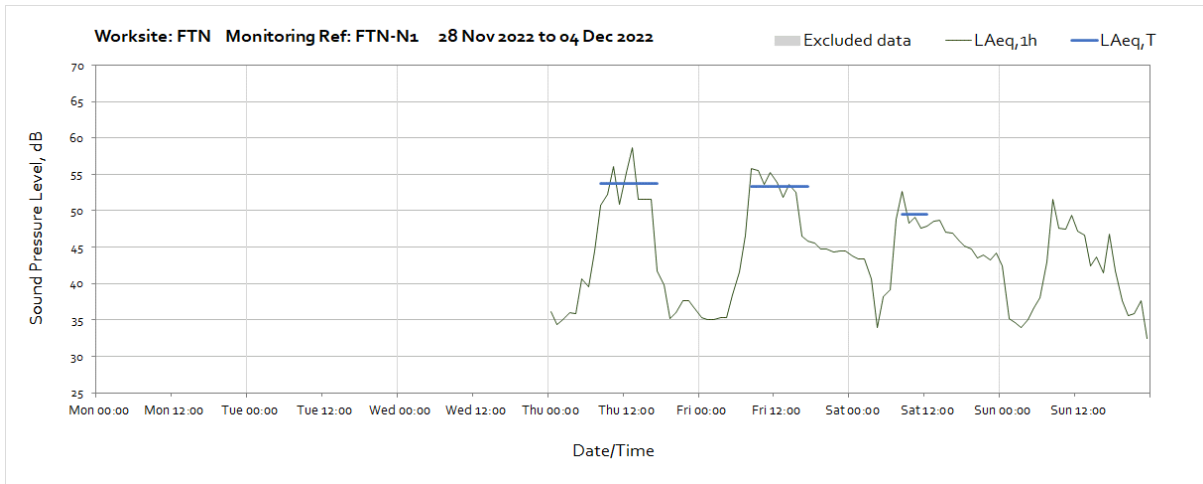
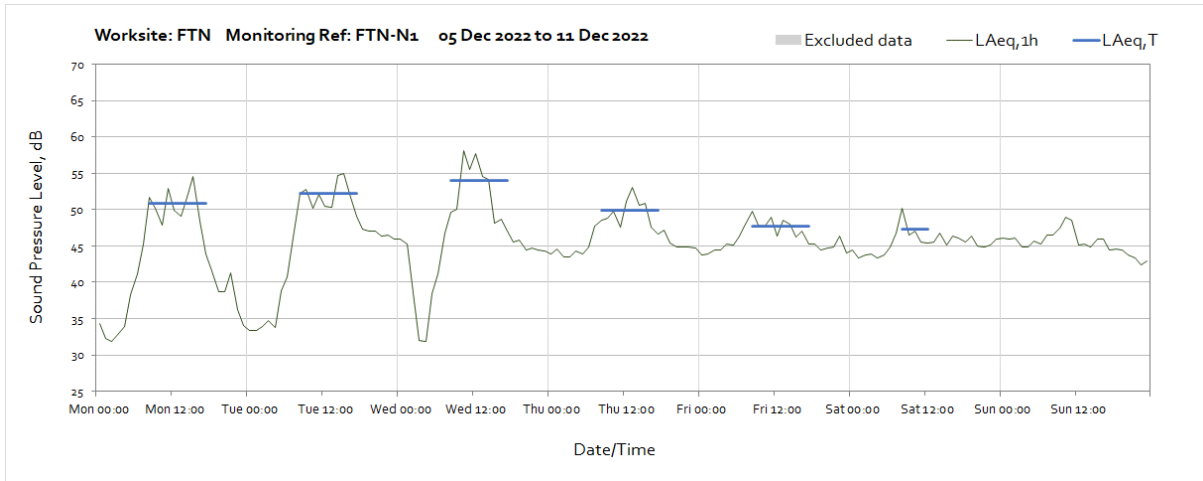
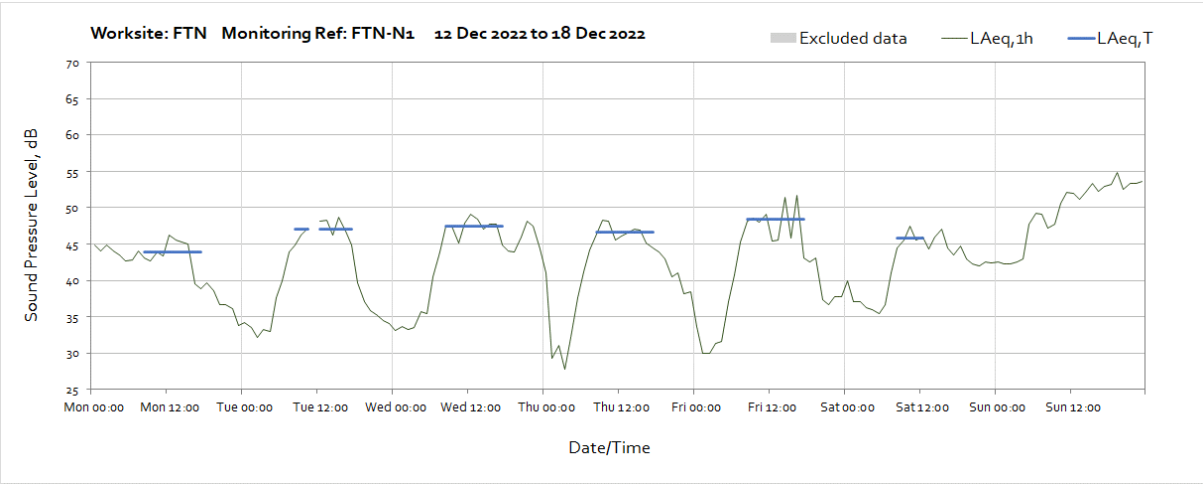
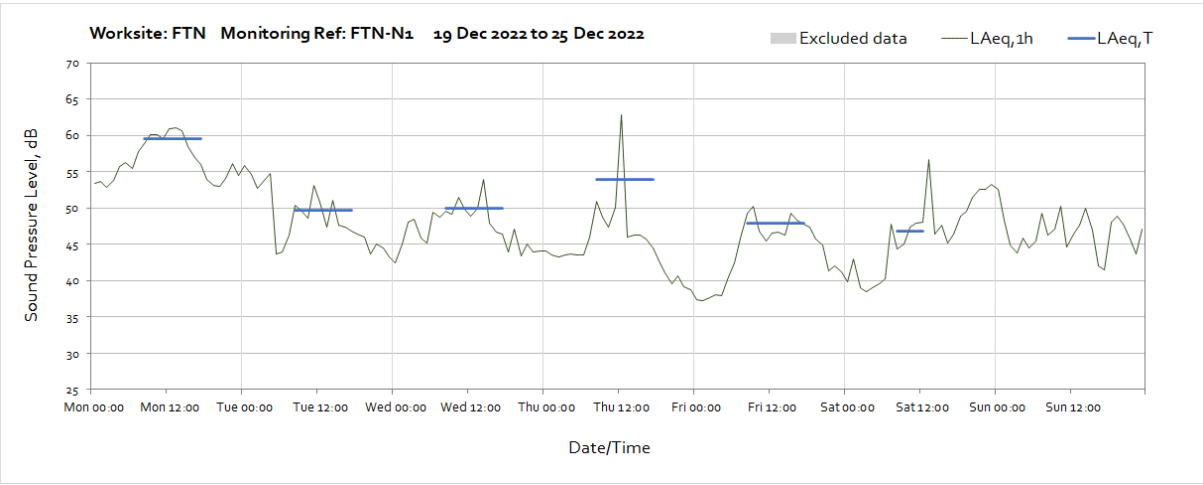
Worksite: FTN – Monitoring Ref: FTN-N1

The following graphs show the hourly measured ambient noise level $L_{Aeq,1h}$ and, where relevant, the averaged noise level $L_{Aeq,T}$ values, where the time period T is as specified in Table 1 of HS2 Information Paper E23. Periods with adversely weather affected noise levels are greyed out and have been excluded from the calculation of the $L_{Aeq,T}$ values in Table 3 of the main report.

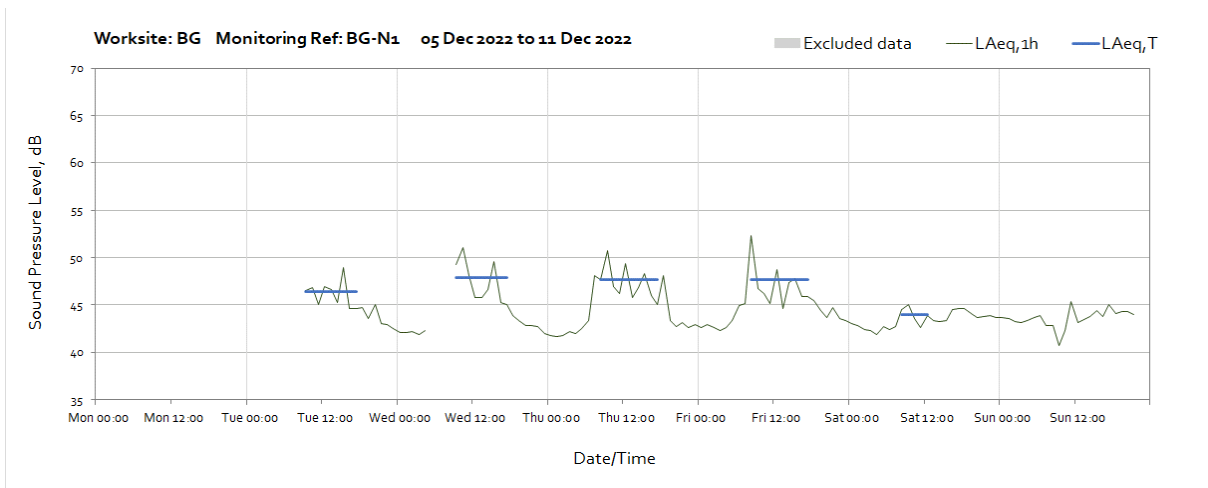
Note: Missing sections of data throughout the week were due to power supply issues as the monitor battery was not receiving sufficient charge.

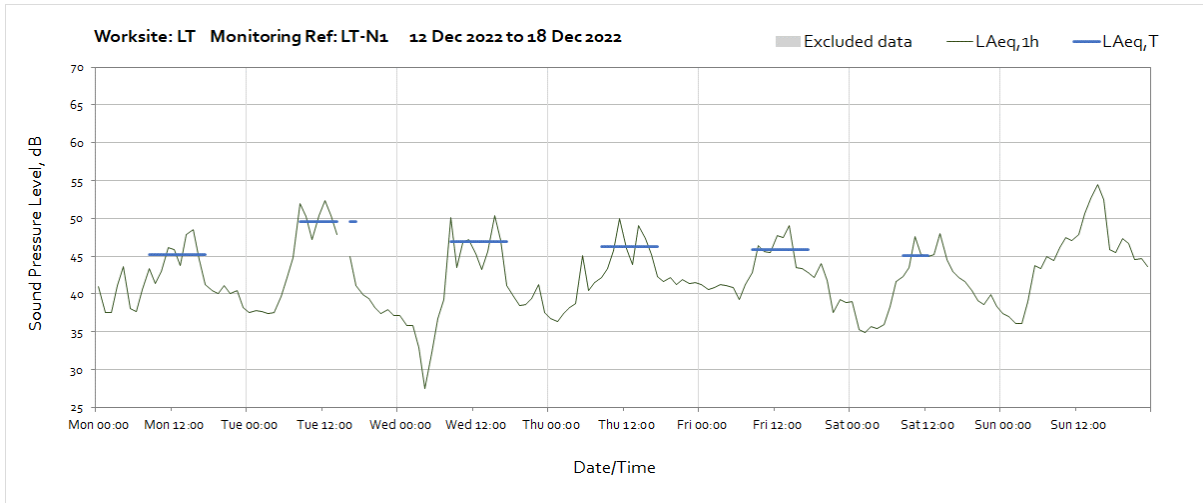
Worksite: LT - Monitoring Ref: LT-N1

Note: Missing data at 15:00 on Tuesday 13th December 2022 were due to maintenance operations at the monitoring station

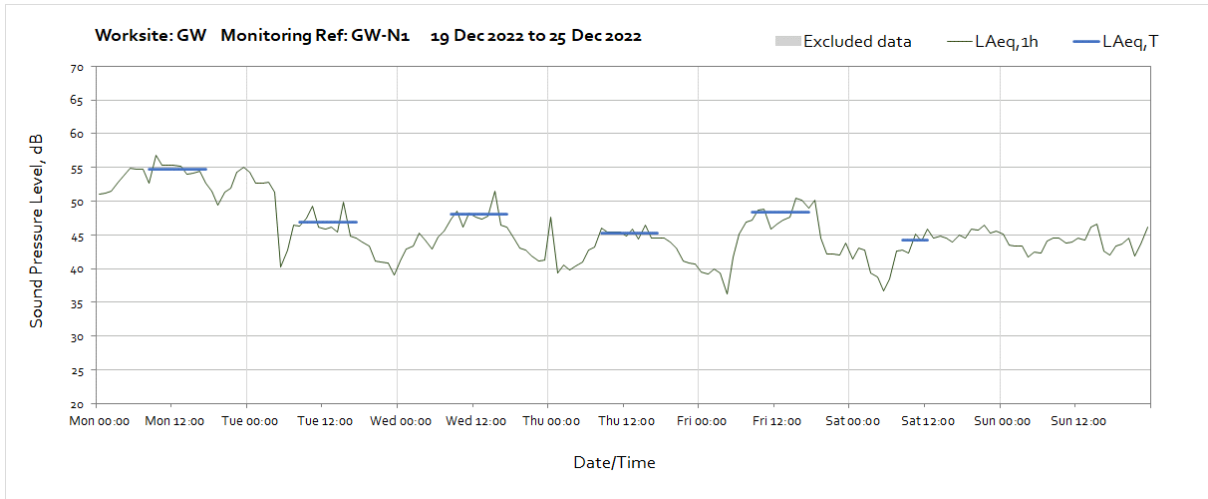
Worksite: GW – Monitoring Ref: GW-N1

Note: Missing data at 15:00 on Tuesday 13th December 2022 were due to maintenance operations at the monitoring station
