Air Quality and Dust Monitoring Monthly Report – January 2023 London Borough of Camden

A report prepared by EWCs and MWCCs on behalf of HS2 Ltd.

Monthly Summary

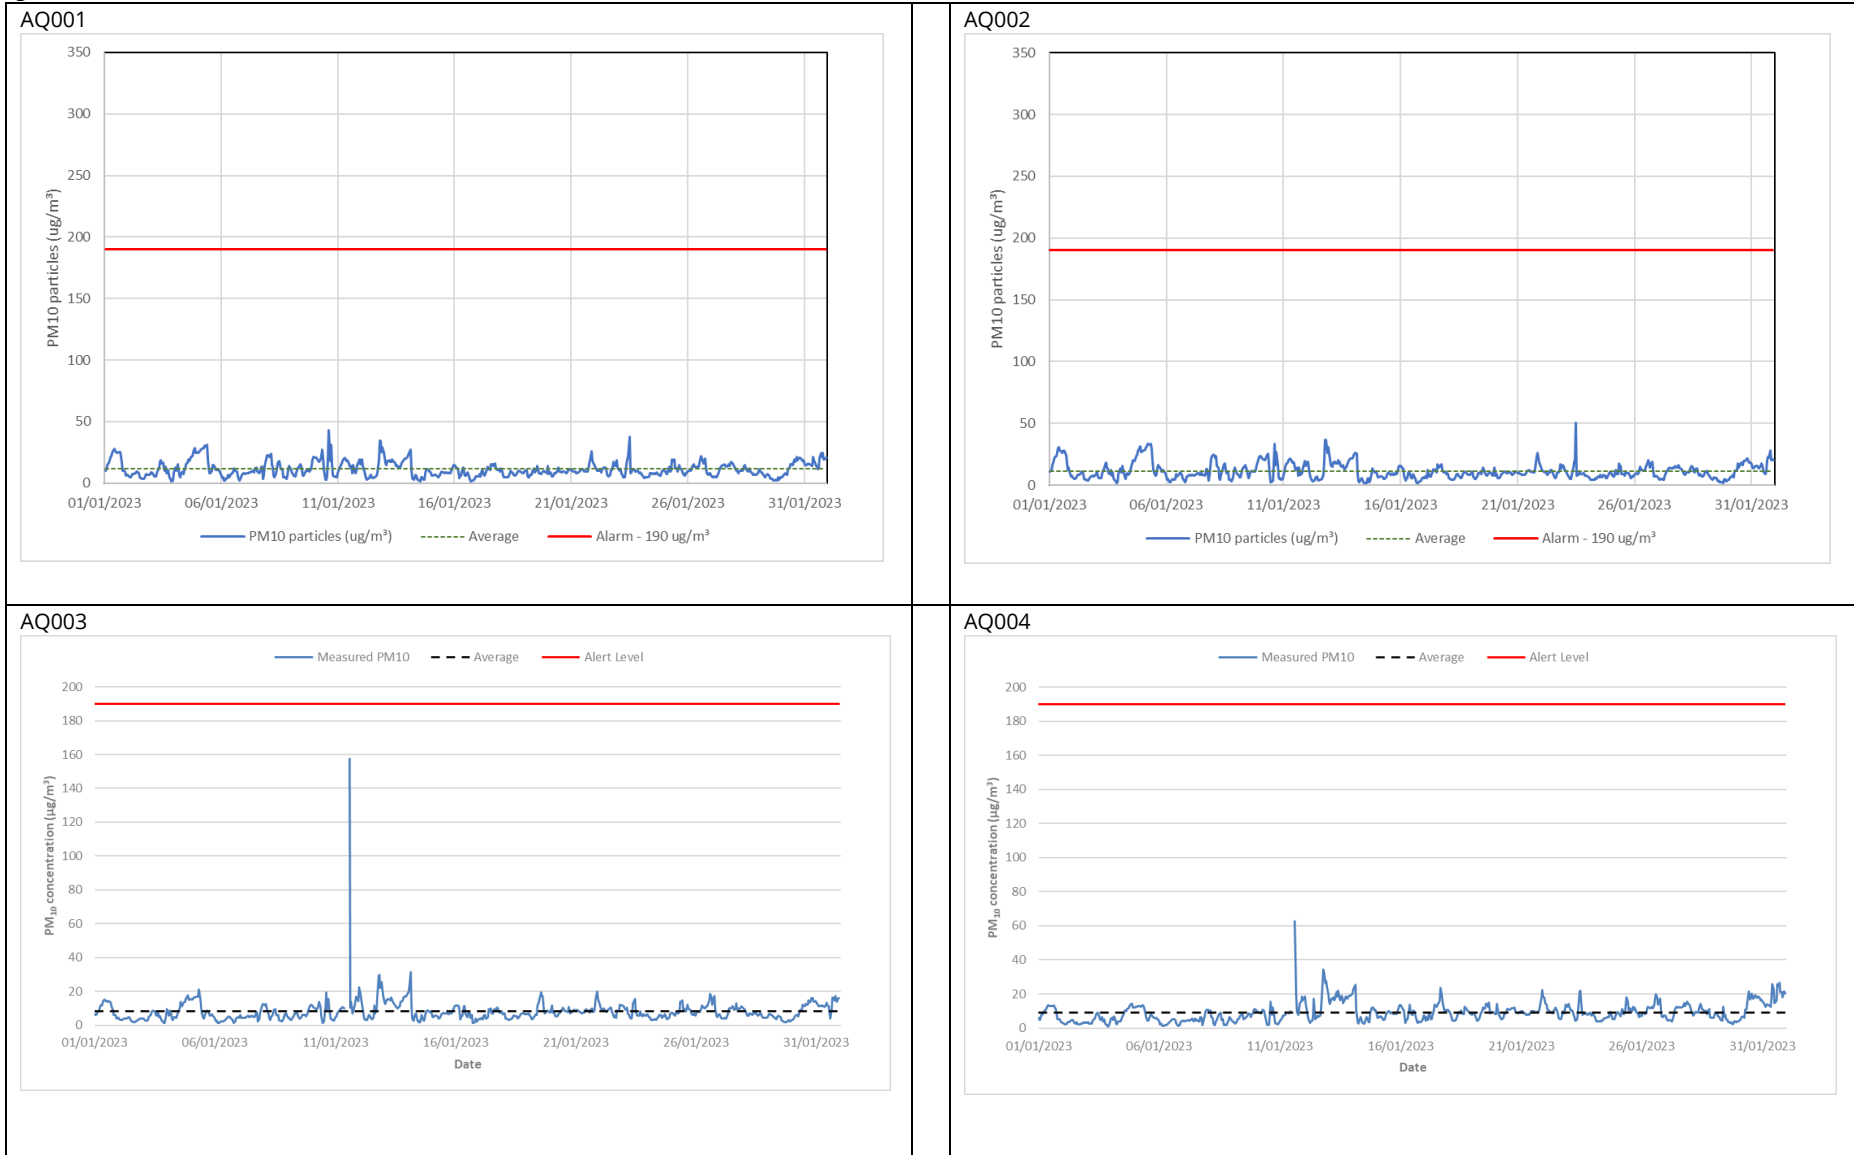
Figure 4: Construction dust 1-hour mean indicative PM₁₀ concentration for dust monitors

1.1.6 Dust monitoring locations and results are presented in Appendix B, Table 1, together with line charts of monthly data from each dust monitor in Figure 6. All continuous dust monitoring is undertaken using indicative monitors. Despite being Environment Agency (MCERTS) certified, indicative monitors carry a higher level of uncertainty than reference monitors, and therefore cannot be strictly compared with Air Quality Standards for

- 1.1.7 The trigger level for PM₁₀ concentrations of 190 µg/m³, over a 1-hour period, in accordance with the updated guidance document '*Guidance on Monitoring in the Vicinity of Demolition and Construction Sites – (October 2018)*' has been applied.

- 1.1.8 No (0) dust trigger alerts were recorded during the monitoring period (January 2023).
- 1.1.9 Data capture was below 90% for monitor AQ007 in January 2023 due to an airflow error that resulted in limited data capture at the beginning of January. The issue has since been resolved.
