Construction Noise and Vibration Monthly Report – January 2023

North Warwickshire Borough Council

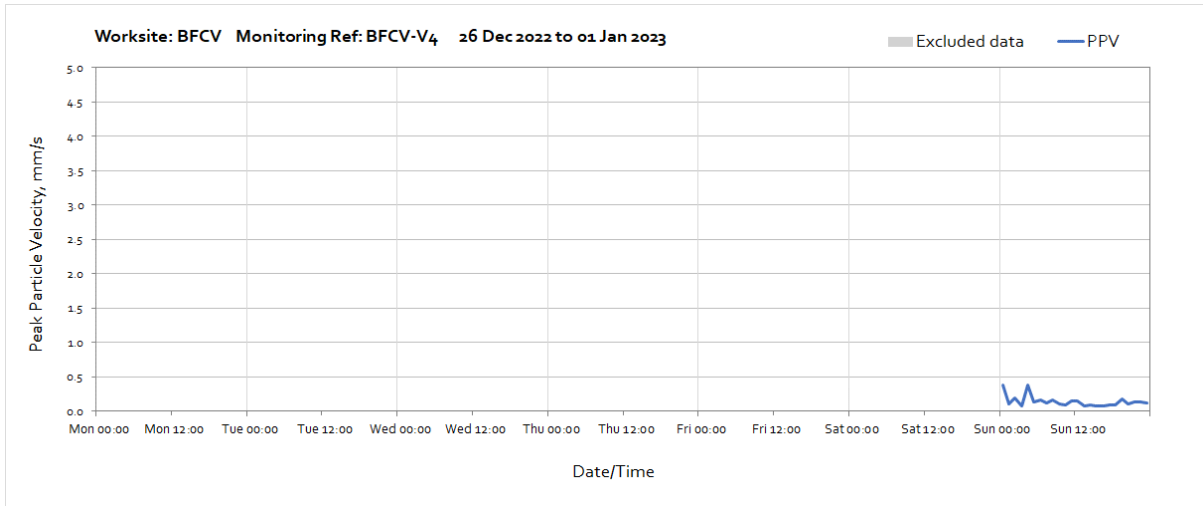
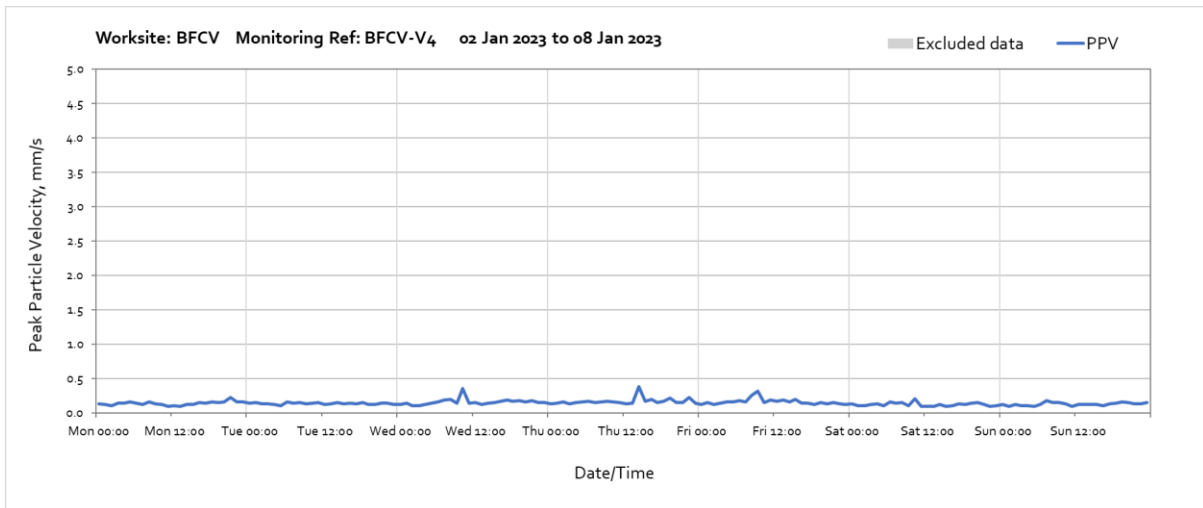
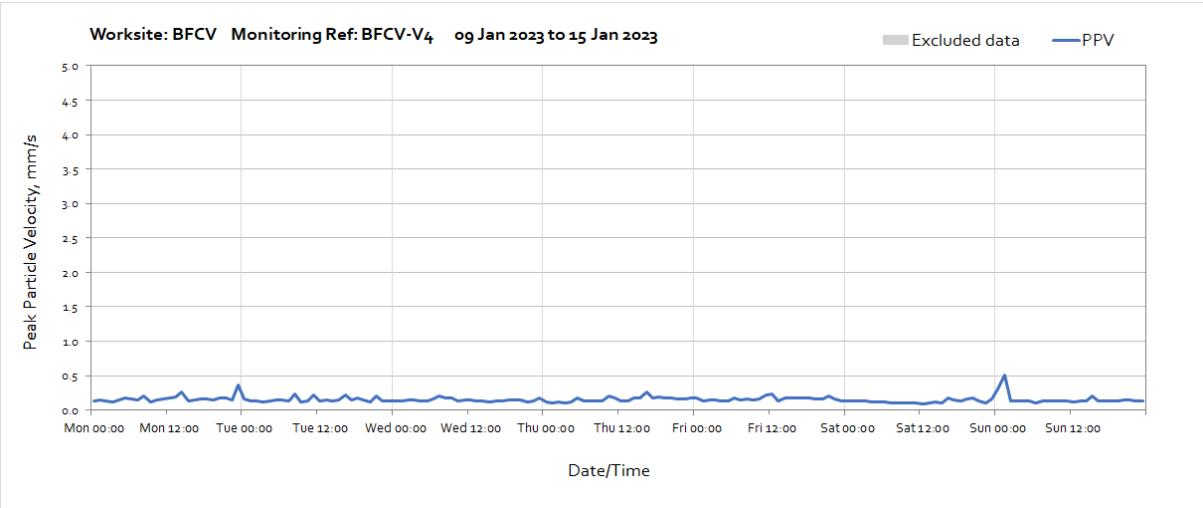
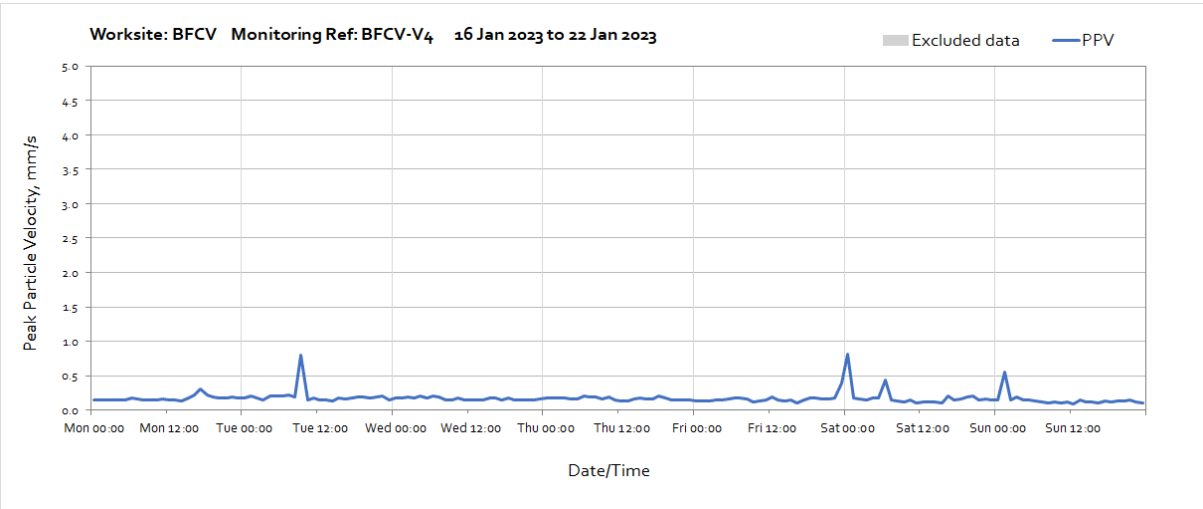
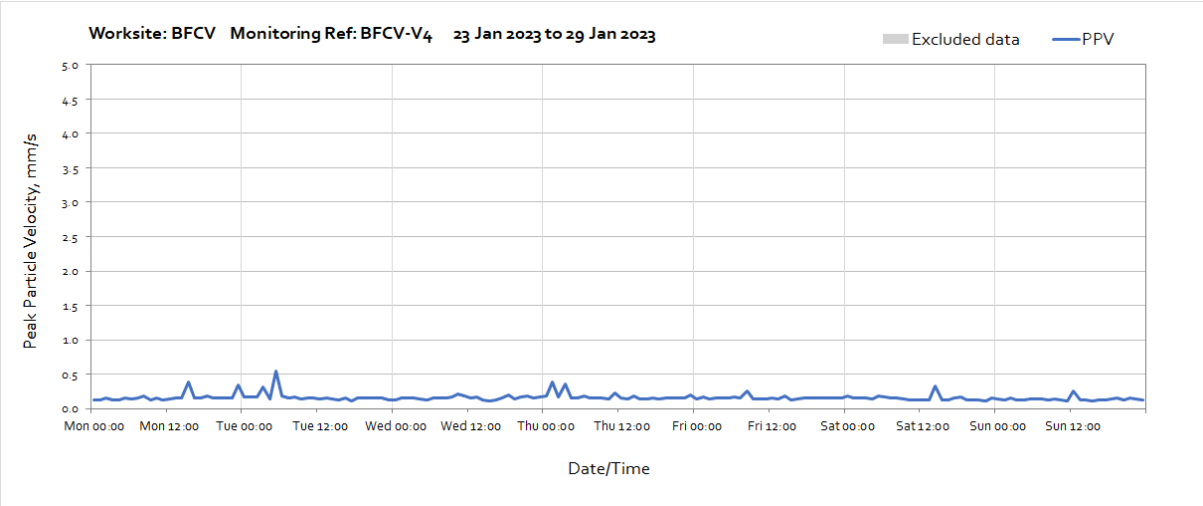
Worksite: BFCV - Monitoring Ref: BFCV-V4

The following graphs show the hourly measured peak particle velocity PPV recorded during the monitoring period. The graphs show the highest PPV of the three orthogonal axes x, y and z. Where high values of PPV were caused by local interference with the vibration monitor, which are not representative of HS2 construction works, these values have been greyed out in the following charts and have been excluded to calculate values in Table 4 of the main report.

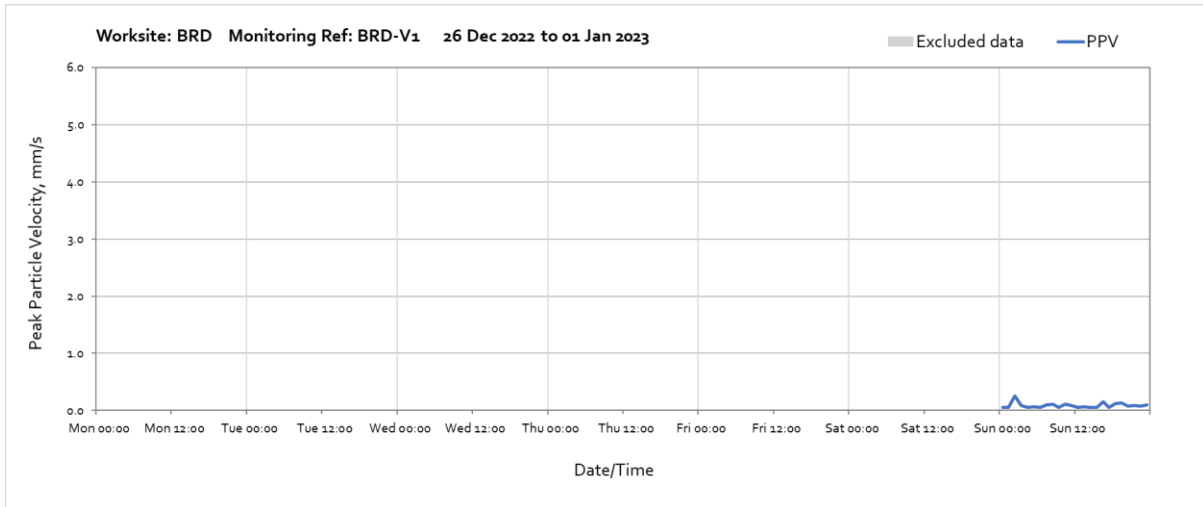
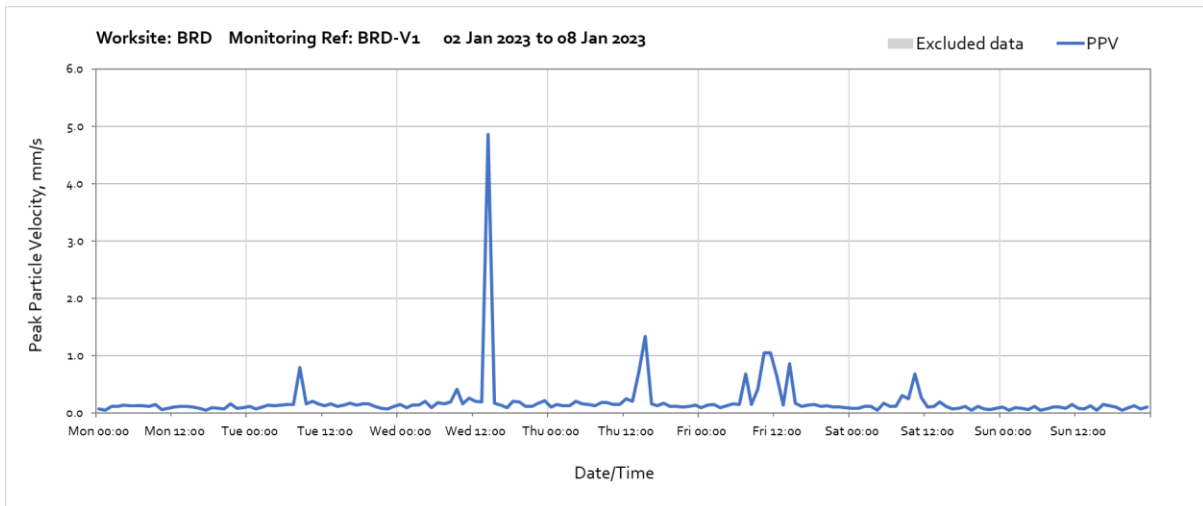
Worksite: BRD – Monitoring Ref: BRD-V1

Note: High vibration levels measured at 14:00 on Wednesday 4th January was due to large stone delivery and street sweeping activities taking place in the vicinity of the monitor.

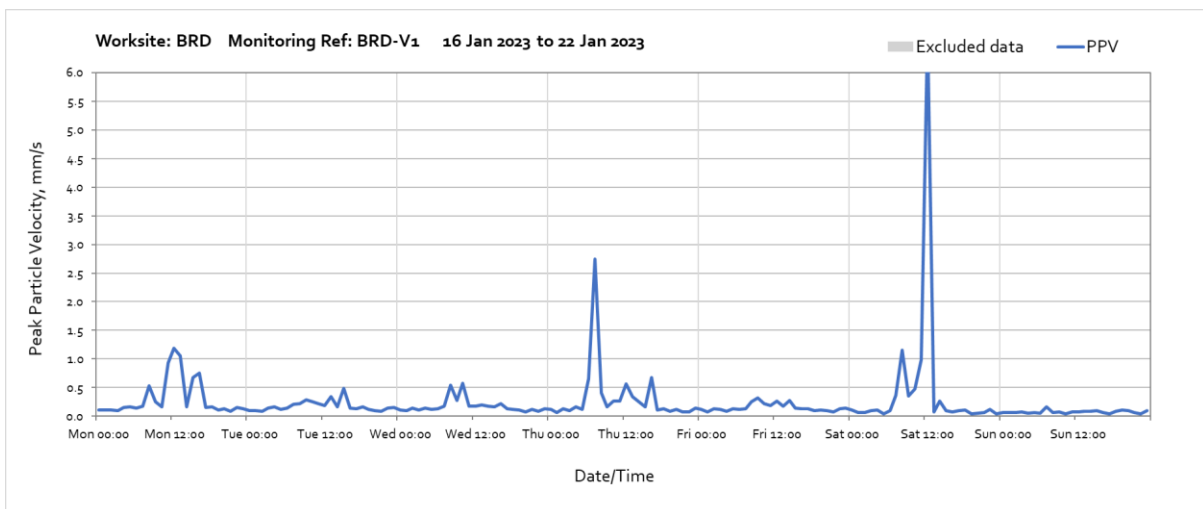
Note: High vibration levels measured at 07:00 on Thursday 19th January and at 12:00 on Saturday 21st January was due to large stone delivery and street sweeping activities taking place in the vicinity of the monitor.

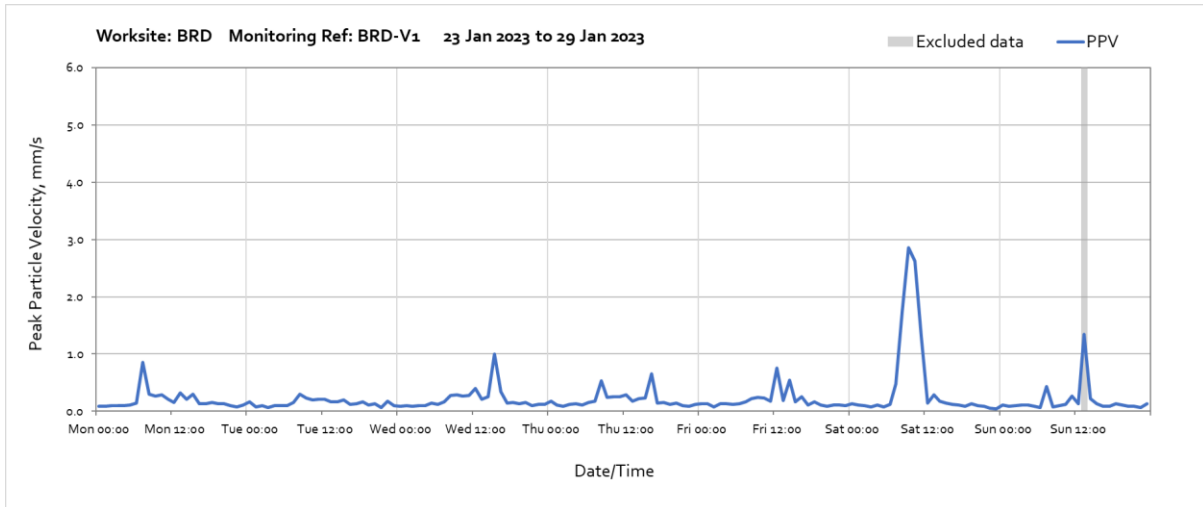
Note: High vibration levels measured between 09:00 and 10:00 on Saturday 28th January and at 13:00 on Sunday 29th January was due to large stone delivery and street sweeping activities taking place in the vicinity of the monitor.
