Construction Noise and Vibration Monthly Report – January 2023

Solihull Metropolitan Borough Council

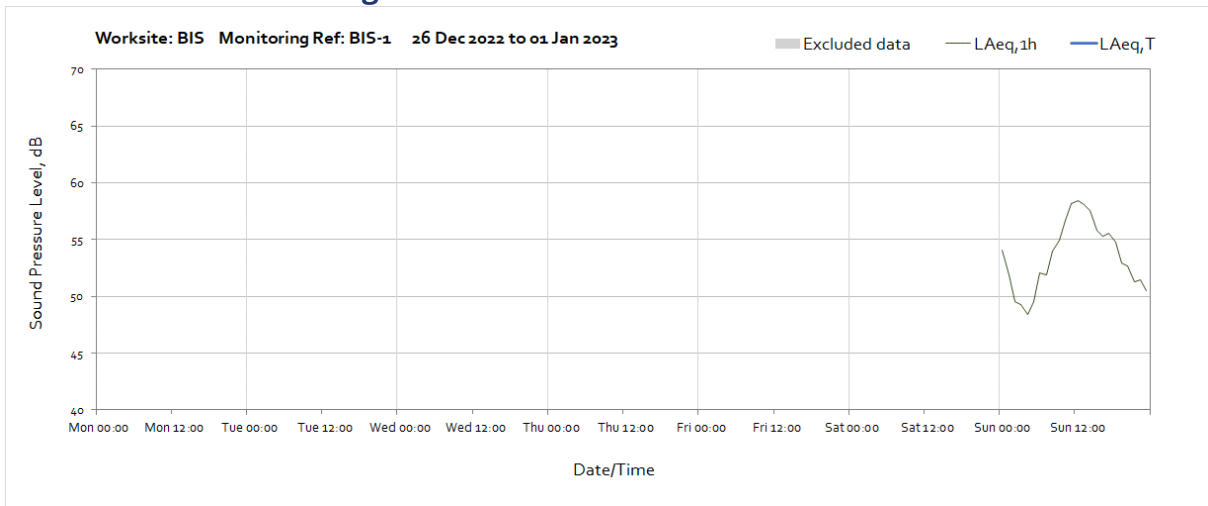
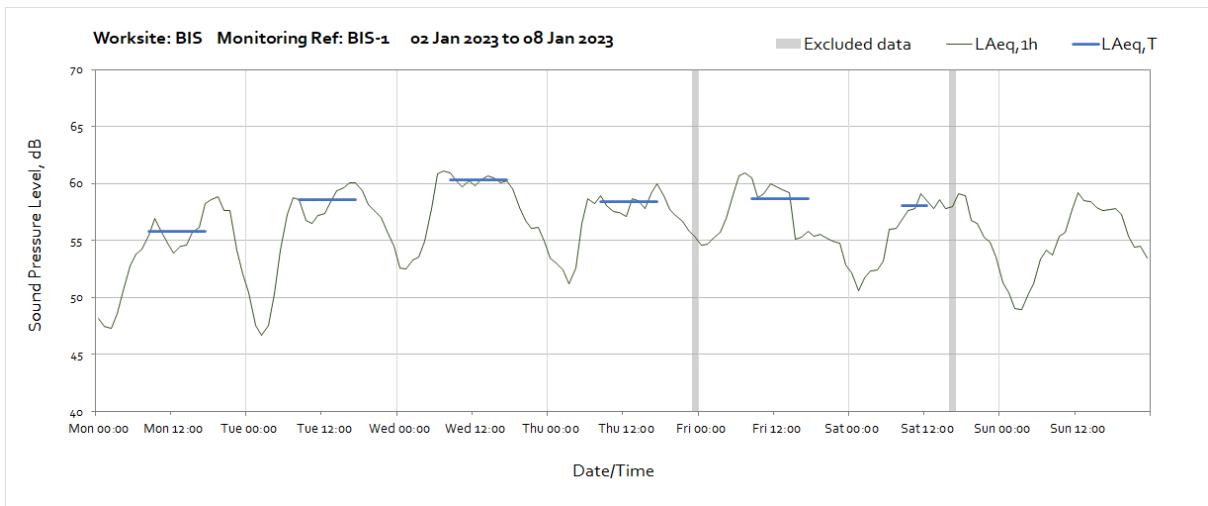
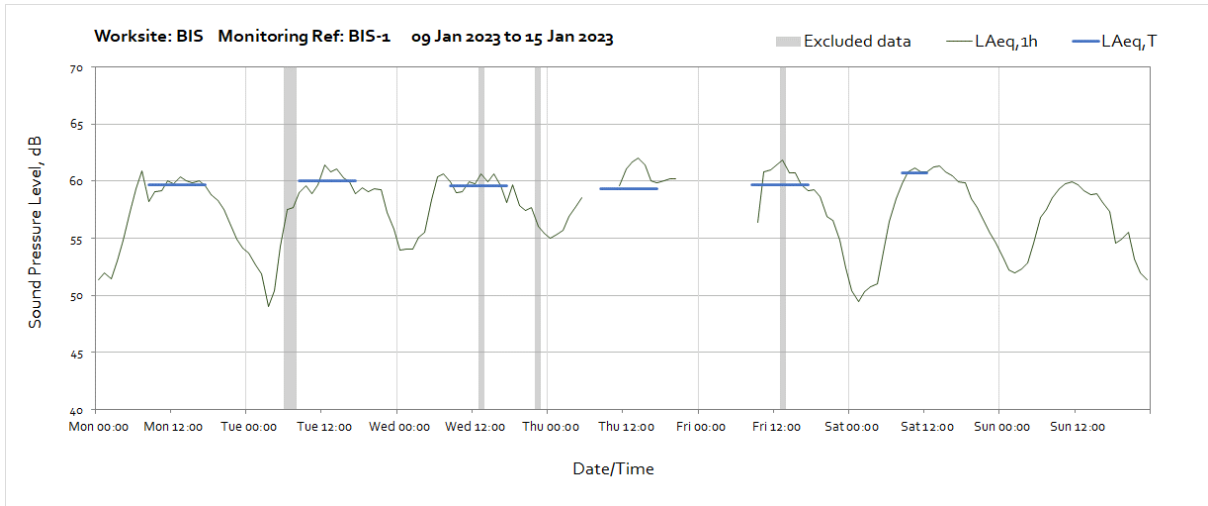
Worksite: BIS- Monitoring Ref: BIS-1

Note: Missing data between 06:00 and 11:00 on Thursday 12th January and between 21:00 on Thursday 12th January and 09:00 on Friday 13th January was due to loss of power to the battery from the solar panels.

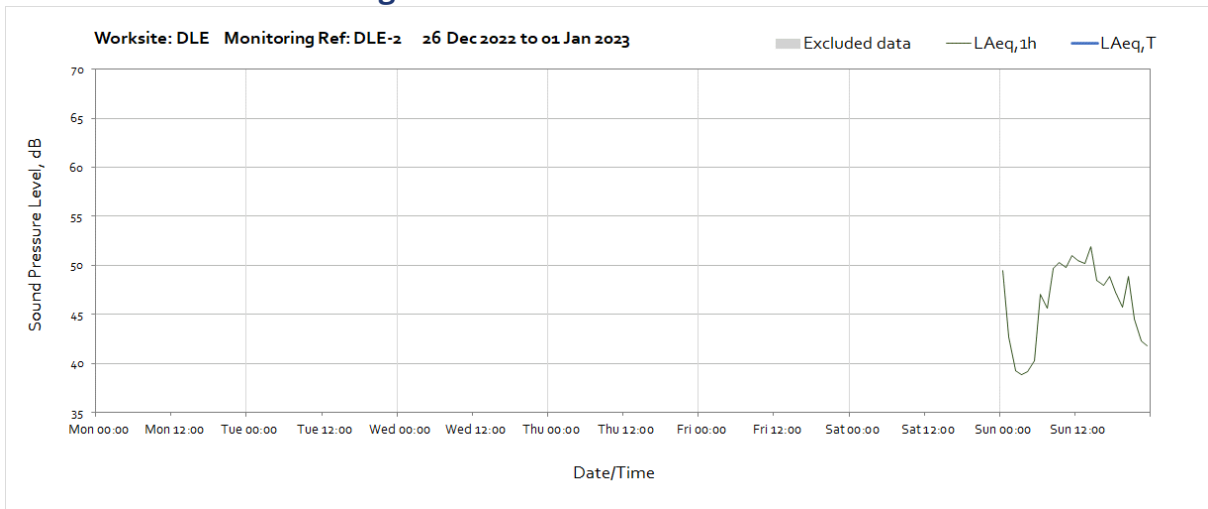
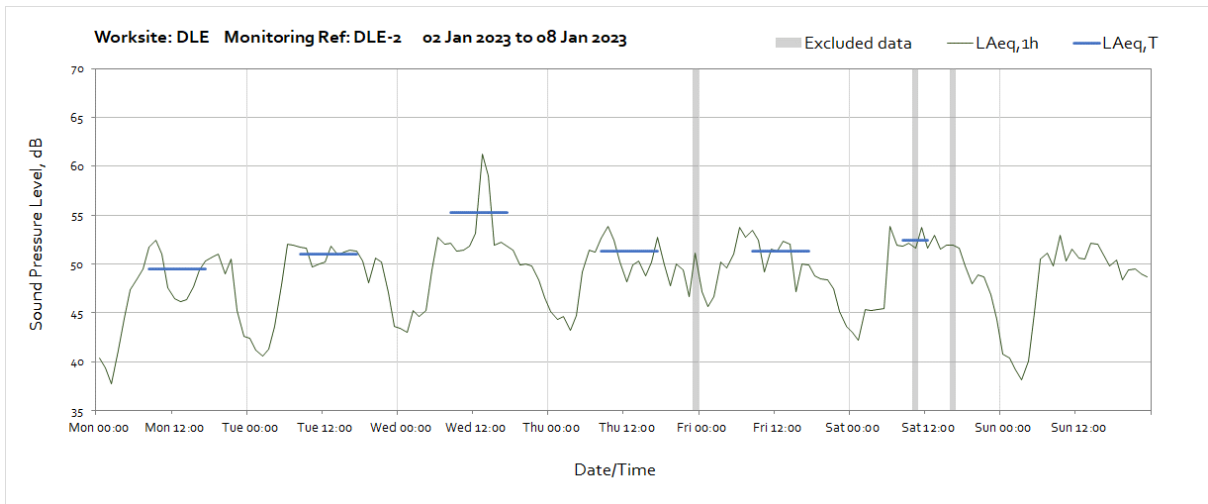
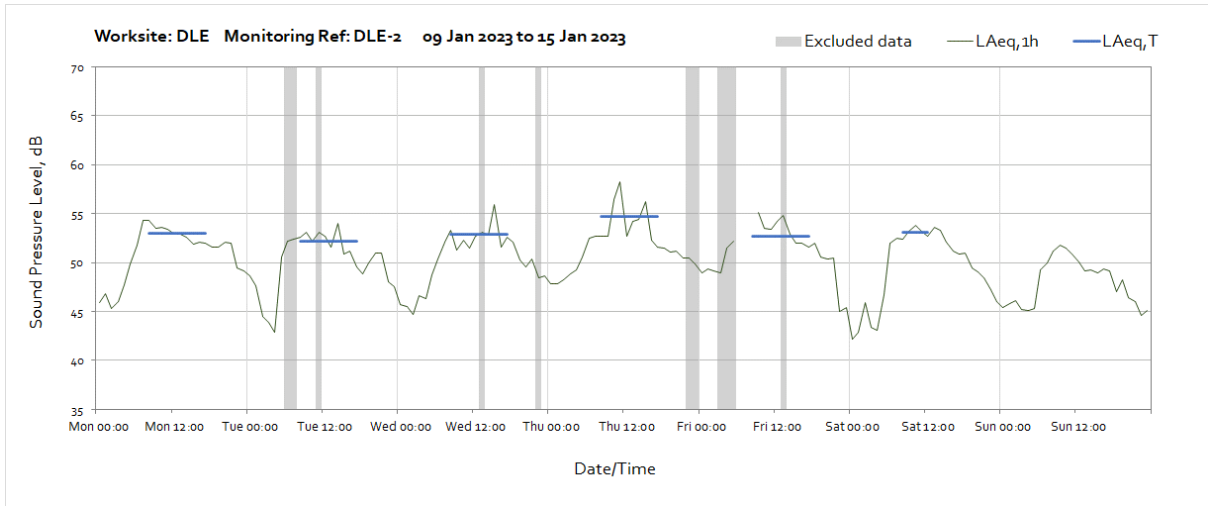
Worksite: DLE - Monitoring Ref: DLE-2

Note: Missing data between 06:00 and 09:00 on Friday 13th January was due system malfunction leading to loss of power supply to the monitor.

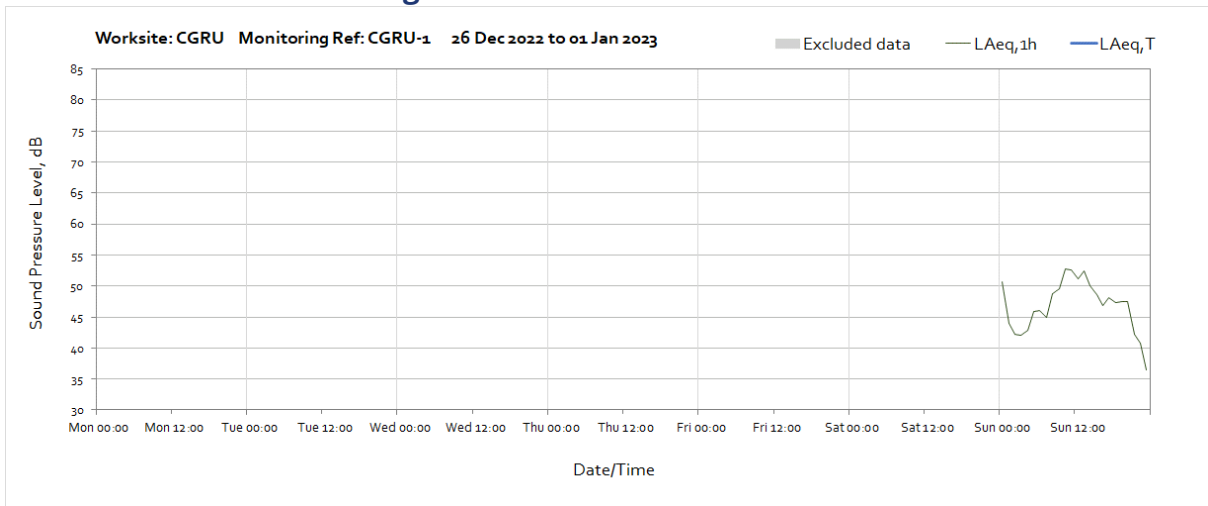
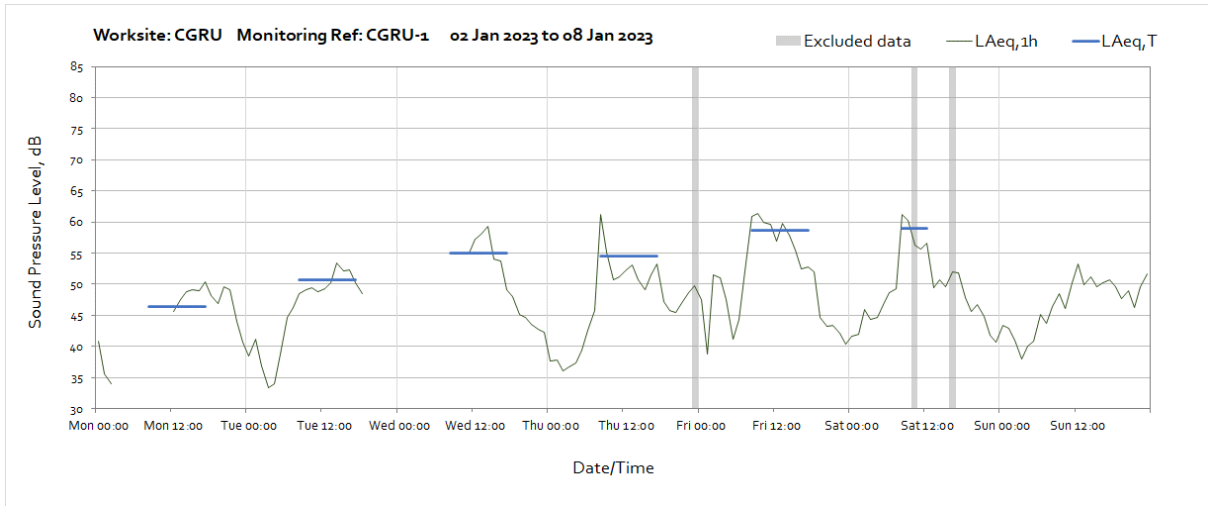
Worksite: CGRU- Monitoring Ref: CGRU-1

Note: Missing data between 03:00 and 11:00 on Monday 2nd January and between 19:00 on Tuesday 3rd January and 10:00 on Wednesday 4th January was due to loss of power to the battery from the solar panels. The batteries were replaced on Wednesday 4th January.

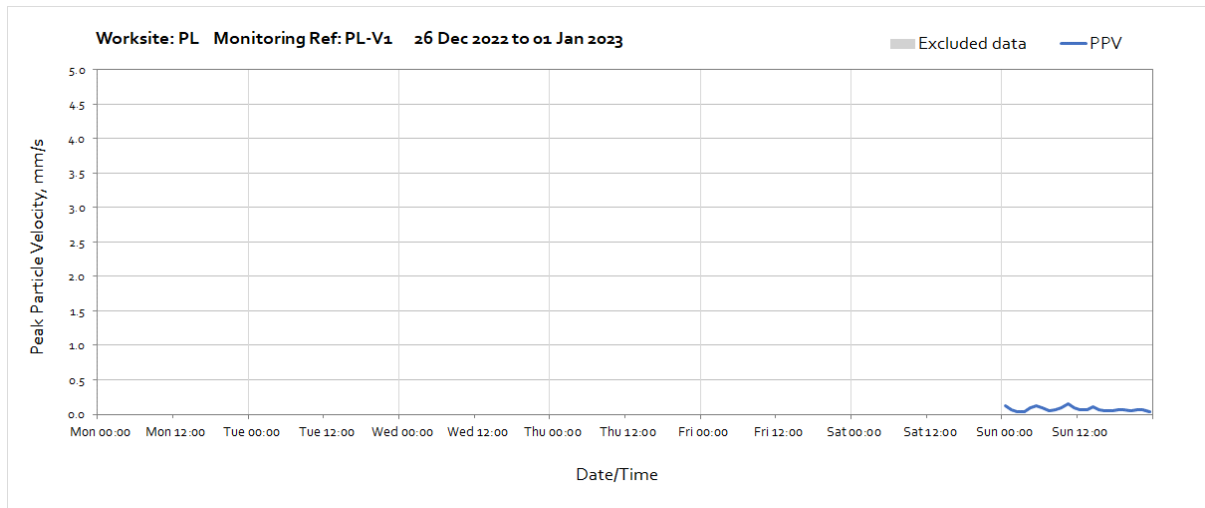
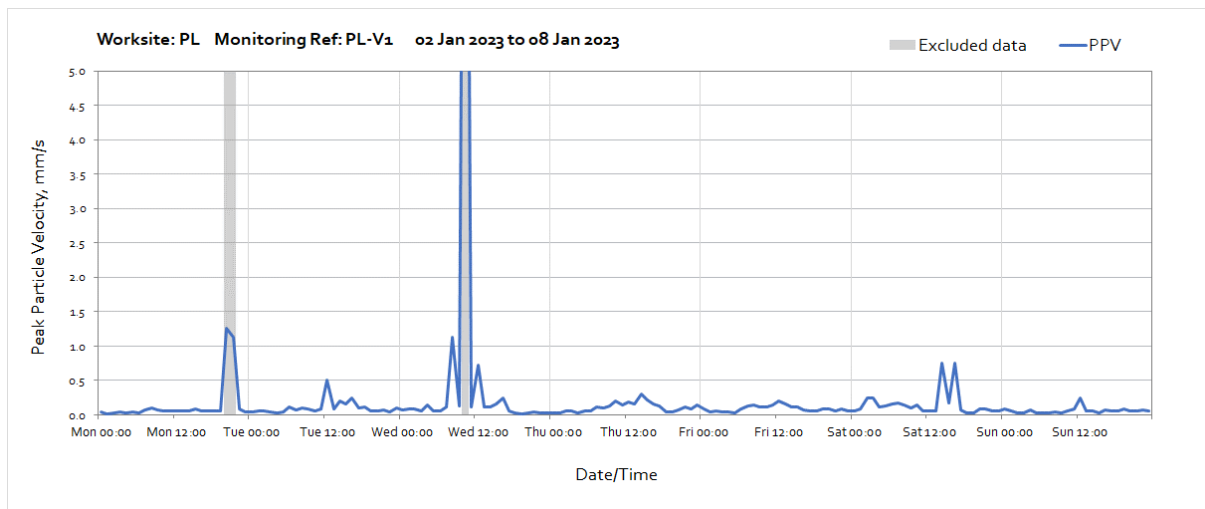
Worksite: PL – Monitoring Ref: PL-V1

Note: High vibration levels measured at 08:00 on Wednesday 4th January was due to plant movement in the vicinity of the monitor.

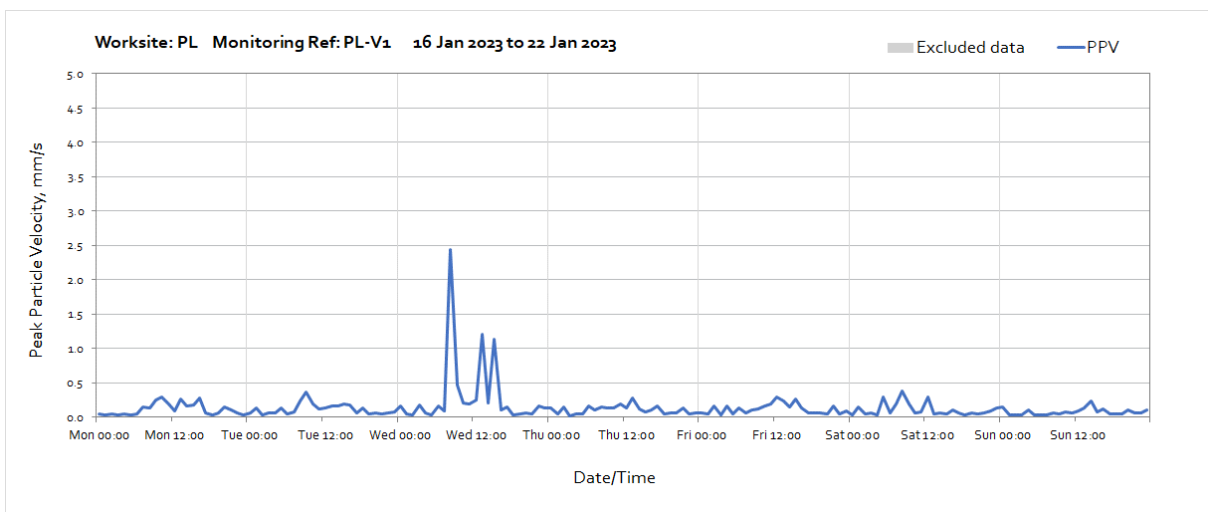
Note: High vibration levels measured at 14:00 and 17:00 on Tuesday 4th January was due to plant movement in the vicinity of the monitor.

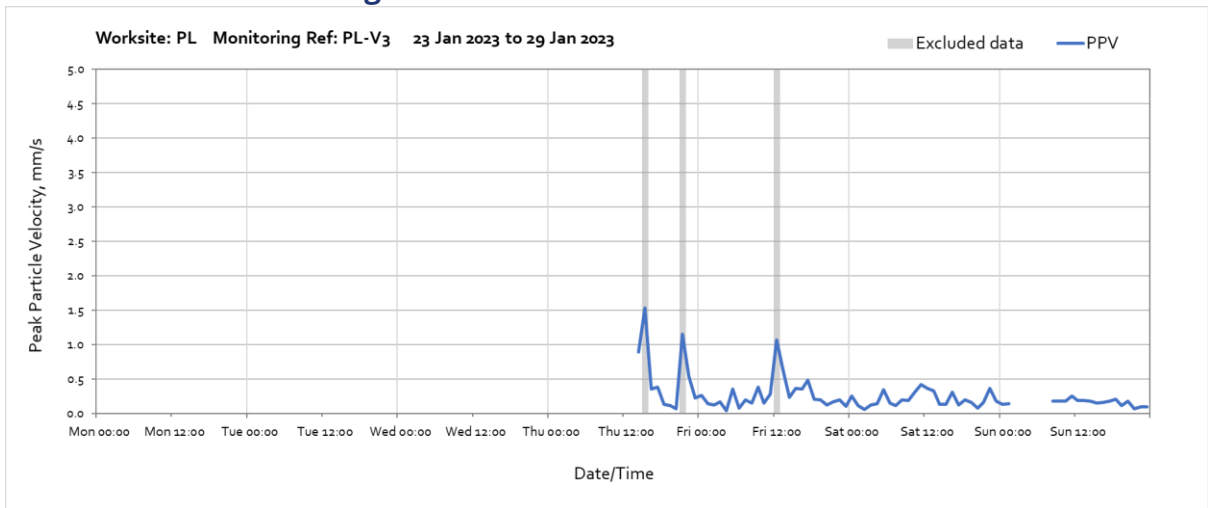
Worksite: PL – Monitoring Ref: PL-V3

Note: Monitor was installed at 13:00 on Thursday 26th January. Missing data between 02:00 and 08:00 on Sunday 29th January was due to failure in clock updates.

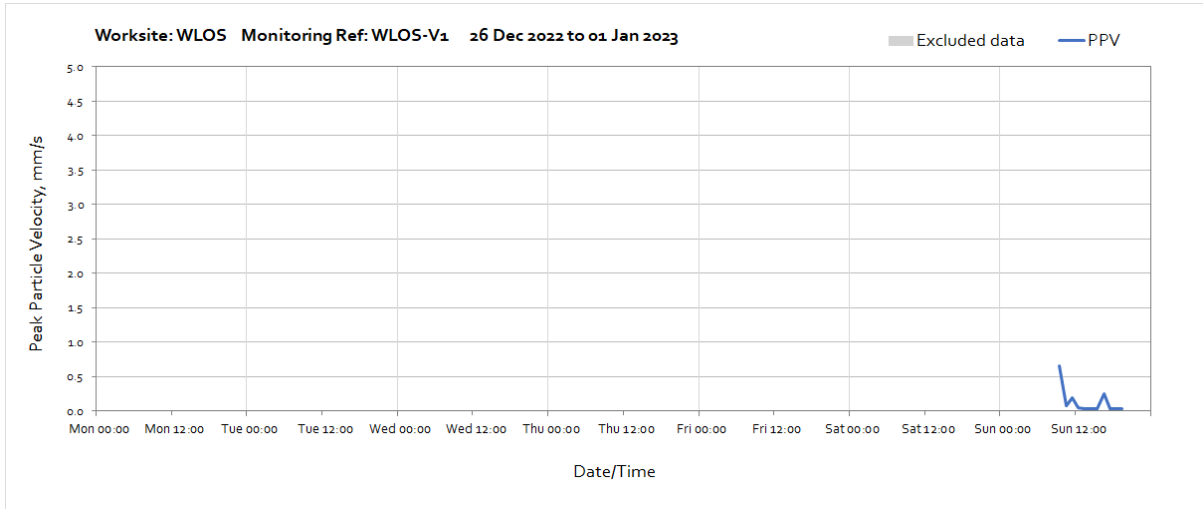
Worksite: WLOS - Monitoring Ref: WLOS-V1

Note: Missing data throughout the week was due to damage to the solar panel resulting loss of power to the monitor. Panel batteries replaced on Tuesday 17th January and solar panel replaced on Tuesday 24th January.

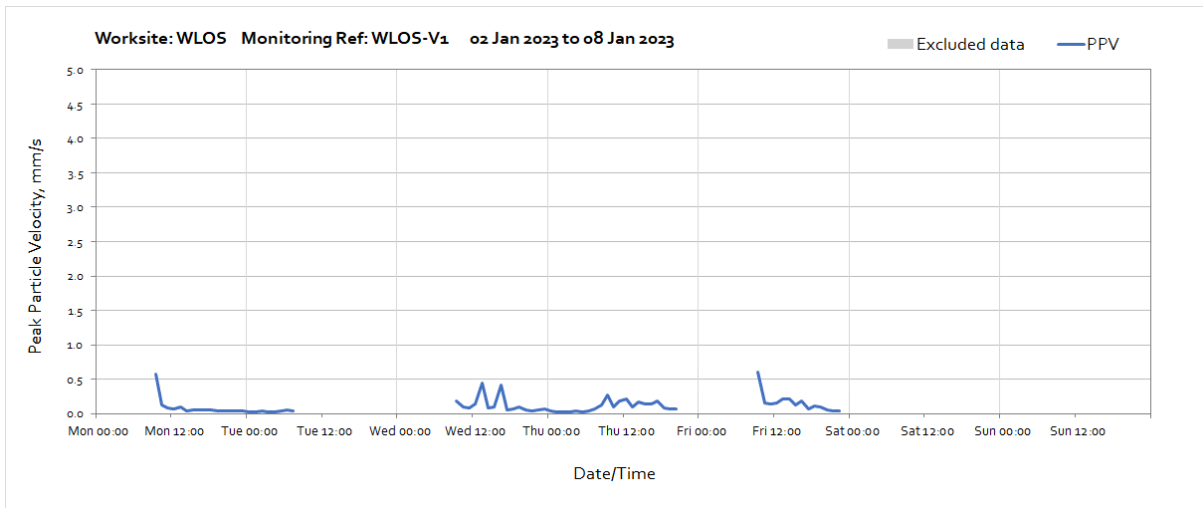
Note: Missing data throughout the week was due to damage to the solar panel resulting loss of power to the monitor. Panel batteries replaced on Tuesday 17th January and solar panel replaced on Tuesday 24th January.

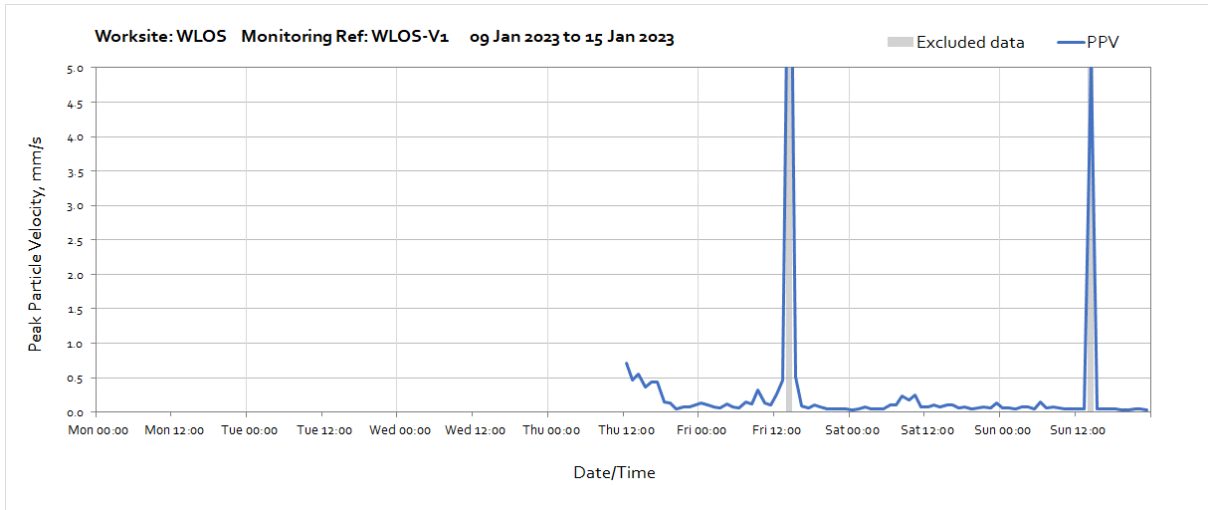
Note: Missing data between 00:00 on Monday 9th January and 12:00 on Thursday 12th January due to damage to the solar panel resulting loss of power to the monitor. Panel batteries replaced on Tuesday 17th January and solar panel replaced on Tuesday 24th January.
