**SALVUS micropoint gas cooker hoses - Male thread end connection issue**

Office for Product  
Safety & Standards

## Product Recall

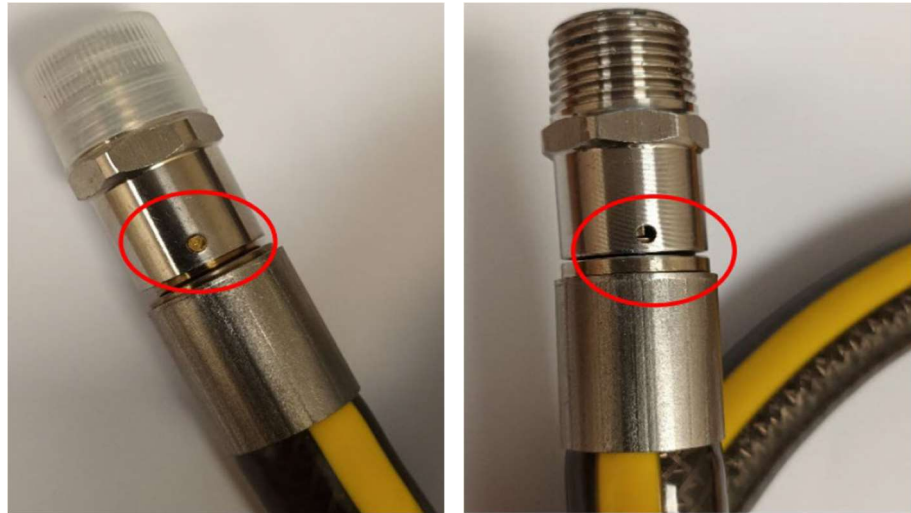
<p>Hose showing pin in place      Hose showing pin not in place</p>
Alert Number	2305-0120
Product Type	Gas appliances and components – Gas Hose
Product Identifiers	Brand: Salvus Affected lines: BFGHENEM-100 SALVUS 1.00M EN 14800 Gas Hose Elbow Micropoint and BFGHENEM-125 SALVUS 1.25M EN 14800 Gas Hose Elbow Micropoint Sales period of affected hoses: January 2019 to December 2022
Product Description	Black and yellow angled micropoint gas hoses.
Country of Origin	China
Counterfeit	Genuine
Risk Type	Fire
Risk Description	<p>The product has been recalled as it has been identified that a very small percentage (1.2%) of their SALVUS branded 1m and 1.25m angled micropoint gas hoses may have a missing pin from the 3-pin array that holds the male thread swivel section joint on to the gas hose itself. The missing pin represents a risk that continued movement and twisting could cause other pins to fall out. If all pins fall out, the male connector section could detach from the hose section and gas will continue to flow from the hose.</p> <p>The product does not comply with the Gas Appliances (Enforcement) and Miscellaneous Amendments Regulations 2018.</p>

Corrective Measures	Recall of the product from end users. For further information, please see: <a href="https://registeredgasengineer.co.uk/technical/safety-alert-031/">https://registeredgasengineer.co.uk/technical/safety-alert-031/</a>
