Construction Noise and Vibration Monthly Report – March 2023

London Borough of Ealing

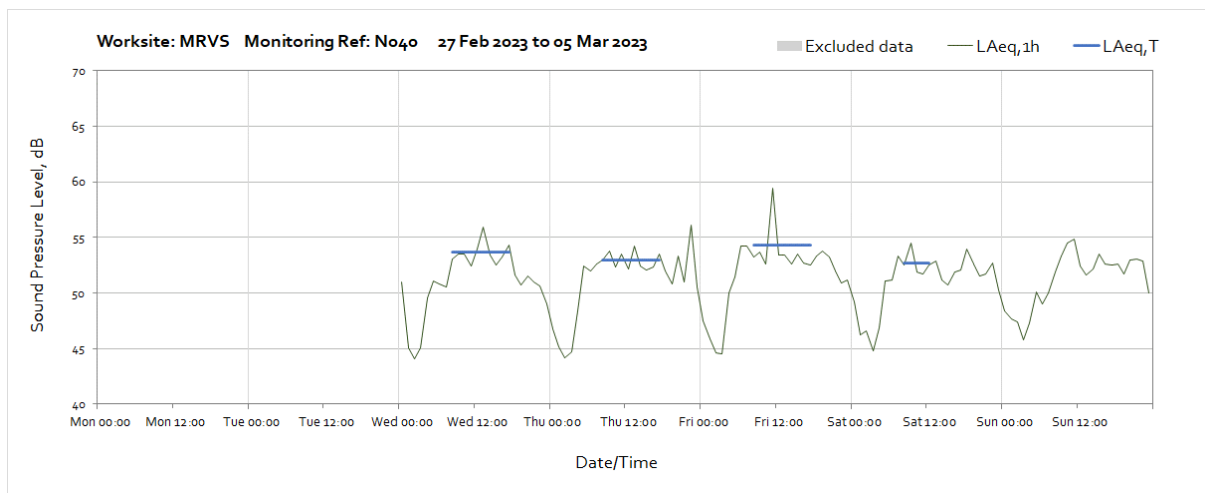
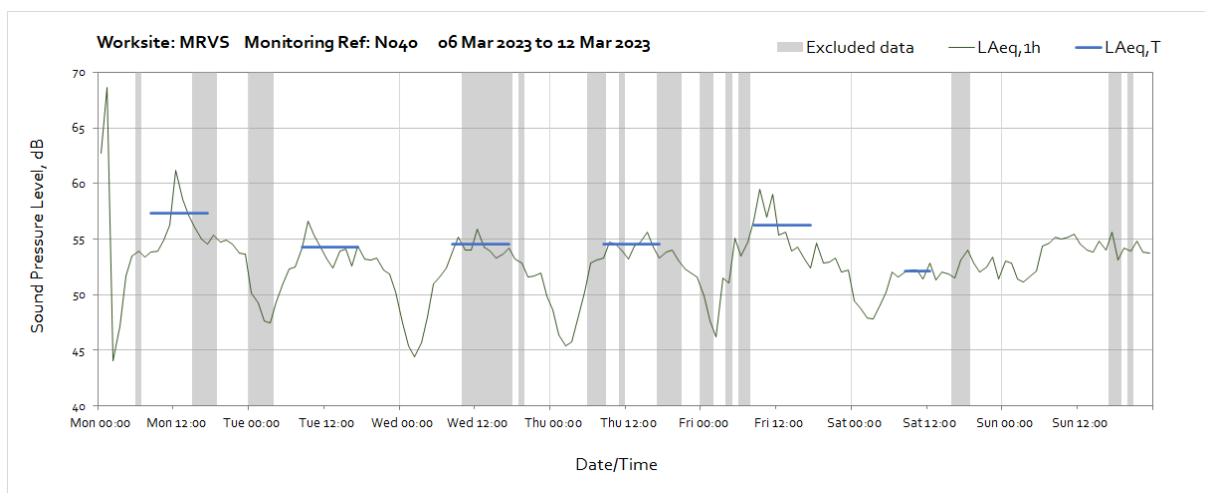
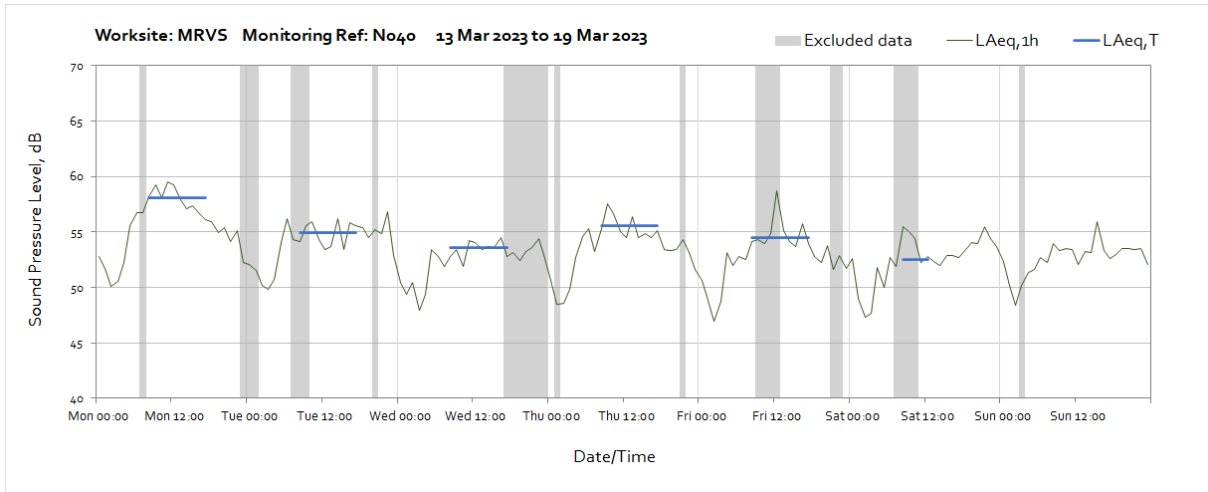
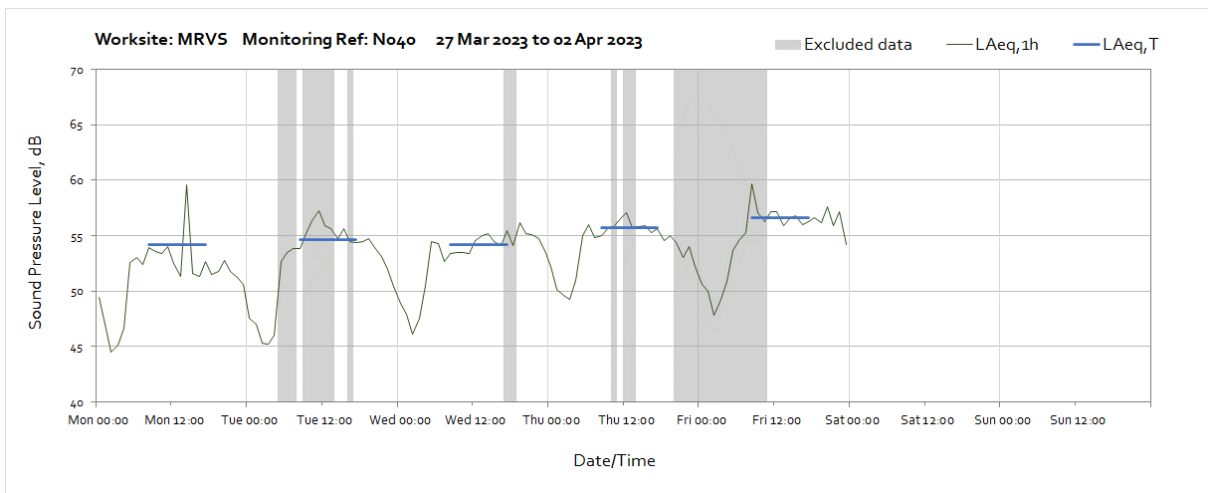
Worksite: MRVS – Monitoring Ref: N040

Note: Missing data between 01:00 and 03:00 on Sunday 26th March was due to a monitor time adjustment at the start of British Summer Time.

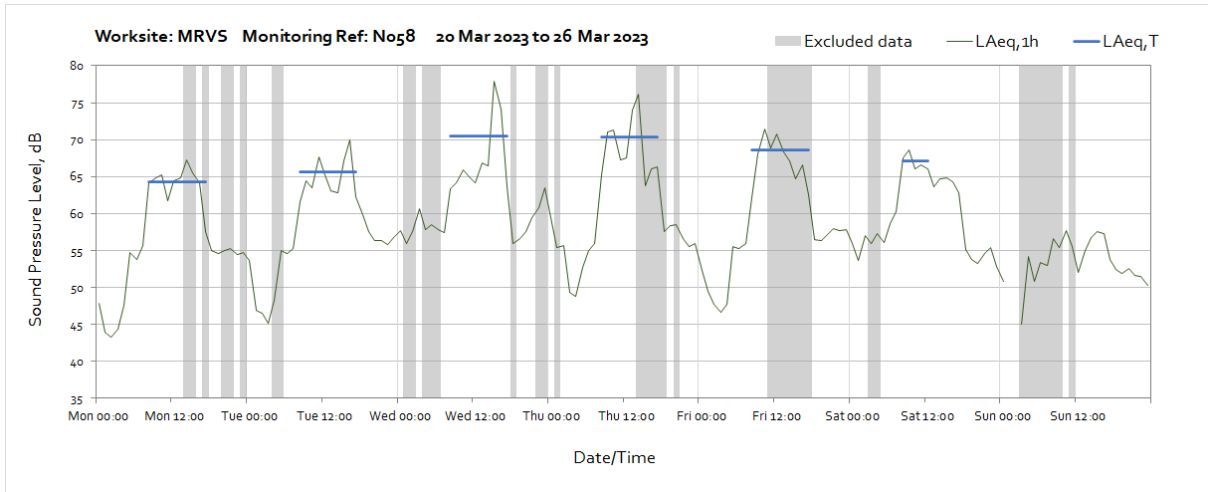
Worksite: MRVS – Monitoring Ref: N058

Note: Missing data between 01:00 and 03:00 on Sunday 26th March was due to a monitor time adjustment at the start of British Summer Time.

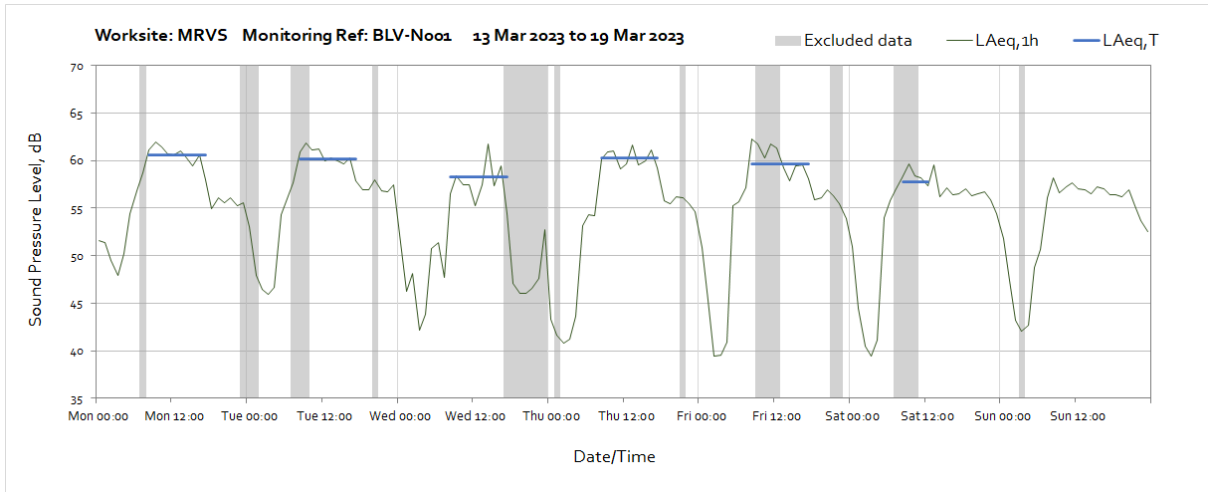
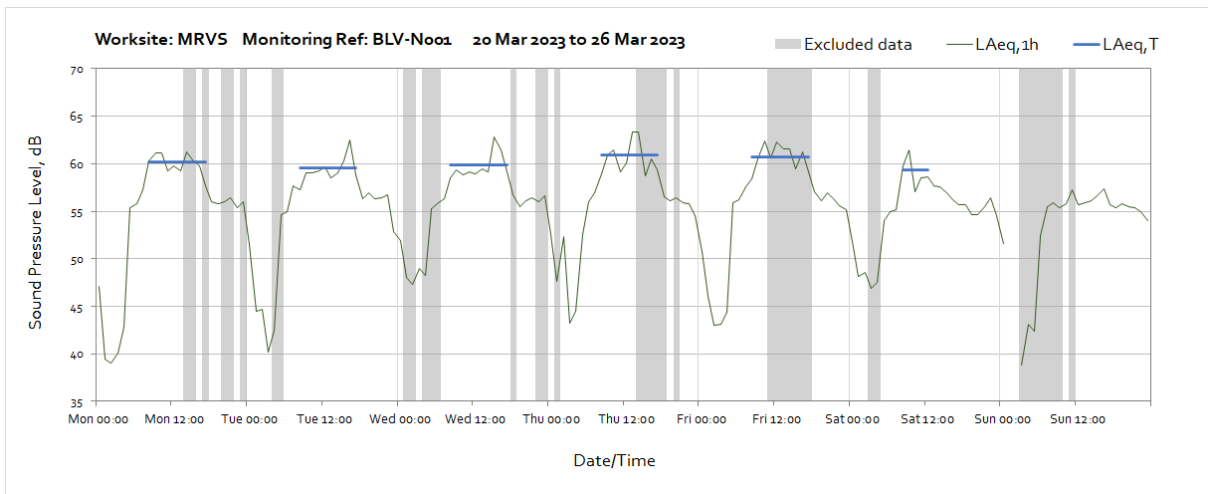
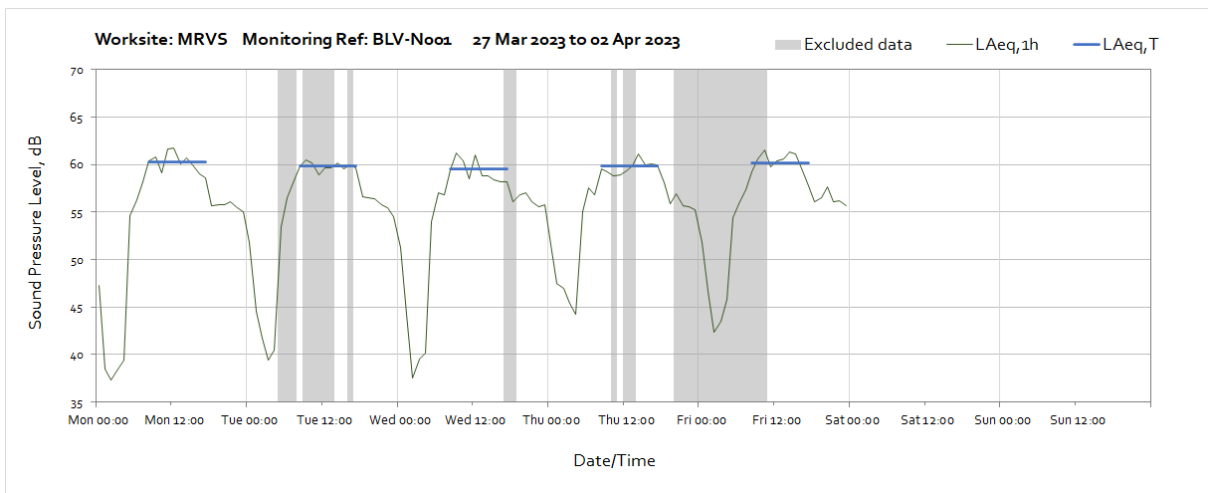
Worksite: MRVS – Monitoring Ref: BLV-N001

Note: Missing data between 01:00 and 03:00 on Sunday 26th March was due to a monitor time adjustment at the start of British Summer Time.

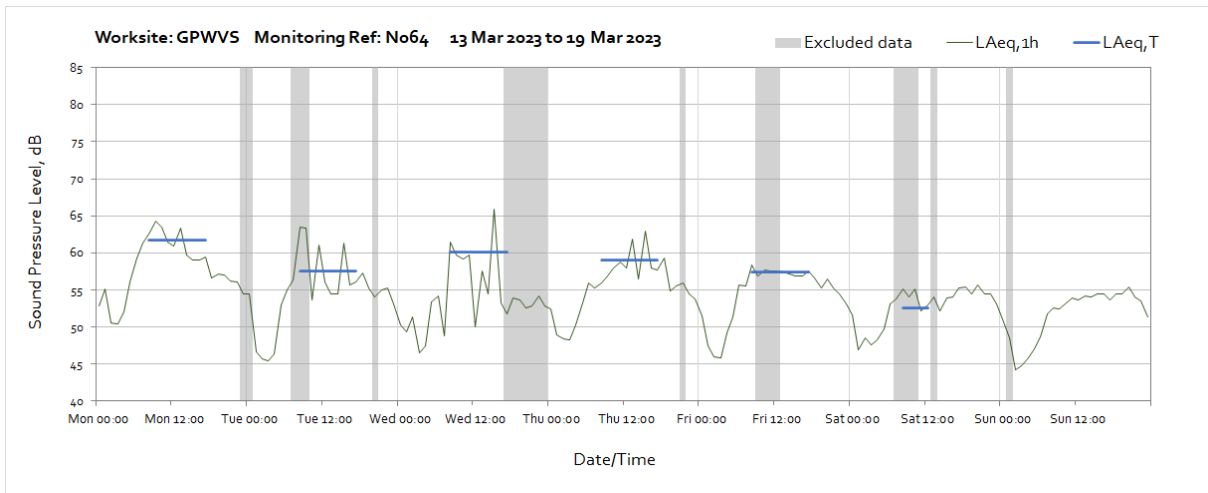
Worksite: GPWVS – Monitoring Ref: N064

Note: Missing data between 01:00 and 03:00 on Sunday 26th March was due to a monitor time adjustment at the start of British Summer Time.

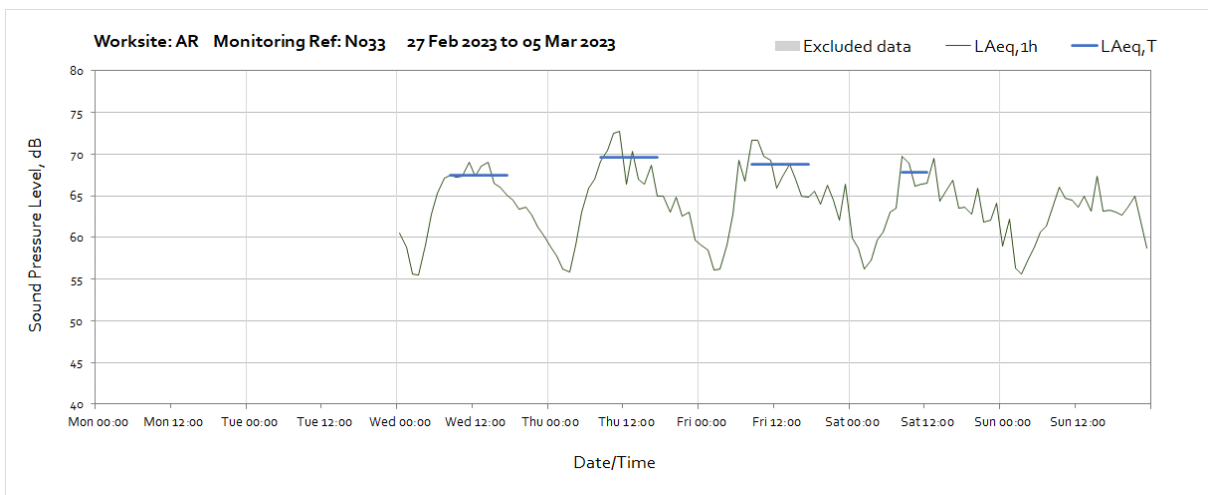
Worksite: AR – Monitoring Ref: N033

Note: Missing data between 01:00 and 03:00 on Sunday 26th March was due to a monitor time adjustment at the start of British Summer Time.

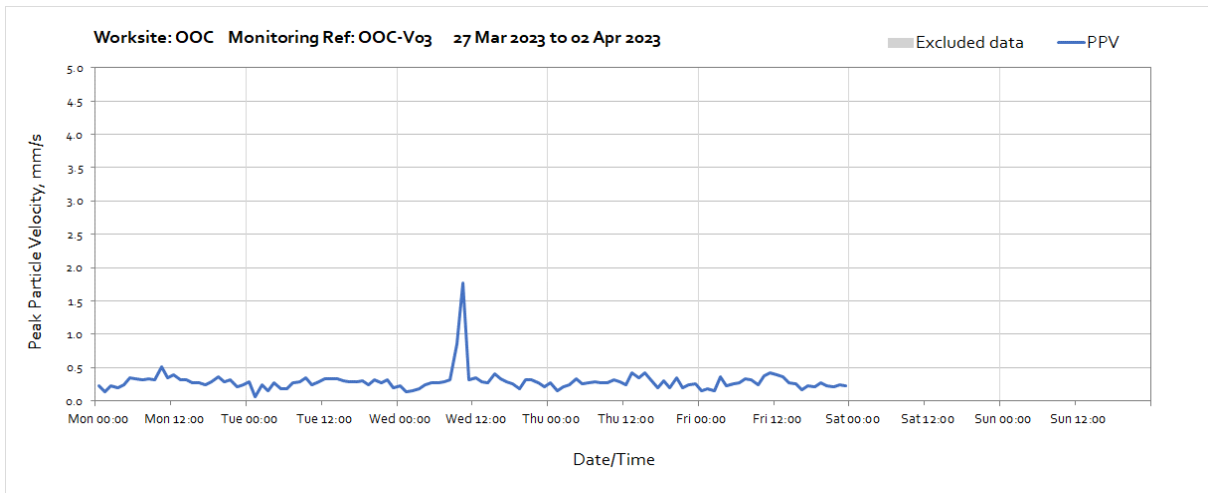
Worksite: OOC – Monitoring Ref: OOC-V03

Note: Missing data between 13:00 on Thursday 16th March and 17:00 on Tuesday 21st March was due to connection error at the monitoring station.
