Construction Noise and Vibration Monthly Report – March 2023

North Warwickshire Borough Council

This Noise and Vibration Monitoring Report fulfils HS2 Limited's commitment detailed in the Environmental Minimum Requirements (EMRs), Annex 1, Code of Construction Practice, to present the results of noise and vibration monitoring carried out within North Warwickshire Borough Council (NWBC) area during the month of March 2023.

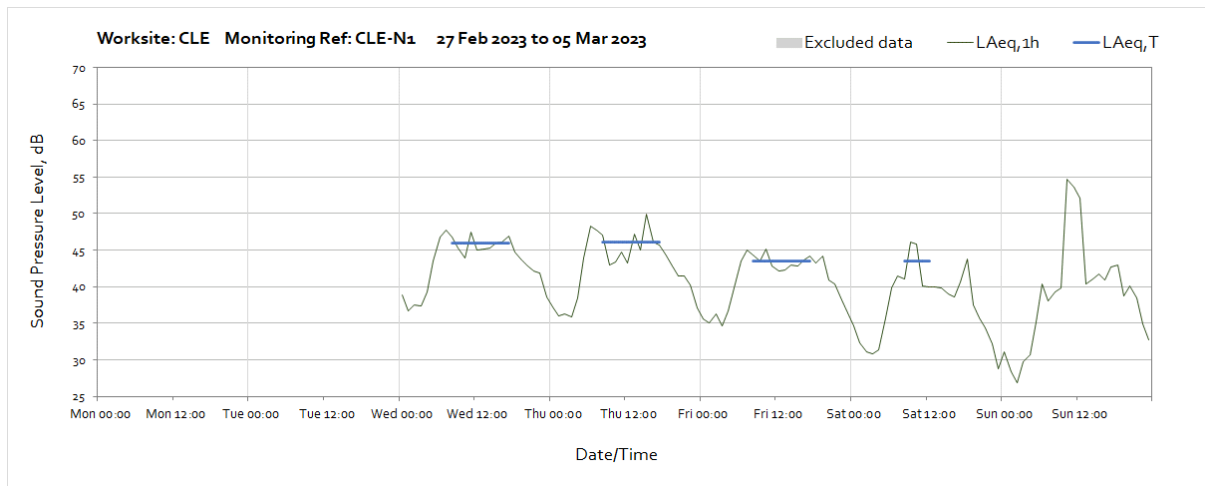
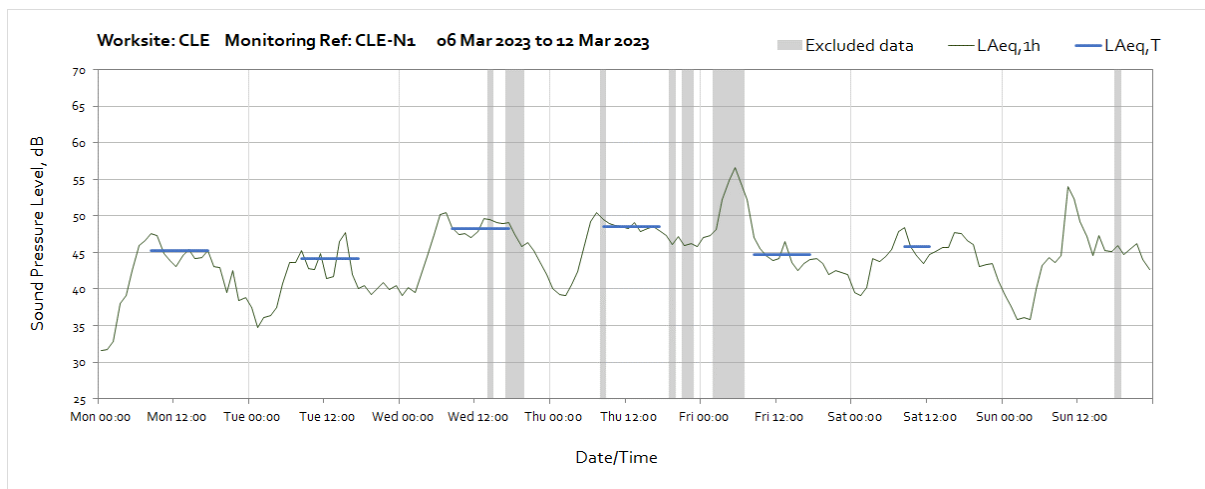
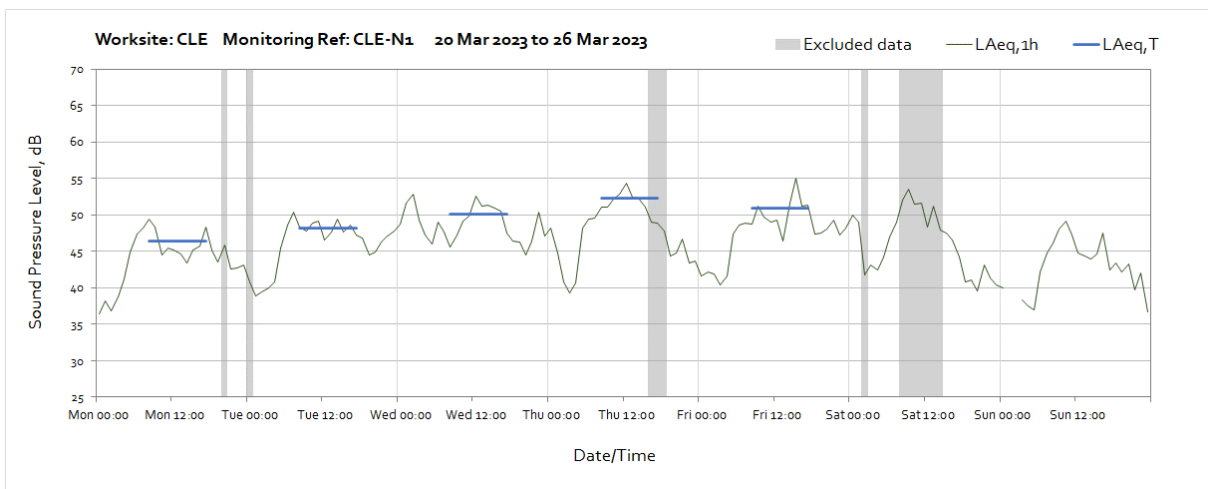
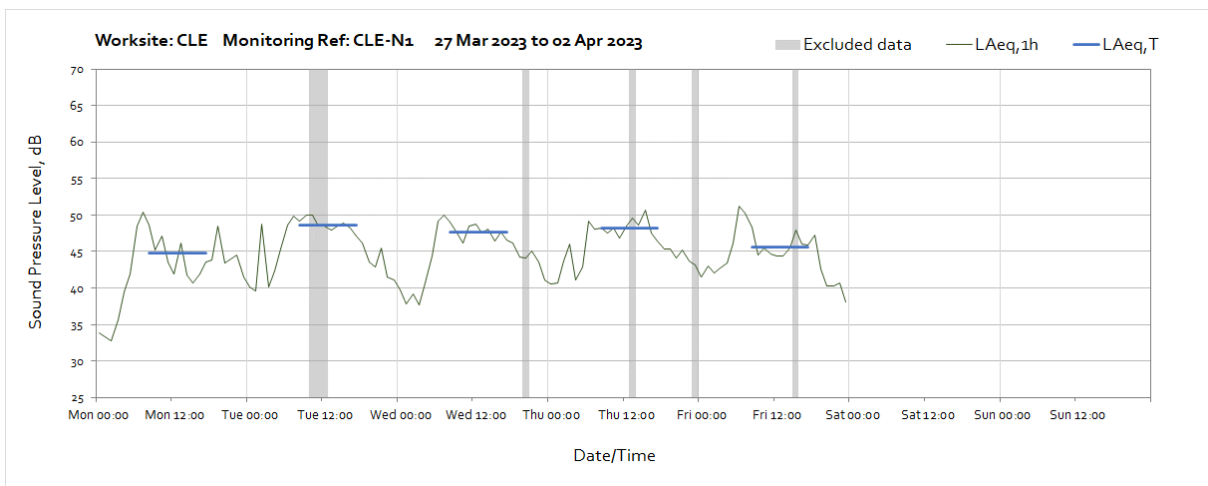
Worksite: CLE – Monitoring Ref: CLE-N1

Note: Missing data between 01:00 and 02:00 on Sunday 26th March was due to a monitor time adjustment at the start of British Summer Time.

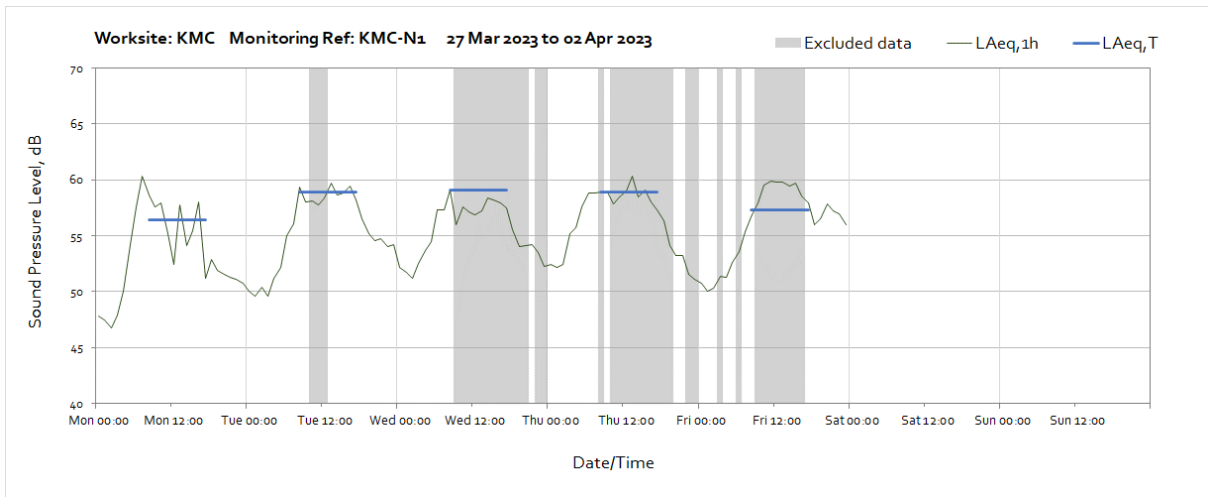
Worksite: KMC – Monitoring Ref: KMC-N1

Note: Missing data between 01:00 and 02:00 on Sunday 26th March was due to a monitor time adjustment at the start of British Summer Time.

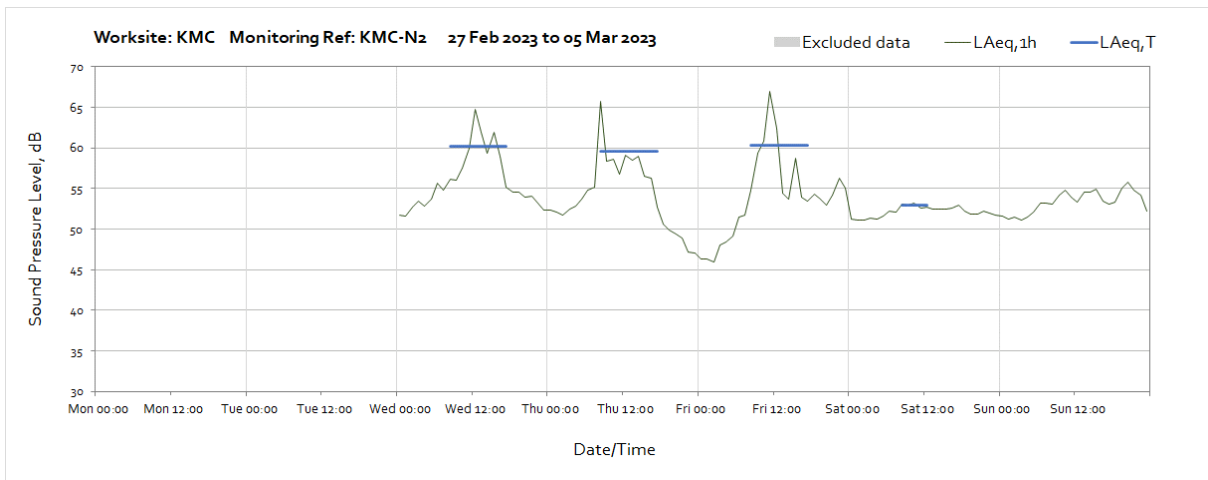
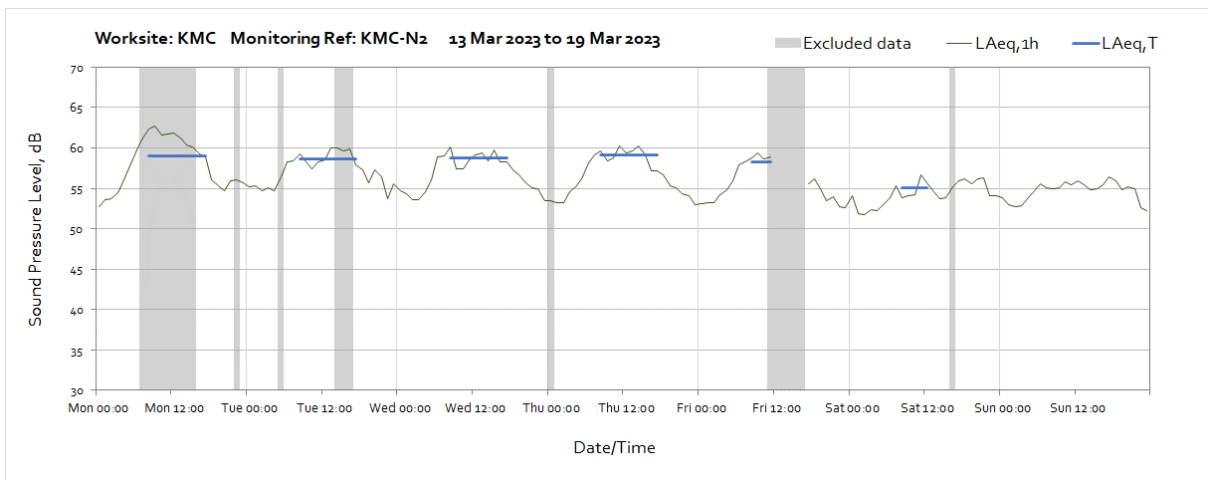
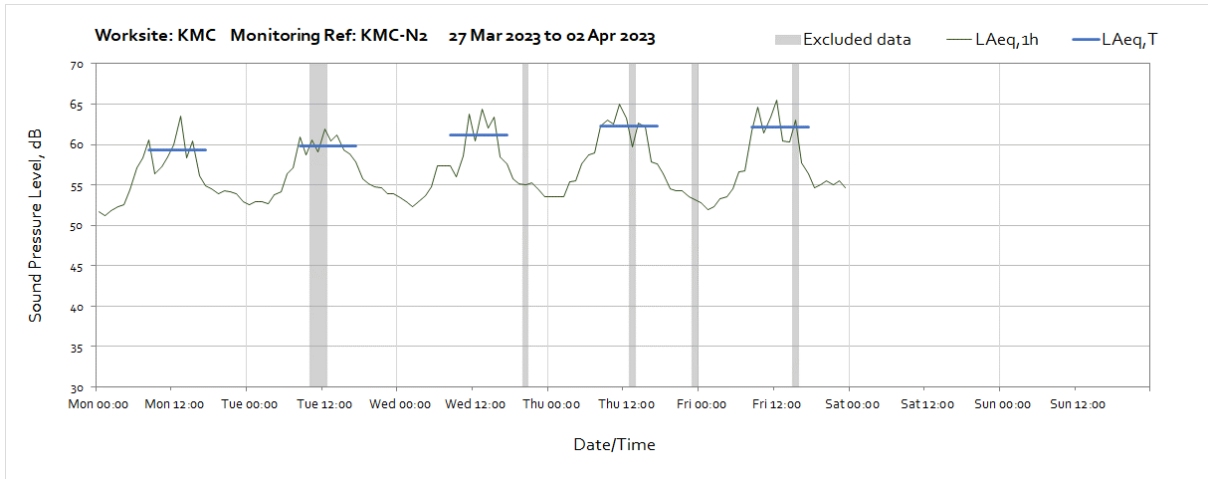
Worksite: KMC – Monitoring Ref: KMC-N2

Note: Missing data between 01:00 and 02:00 on Sunday 26th March was due to a monitor time adjustment at the start of British Summer Time.

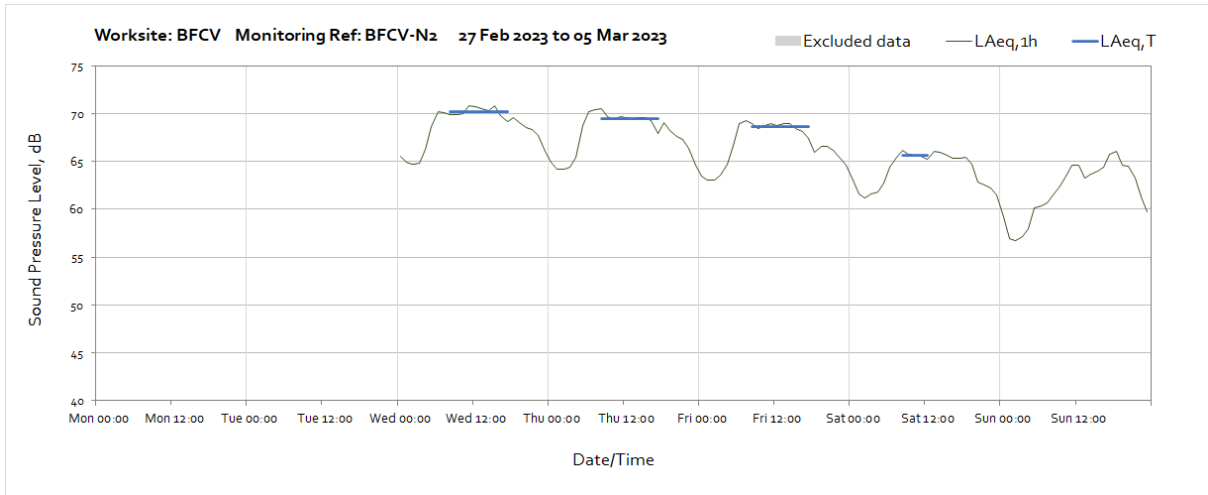
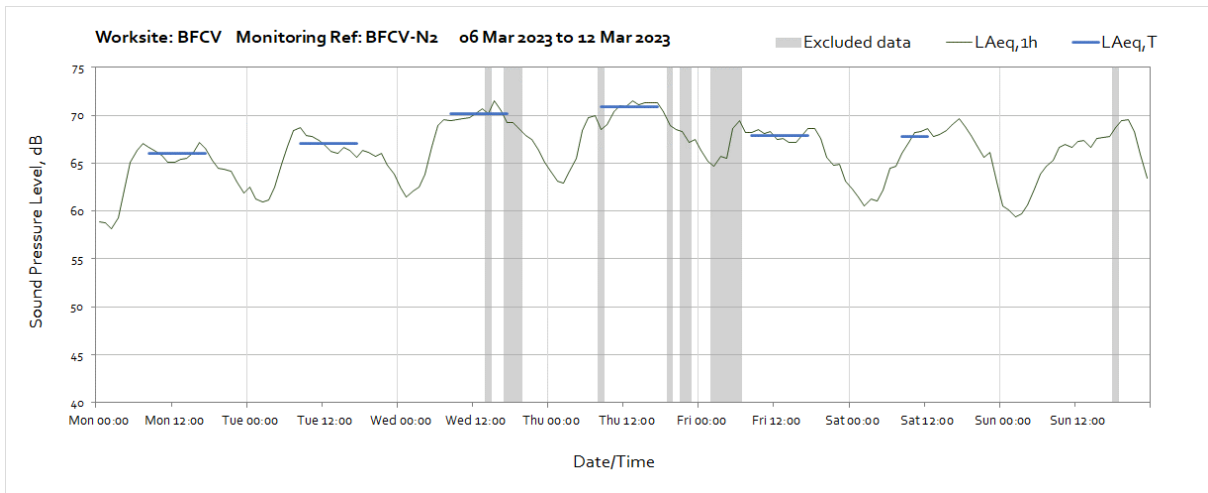
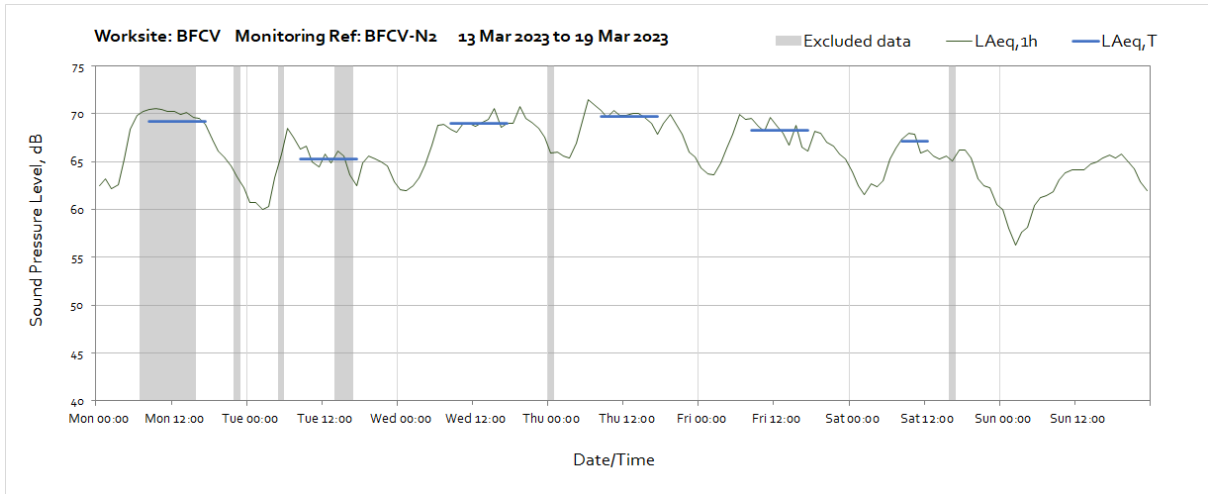
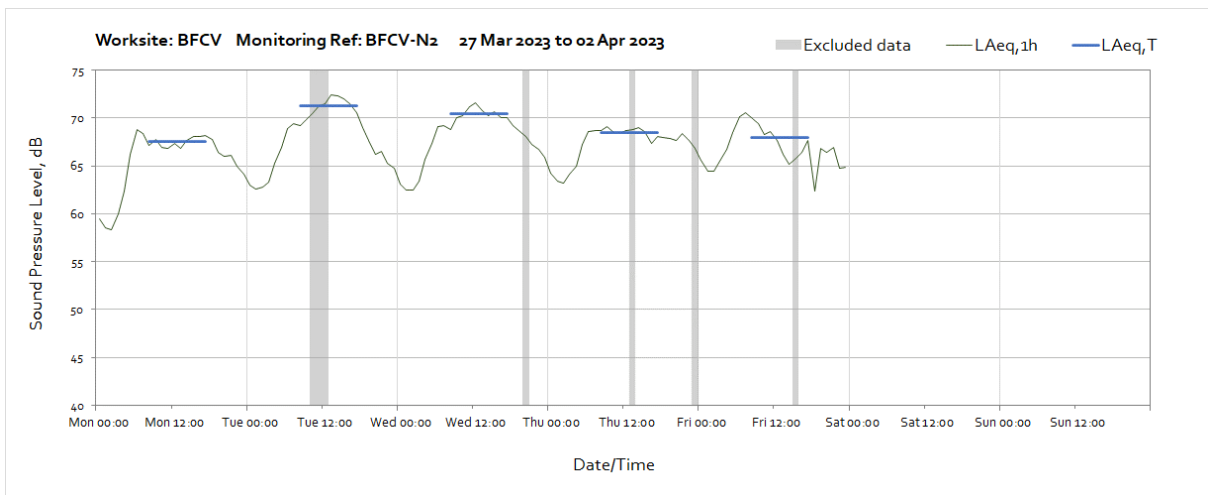
Worksite: BFCV - Monitoring Ref: BFCV-N2

Note: Missing data between 01:00 and 03:00 on Sunday 26th March was due to a monitor time adjustment at the start of British Summer Time

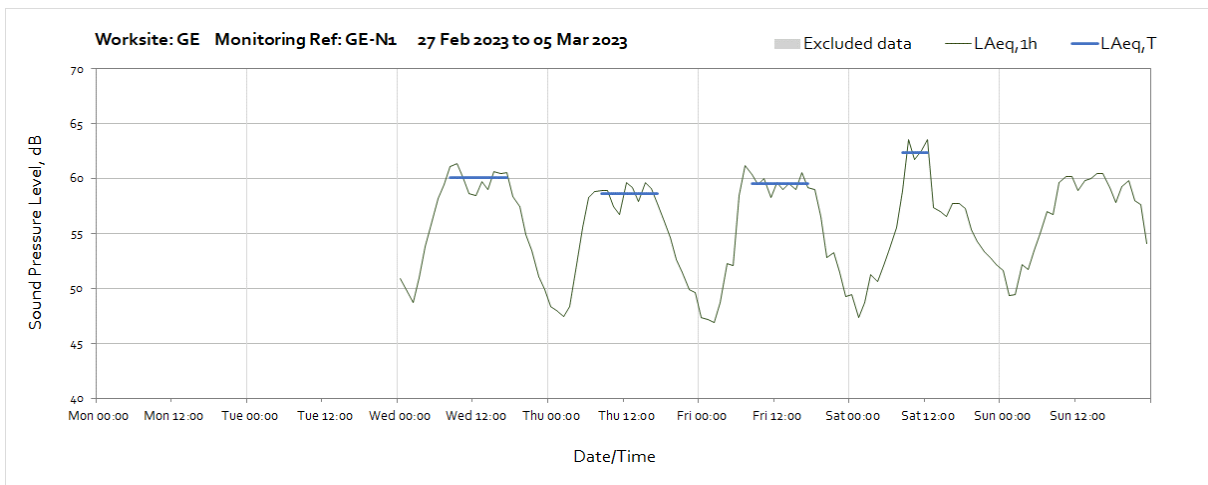
Worksite: GE – Monitoring Ref: GE-N1

Note: Missing data between 01:00 and 03:00 on Sunday 26th March was due to a monitor time adjustment at the start of British Summer Time.
