Construction Noise and Vibration Monthly Report – March 2023

Warwick District Council

Non-Technical Summary

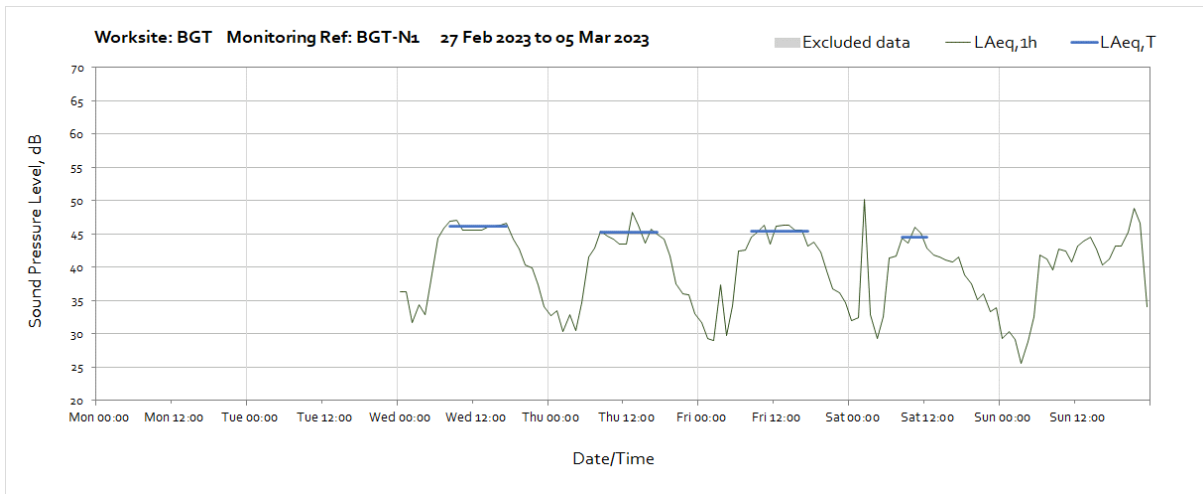
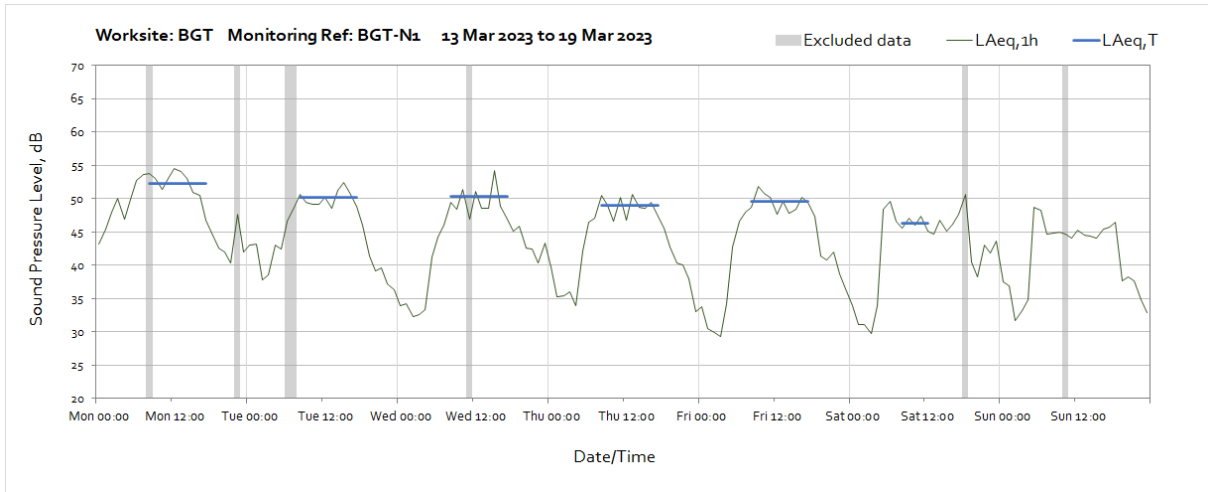
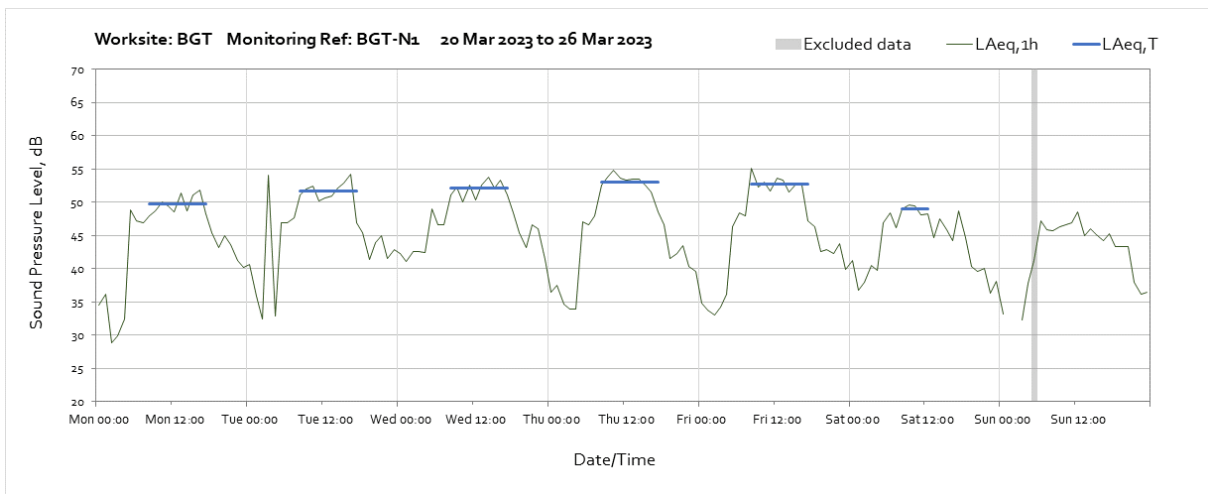
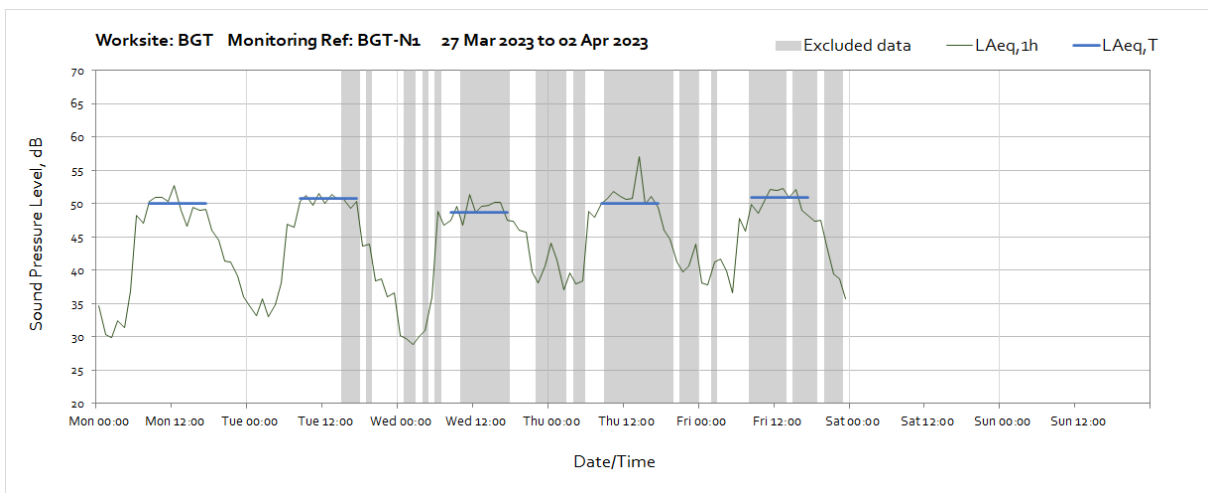
Worksite: BGT - Monitoring Ref: BGT-N1

The following graphs show the hourly measured ambient noise level $L_{Aeq,1h}$ and, where relevant, the averaged noise level $L_{Aeq,T}$ values, where the time period T is as specified in Table 1 of HS2 Information Paper E23. Periods with adversely weather affected noise levels are greyed out and have been excluded from the calculation of the $L_{Aeq,T}$ values in Table 3 of the main report.

Note: Missing data between 01:00 and 03:00 on Sunday 26th March was due to a monitor time adjustment at the start of British Summer Time.

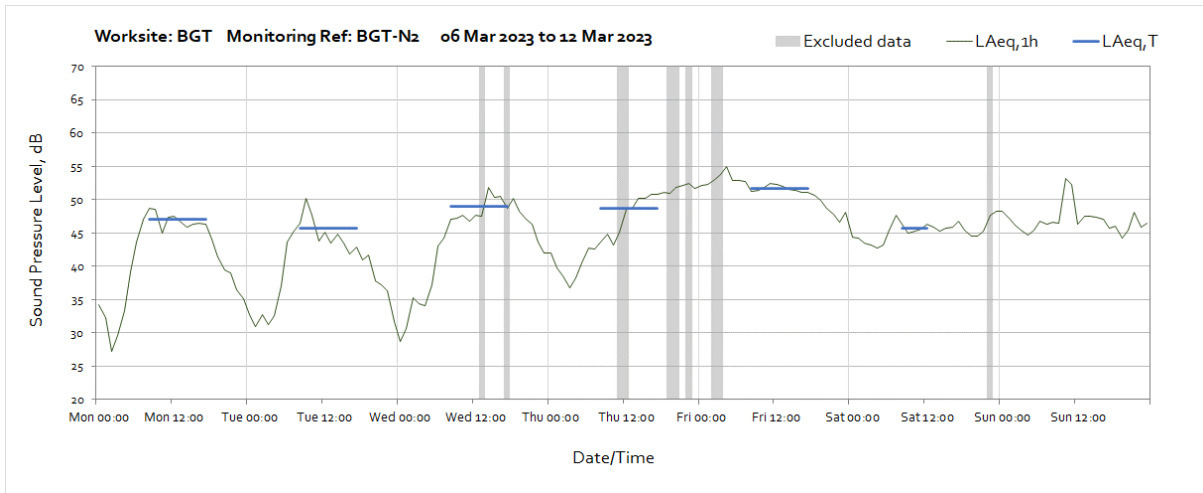
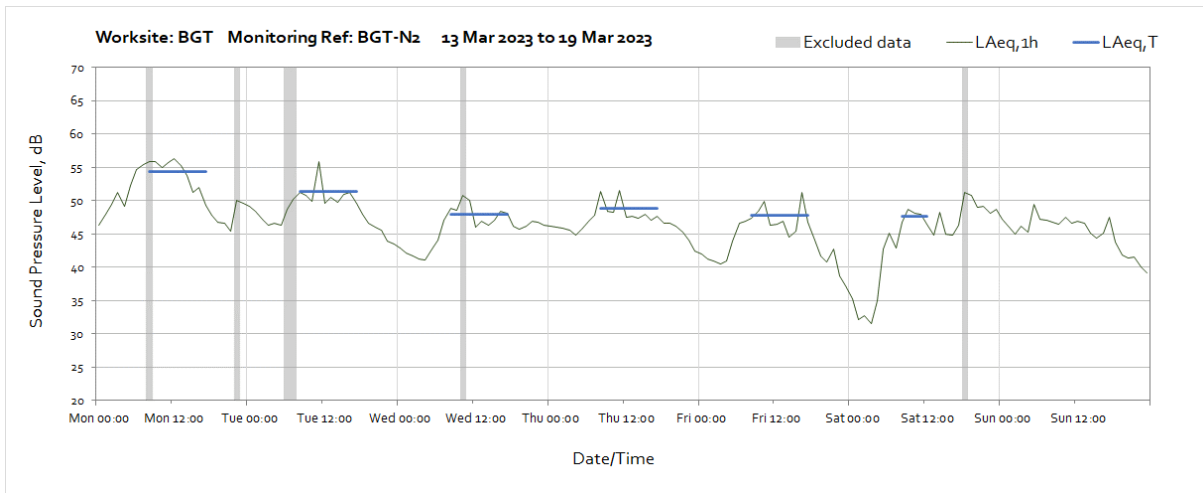
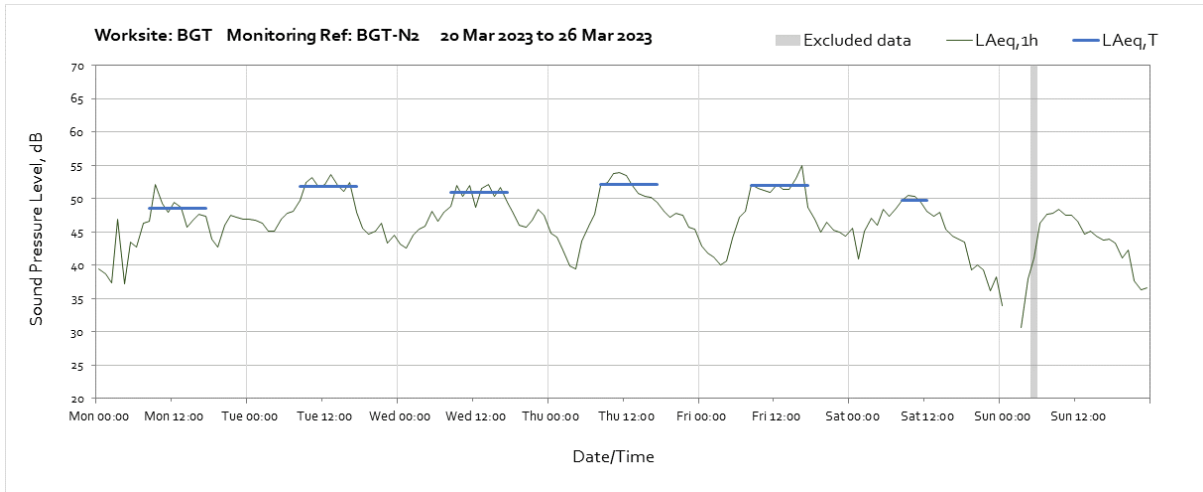
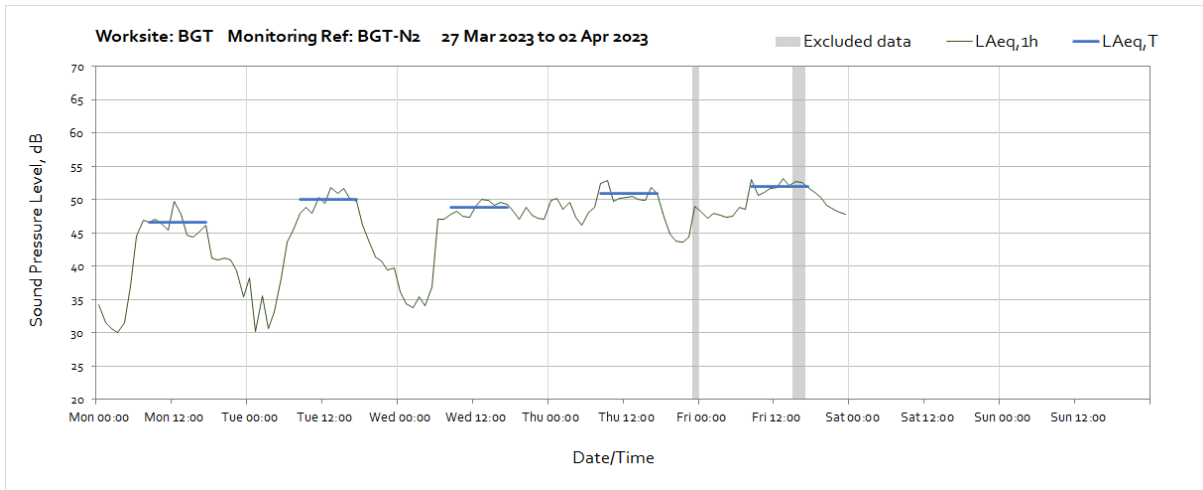
Worksite: BGT - Monitoring Ref: BGT-N2

Note: Missing data between 01:00 and 03:00 on Sunday 26th March was due to a monitor time adjustment at the start of British Summer Time.

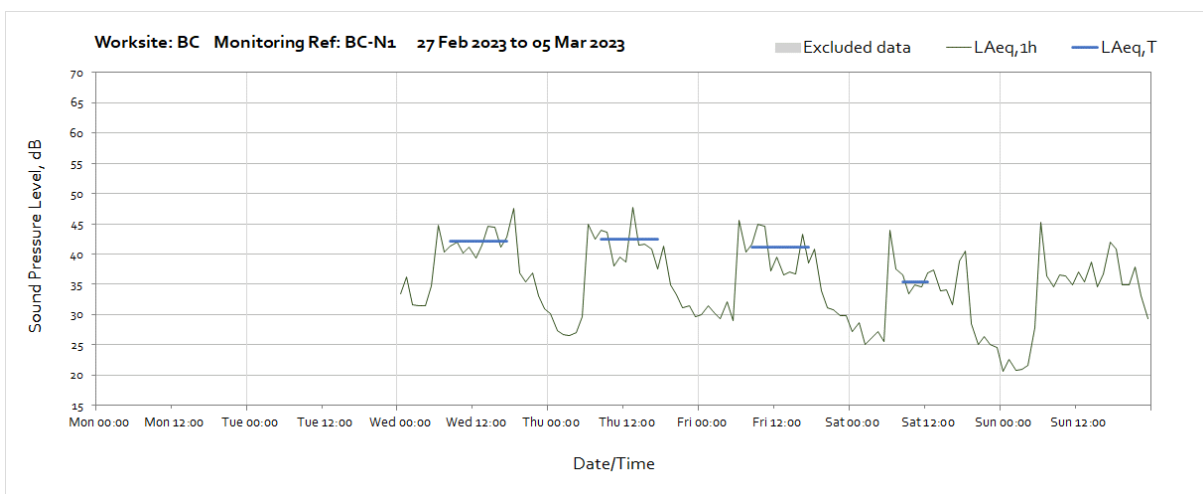
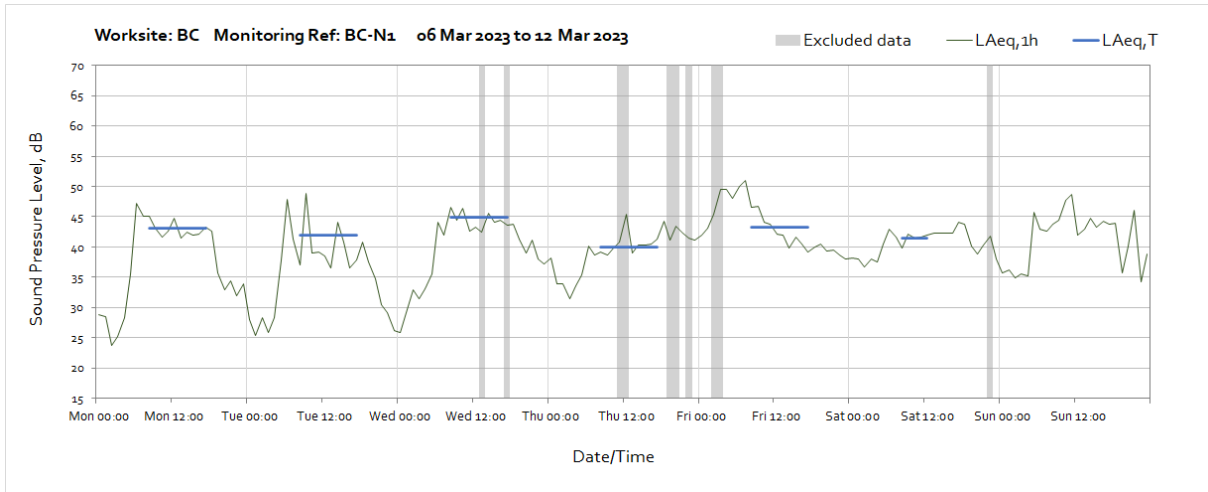
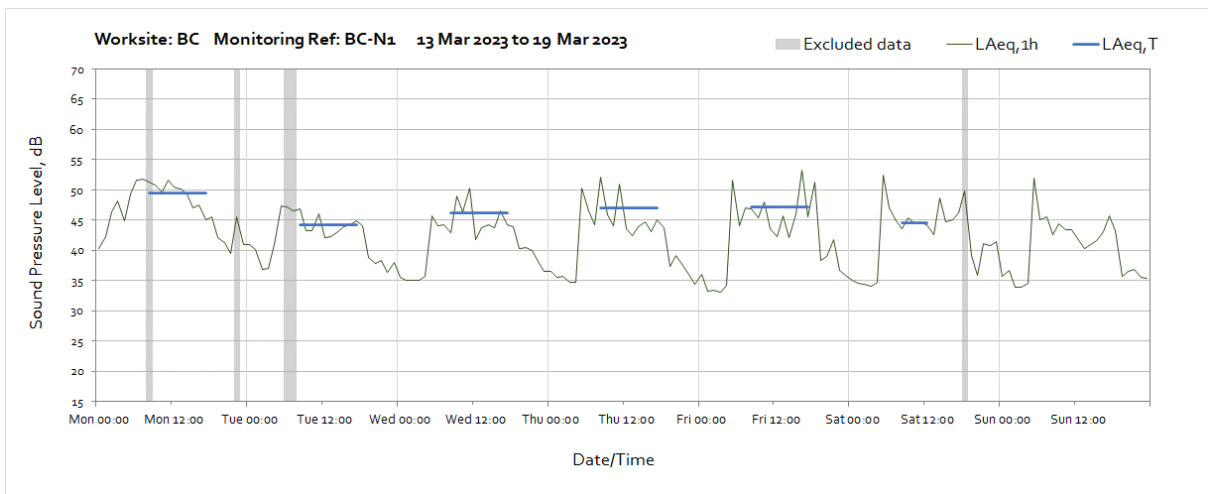
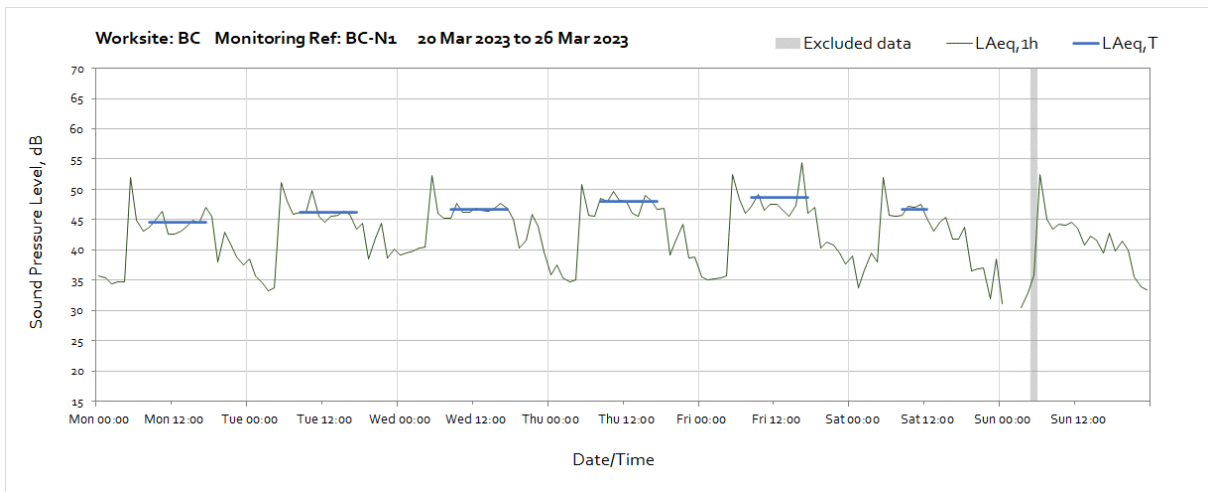
Worksite: BC – Monitoring Ref: BC-N1

Note: Missing data between 01:00 and 03:00 on Sunday 26th March was due to a monitor time adjustment at the start of British Summer Time.

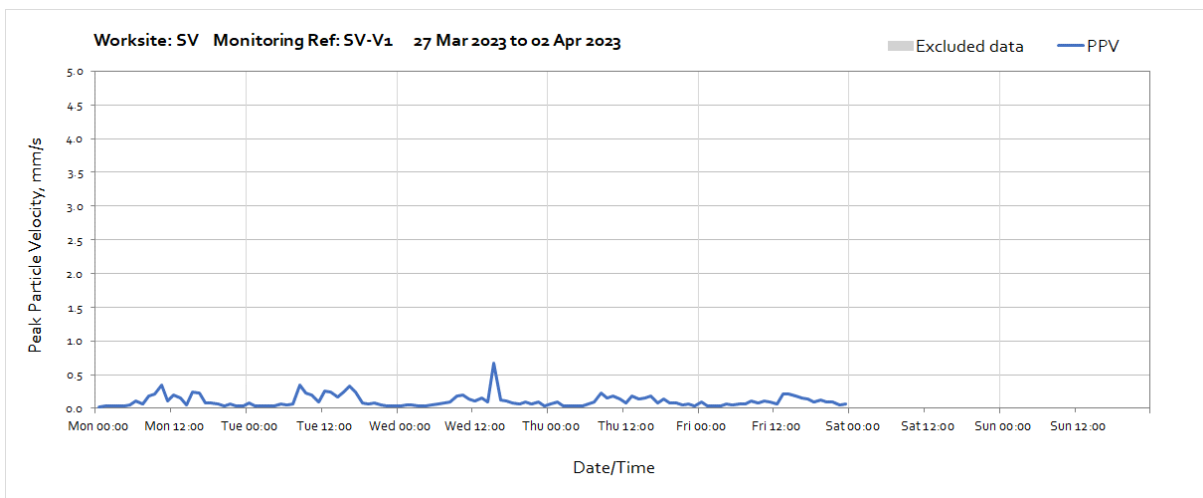
Worksite: SV – Monitoring Ref: SV-V1

Note: After a period of inactivity owing to power supply issues this monitor resumed operation on 9th March.

Note: Missing data between 01:00 and 03:00 on Sunday 26th March was due to a monitor time adjustment at the start of British Summer Time.
