Air Quality and Dust Monitoring Monthly Report – April 2023

London Borough of Brent

A report prepared by EWCs and MWCCs on behalf of HS2 Ltd.

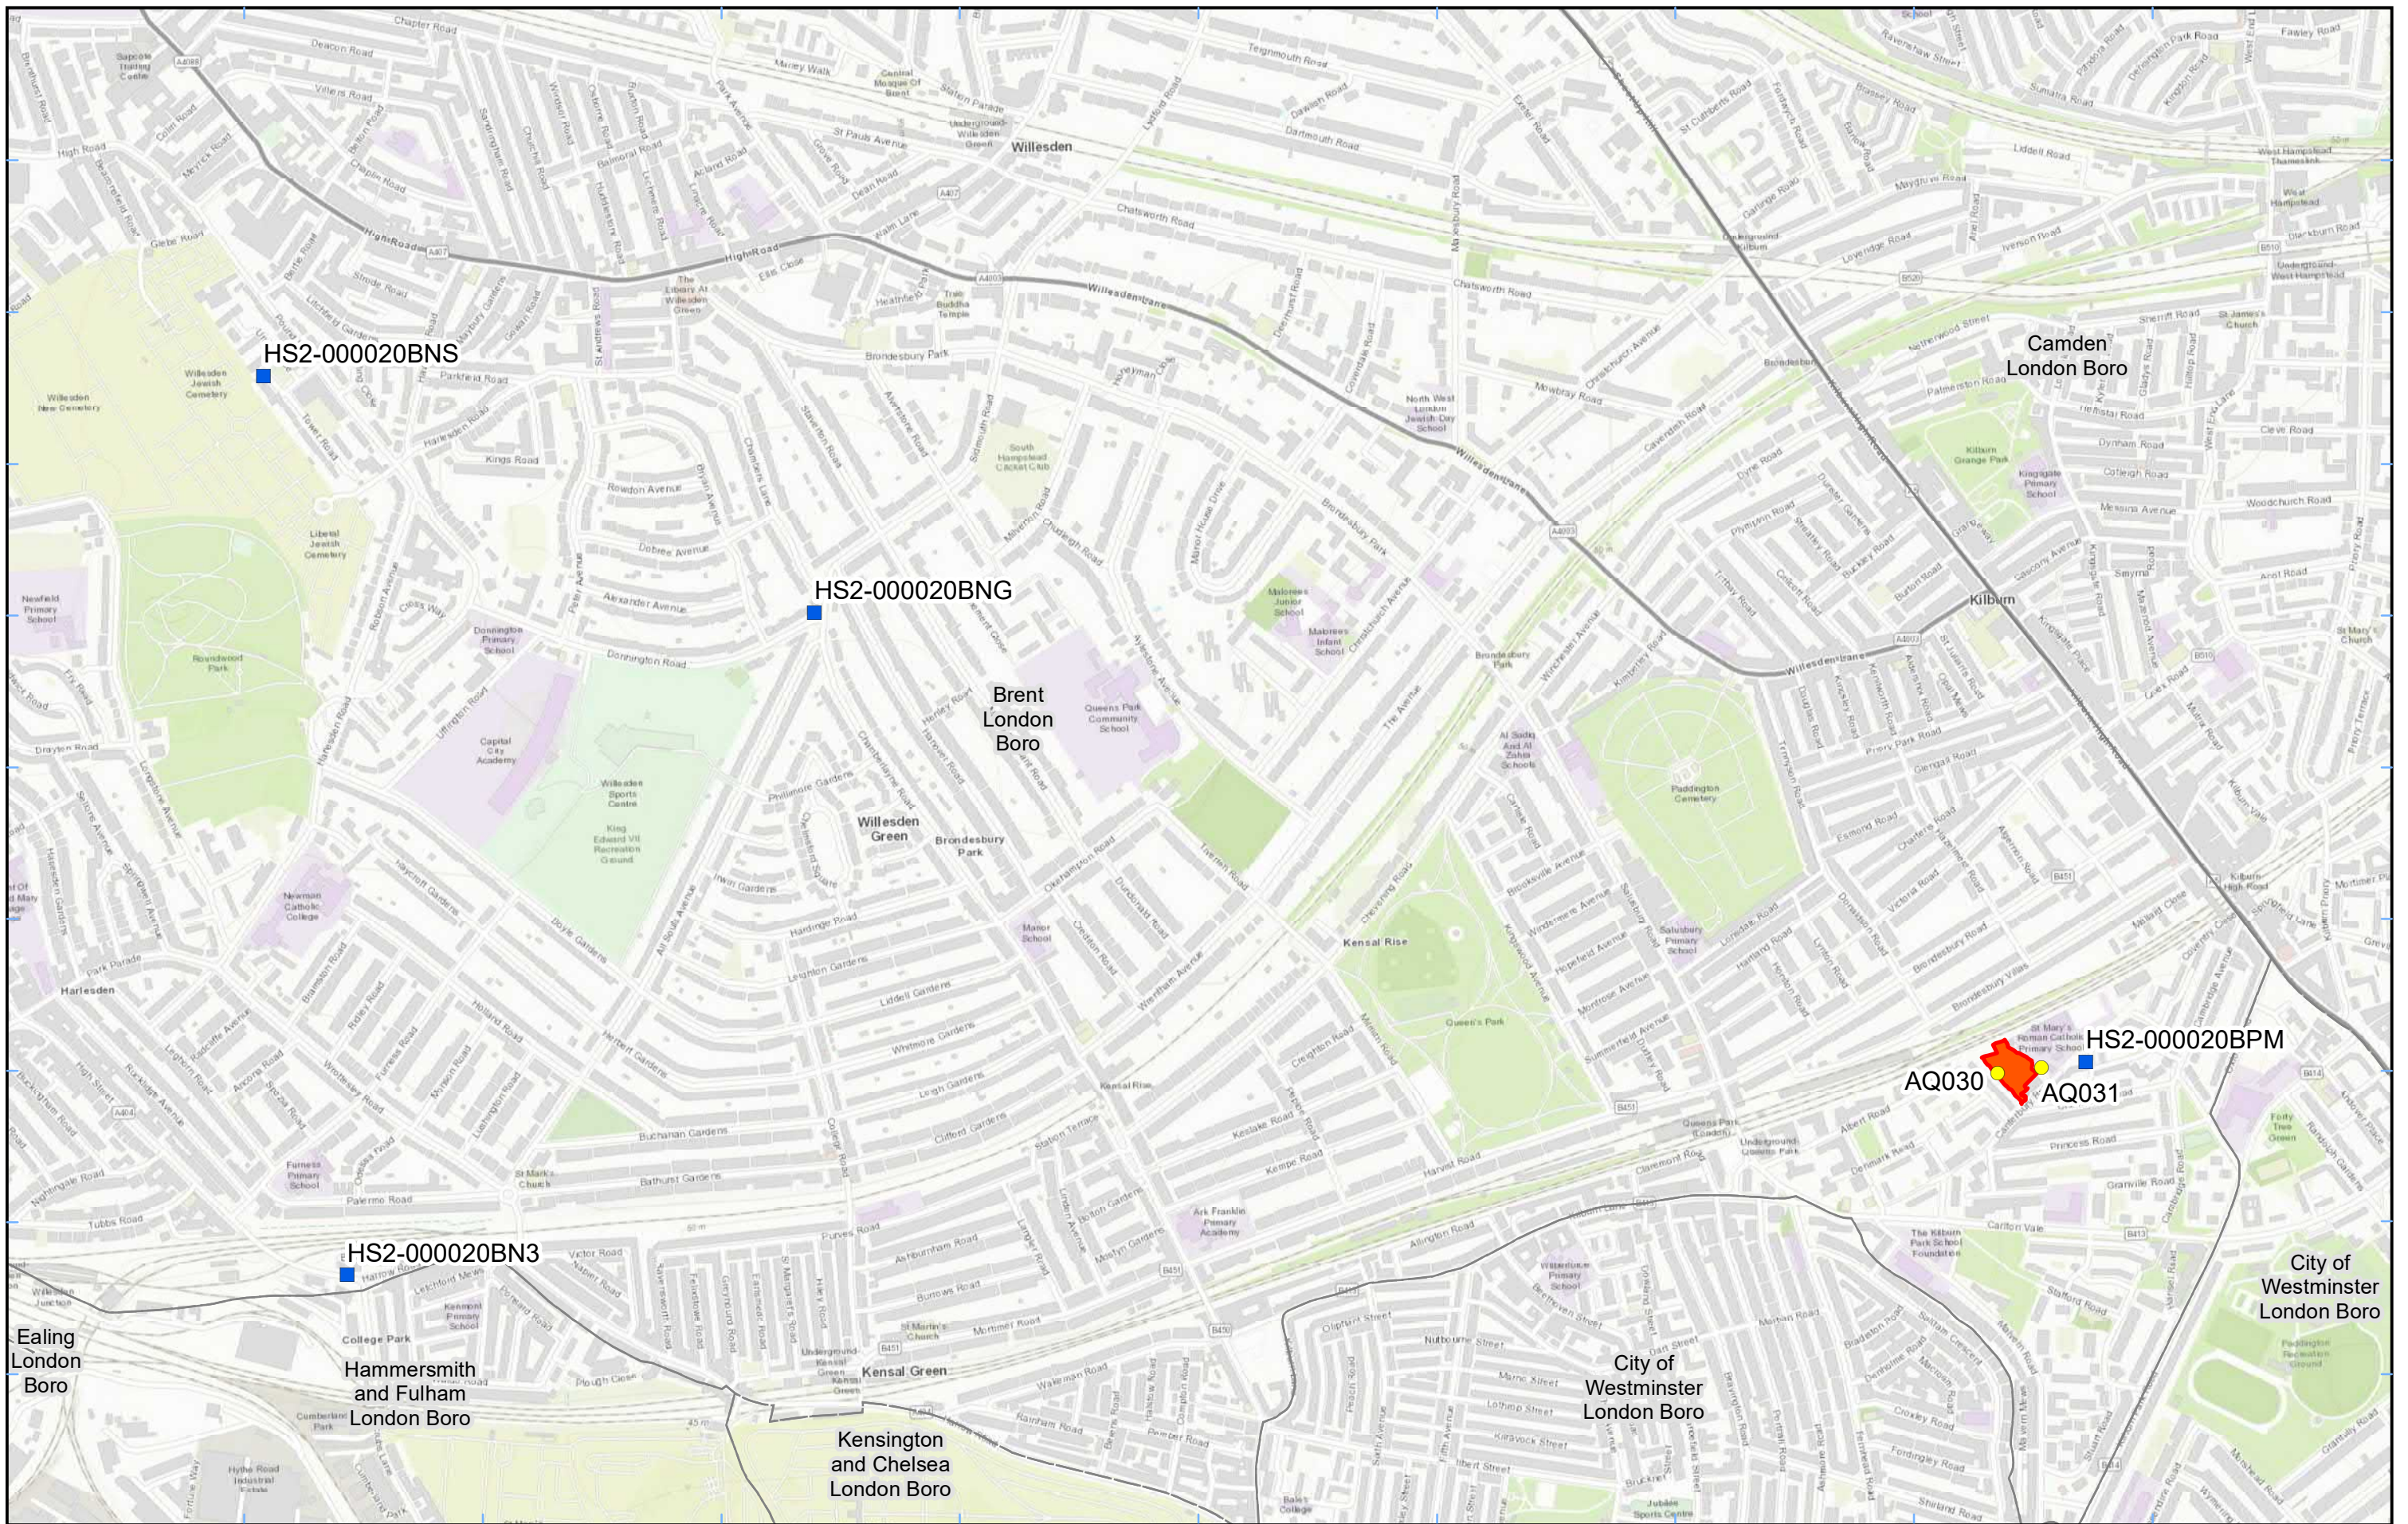
Figure 1: Worksites and monitoring locations within the LBB

- 1.1.2 Figure 1 in Appendix A indicates the current worksites together with air quality monitoring locations.
- 1.1.3 This summary should be read in conjunction with the overview monitoring report available from www.gov.uk/government/collections/monitoring-the-environmental-effects-of-hs2, which highlights: the applicable standards and guidance, as well as the air quality and dust monitoring methodologies to be implemented by nominated undertakers throughout construction.

- 1.1.4 The current phase of works commenced within the LBB in August 2020 and is expected to be completed by the end of 2025. The current worksites, as presented in Appendix A, Figure 1 include:

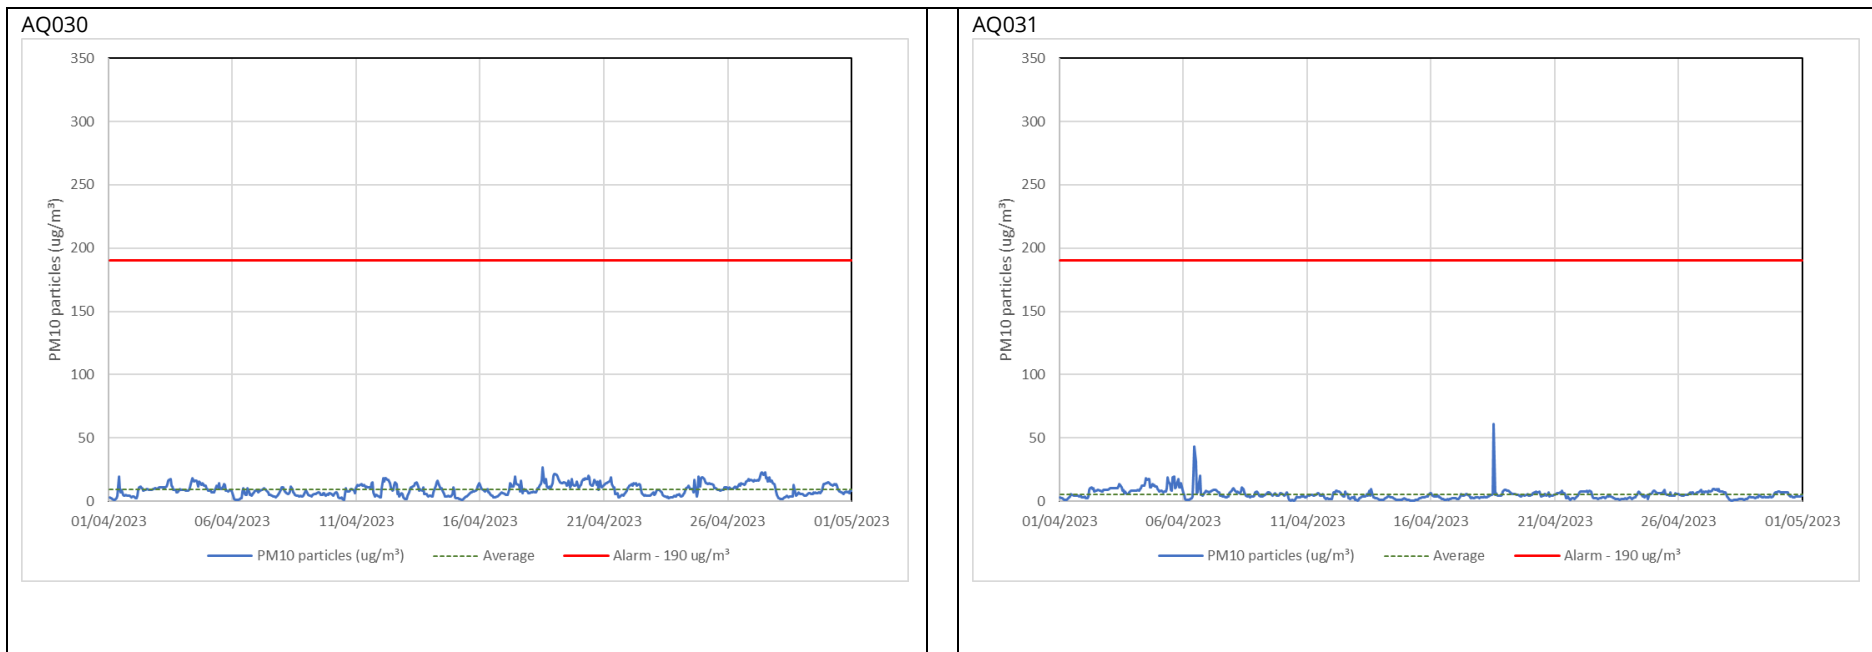
Figure 2: Construction dust 1-hour mean indicative PM₁₀ concentration for dust monitors

- 1.1.6 Dust monitoring location and results are presented in Appendix B, Table 1, together with line chart of monthly data from the dust monitor in Figure 2. The continuous dust monitoring is undertaken using indicative monitors. Despite being Environment Agency (MCERTS) certified, indicative monitors carry a higher level of uncertainty than reference monitors, and therefore cannot be strictly compared with Air Quality Standards for human health and the environment. The purpose of the monitoring undertaken is to ensure the effectiveness of the on-site mitigation.

- 1.1.7 The trigger level for PM₁₀ concentrations of 190 µg/m³, over a 1-hour period, in accordance with the updated guidance document '*Guidance on Monitoring in the Vicinity of Demolition and Construction Sites – (October 2018)*' has been applied.

- 1.1.8 No (0) dust trigger alerts were recorded during the monitoring period (April, 2023).
