Construction Noise and Vibration Monthly Report – April 2023

London Borough of Ealing

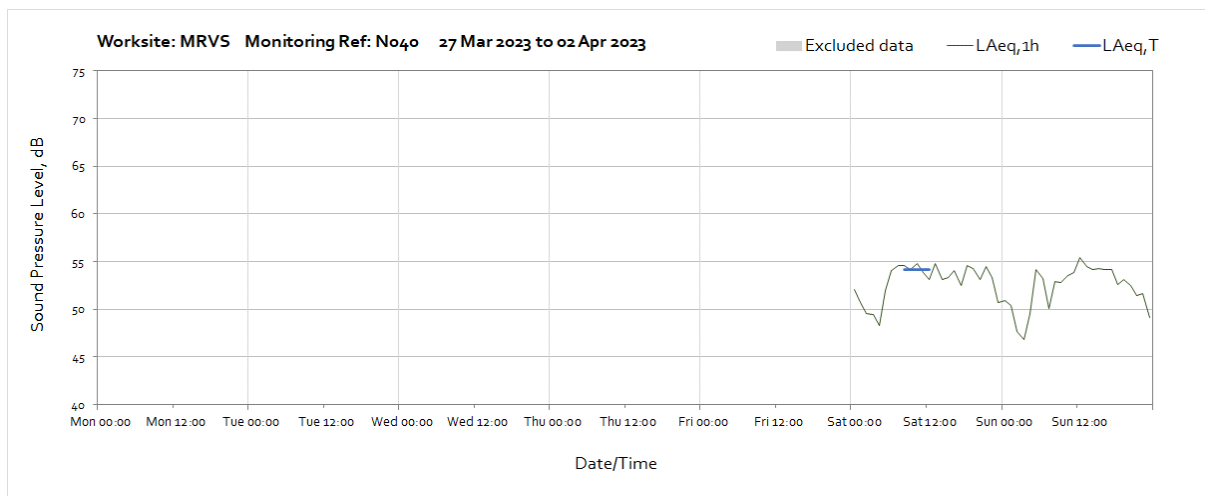
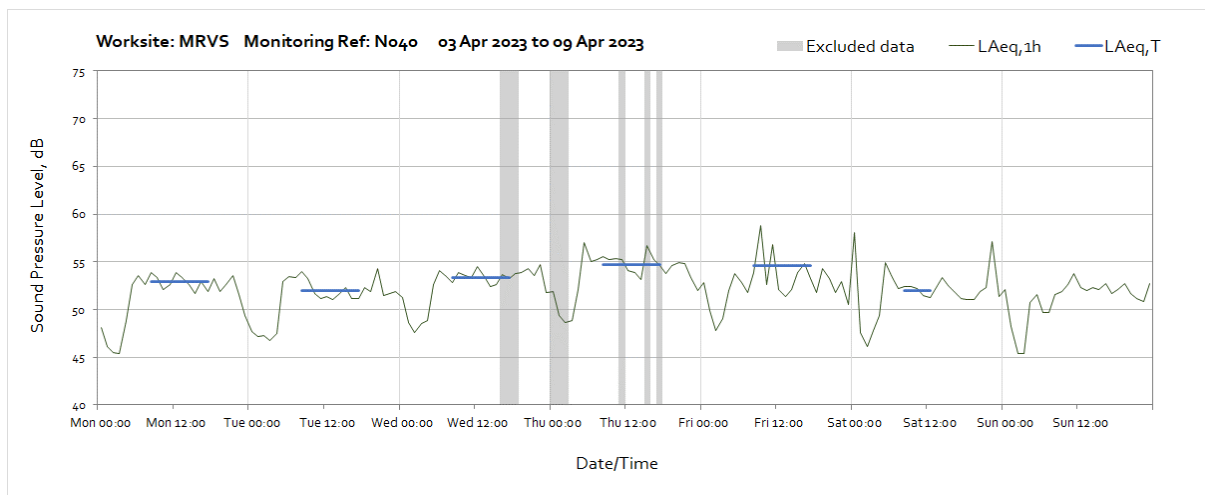
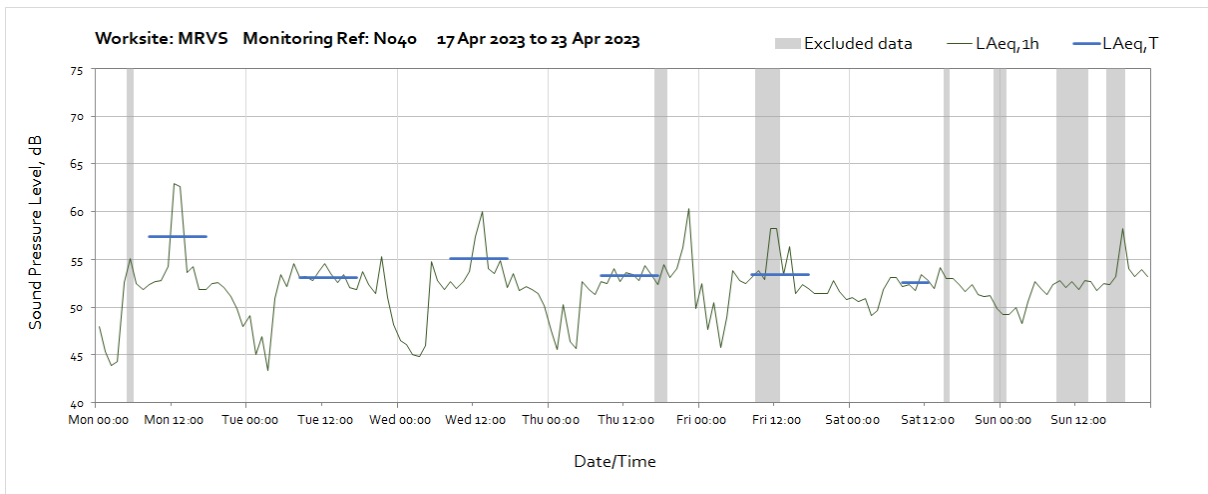
Worksite: MRVS – Monitoring Ref: N040

The following graphs show the hourly measured ambient noise level $L_{Aeq,1h}$ and, where relevant, the averaged noise level $L_{Aeq,T}$ values, where the time period T is as specified in Table 1 of HS2 Information Paper E23. Periods with adversely weather affected noise levels are greyed out and have been excluded from the calculation of the $L_{Aeq,T}$ values in Table 3 of the main report.

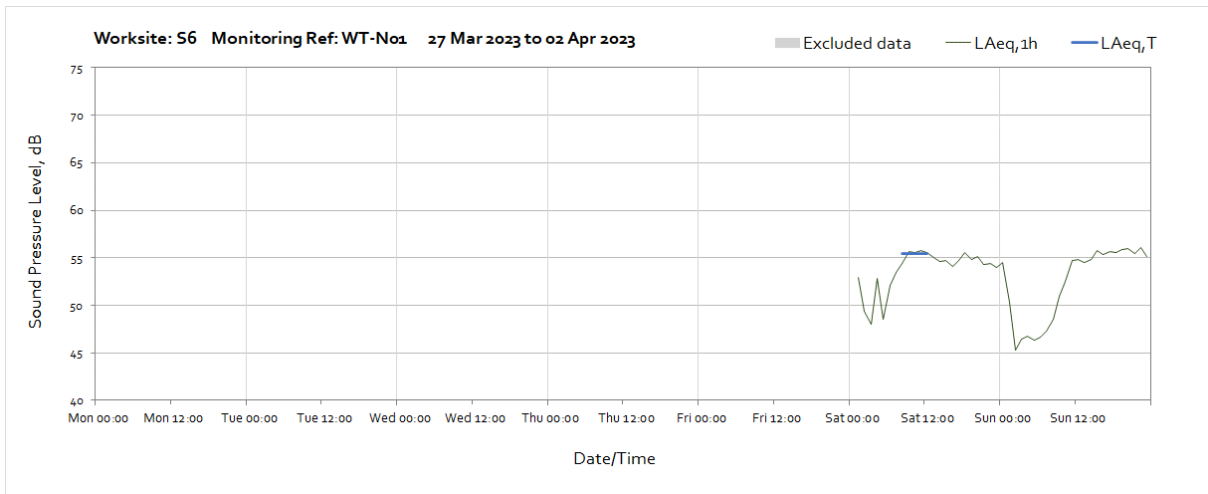
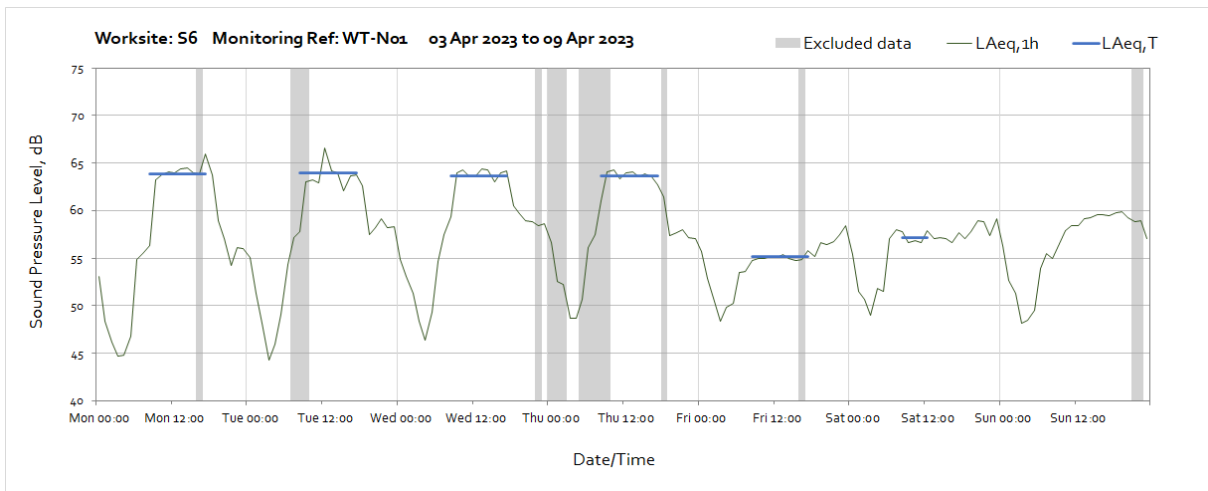
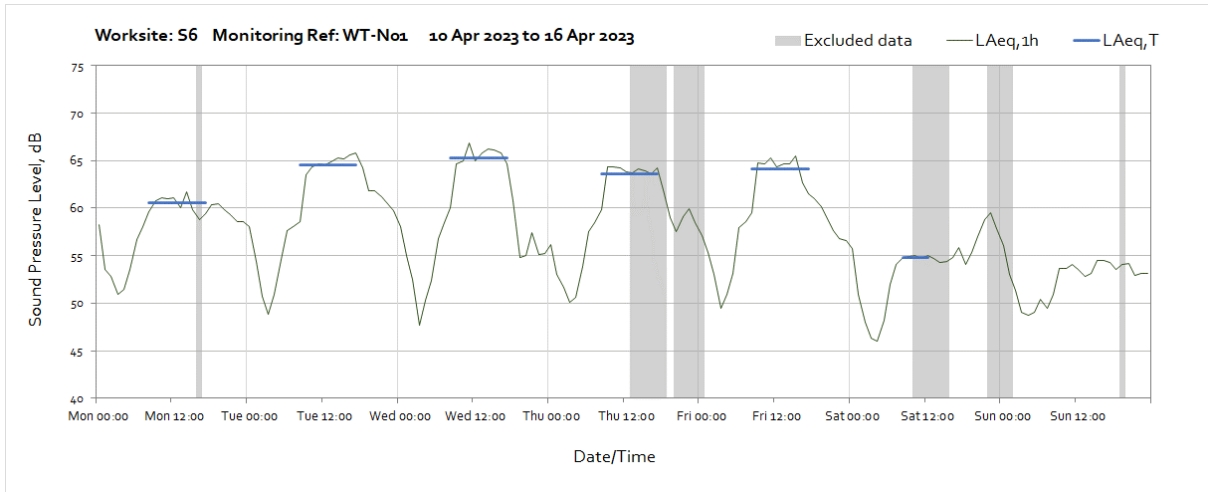
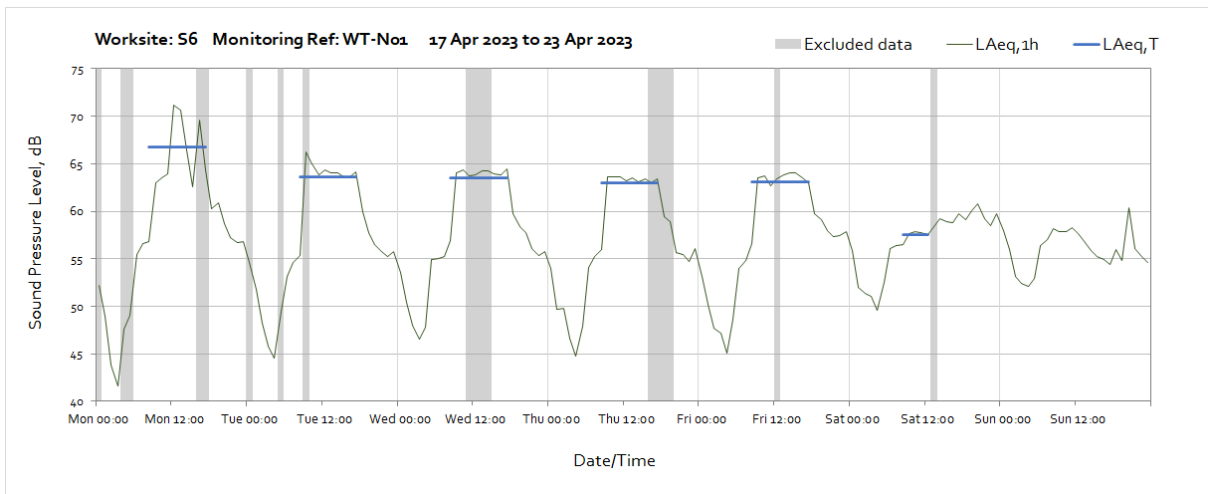
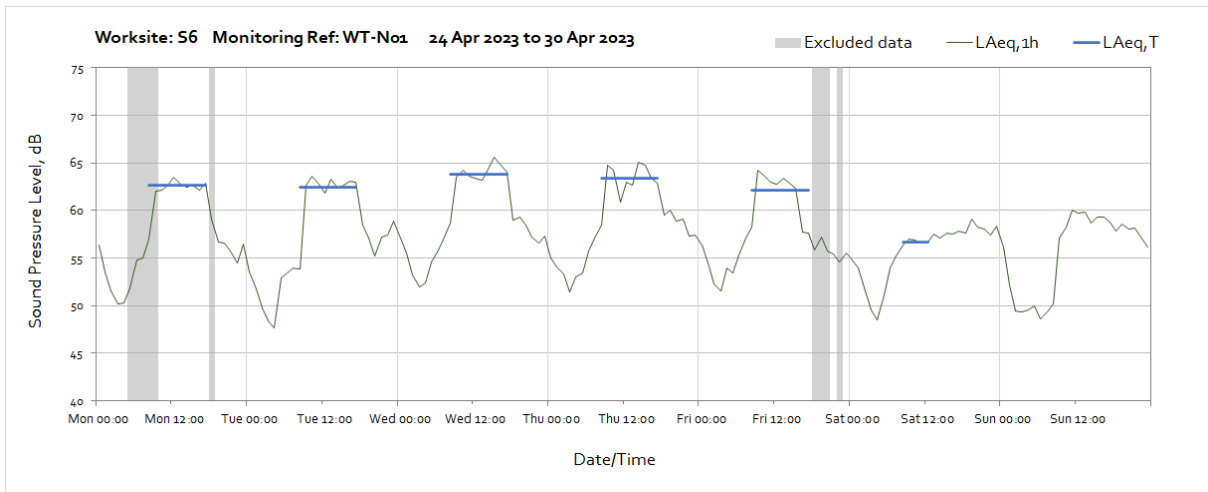
Worksite: S6 – Monitoring Ref: WT-N01

Note: Missing data between 00:00 and 01:00 on Saturday 1st April were due to an error at the monitoring station.

2.2.6 Seventeen (17) 24-hour periods that experienced an exceedance of the SOAEL were recorded due to HS2 construction works during April 2023. Exceedances occurred at noise monitor N058 during Sundays and noise monitor WT-N01 during night-time periods.

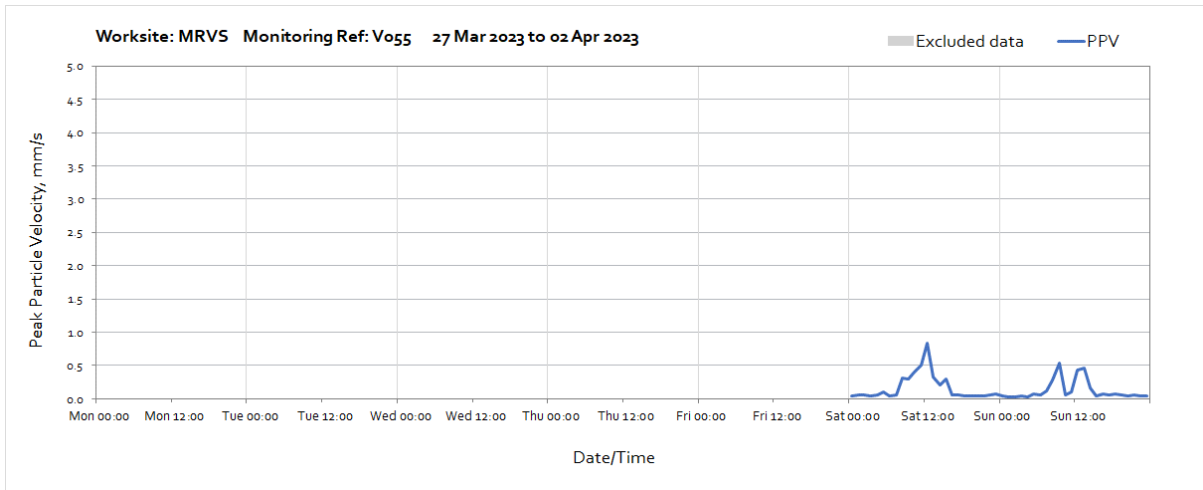
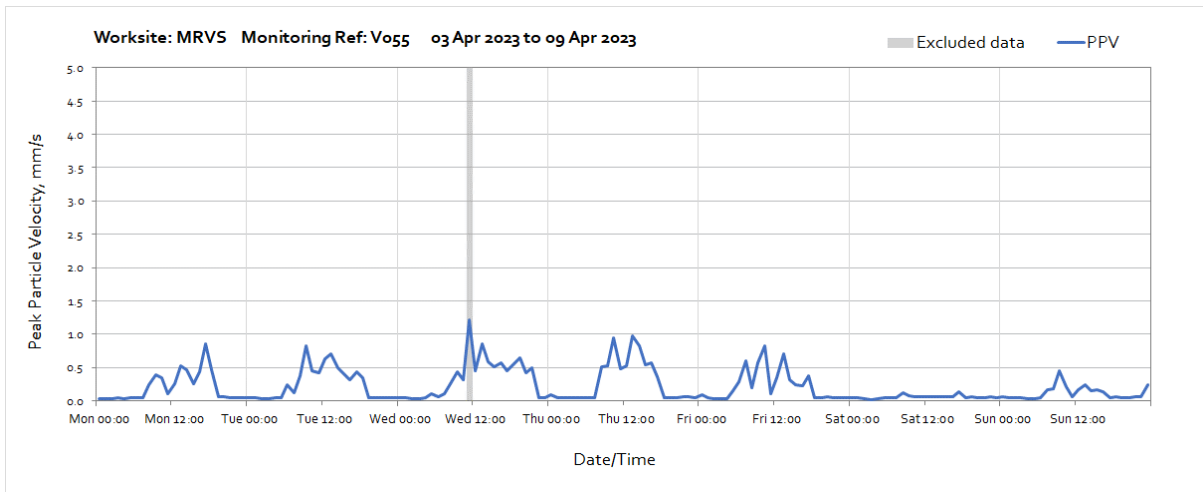
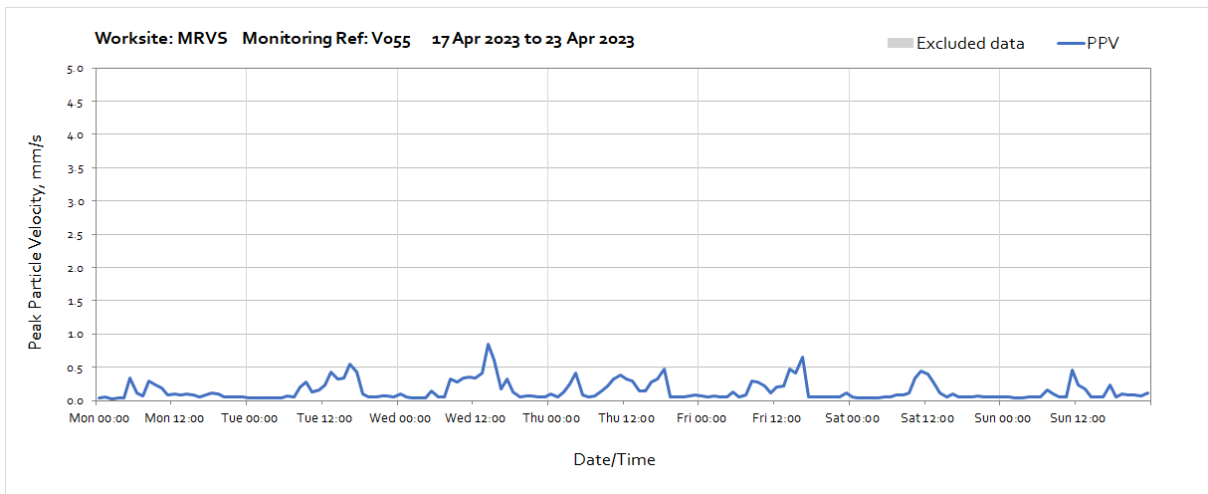
Worksite: MRVS – Monitoring Ref: V055

The following graphs show the hourly measured peak particle velocity PPV recorded during the monitoring period. The graphs show the highest PPV of the three orthogonal axis x, y and z. Where high values of PPV were caused by local interference with the vibration monitor, which are not representative of HS2 construction works, these values have been greyed out in the following charts and have been excluded to calculate values in Table 4 of the main report.
