Construction Noise and Vibration Monthly Report – April 2023

Lichfield District Council

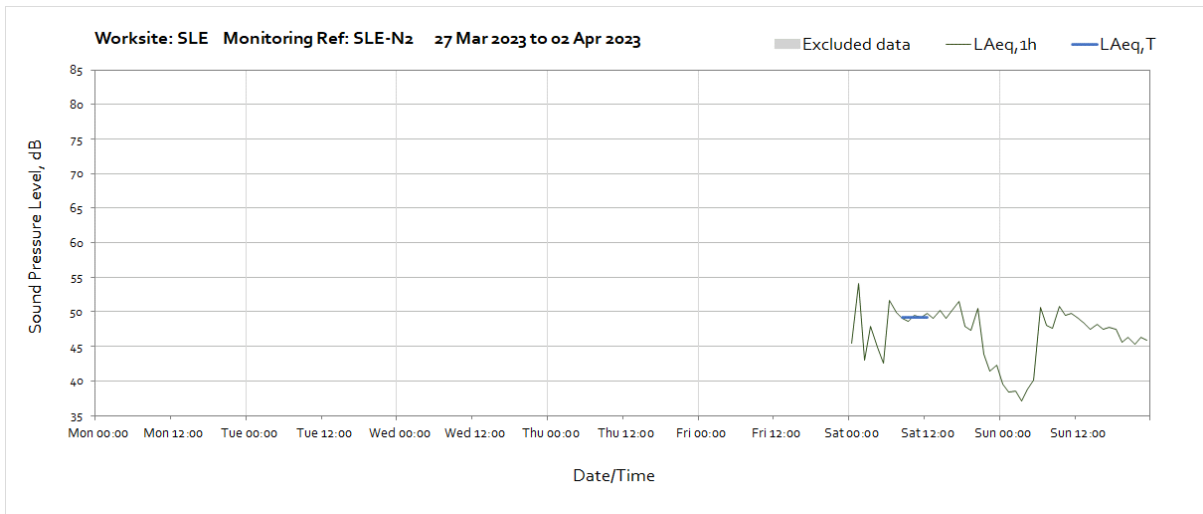
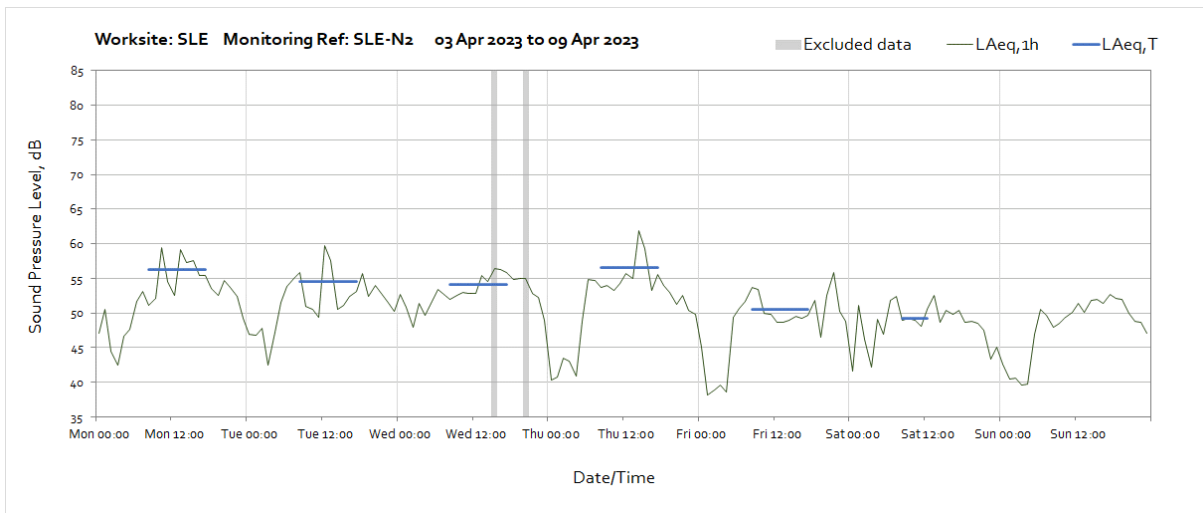
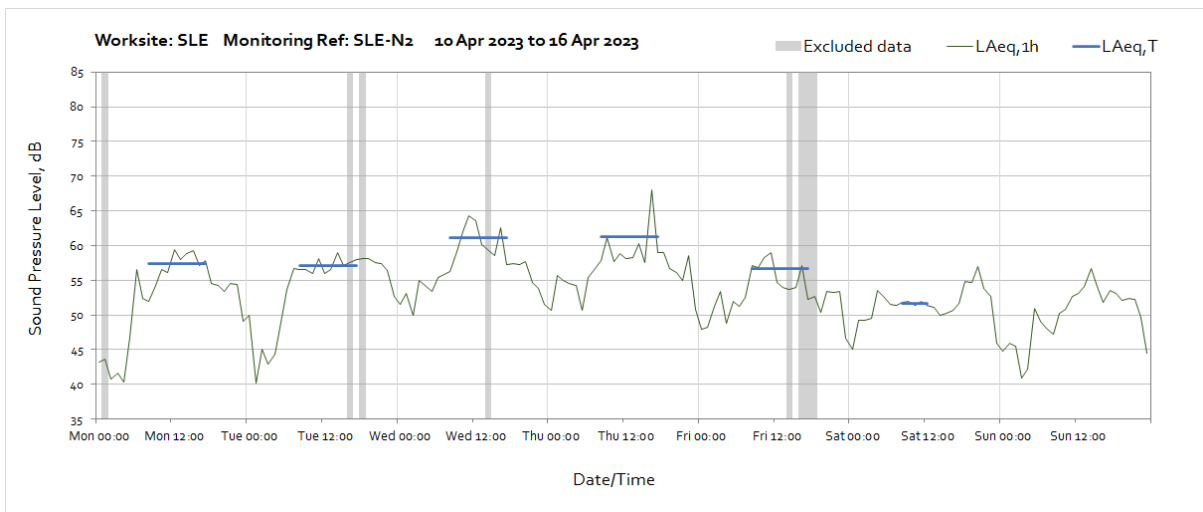
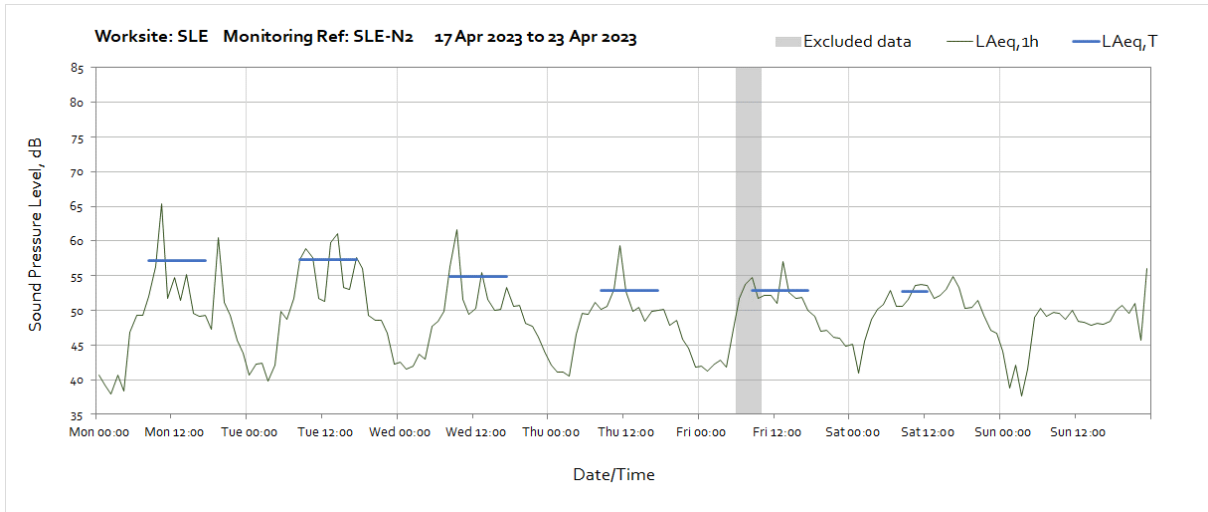
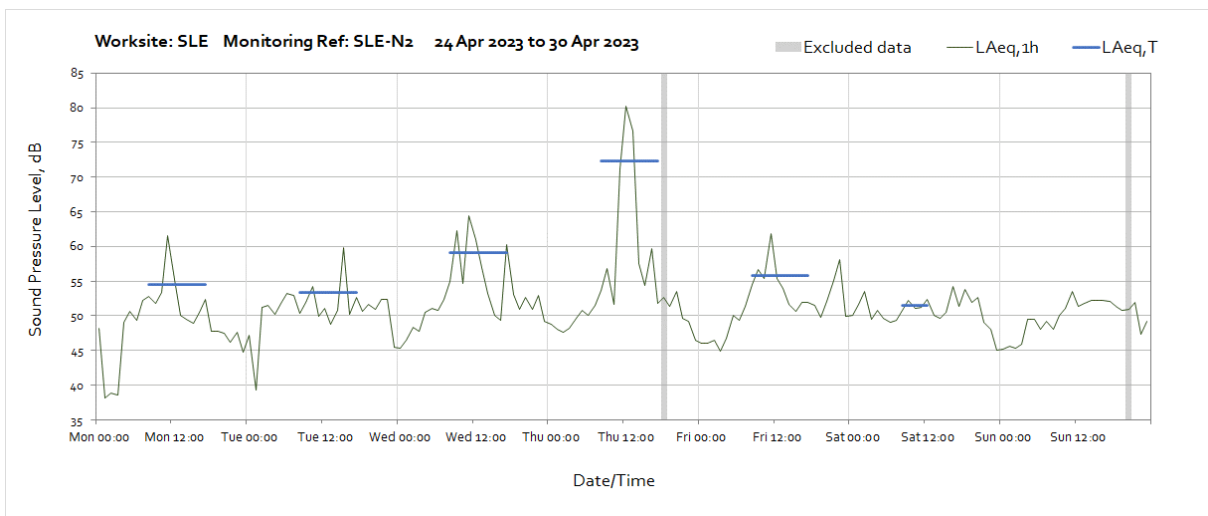
Worksite:SLE – Monitoring Ref: SLE-N2

The following graphs show the hourly measured ambient noise level $L_{Aeq,1h}$ and, where relevant, the averaged noise level $L_{Aeq,T}$ values, where the time period T is as specified in Table 1 of HS2 Information Paper E23. Periods with adversely weather affected noise levels are greyed out and have been excluded from the calculation of the $L_{Aeq,T}$ values in Table 3 of the main report.
