Construction Noise and Vibration Monthly Report – April 2023

North Warwickshire Borough Council

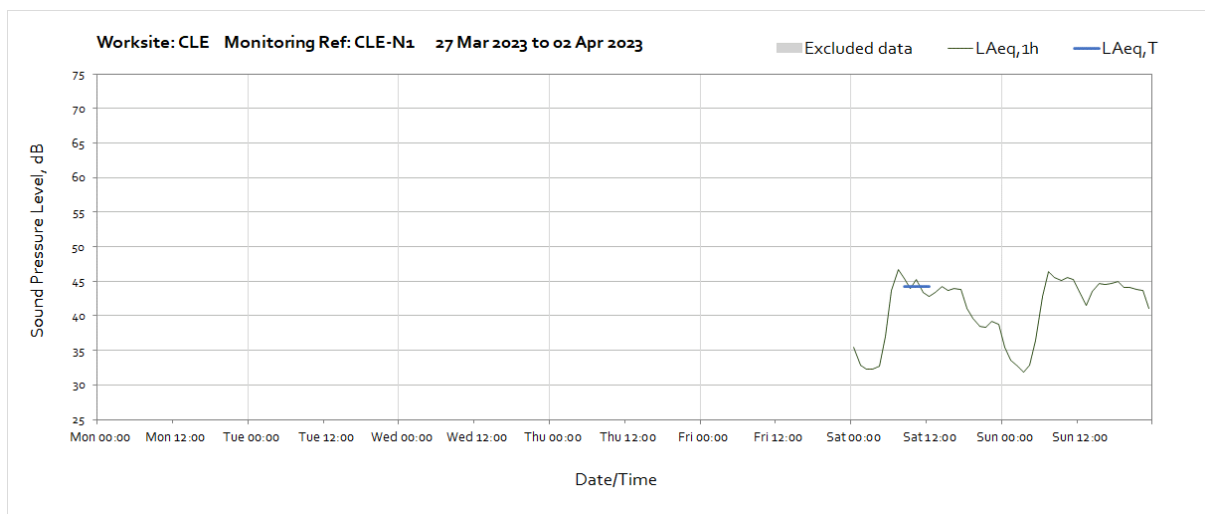
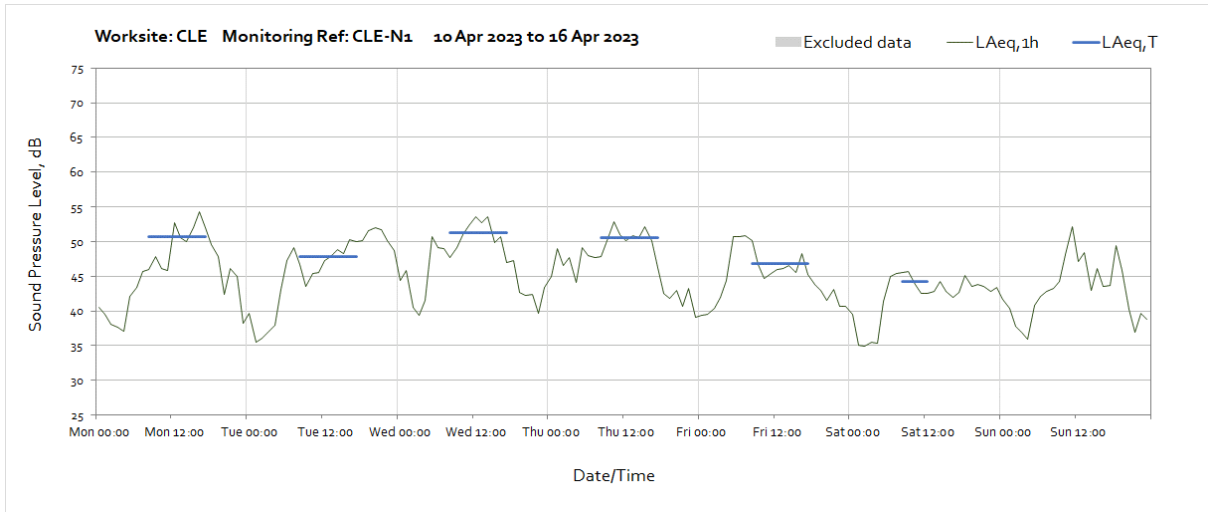
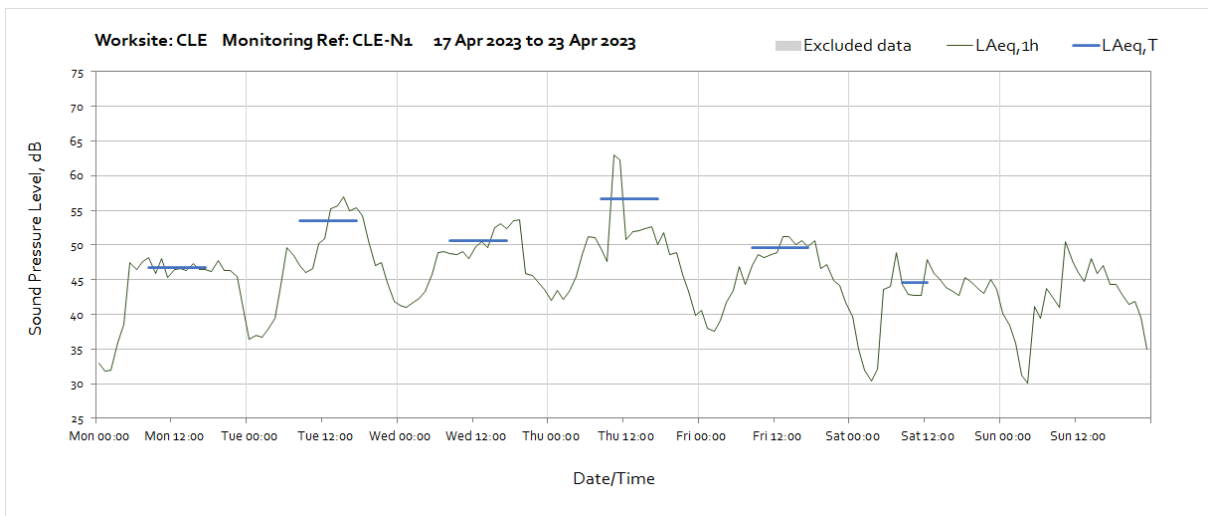
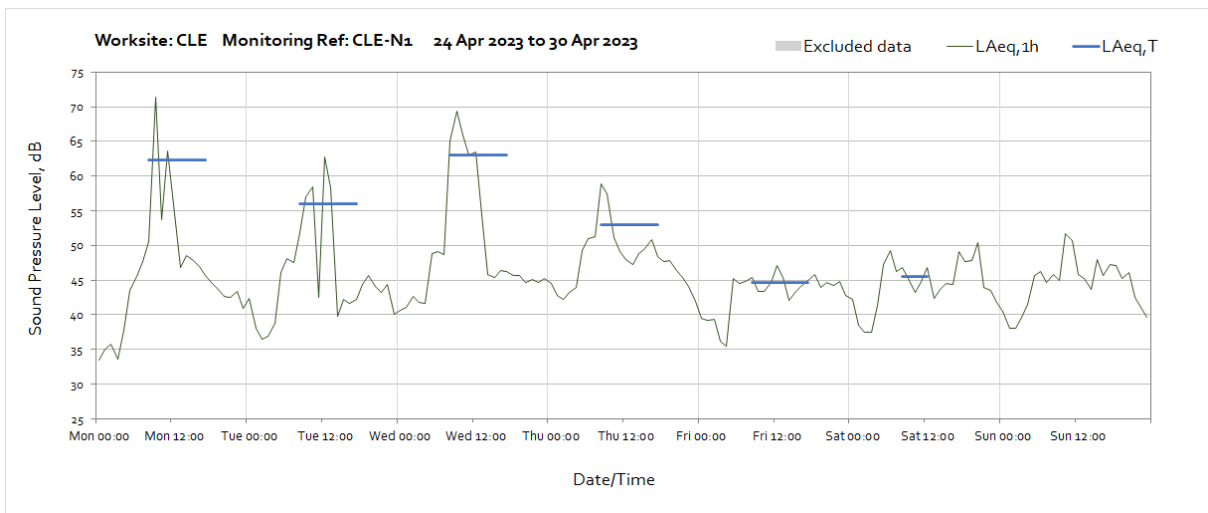
Worksite: CLE – Monitoring Ref: CLE-N1

The following graphs show the hourly measured ambient noise level $L_{Aeq,1h}$ and, where relevant, the averaged noise level $L_{Aeq,T}$ values, where the time period T is as specified in Table 1 of HS2 Information Paper E23. Periods with adversely weather affected noise levels are greyed out and have been excluded from the calculation of the $L_{Aeq,T}$ values in Table 3 of the main report.:

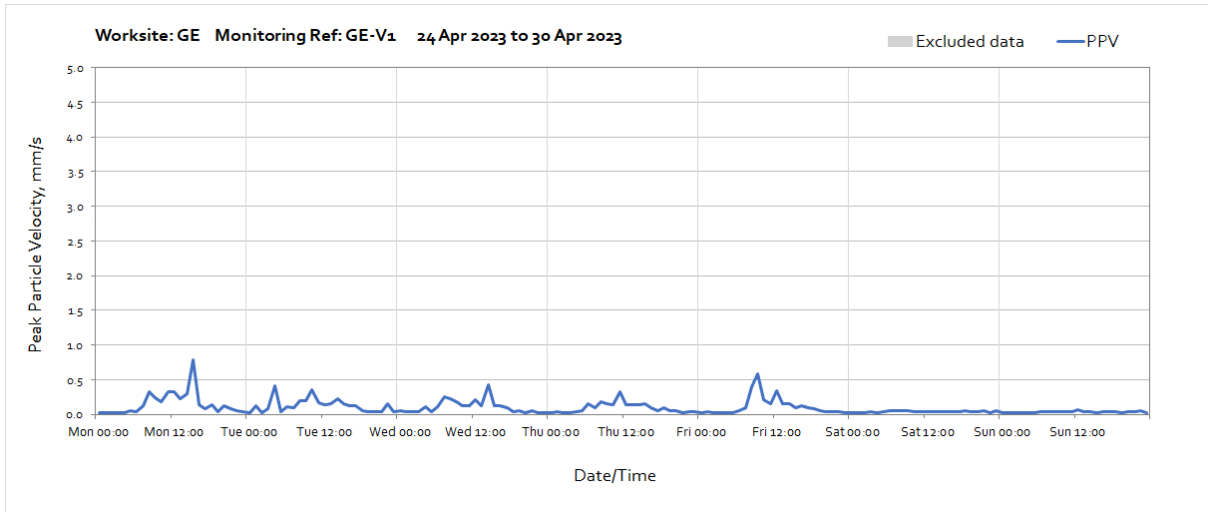
Worksite: GE - Monitoring Ref: GE-V1

Note: High vibration on 19th April at 12:00 is due to muck away of soil in close proximity to the cottage,.

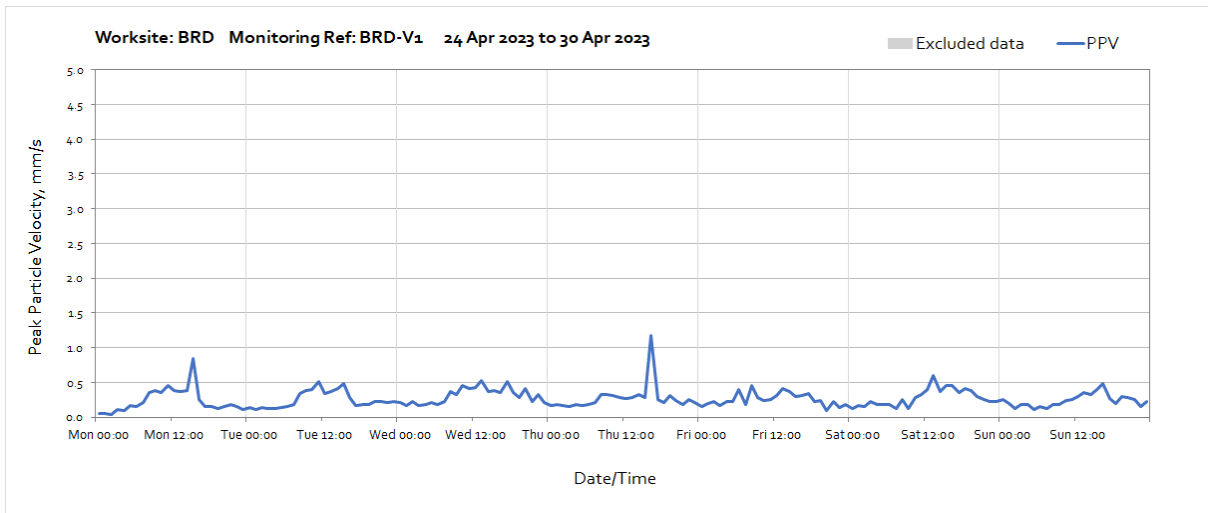
Worksite: BRD – Monitoring Ref: BRD-V1

Note: Missing data on 18th April between 10:00 and 16:00 due to meter configuration fault.
