Construction Noise and Vibration Monthly Report – April 2023

Stratford-on-Avon District Council

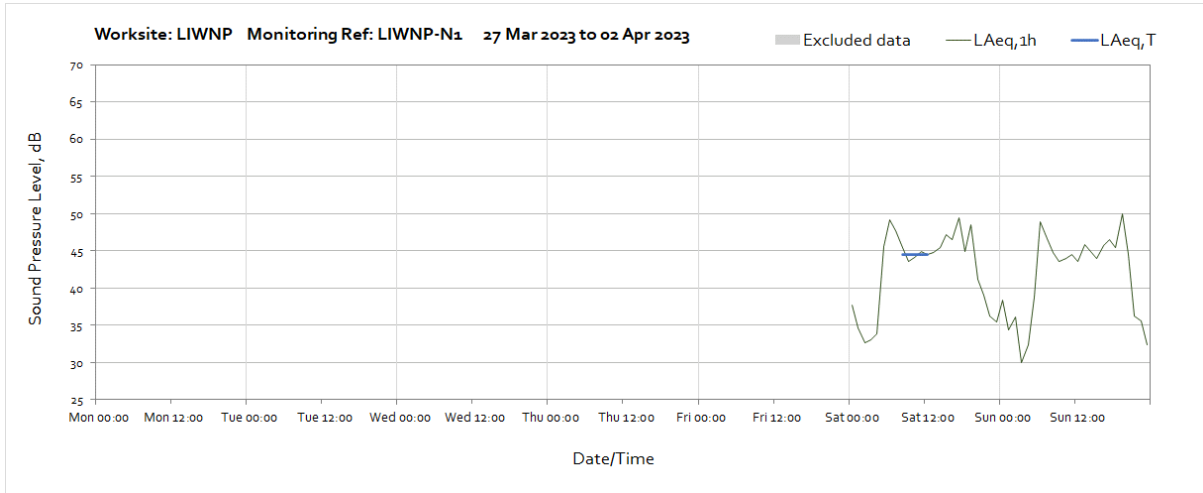
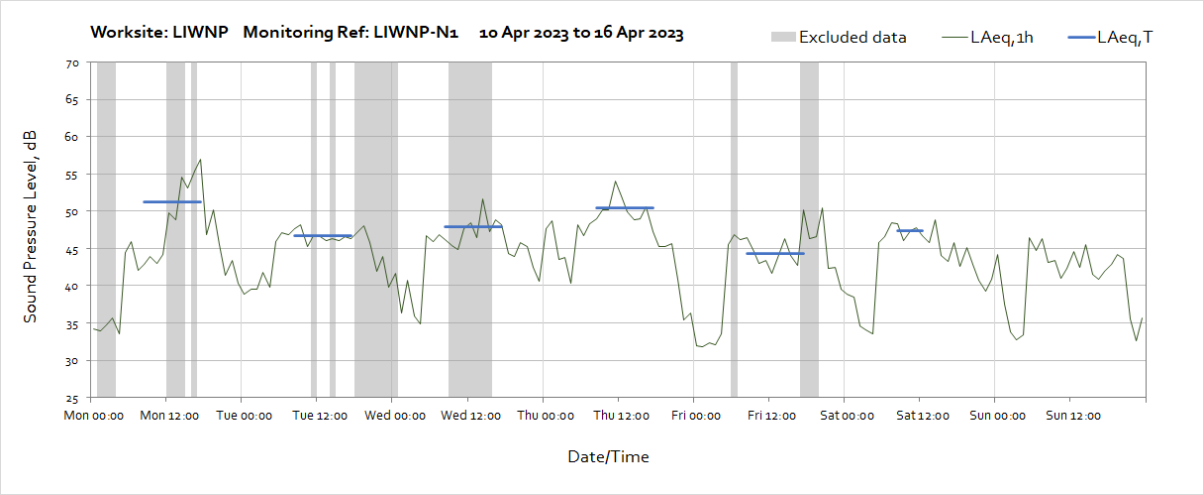
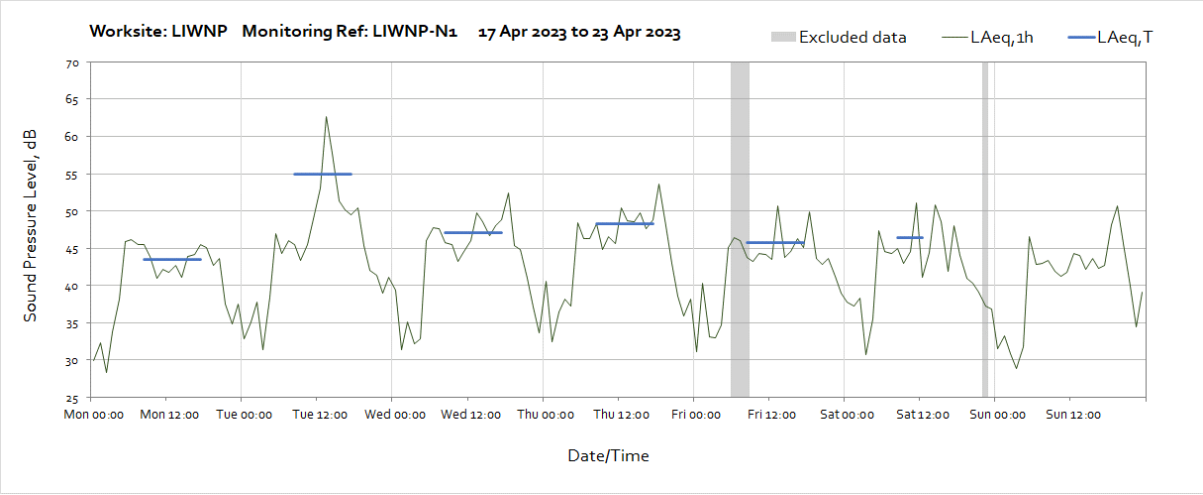
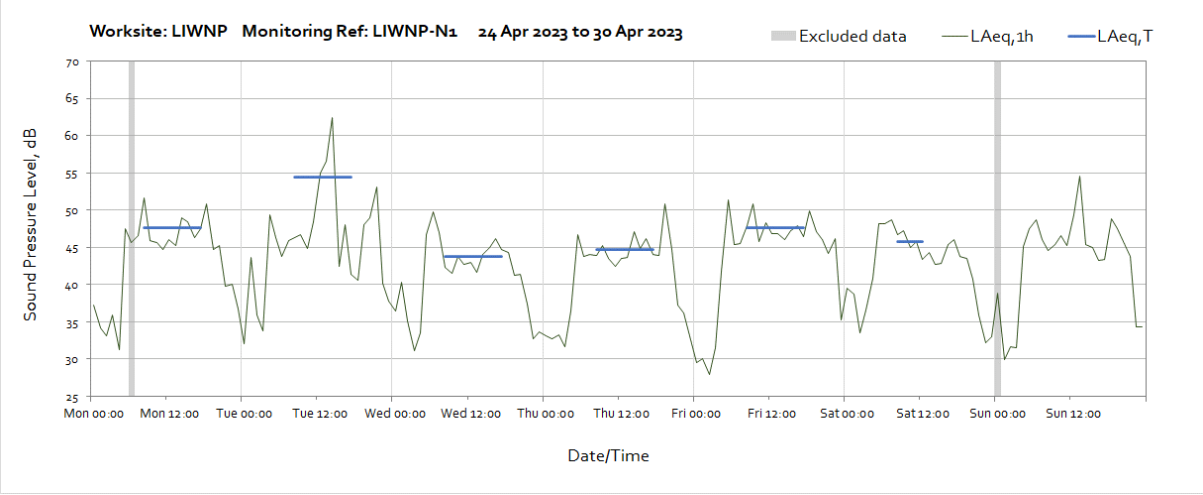
Worksite: LIWNP Monitoring Ref: LIWNP-N1

The following graphs show the hourly measured ambient noise level $L_{Aeq,1h}$ and, where relevant, the averaged noise level $L_{Aeq,T}$ values, where the time period T is as specified in Table 1 of HS2 Information Paper E23. Periods with adversely weather affected noise levels are greyed out and have been excluded from the calculation of the $L_{Aeq,T}$ values in Table 3 of the main report.

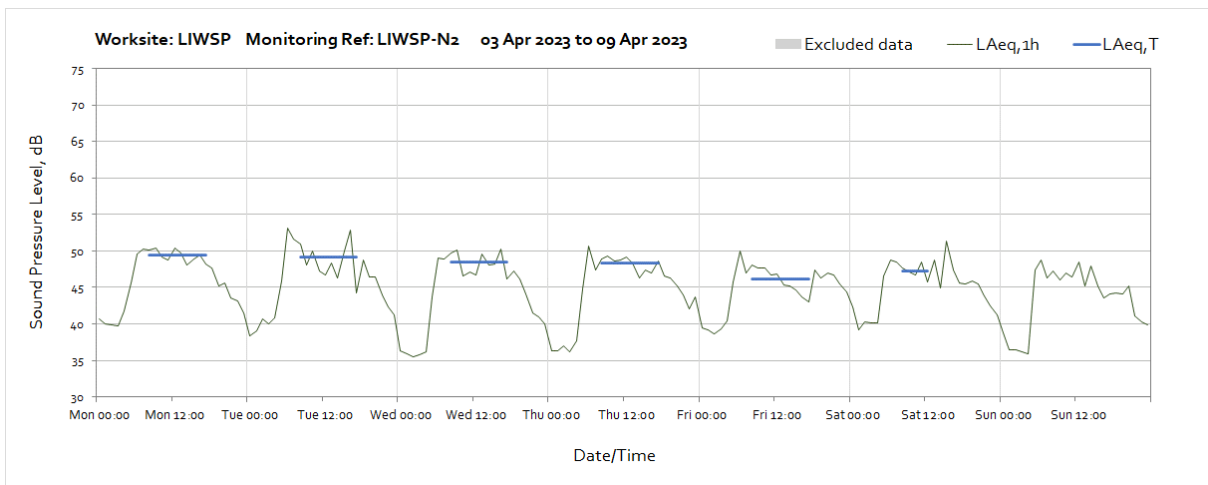
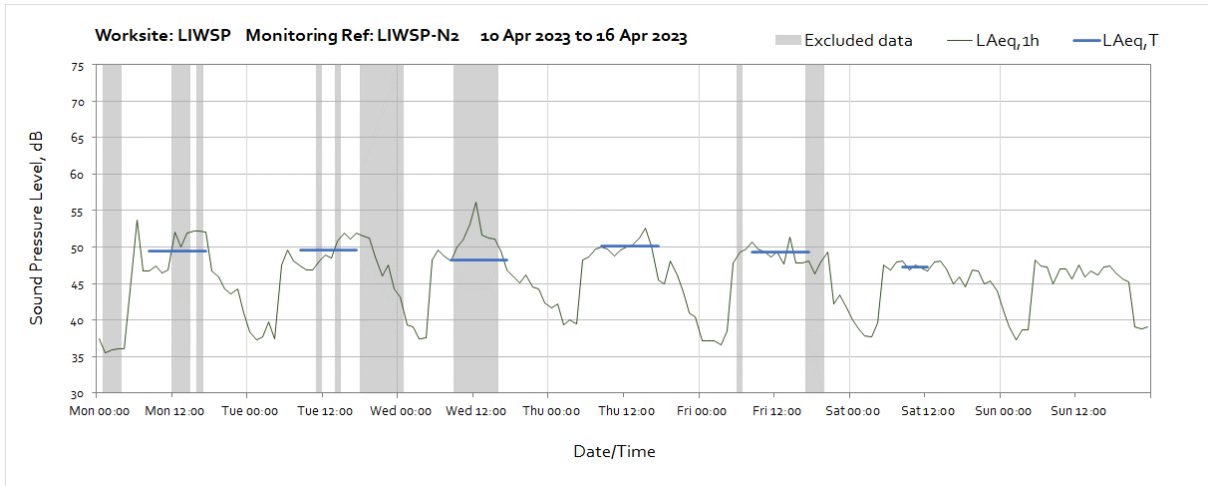
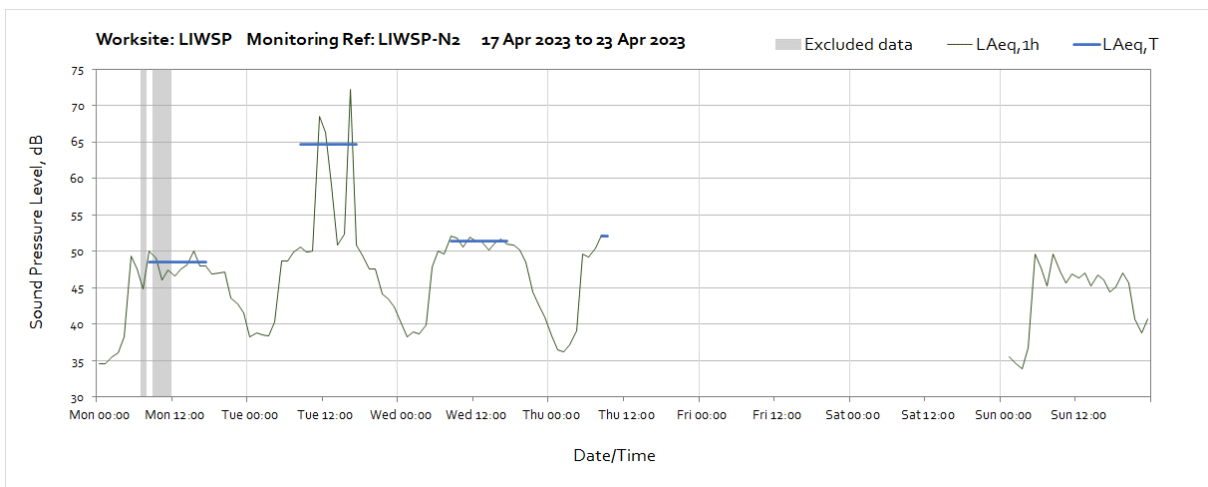
Worksite: LIWSP Monitoring Ref: LIWSP-N2

Note: Missing data between 20th Thursday and 23rd Sunday due to missing log information possibly due to end of life of micro-SD card.

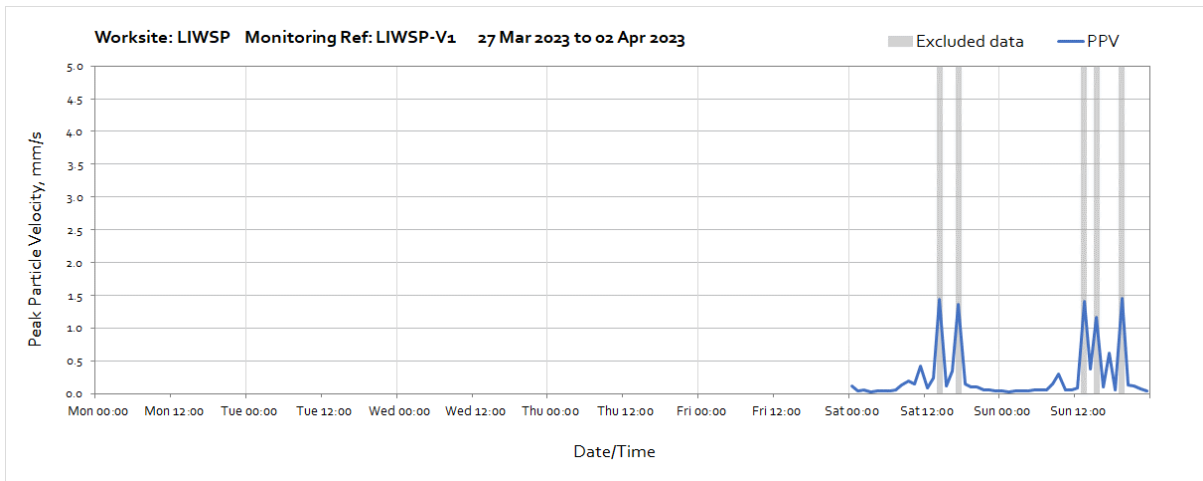
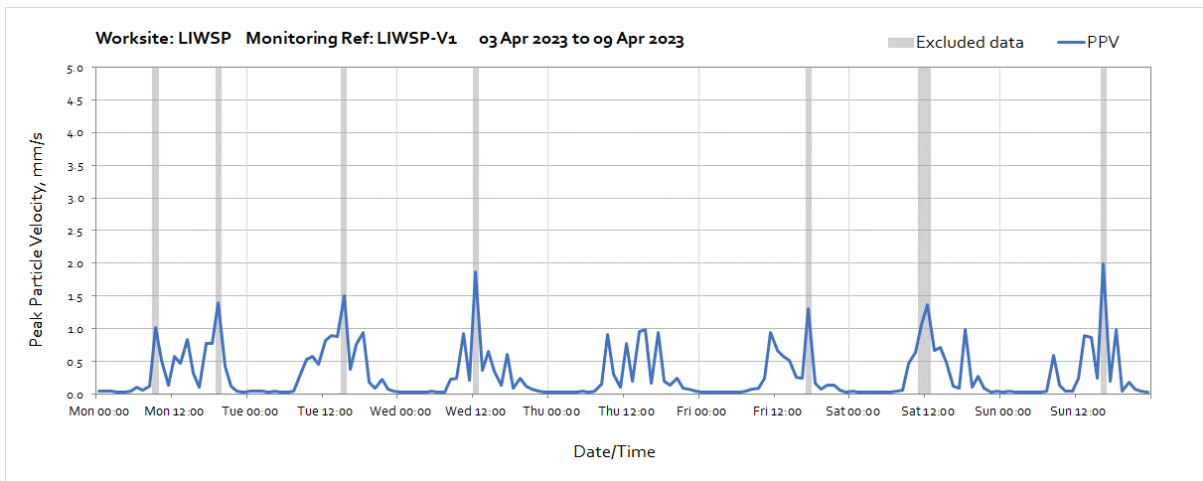
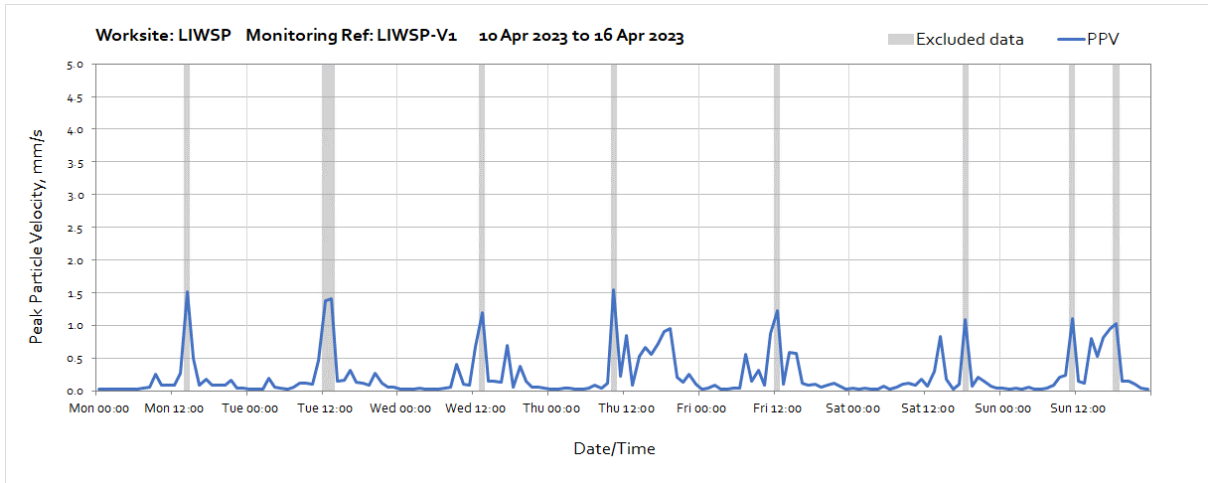
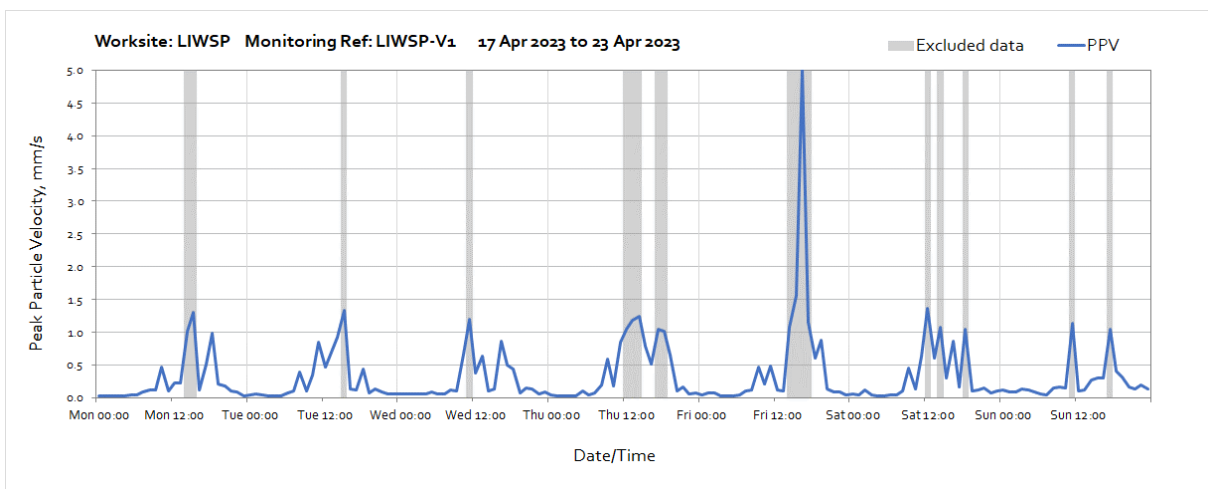
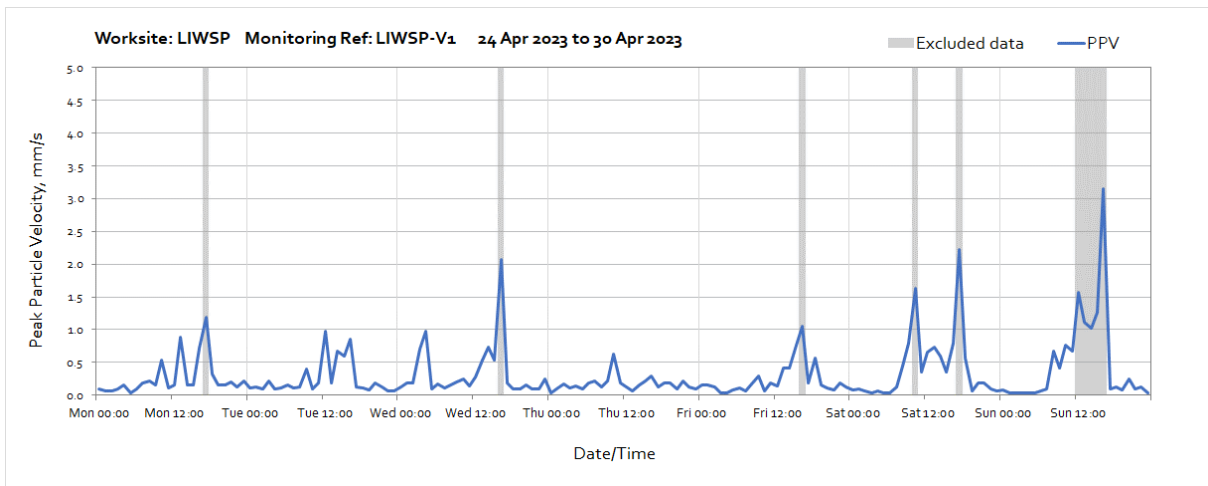
Worksite: LIWSP Monitoring Ref: LIWSP-V1

The following graphs show the hourly measured peak particle velocity PPV recorded during the monitoring period. The graphs show the highest PPV of the three orthogonal axes x, y and z. Where high values of PPV were caused by local interference with the vibration monitor, which are not representative of HS2 construction works, these values have been greyed out in the following charts and have been excluded to calculate values in Table 4 of the main report.

Worksite Reference	Measurement Reference	Monitor Address	Highest PPV measured in any axis, mm/s
LIWSP - Long Itchington Wood South Portal	LIWSP-V1	Woodside House, Bascote Heath, Southam	0.98 (Y-axis)
