| VEVOR Ultrasonic Cleaner | |
| Alert Number | 2203-0390 |
| Product Type | Electrical appliances and equipment – Ultrasonic Cleaner |

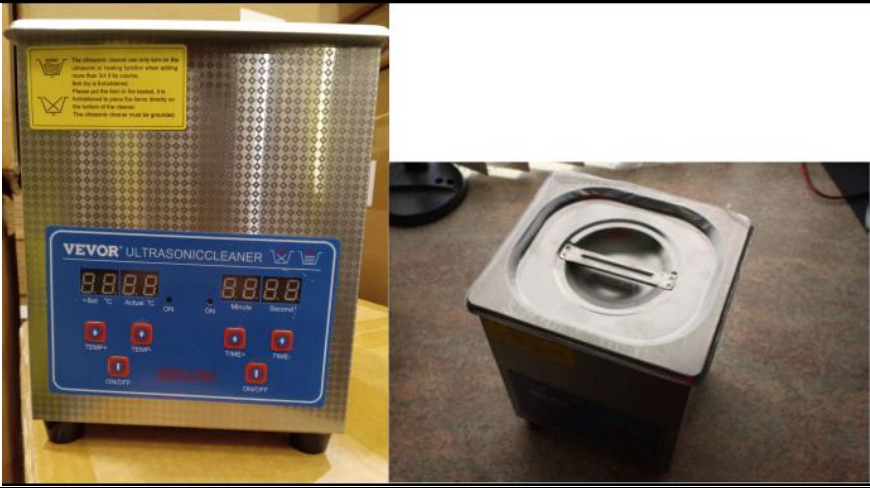
| VEVOR Ultrasonic Cleaner | |
|---|---|
| Images | |

| VEVOR Ultrasonic Cleaner | |
|---|---|
| Product Description | Silver rectangular unit with control panel on the front and a lid. |
| Risk Description | <p>The product presents a serious risk of electric shock as the appliance was inadequately earthed and was not adequately secured against accidental loosening, which may electrocute consumers. The plug on this sample failed to comply with BS1363-1 and the fuse had not been supplied with any granular filler. The filler is required to ensure the safe operation of the fuse under fault conditions.</p> <p>The product does not meet the requirements of the Electrical Equipment (Safety) Regulations 2016.</p> |

| VEVOR Ultrasonic Cleaner | |
|---|---|
| Corrective Measures | <p>The product has been recalled from end users. For further information, access the Vevor recall webpage at: https://uk.vevor.com/pages/Product-Recall-Statement</p> <p>The import has been rejected at the border and destroyed.</p> |
