Construction noise and vibration Monthly Report – May 2023

London Borough of Hillingdon

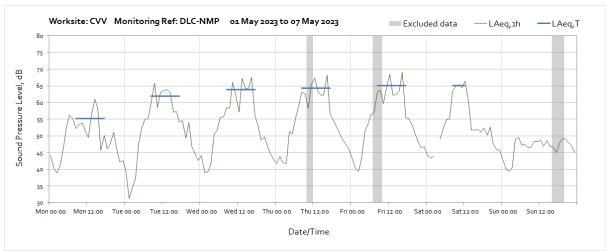
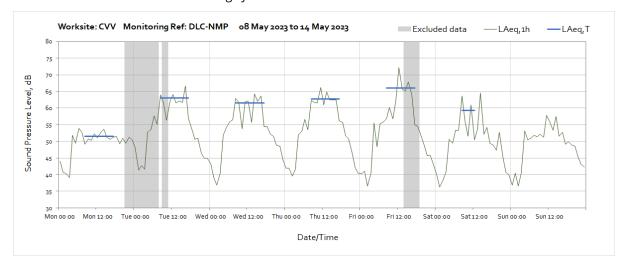
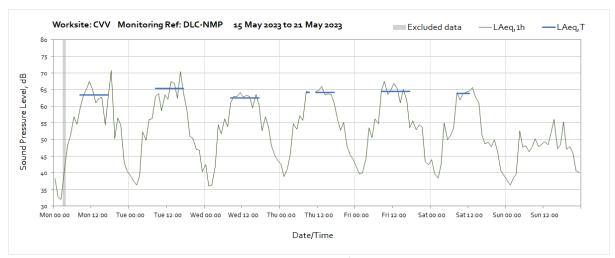
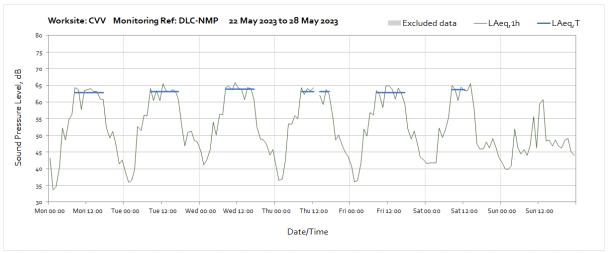
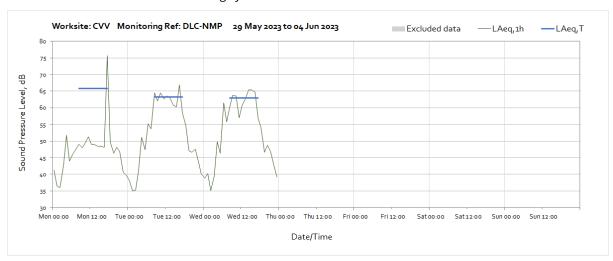
Worksite: CVV - Monitoring Ref: DLC-NMP

The following graphs show the hourly measured ambient noise level $L_{Aeq,1h}$ and, where relevant, the averaged noise level $L_{Aeq,T}$ values, where the time period T is as specified in Table 1 of HS2 Information Paper E23. Periods with adversely weather affected noise levels are greyed out and have been excluded from the calculation of the $L_{Aeq,T}$ values in Table 3 of the main report.

Note: Missing data between 03:00 and 04:00 on Saturday 6th May was due to a communication error between the server and the monitoring system.

Note: Missing data between 10:00 and 11:00 on Thursday 18th May was due to a communication error between the server and the monitoring system.

Note: Missing data between 13:00 and 14:00 on Thursday 25th May was due to a communication error between the server and the monitoring system.

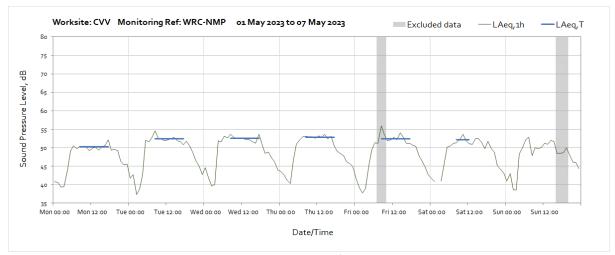
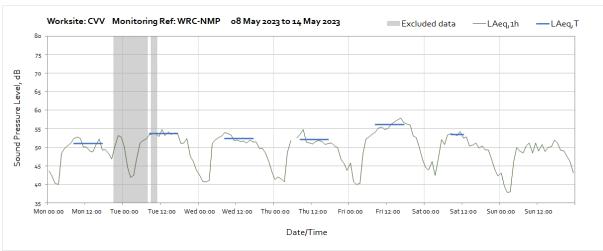
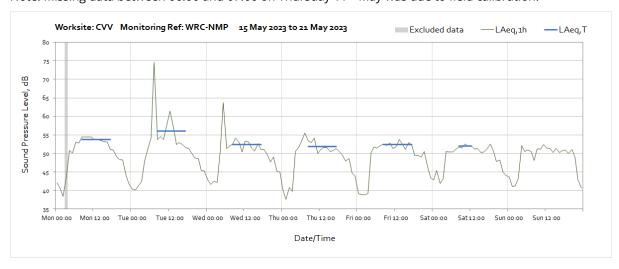
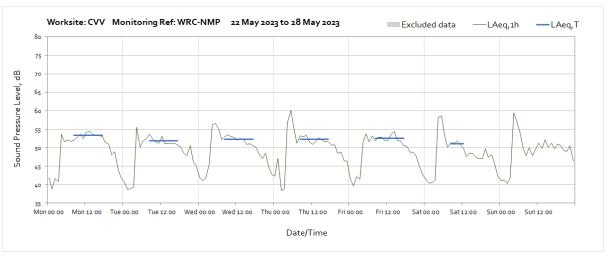
Worksite: CVV - Monitoring Ref: WRC-NMP

Note: Missing data between 02:00 and 03:00 on Saturday 6^{th} May was due to a communication error between the server and the monitoring system.

Note: Missing data between 06:00 and 07:00 on Thursday 11th May was due to field calibration.

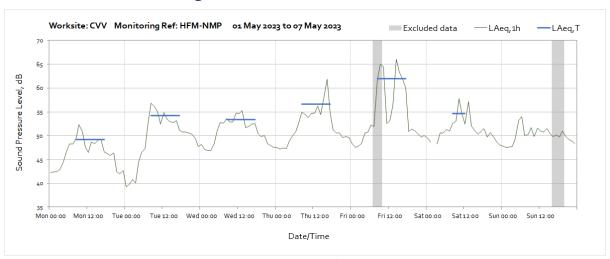
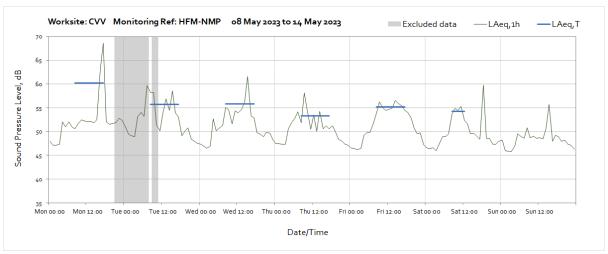
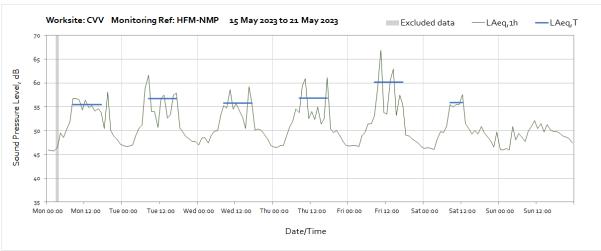
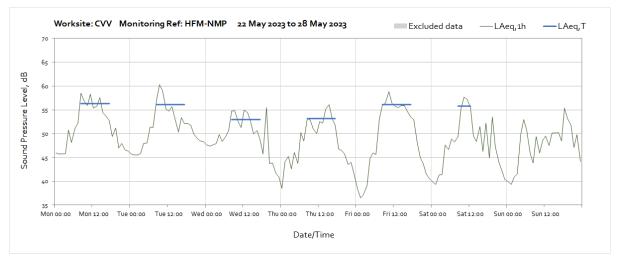
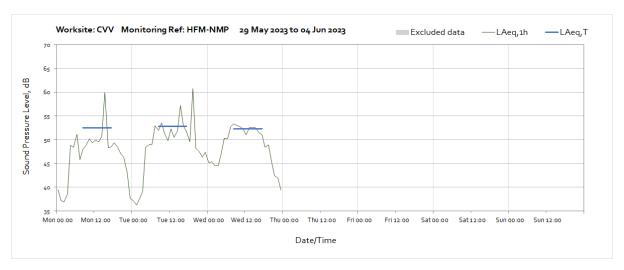
Worksite: CVV - Monitoring Ref: HFM-NMP

Note: Missing data between 02:00 and 03:00 on Saturday 6^{th} May was due to a communication error between the server and the monitoring system.

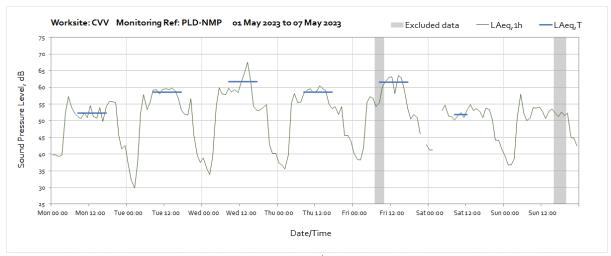
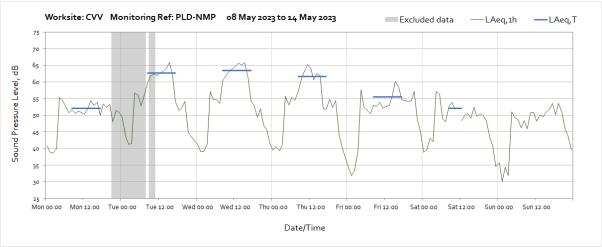
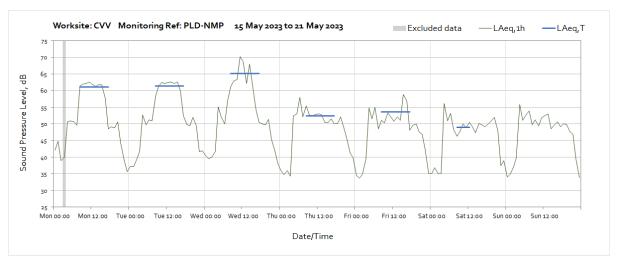
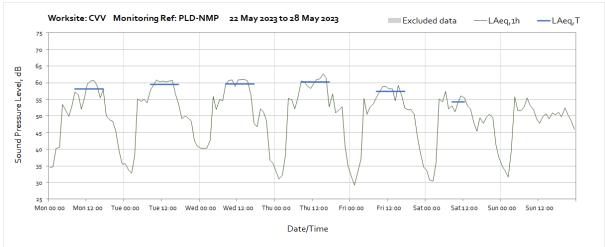
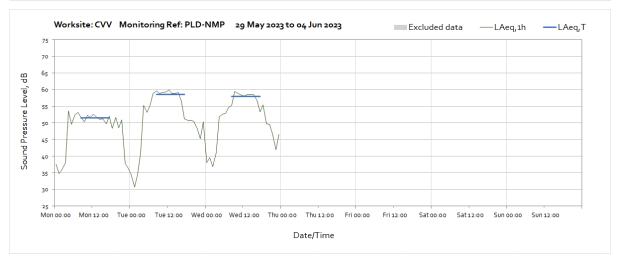
Worksite: CVV - Monitoring Ref: PLD-NMP

Note: Missing data between 22:00 and 23:00 on Friday 5th May and between 02:00 and 04:00 on Saturday 6th May was due to a communication error between the server and the monitoring system.

Note: Missing data between 11:00 and 12:00 on Saturday 13th May was due to a communication error between the server and the monitoring system.

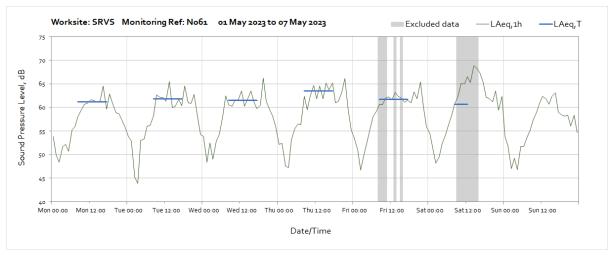
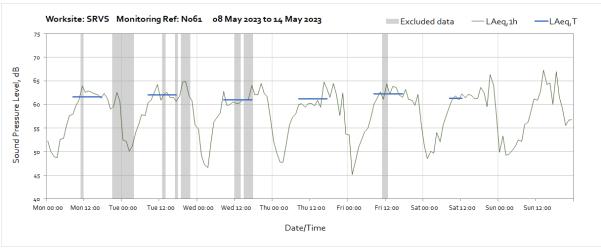
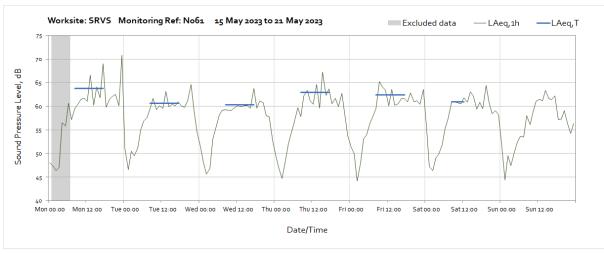
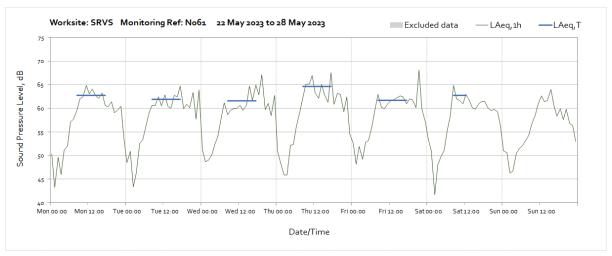
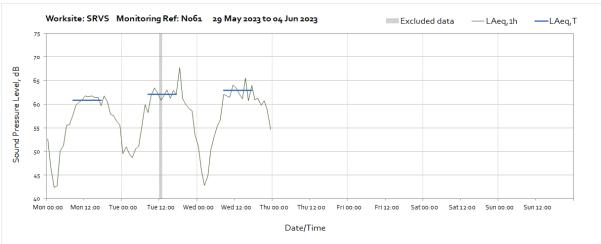
Worksite: SRVS - Monitoring Ref: N061

2.1.3 Appendix C presents graphs of the noise and vibration monitoring data over the month for each of the measurement locations. Noise data presented consists of the hourly L_{Aeq} values and, where relevant, the L_{Aeq,T} values (where the time period T has been taken to be the averaging period as specified in Table 1 of HS2 Information Paper E23). Vibration data presented consist of hourly PPV values. The full data set for the monitoring equipment can be found at the following location: https://data.gov.uk/dataset/24542ae7-dd44-444f-b259-871c4cc43b5e/environmental-monitoring-data.

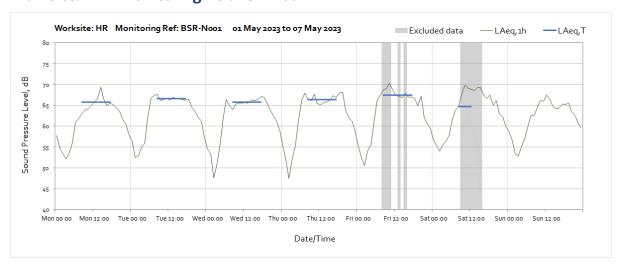
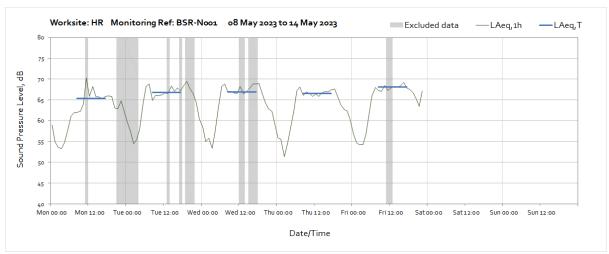
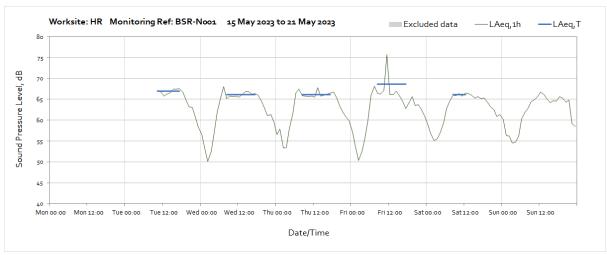
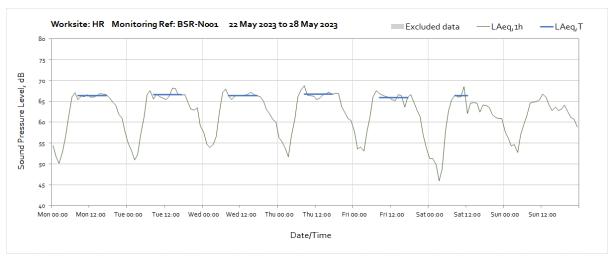
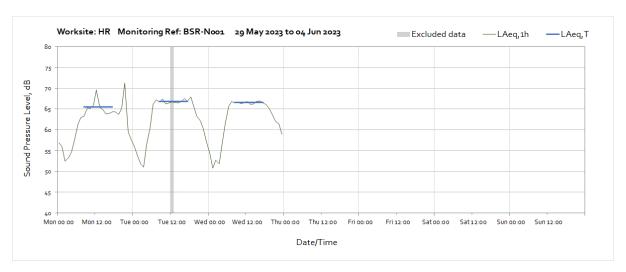
Worksite: HR - Monitoring Ref: BSR-N001

Note: Missing data between 23:00 on Friday 12th May and 10:00 on Tuesday 16th May was due to monitor power loss from insufficient solar power.

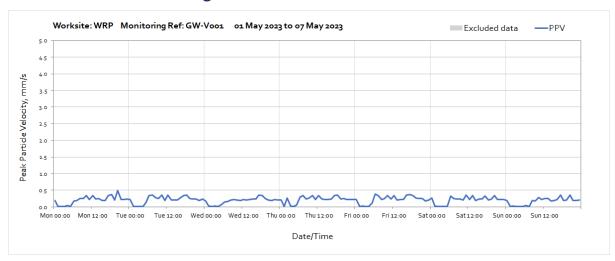
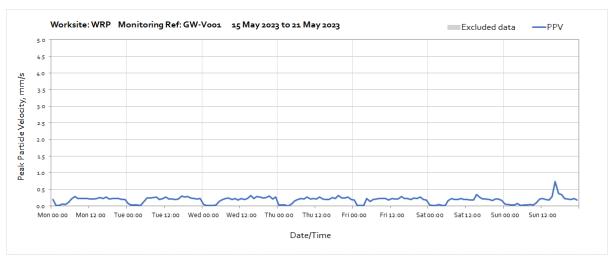
Worksite: WRP - Monitoring Ref: GW-V001

The following graphs show the hourly measured peak particle velocity PPV recorded during the monitoring period. The graphs show the highest PPV of the three orthogonal axis x, y and z. Where high values of PPV were caused by local interference with the vibration monitor, which are not representative of HS2 construction works, these values have been greyed out in the following charts and have been excluded to calculate values in Table 4 of the main report.
