Construction Noise and Vibration Monthly Report – May 2023

Solihull Metropolitan Borough Council

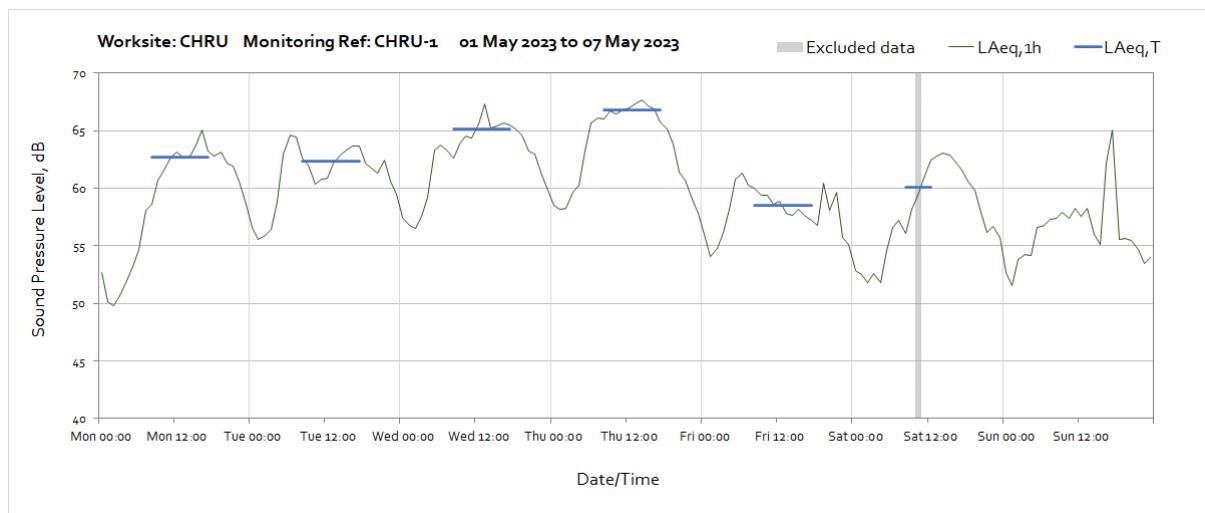
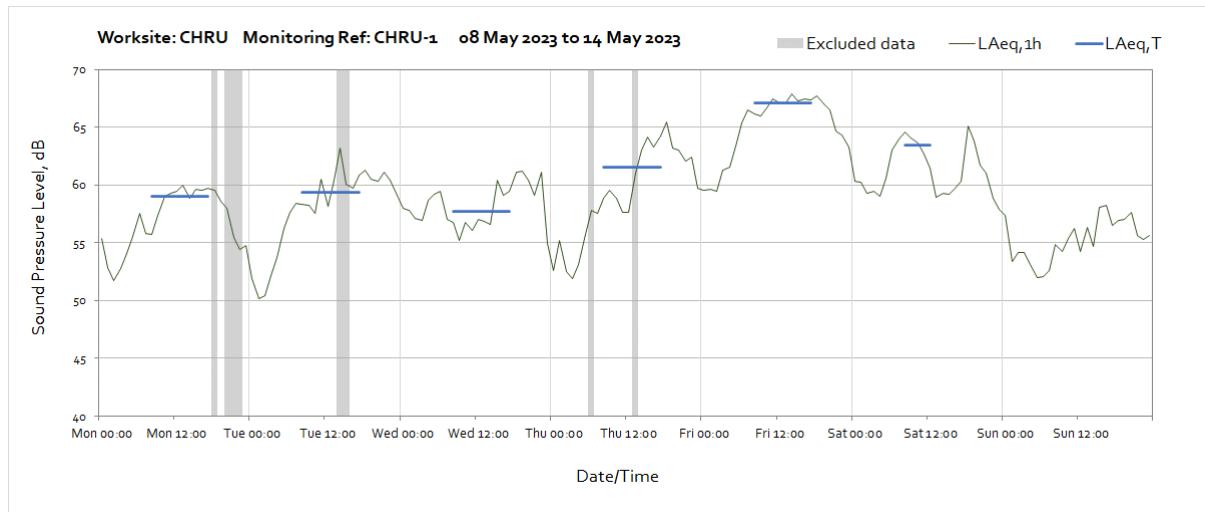
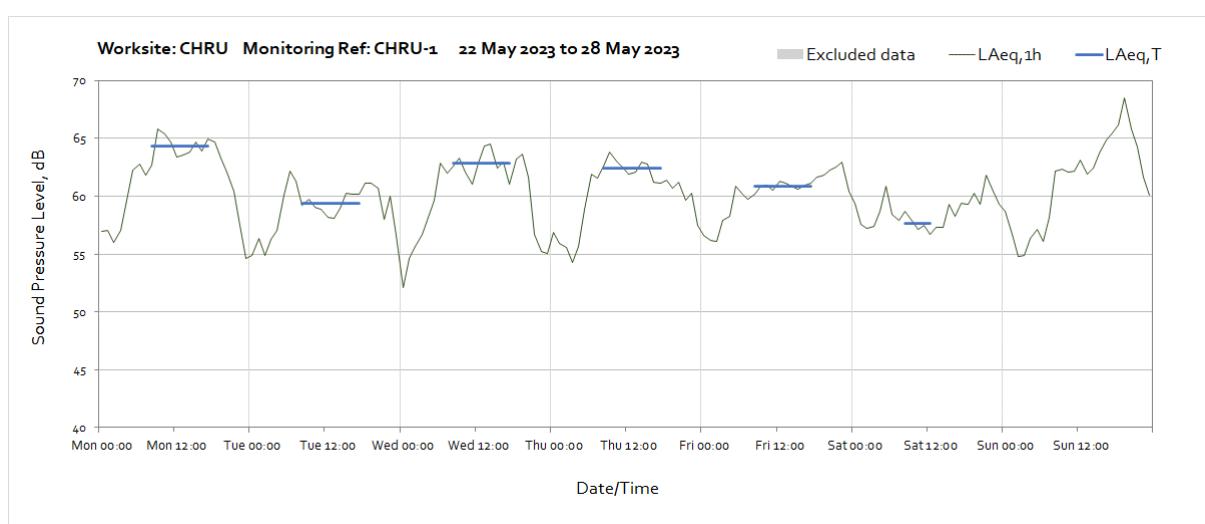
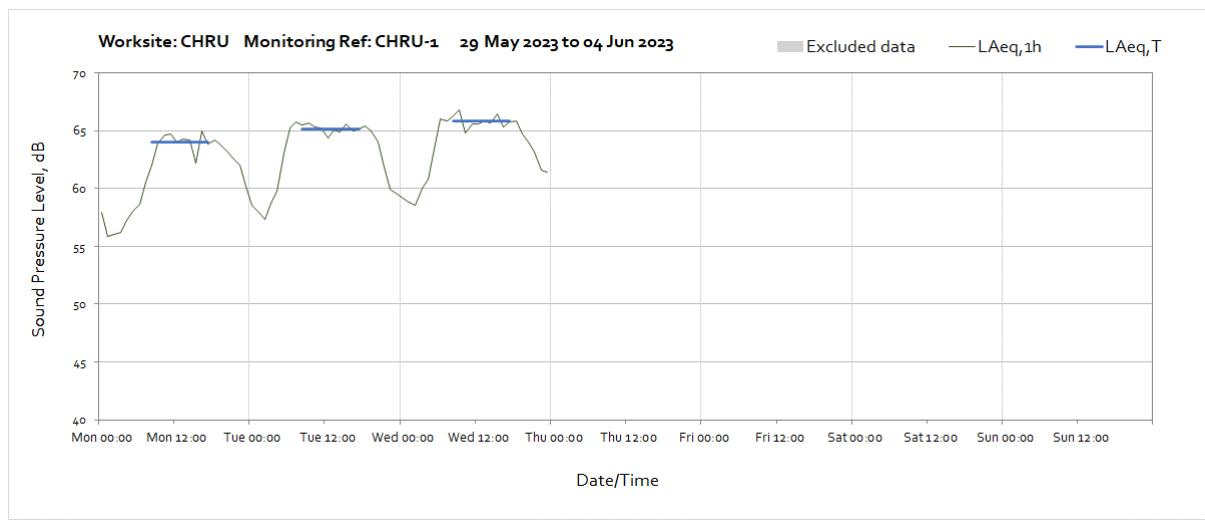
Worksite: CHR - Monitoring Ref: CHRU-1

The following graphs show the hourly measured ambient noise level $L_{Aeq,1h}$ and, where relevant, the averaged noise level $L_{Aeq,T}$ values, where the time period T is as specified in Table 1 of HS2 Information Paper E23. Periods with adversely weather affected noise levels are greyed out and have been excluded from the calculation of the $L_{Aeq,T}$ values in Table 3 of the main report.

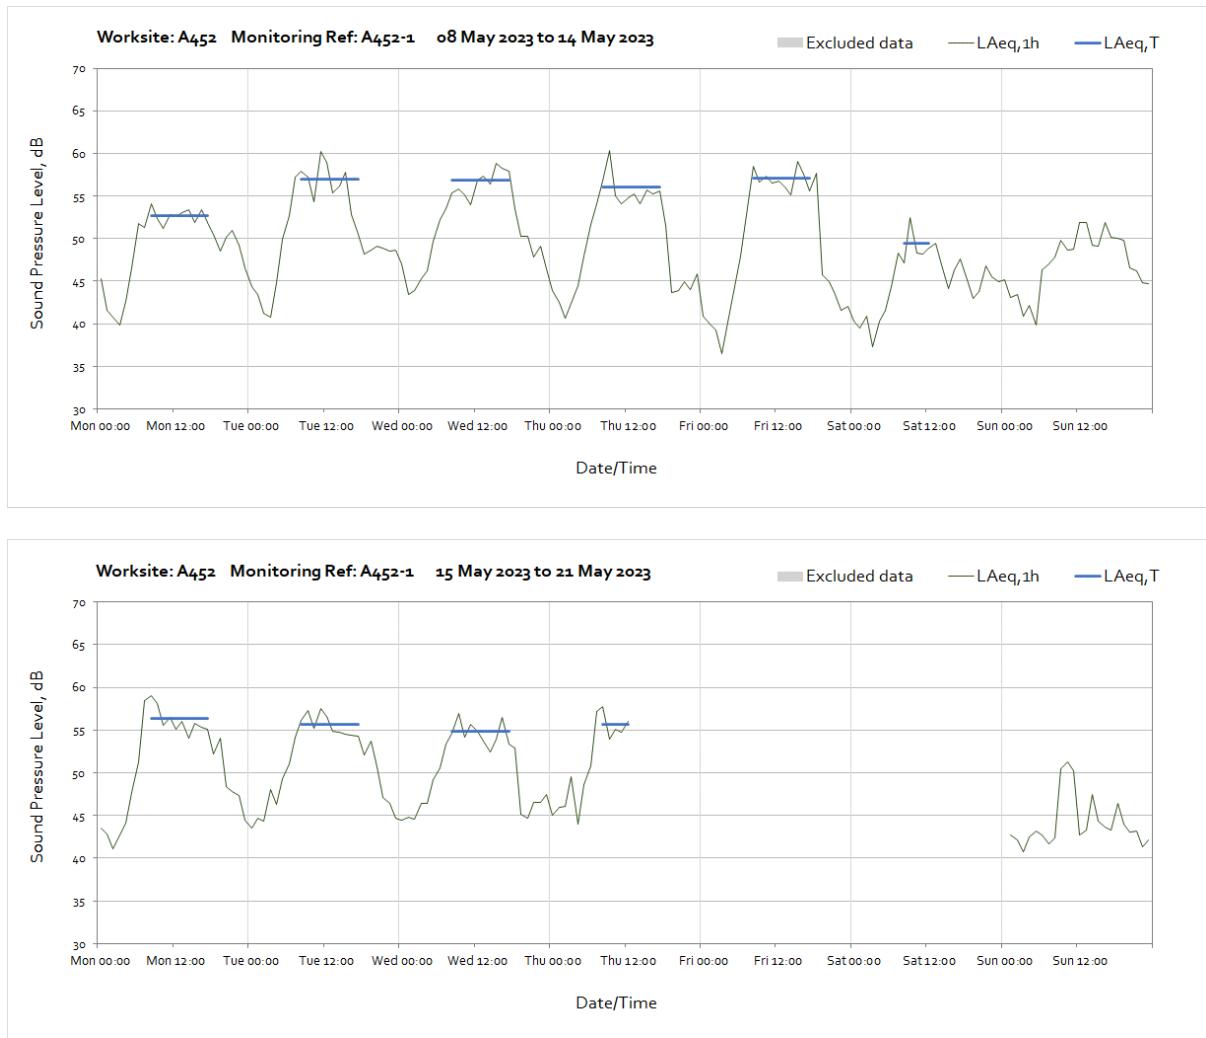
Worksite: A452 Compound – Monitoring Ref: A452-1

Note: Missing data between 13:00 on Thursday 18th May and 01:00 on Sunday 21st May was due to malfunction of memory card of the noise monitor.

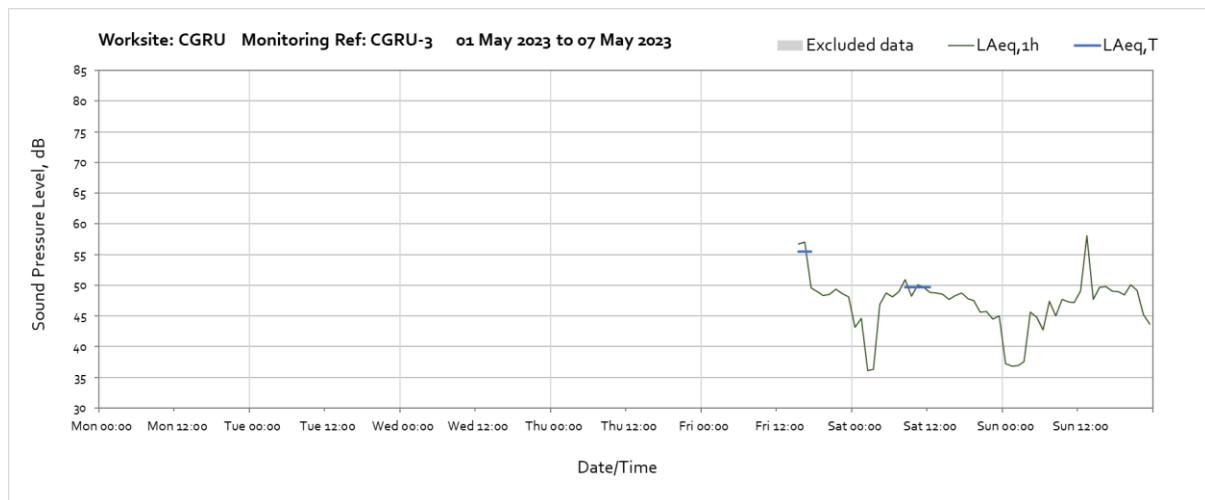
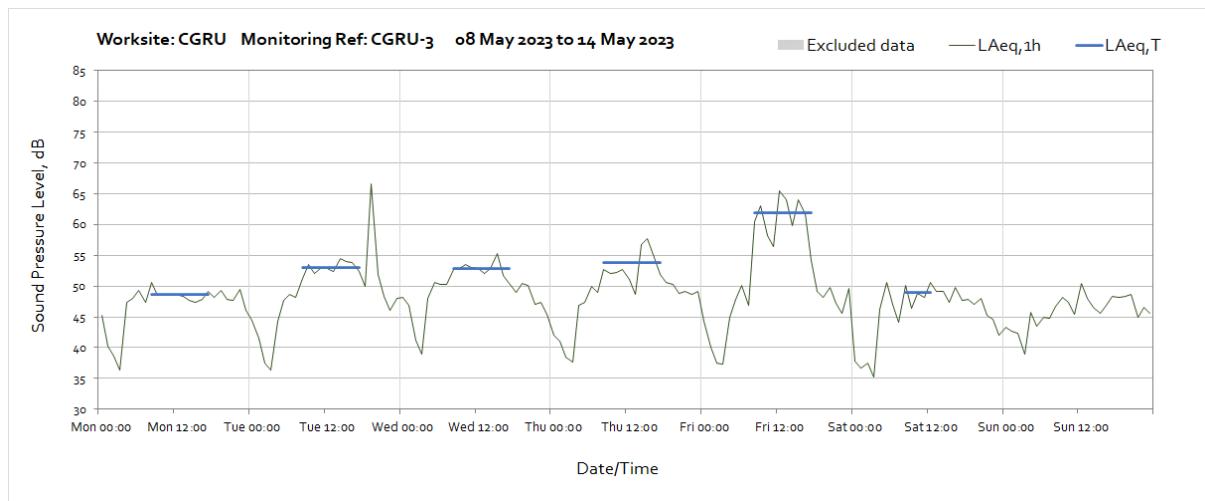
Worksite: CGRU- Monitoring Ref: CGRU-3

Note: Missing data between 00:00 on Monday 1st May 15:00 on Friday 5th May was due to loss of power to the monitor.

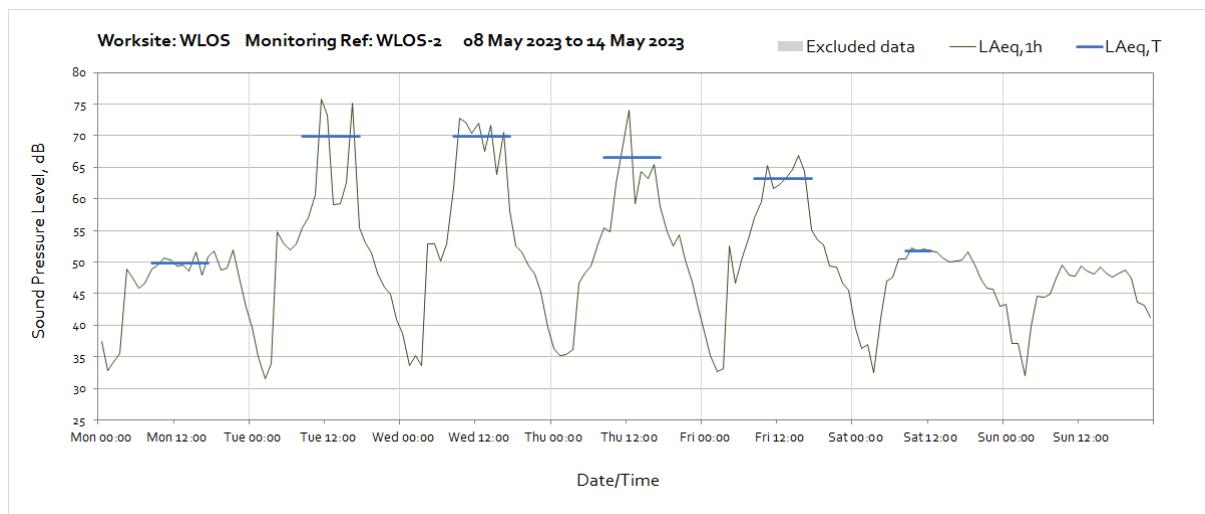
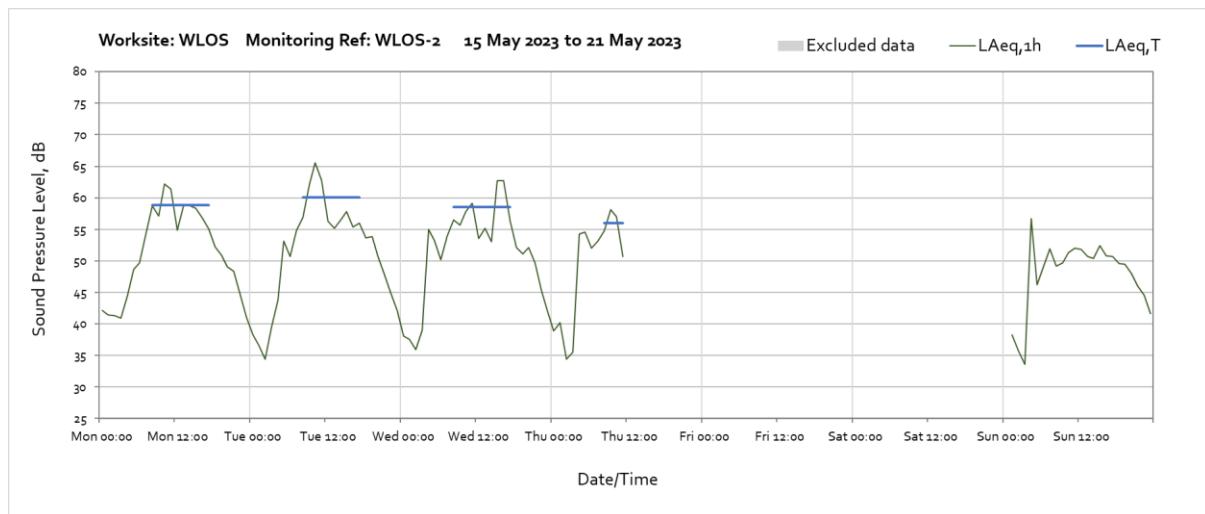
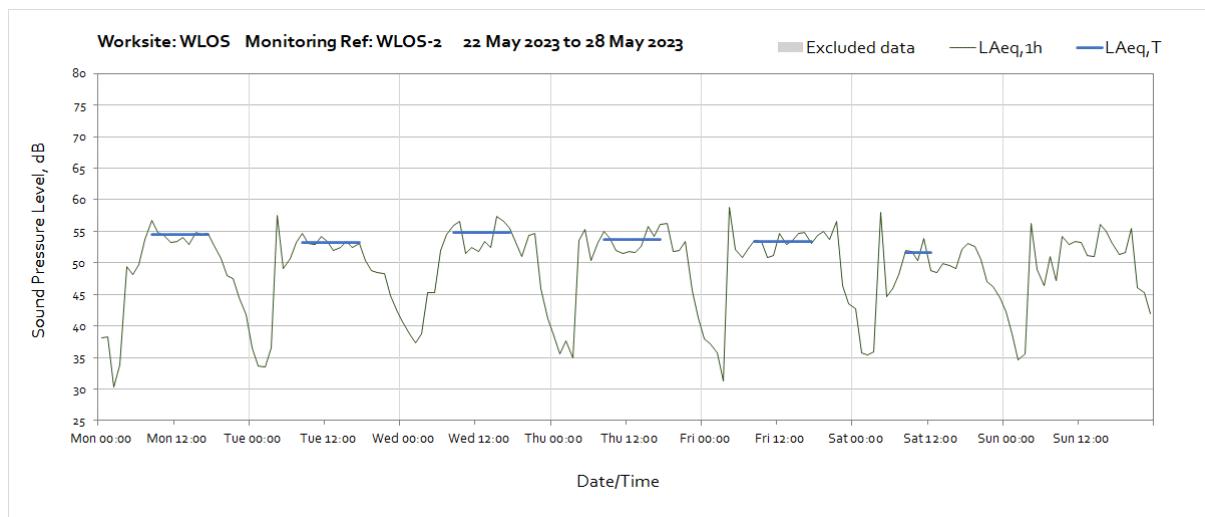
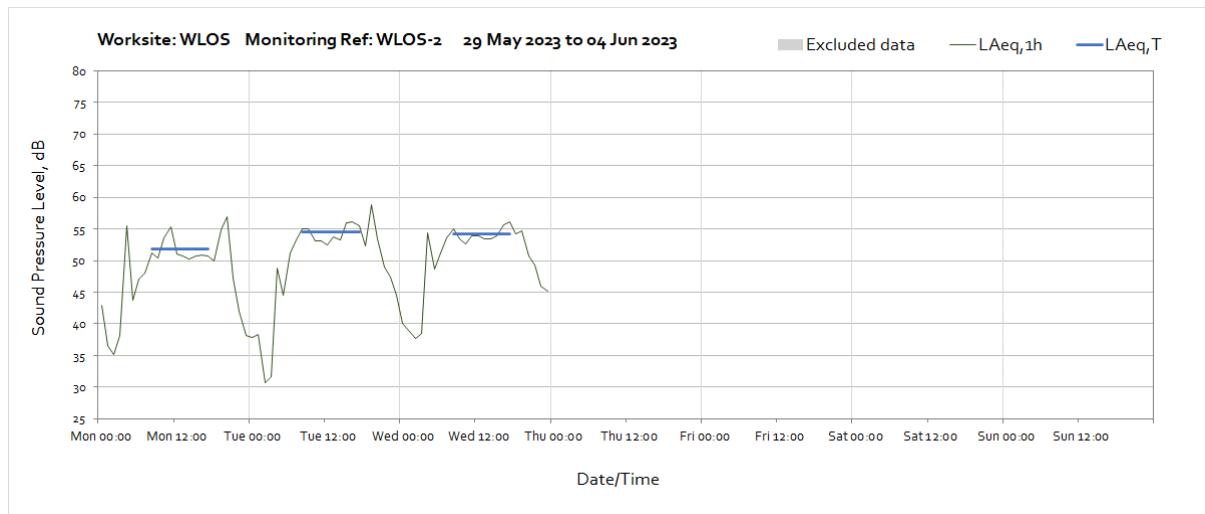
Worksite: WLOS – Monitoring Ref: WLOS-2

Note: Missing data between 12:00 on Thursday 18th May and 01:00 on Sunday 21st May was due to loss of power to the monitor.

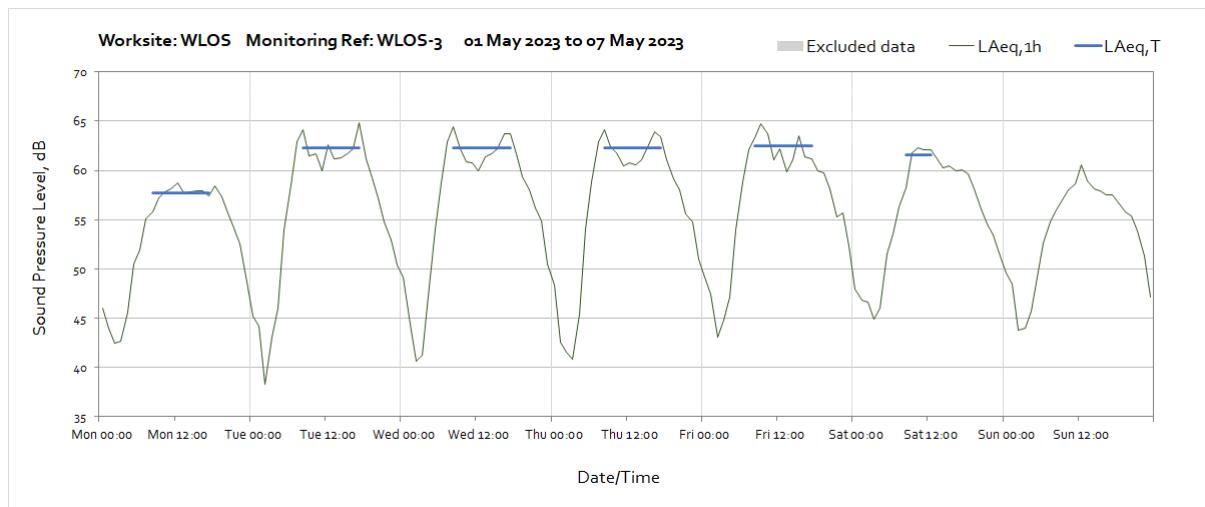
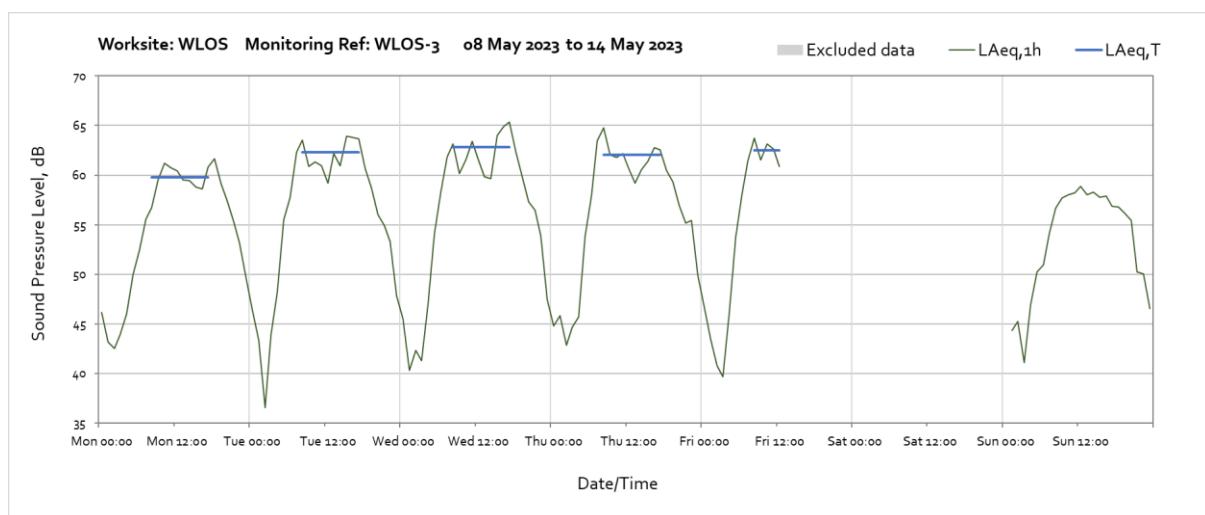
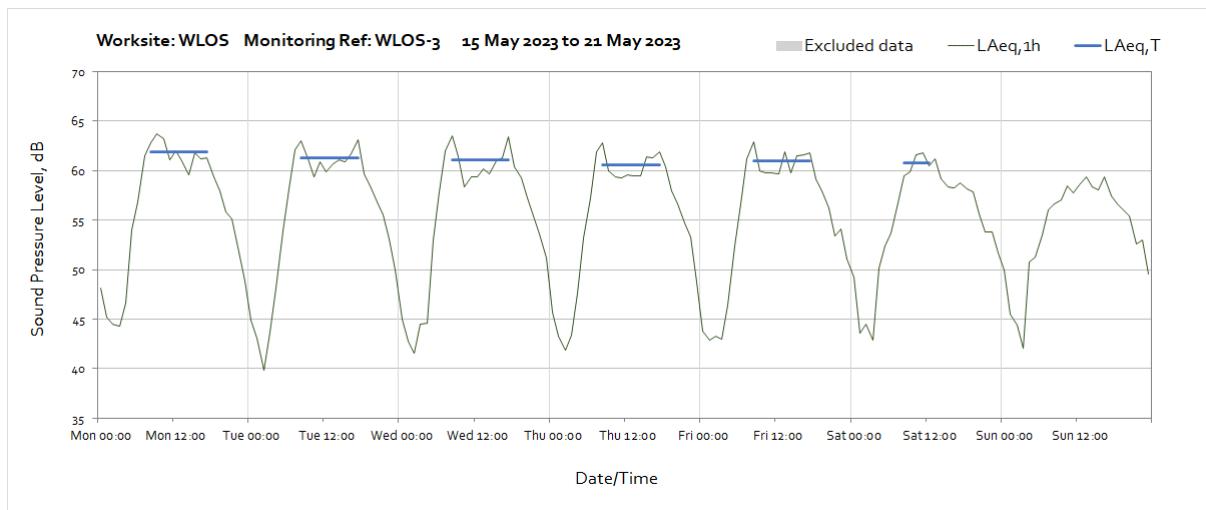
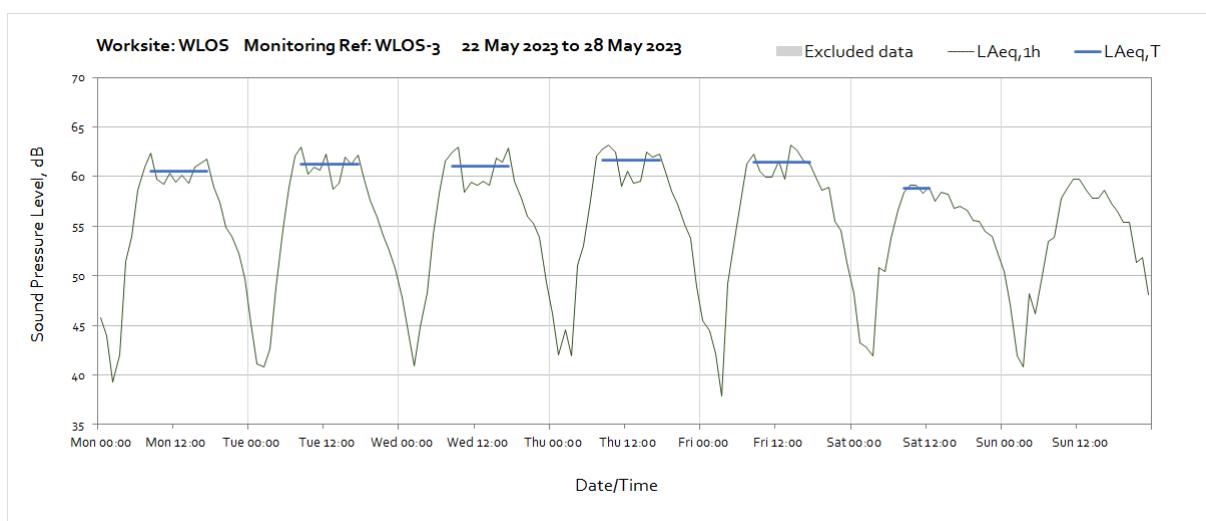
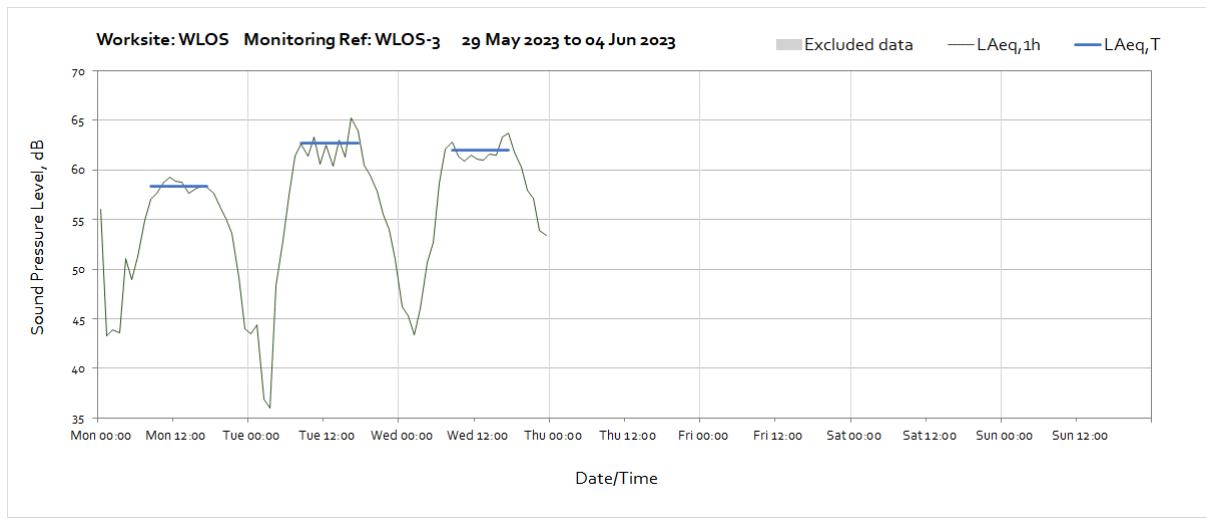
Worksite: WLOS – Monitoring Ref: WLOS-3

Note: Missing data between 13:00 on Friday 12nd May and 01:00 on Sunday 14th May was due to loss of power to the monitor.

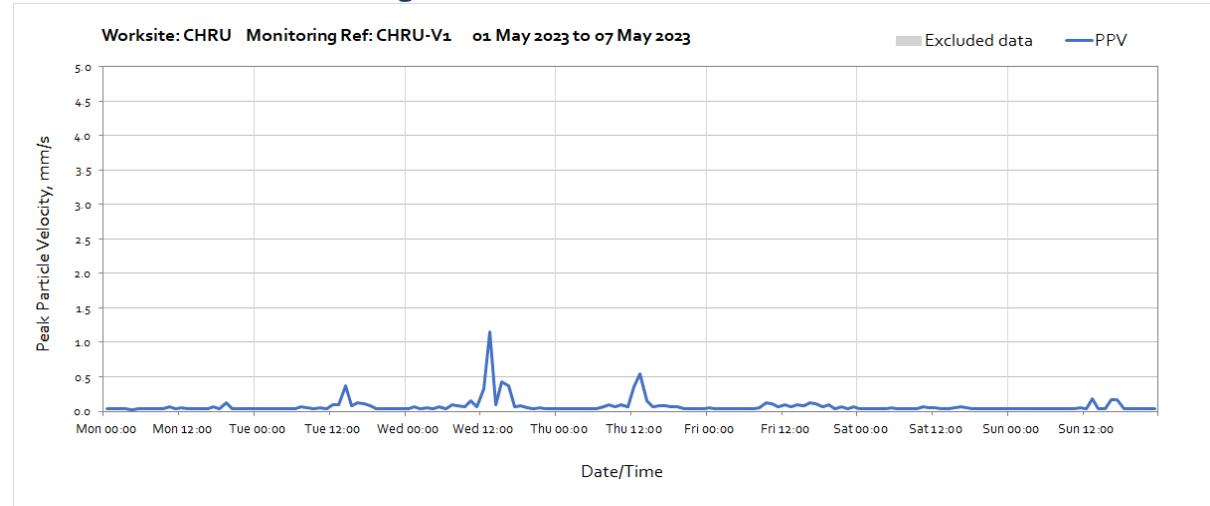
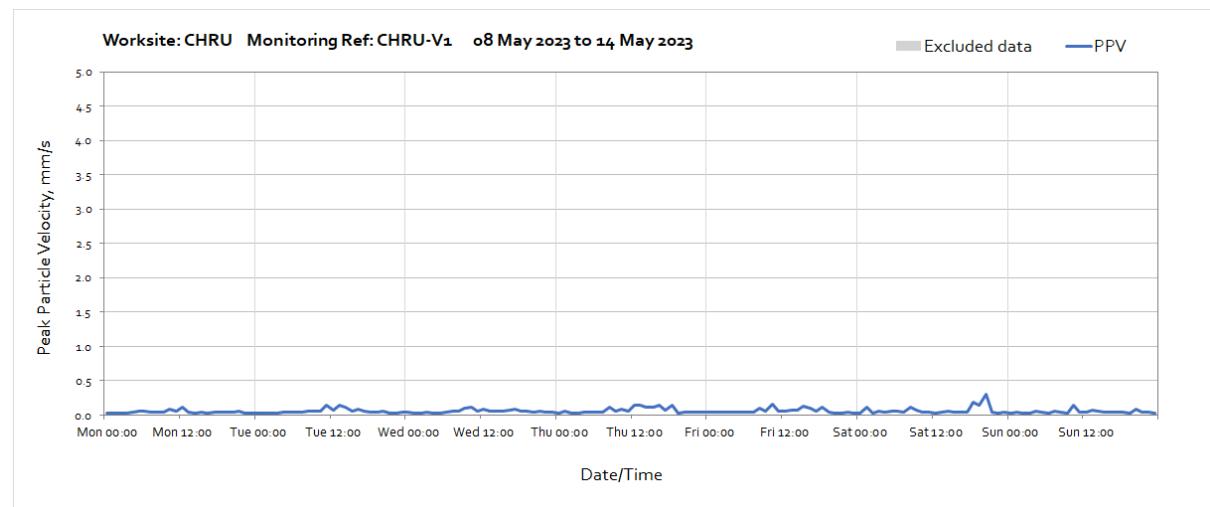
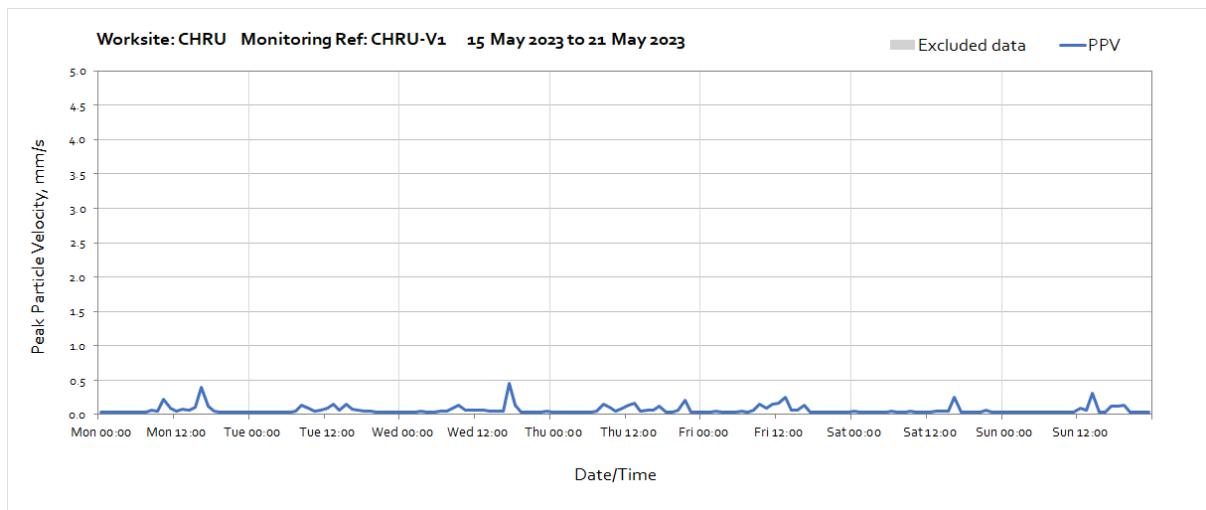
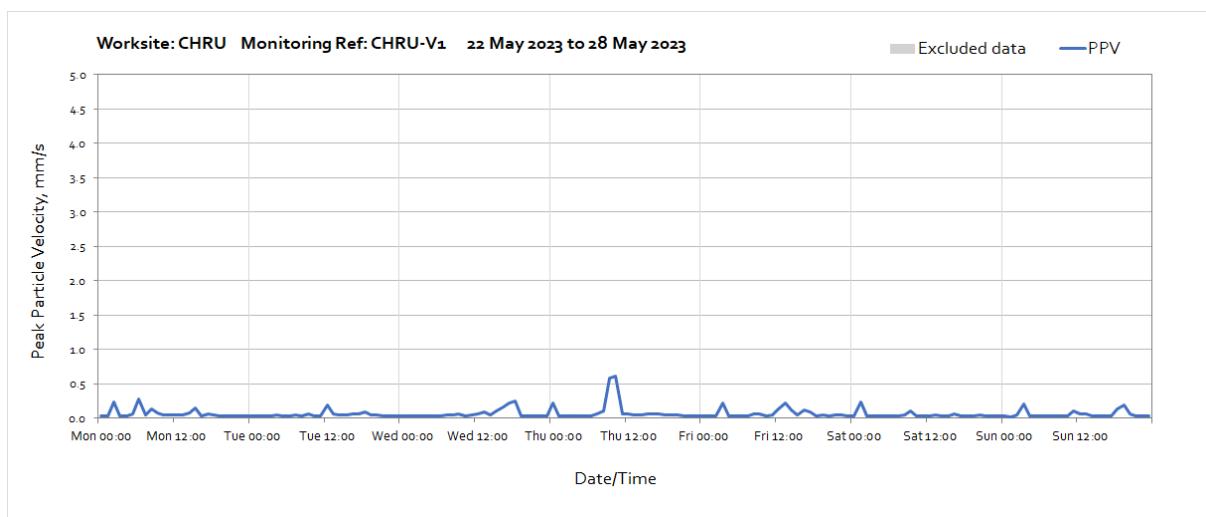
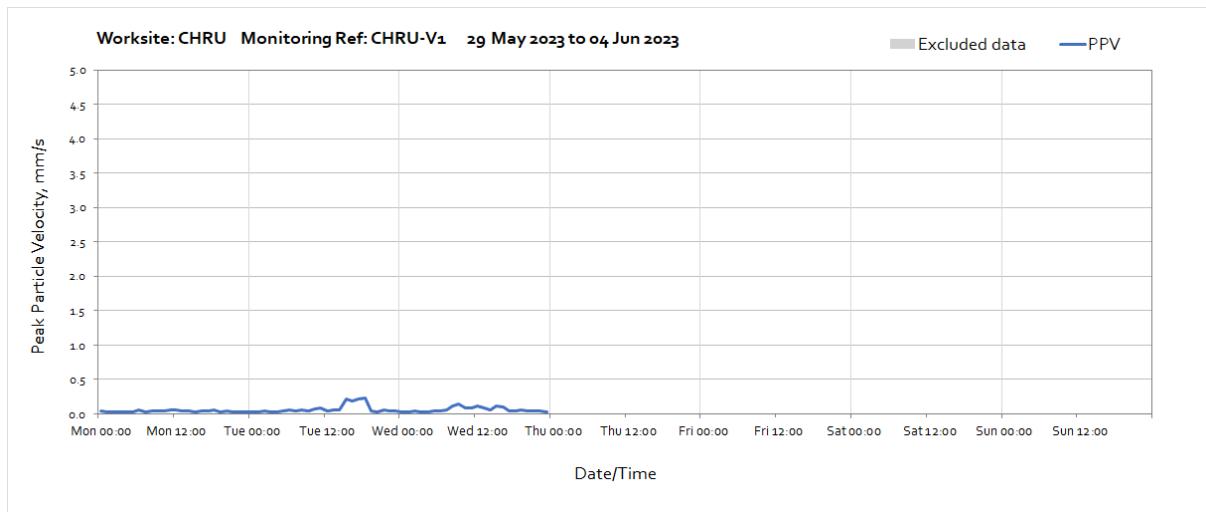
Worksite: CHR – Monitoring Ref: CHRU-V1

The following graphs show the hourly measured peak particle velocity PPV recorded during the monitoring period. The graphs show the highest PPV of the three orthogonal axes x, y and z. Where high values of PPV were caused by local interference with the vibration monitor, which are not representative of HS2 construction works, these values have been greyed out in the following charts and have been excluded to calculate values in Table 4 of the main report.

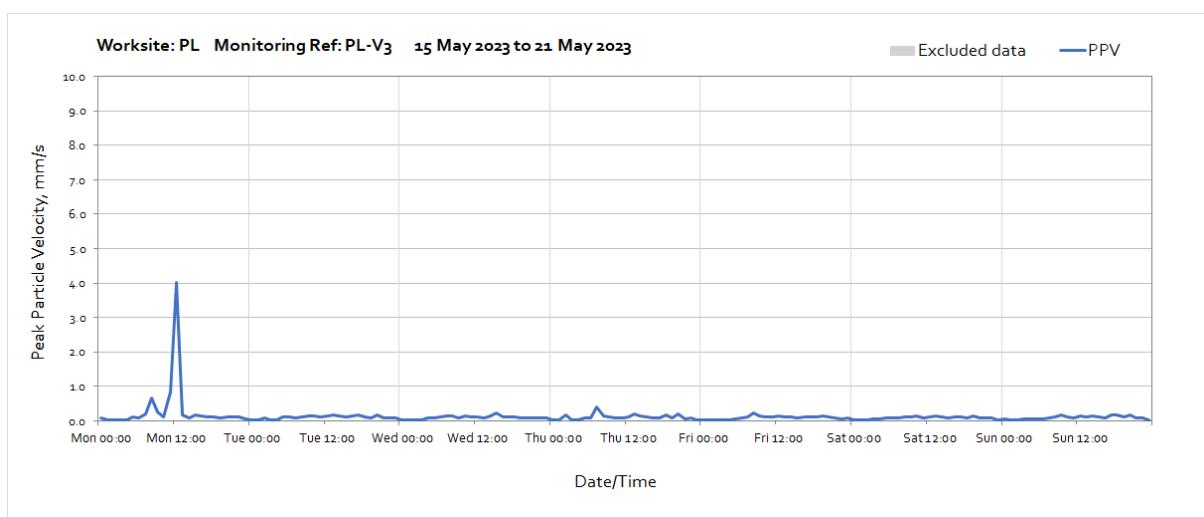
Note: High vibration levels measured at 12:00 on 15th May was due to compacting road surface works using roller in the vicinity of the monitor.
