## **Construction Noise and Vibration Monthly Report – July 2023**

**London Borough of Ealing**

# Non-Technical Summary

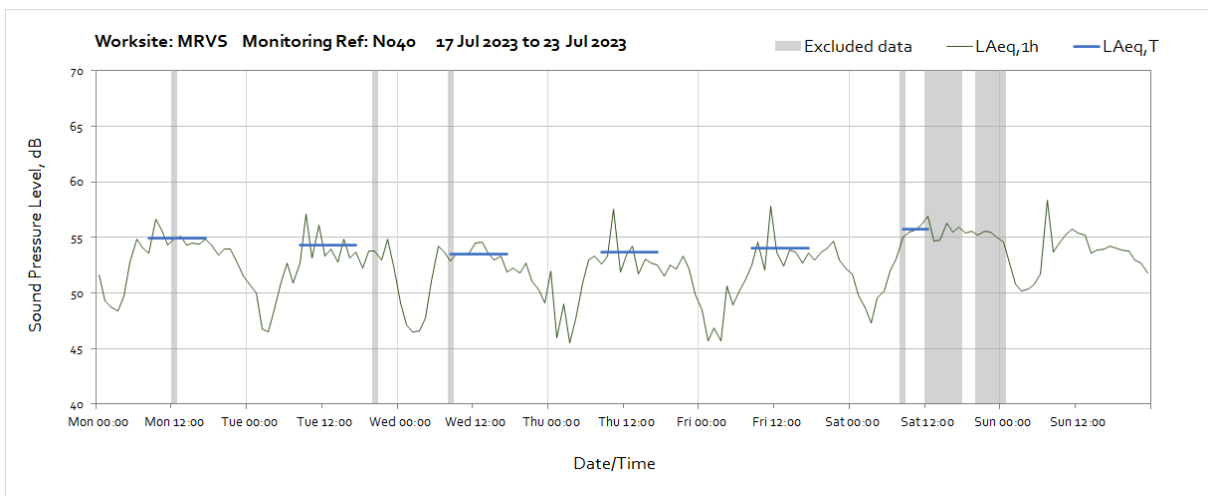
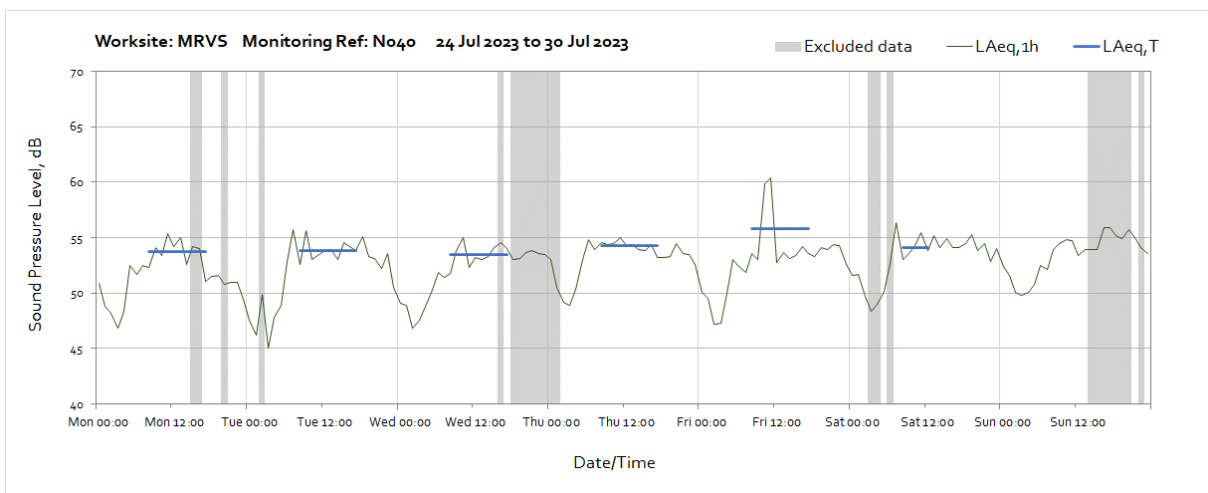
### Worksite: MRVS – Monitoring Ref: N040

The following graphs show the hourly measured ambient noise level  $L_{Aeq,1h}$  and, where relevant, the averaged noise level  $L_{Aeq,T}$  values, where the time period T is as specified in Table 1 of HS2 Information Paper E23. Periods with adversely weather affected noise levels are greyed out and have been excluded from the calculation of the  $L_{Aeq,T}$  values in Table 3 of the main report.

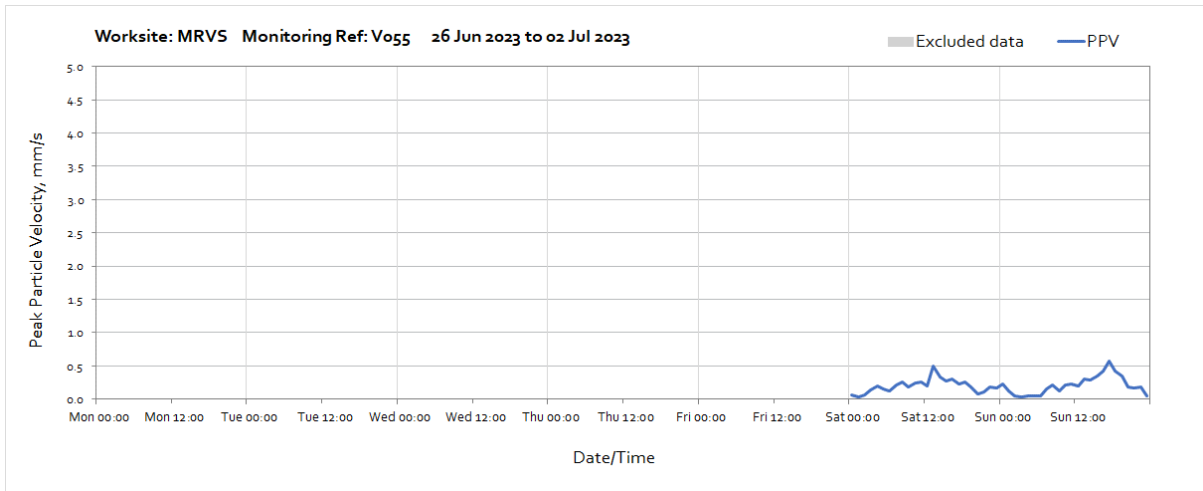
## Worksite: MRVS – Monitoring Ref: V055

The following graphs show the hourly measured peak particle velocity PPV recorded during the monitoring period. The graphs show the highest PPV of the three orthogonal axis x, y and z. Where high values of PPV were caused by local interference with the vibration monitor, which are not representative of HS2 construction works, these values have been greyed out in the following charts and have been excluded to calculate values in Table 4 of the main report.
