Construction Noise and Vibration Monthly Report – July 2023

Lichfield District Council

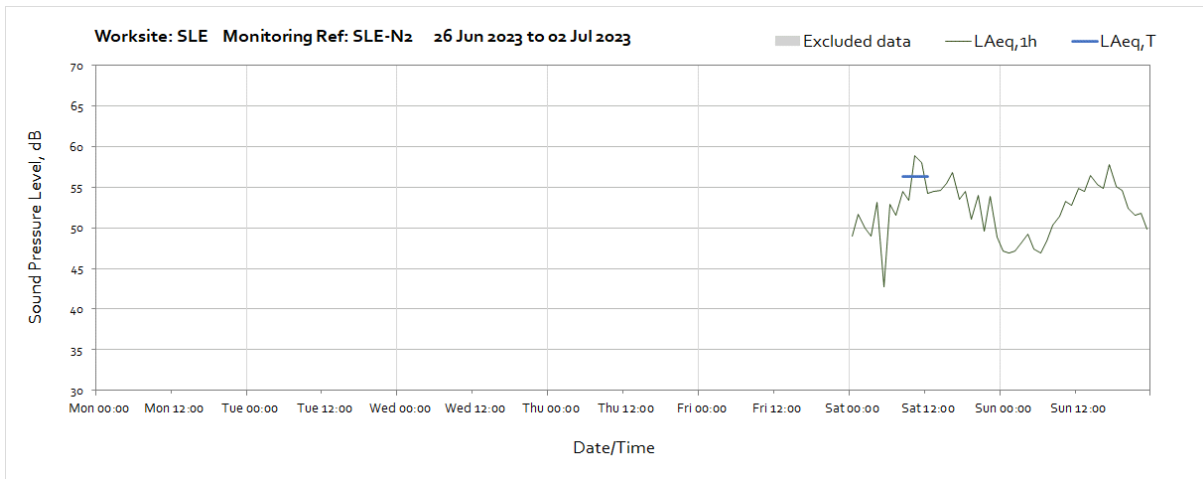
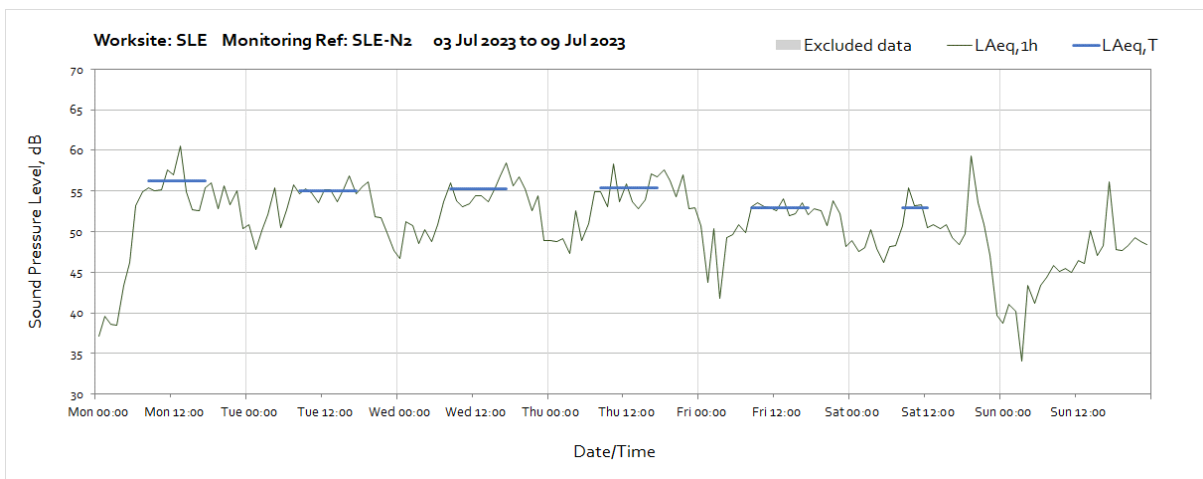
Worksite:SLE – Monitoring Ref: SLE-N2

The following graphs show the hourly measured ambient noise level $L_{Aeq,1h}$ and, where relevant, the averaged noise level $L_{Aeq,T}$ values, where the time period T is as specified in Table 1 of HS2 Information Paper E23. Periods with adversely weather affected noise levels are greyed out and have been excluded from the calculation of the $L_{Aeq,T}$ values in Table 3 of the main report.
