# HS2

September 2023

## **Construction Noise and Vibration Monthly Report – July 2023**

**North Warwickshire Borough Council**

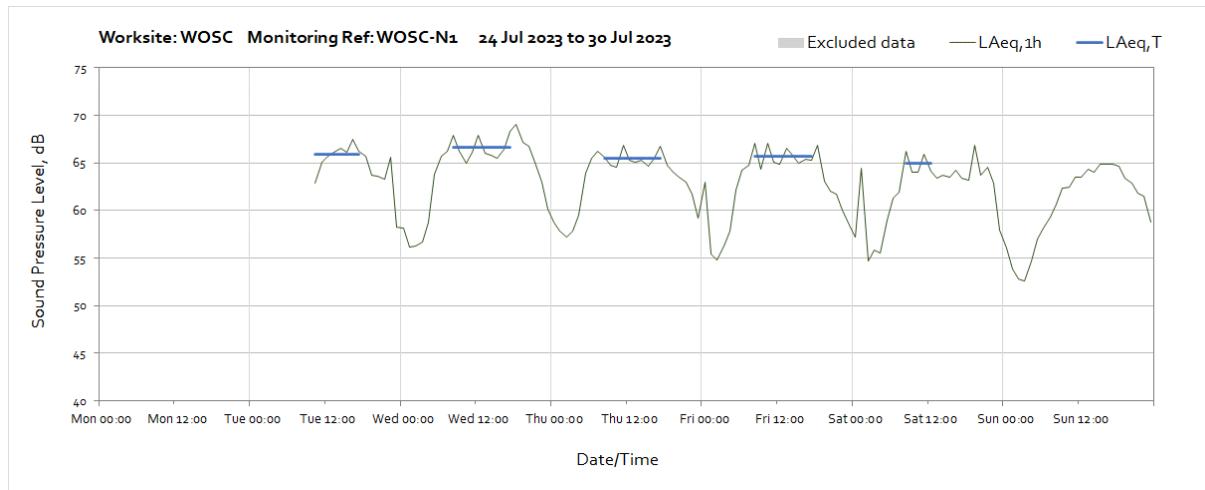
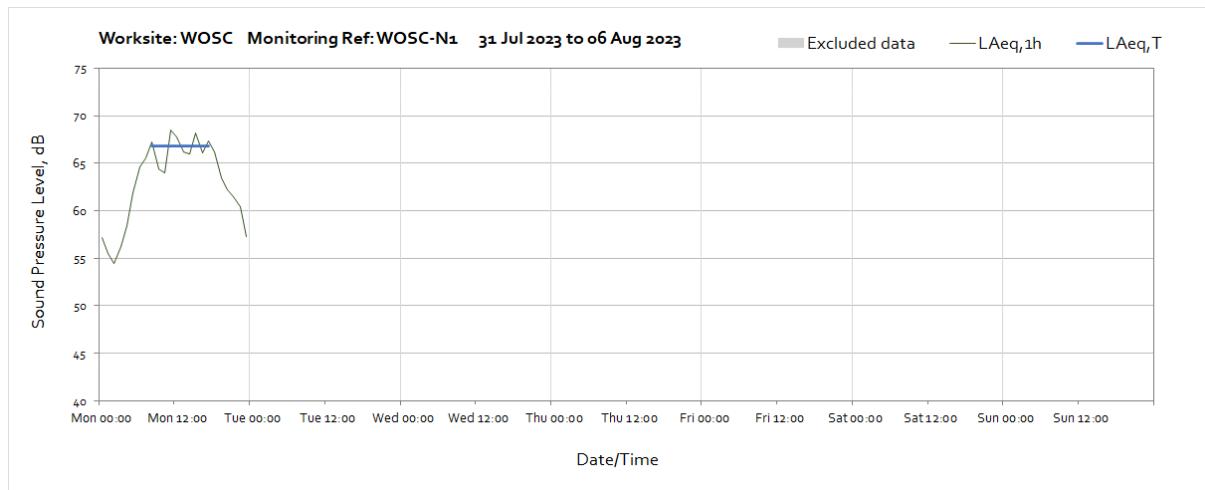
## Worksite: WOSC – Monitoring Ref: WOSC-N1

Note: Missing data from the beginning of July until 12:00 Tuesday 25<sup>th</sup> July was due vegetation overgrowth blocking the monitoring station solar panels leading to depletion of the monitor battery. The area has since been cleared of vegetation with view of minimising loss of data in the future.

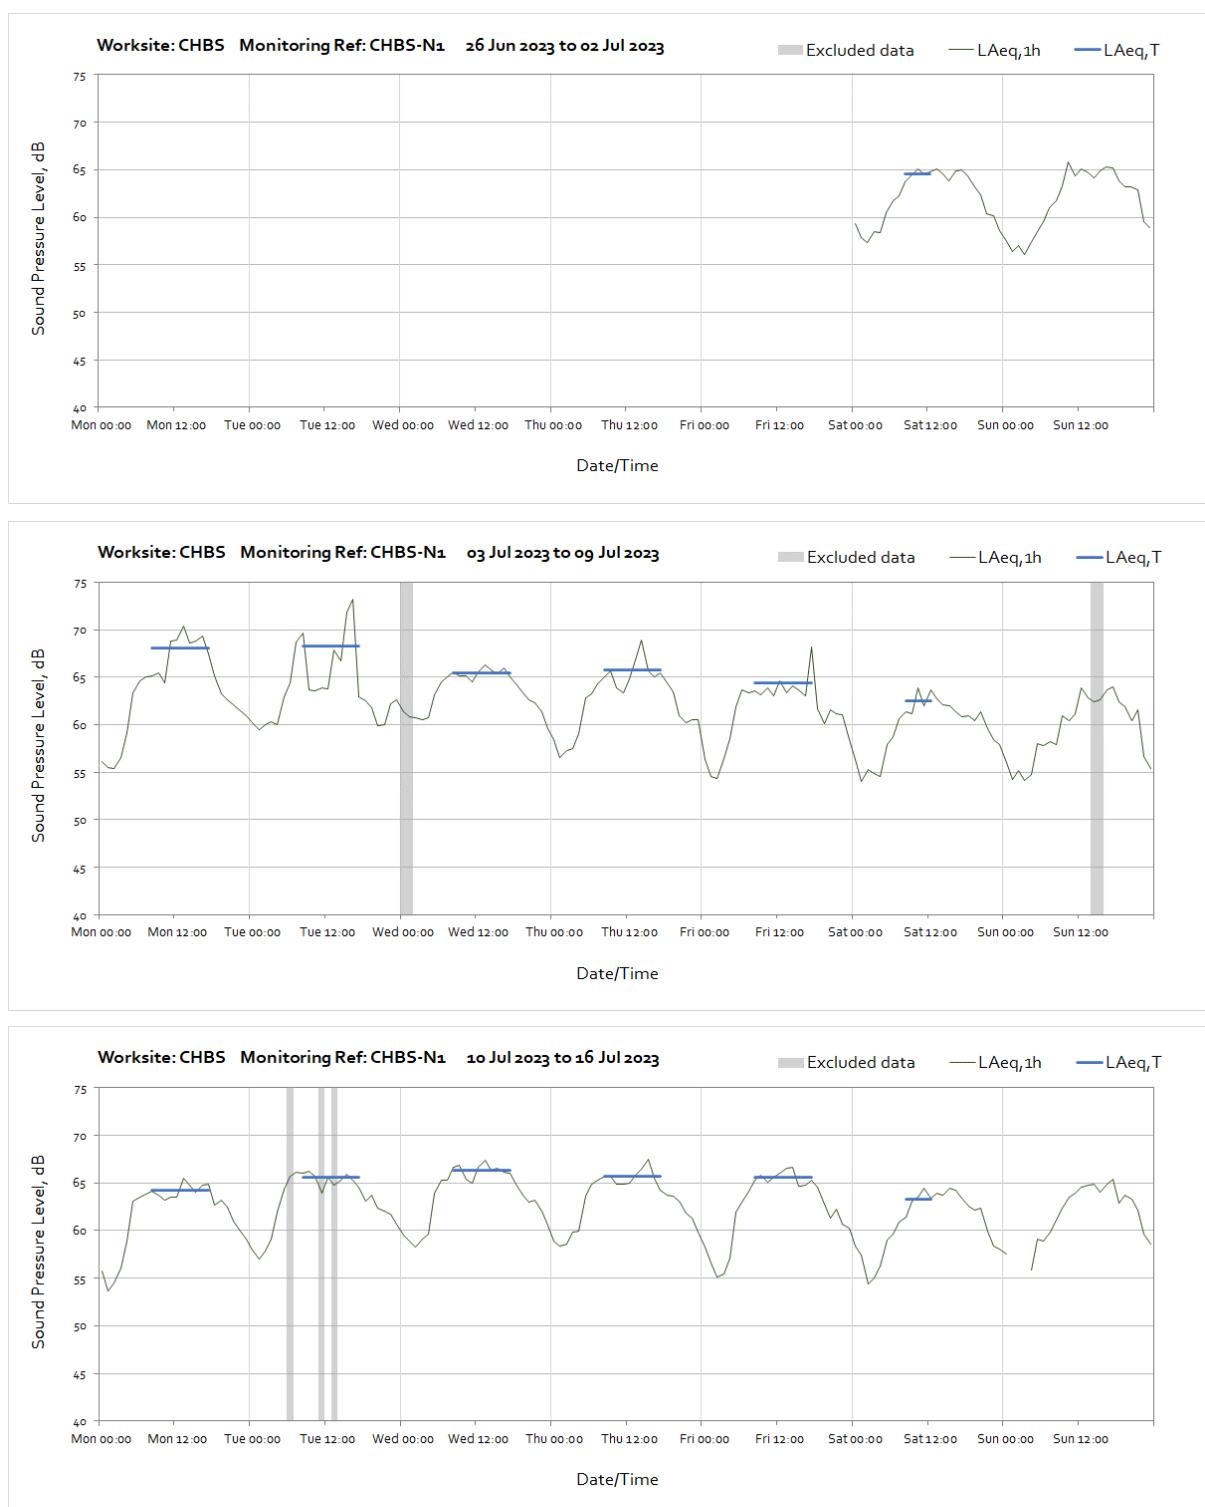
## Worksite: CHBS – Monitoring Ref: CHBS-N1

Note: Missing data between 01:00 and 04:00 on Sunday 16<sup>th</sup> July was due to an SD card issue which has since been resolved.

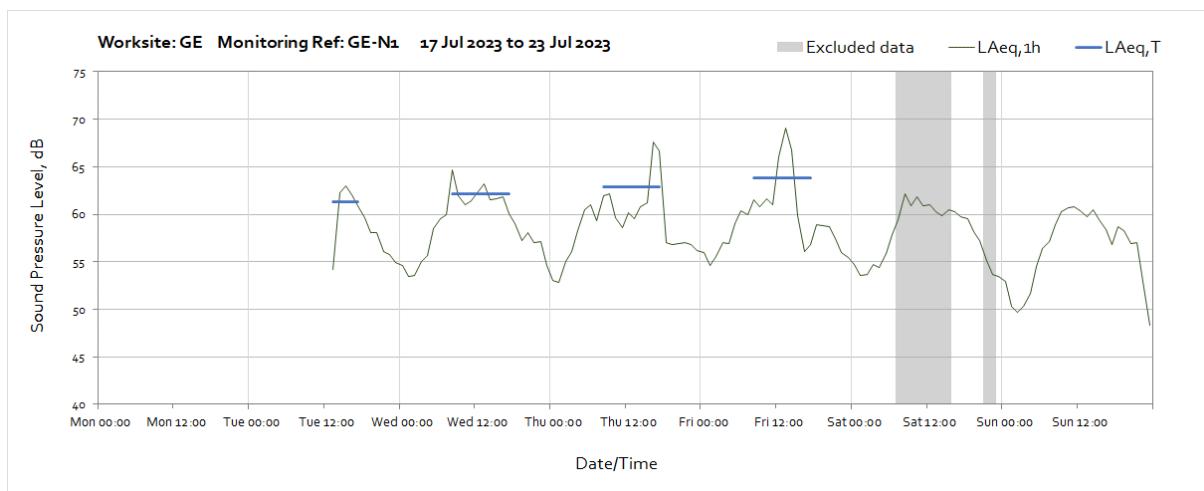
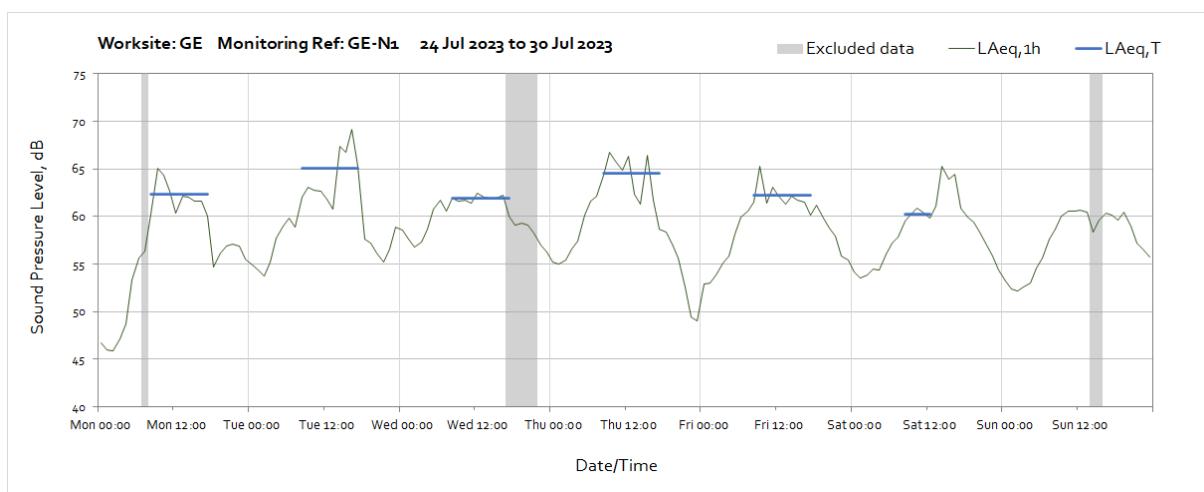
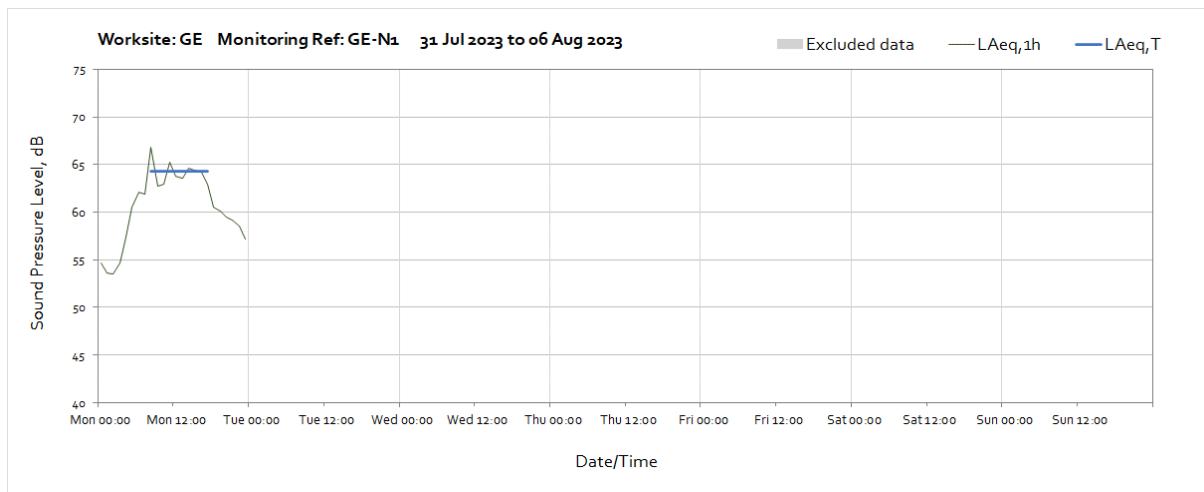
## Worksite: GE – Monitoring Ref: GE-N1

Note: Missing data from the beginning of July until 12:00 Tuesday 25th July was due to a loss of mains power to the monitor due to resident switching off power while out of the property for an extended period.

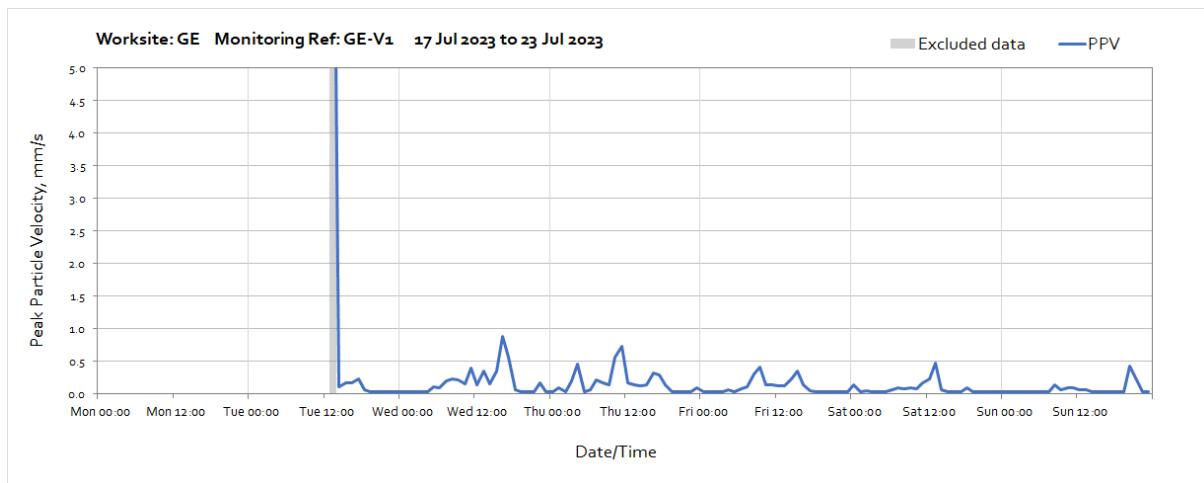
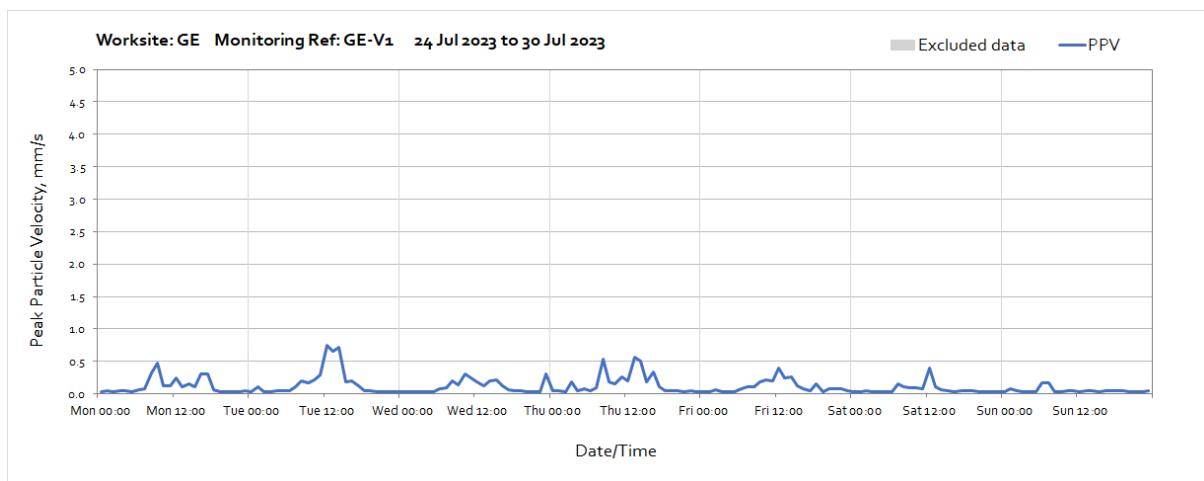
### Worksite: GE – Monitoring Ref: GE-V1

Note: Missing data from the beginning of July until 12:00 Tuesday 25th July until the end of the month was due to a loss of mains power to the monitor due to resident switching off power while out of the property for an extended period..
