Construction Noise and Vibration Monthly Report – July 2023

Stratford-on-Avon District Council

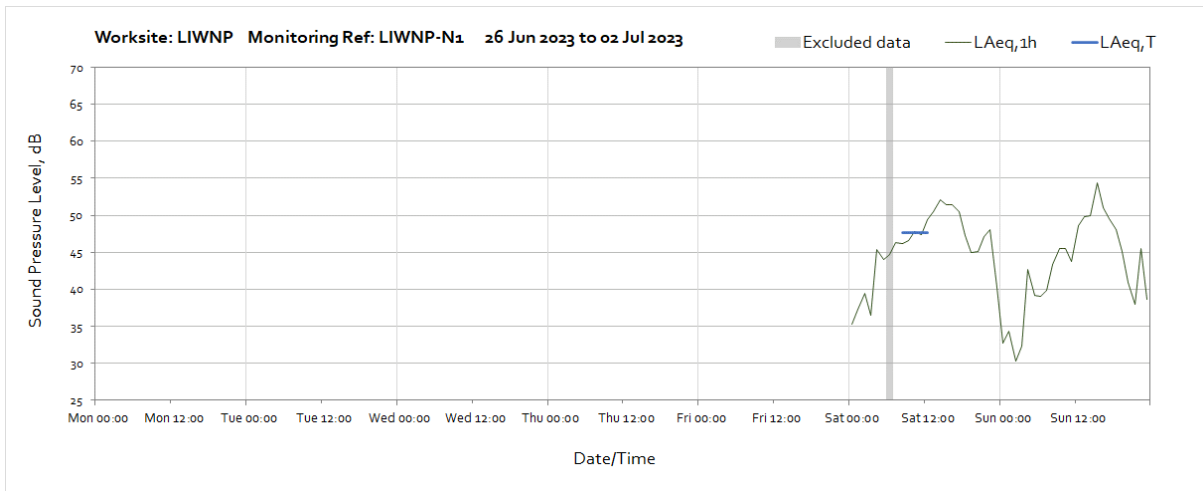
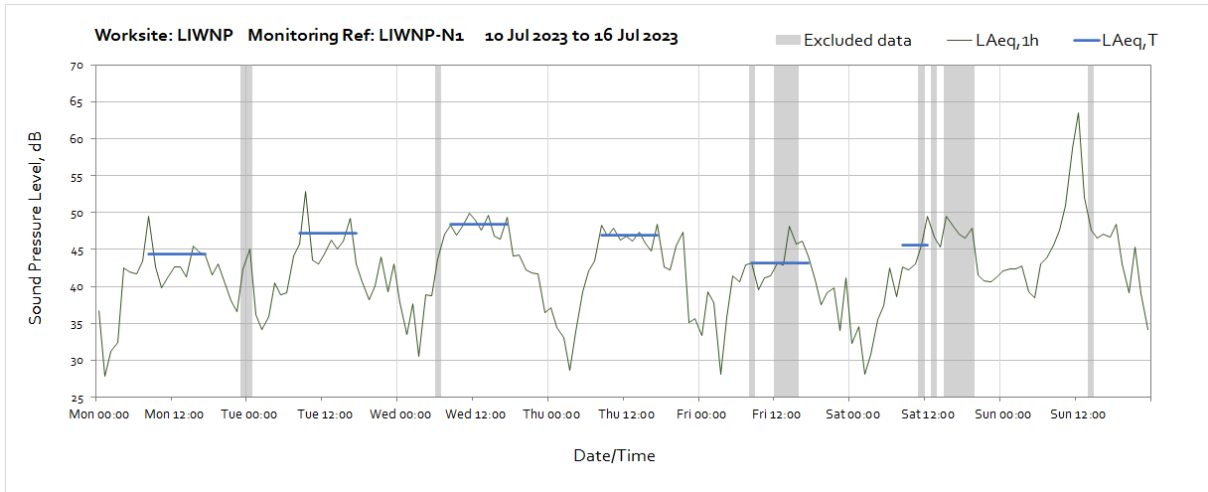
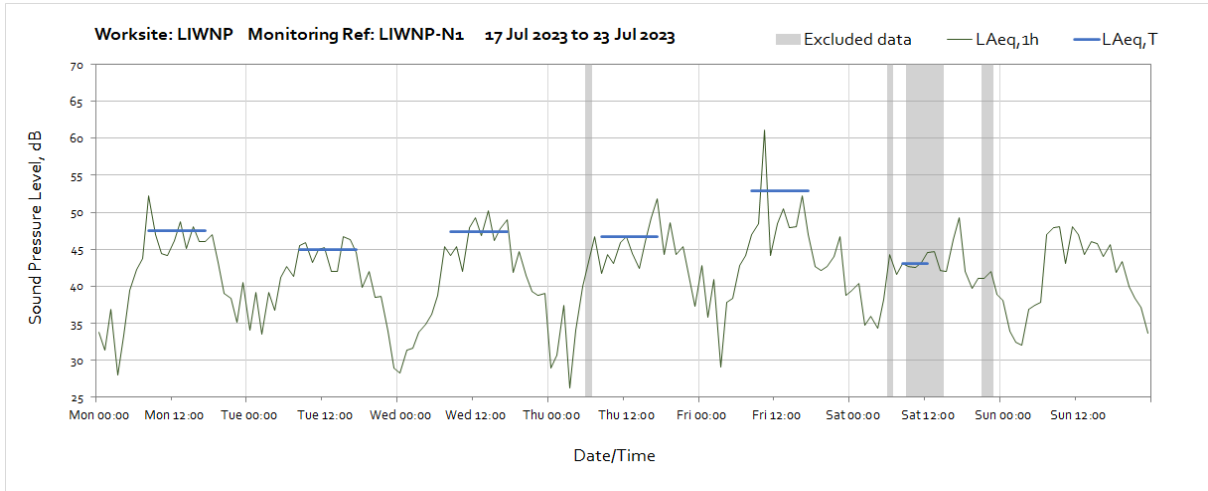
Worksite: LIWNP Monitoring Ref: LIWNP-N1

The following graphs show the hourly measured ambient noise level $L_{Aeq,1h}$ and, where relevant, the averaged noise level $L_{Aeq,T}$ values, where the time period T is as specified in Table 1 of HS2 Information Paper E23. Periods with adversely weather affected noise levels are greyed out and have been excluded from the calculation of the $L_{Aeq,T}$ values in Table 3 of the main report.

2.2.8 Two (2) SOAEL exceedances were recorded due to HS2 construction works during July 2023. The exceedance occurred at LIWNP-N1 during Sunday working hours and HF-N1 during Saturday working hours.

Complaint Reference Number	Worksite Reference	Description of Complaint	Results of Investigation	Actions Taken
HS2-23-44804-C	LIWNP	Complaint due to noise on a Sunday.	Work was in line with Section 61 consent and monitored noise levels were within prescribed noise limits.	Results of the investigation and monitoring data were provided to the stakeholder.

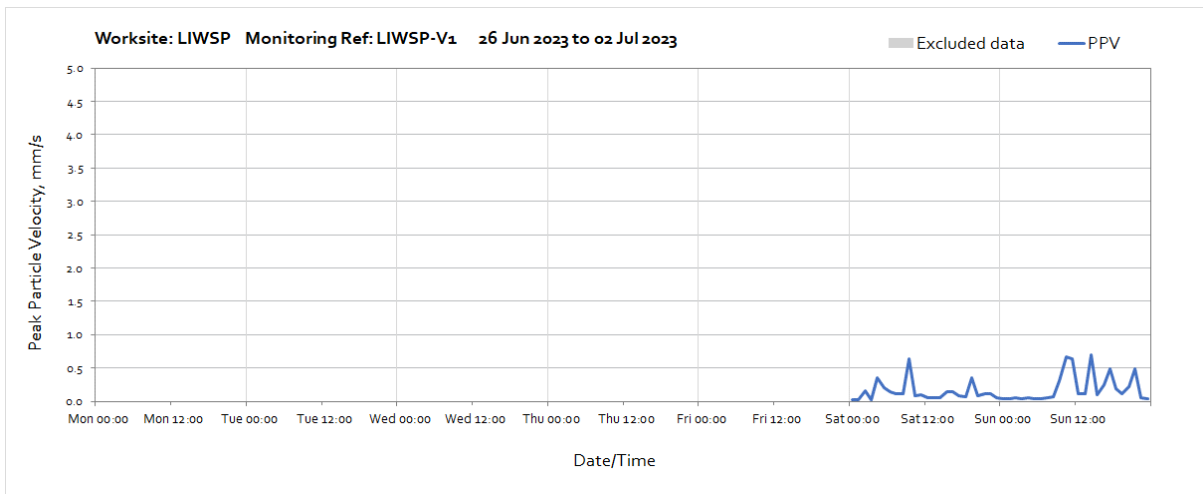
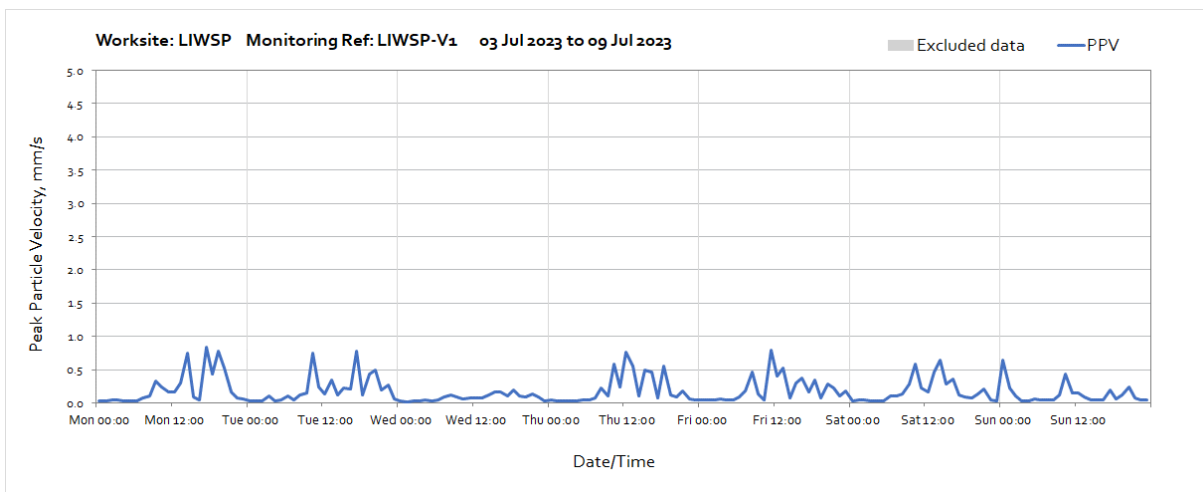
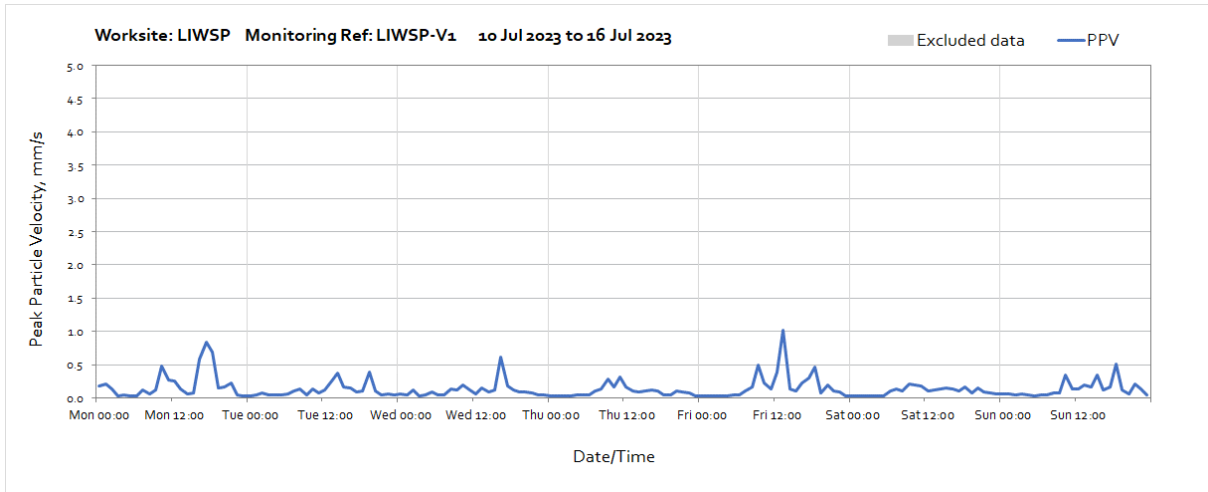
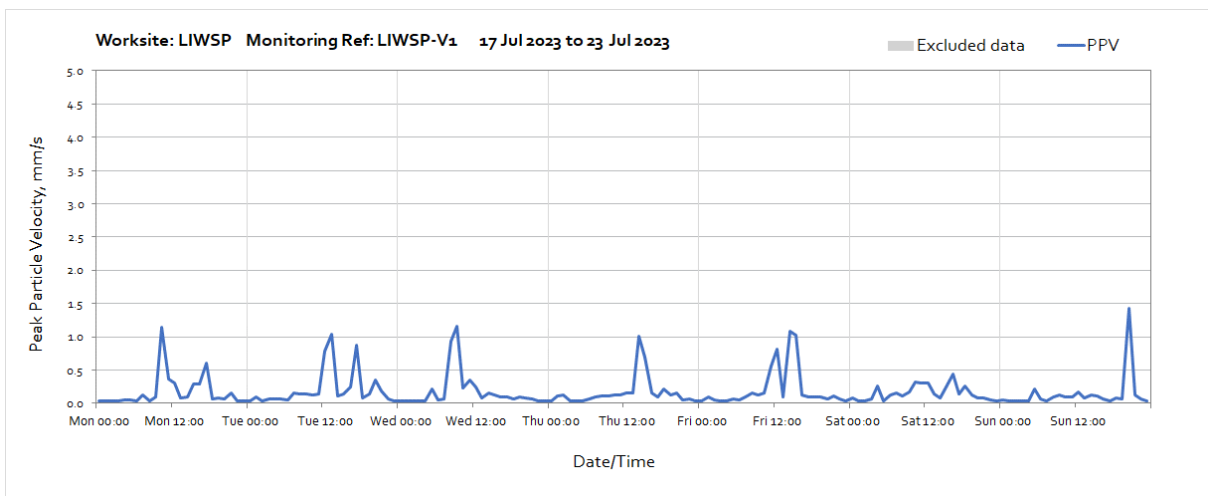
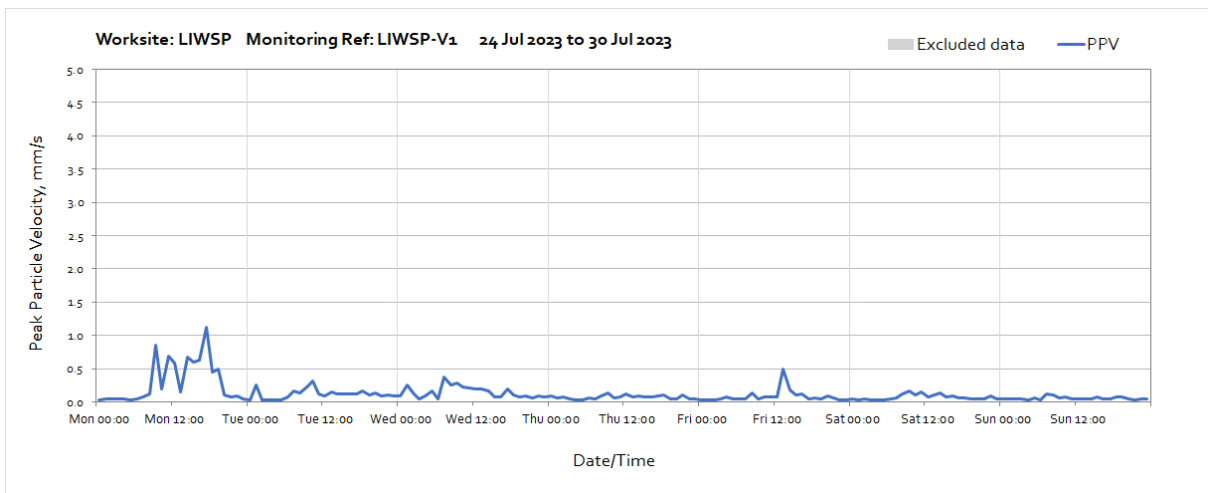
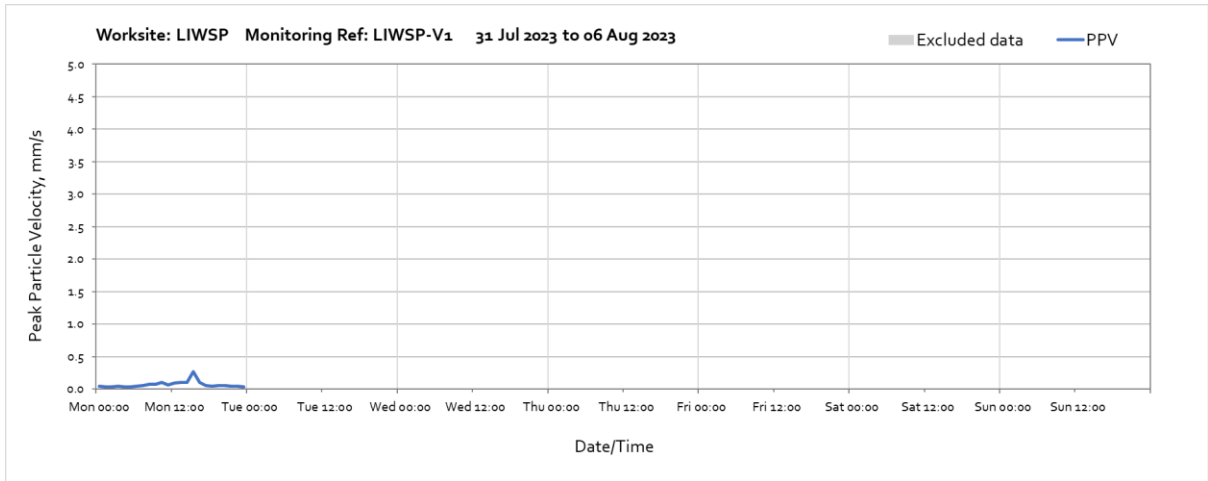
Worksite: LIWSP Monitoring Ref: LIWSP-V1

The following graphs show the hourly measured peak particle velocity PPV recorded during the monitoring period. The graphs show the highest PPV of the three orthogonal axes x, y and z. Where high values of PPV were caused by local interference with the vibration monitor, which are not representative of HS2 construction works, these values have been greyed out in the following charts and have been excluded to calculate values in Table 4 of the main report.

Worksite Reference	Measurement Reference	Monitor Address	Highest PPV measured in any axis, mm/s
LIWSP - Long Itchington Wood South Portal	LIWSP-V1	Woodside House, Bascote Heath, Southam	1.06 (Z-axis)
