Air Quality and Dust Monitoring Monthly Report – August 2023

London Borough of Brent

A report prepared by EWCs and MWCCs on behalf of HS2 Ltd.

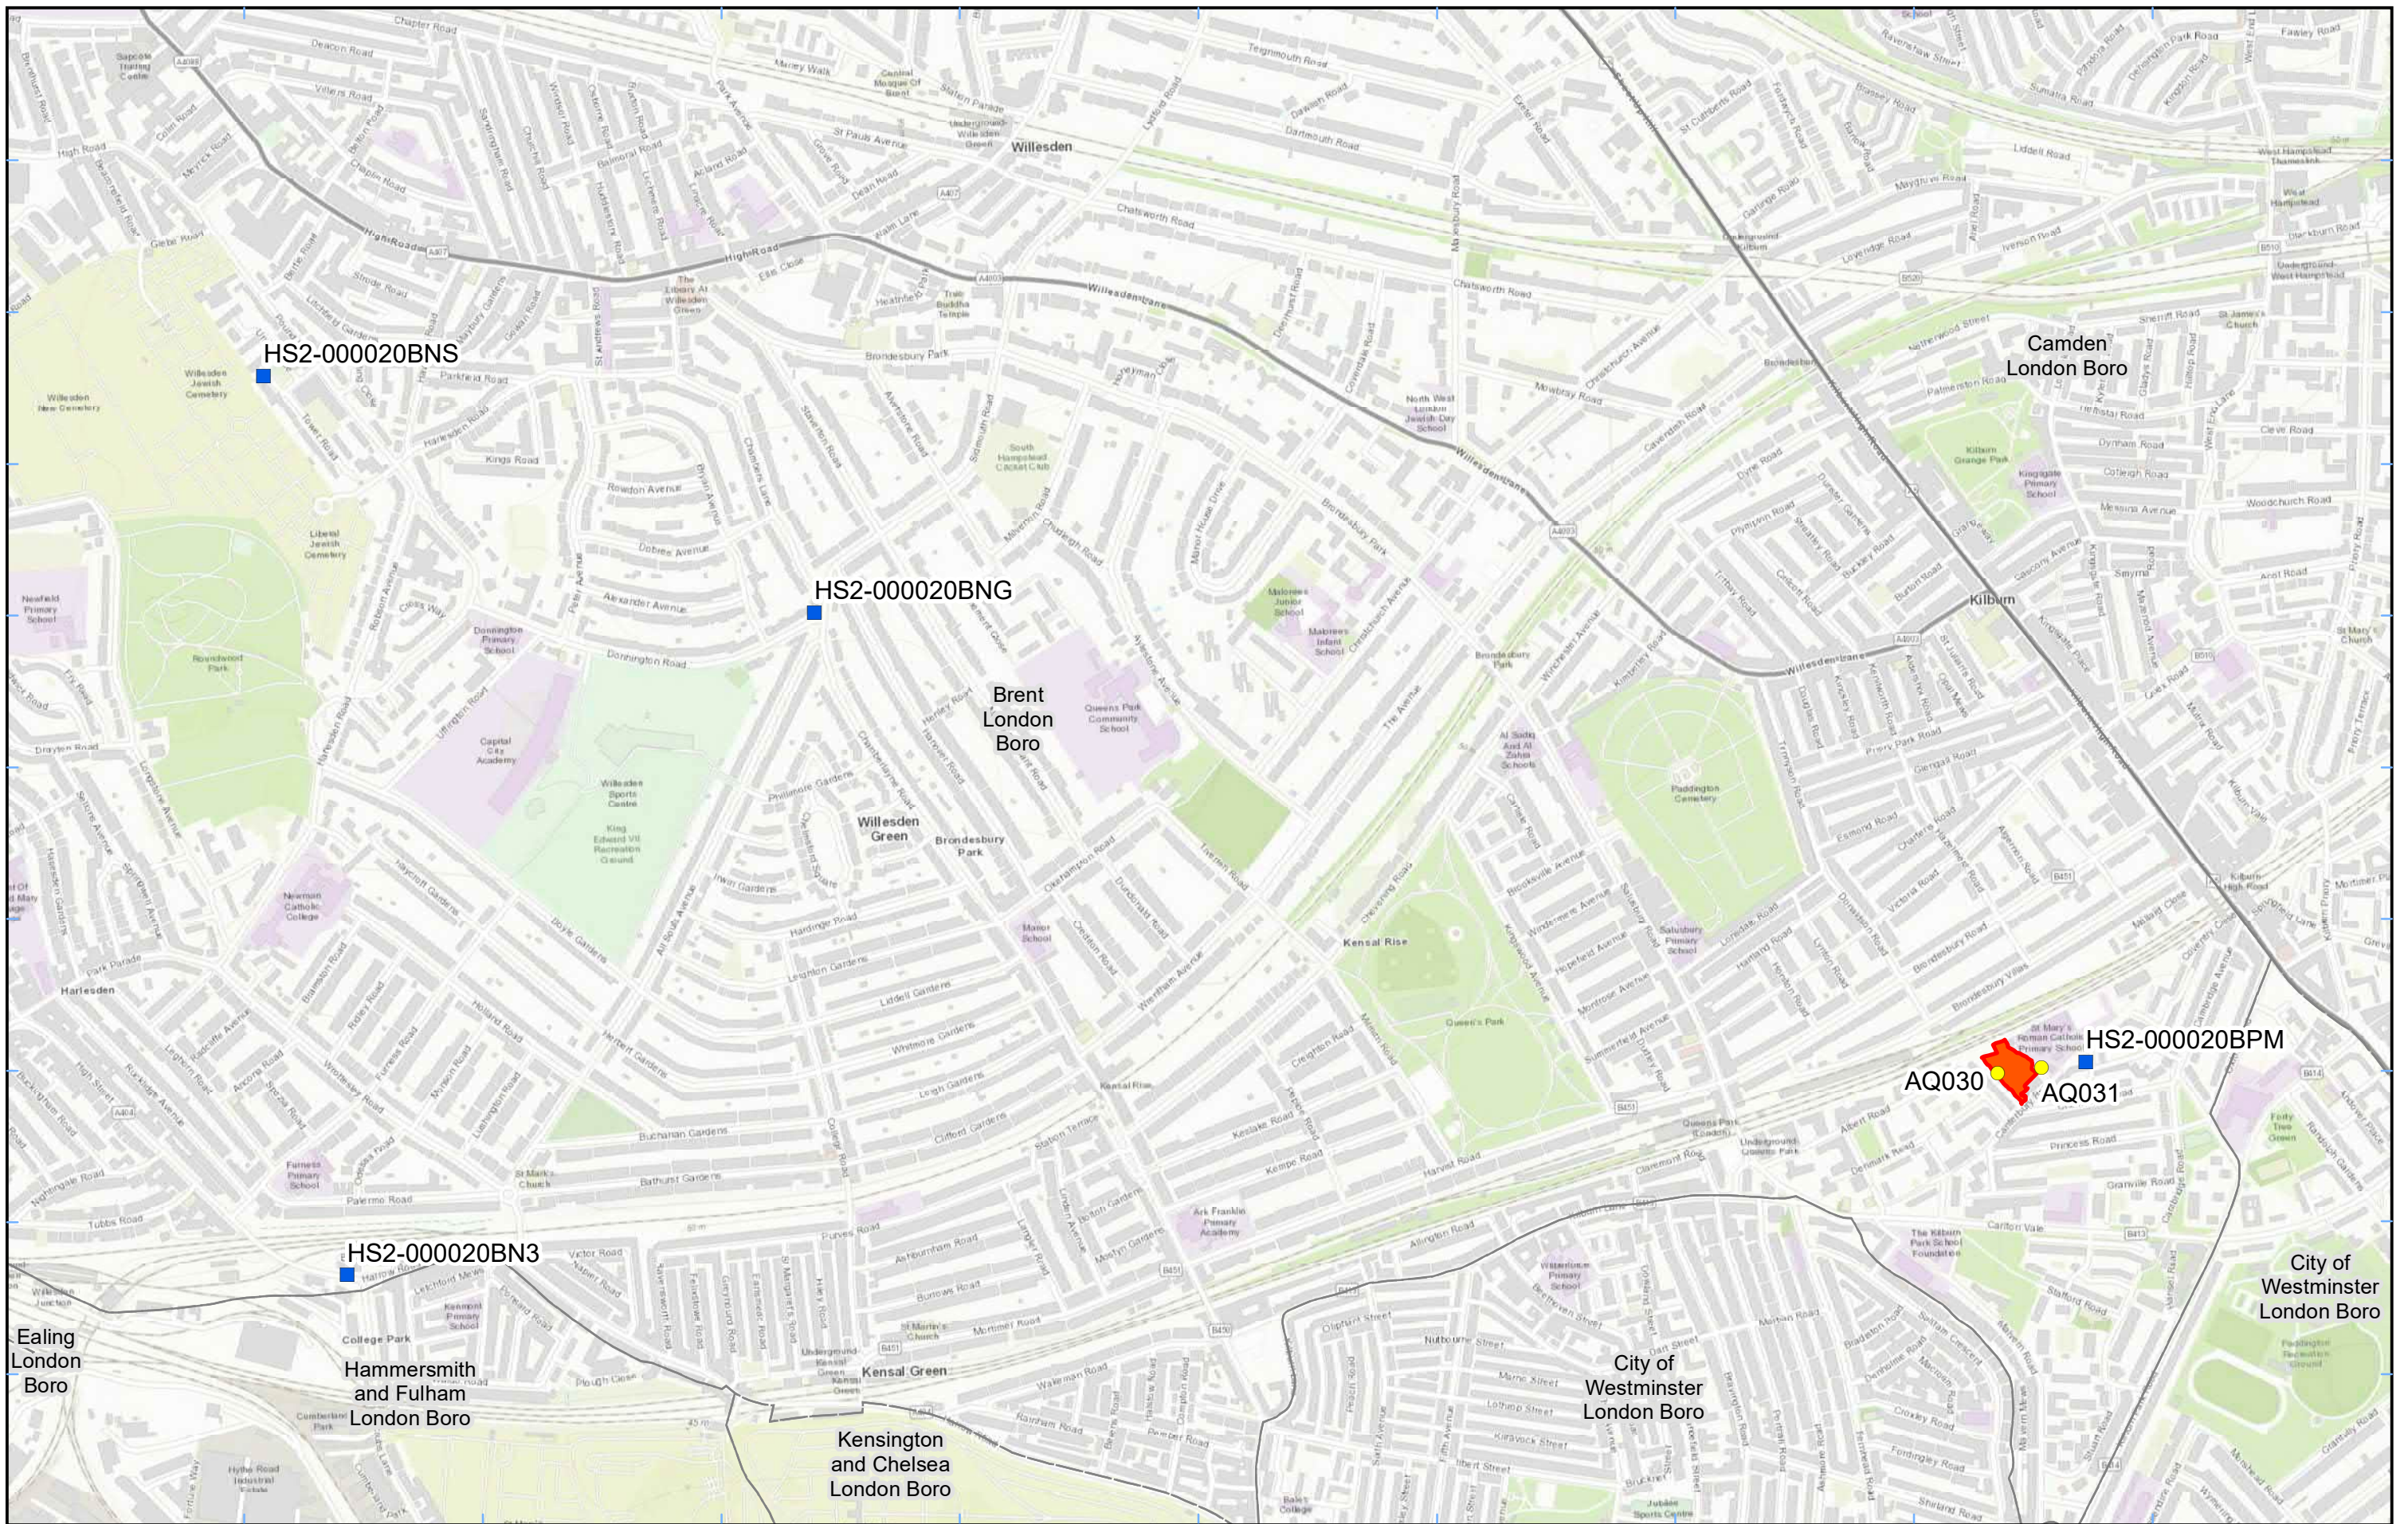
Figure 1: Worksites and monitoring locations within the LBB

- 1.1.2 Figure 1 in Appendix A indicates the current worksites together with air quality monitoring locations.
- 1.1.3 This summary should be read in conjunction with the overview monitoring report available from www.gov.uk/government/collections/monitoring-the-environmental-effects-of-hs2, which highlights: the applicable standards and guidance, as well as the air quality and dust monitoring methodologies to be implemented by nominated undertakers throughout construction.

- 1.1.4 The current phase of works commenced within the LBB in August 2020 and is expected to be completed by the end of 2025. The current worksites, as presented in Appendix A, Figure 1 include:

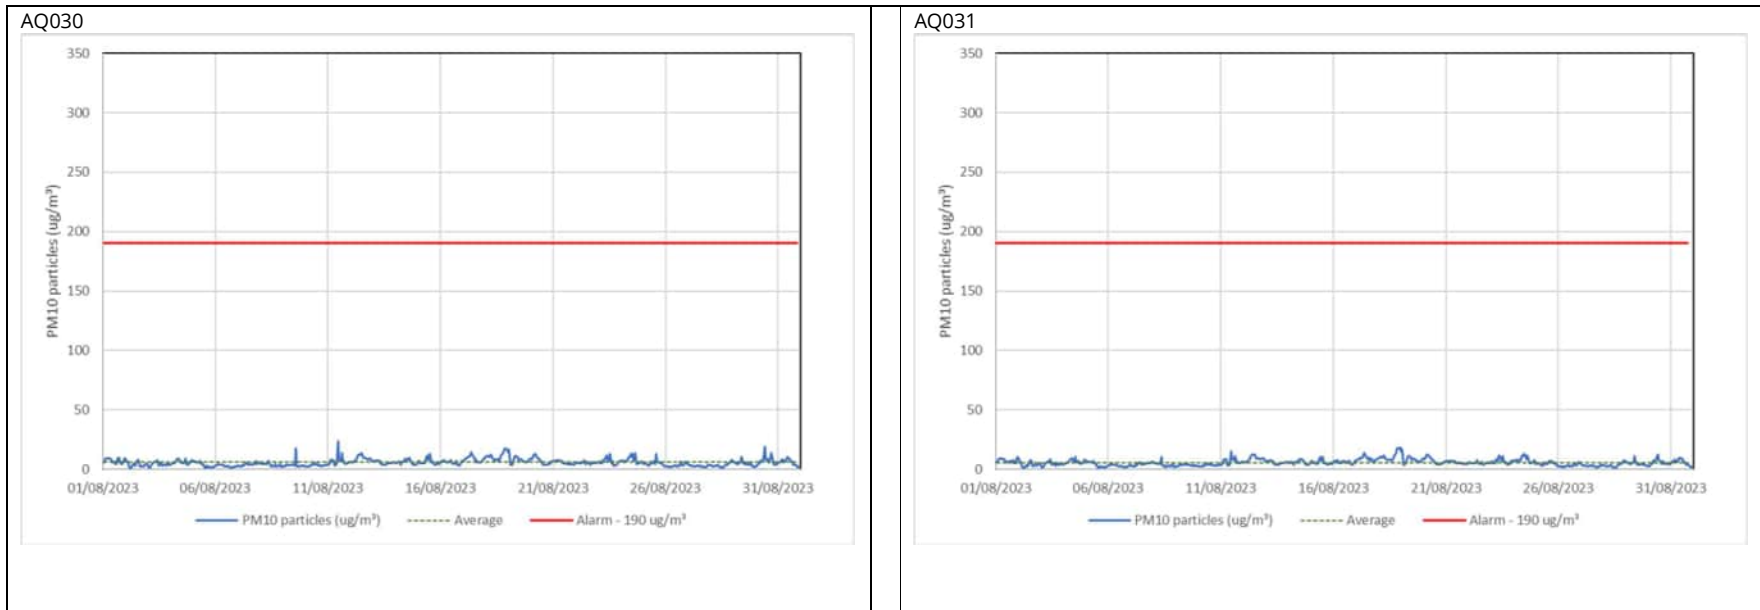
Figure 2: Construction dust 1-hour mean indicative PM₁₀ concentration for dust monitors

- 1.1.6 Dust monitoring location and results are presented in Appendix B, Table 1, together with line chart of monthly data from the dust monitor in Figure 2. The continuous dust monitoring is undertaken using indicative monitors. Despite being Environment Agency (MCERTS) certified, indicative monitors carry a higher level of uncertainty than reference monitors, and therefore cannot be strictly compared with Air Quality Standards for human health and the environment. The purpose of the monitoring undertaken is to ensure the effectiveness of the on-site mitigation.

- 1.1.7 The trigger level for PM₁₀ concentrations of 190 µg/m³, over a 1-hour period, in accordance with the updated guidance document '*Guidance on Monitoring in the Vicinity of Demolition and Construction Sites – (October 2018)*' has been applied.

- 1.1.8 No (0) dust trigger alerts were recorded during the monitoring period (July 2023).
