Construction Noise and Vibration Monthly Report – August 2023

London Borough of Ealing

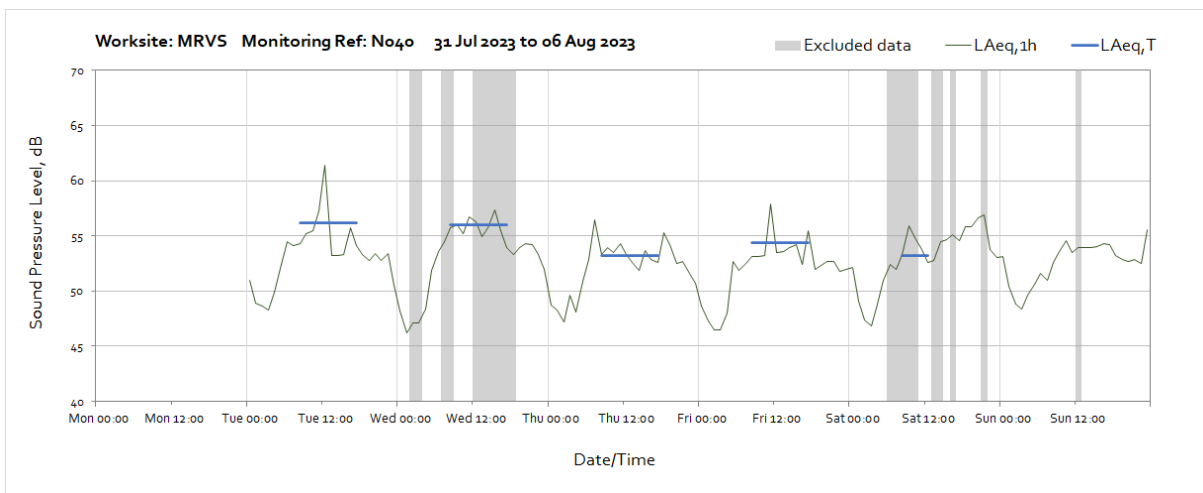
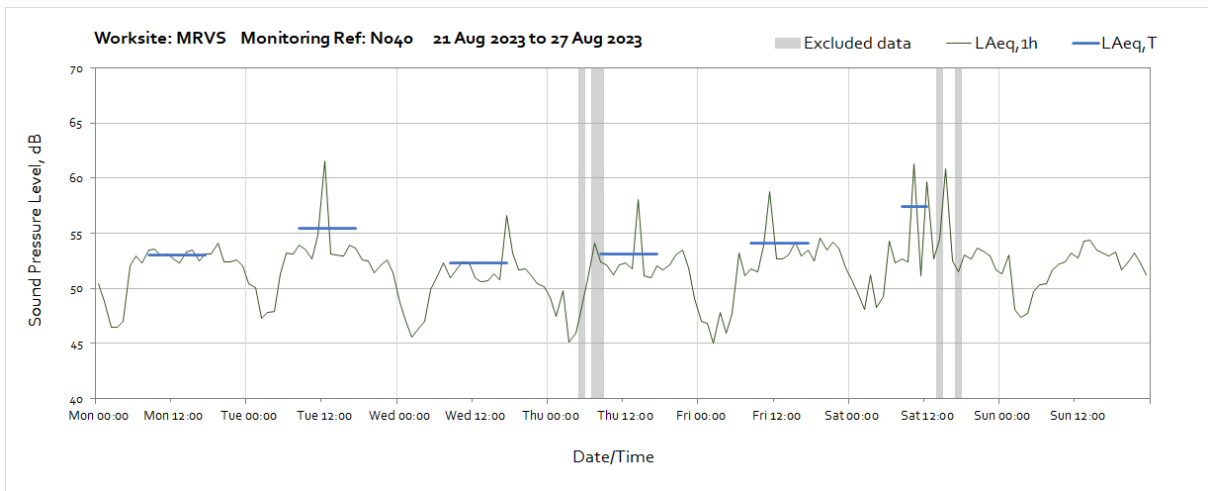
Worksite: MRVS – Monitoring Ref: N040

The following graphs show the hourly measured ambient noise level $L_{Aeq,1h}$ and, where relevant, the averaged noise level $L_{Aeq,T}$ values, where the time period T is as specified in Table 1 of HS2 Information Paper E23. Periods where noise levels are adversely affected by weather or only measured for part of the period, which are not representative of HS2 construction works, have been greyed out and excluded from the calculation of the $L_{Aeq,T}$ values in Table 3 of the main report.

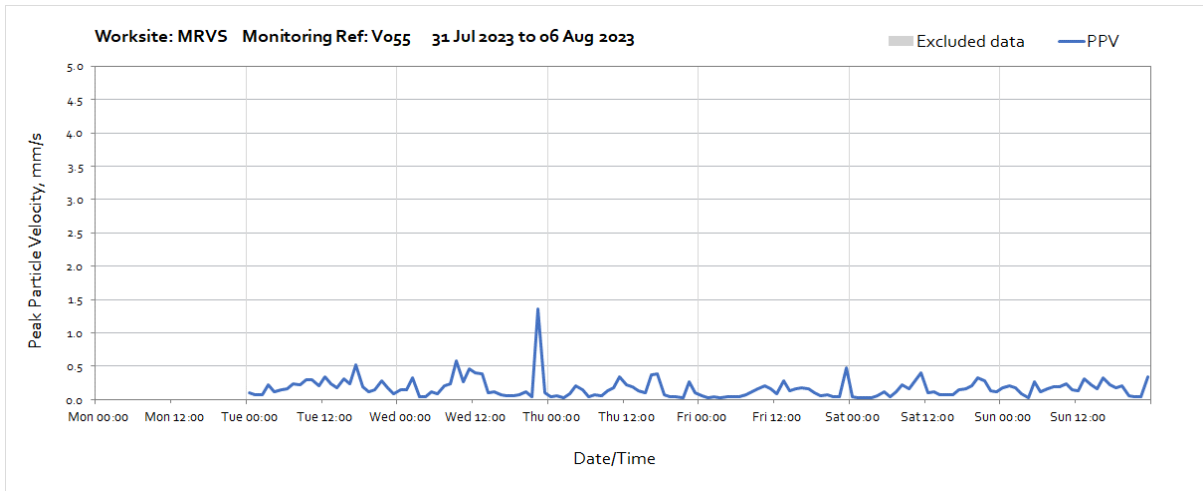
Worksite: MRVS – Monitoring Ref: V055

The following graphs show the hourly measured peak particle velocity PPV recorded during the monitoring period. The graphs show the highest PPV of the three orthogonal axis x, y and z. Periods where PPV values have been affected by local interference with the vibration monitor or only measured for part of the period, which are not representative of HS2 construction works, have been greyed out and excluded when calculating values in Table 4 of the main report.
