## **Construction noise and vibration Monthly Report – August 2023**

**London Borough of Hillingdon**

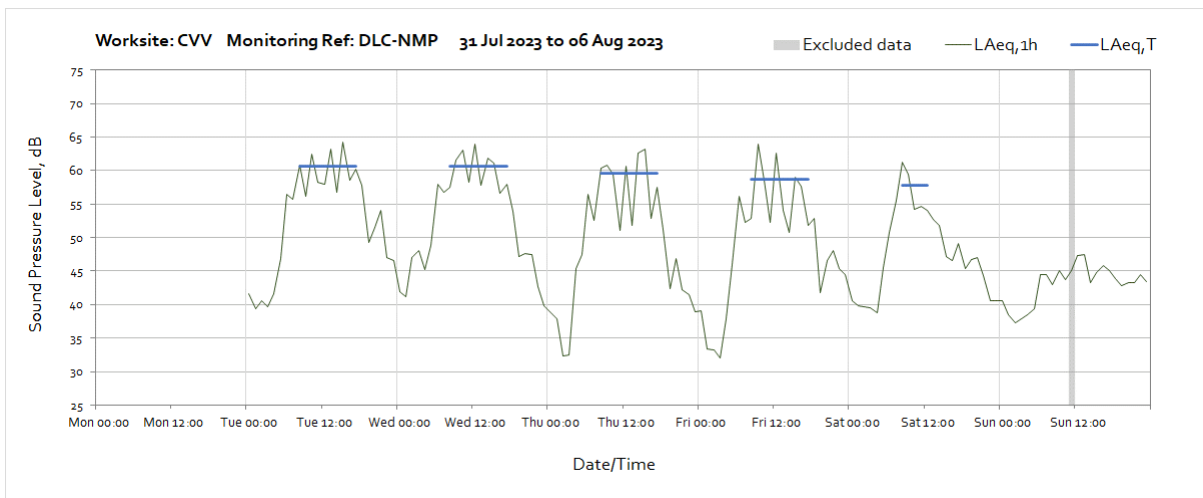
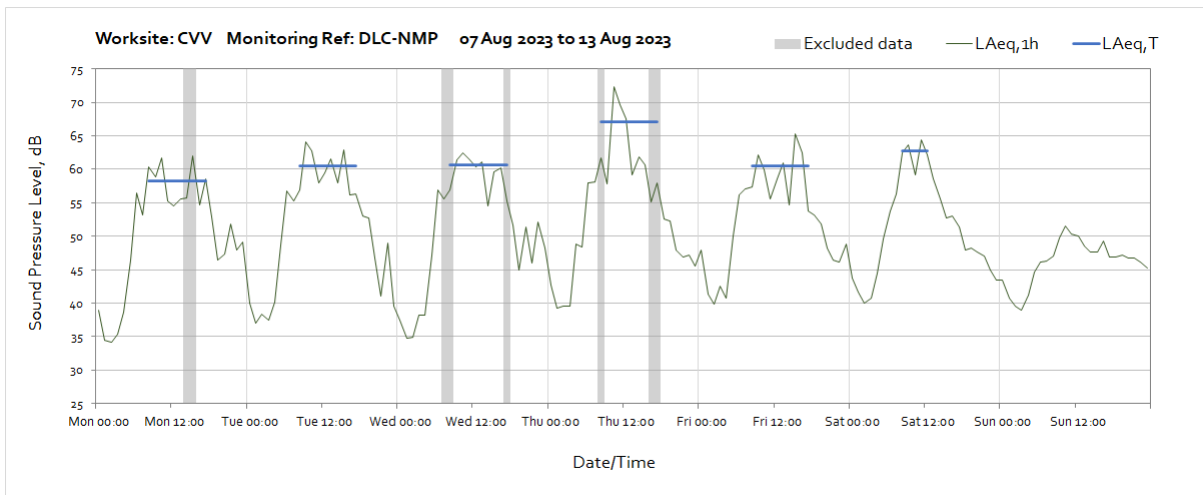
### Worksite: CVV – Monitoring Ref: DLC-NMP

The following graphs show the hourly measured ambient noise level  $L_{Aeq,1h}$  and, where relevant, the averaged noise level  $L_{Aeq,T}$  values, where the time period T is as specified in Table 1 of HS2 Information Paper E23. Periods where noise levels are adversely affected by weather or only measured for part of the period, which are not representative of HS2 construction works, have been greyed out and excluded from the calculation of the  $L_{Aeq,T}$  values in Table 3 of the main report.

Note: Missing data between 09:00 and 10:00 on Thursday 17<sup>th</sup> August was due to monitor maintenance.

Note: Missing data between 06:00 and 07:00 on Thursday 31<sup>st</sup> August was due to remote connection issues.

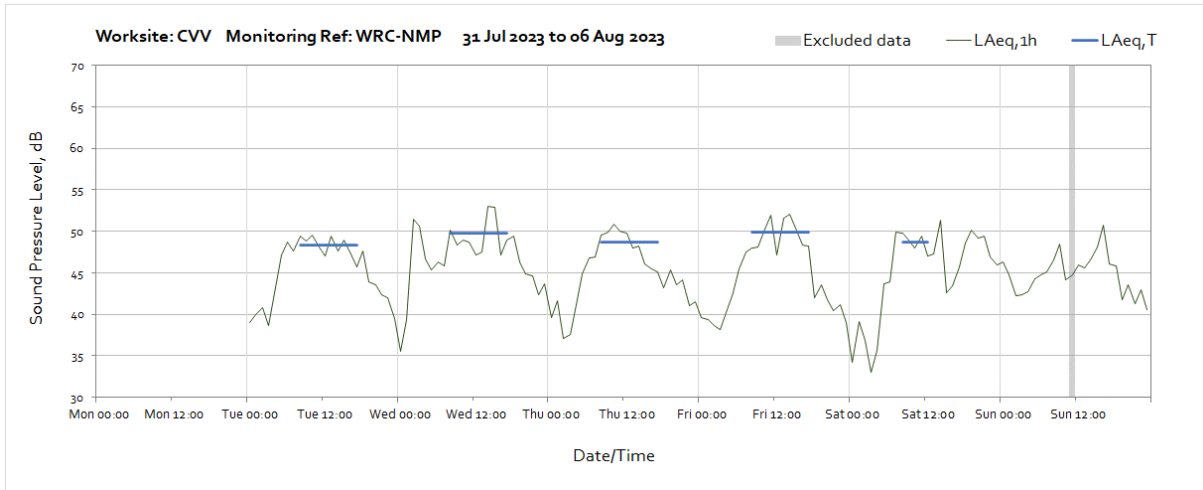
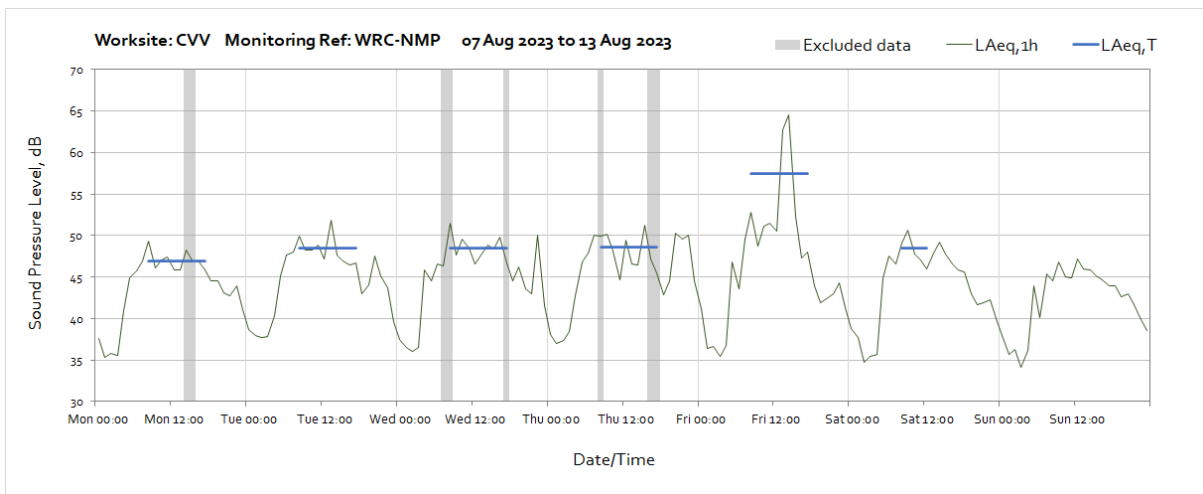
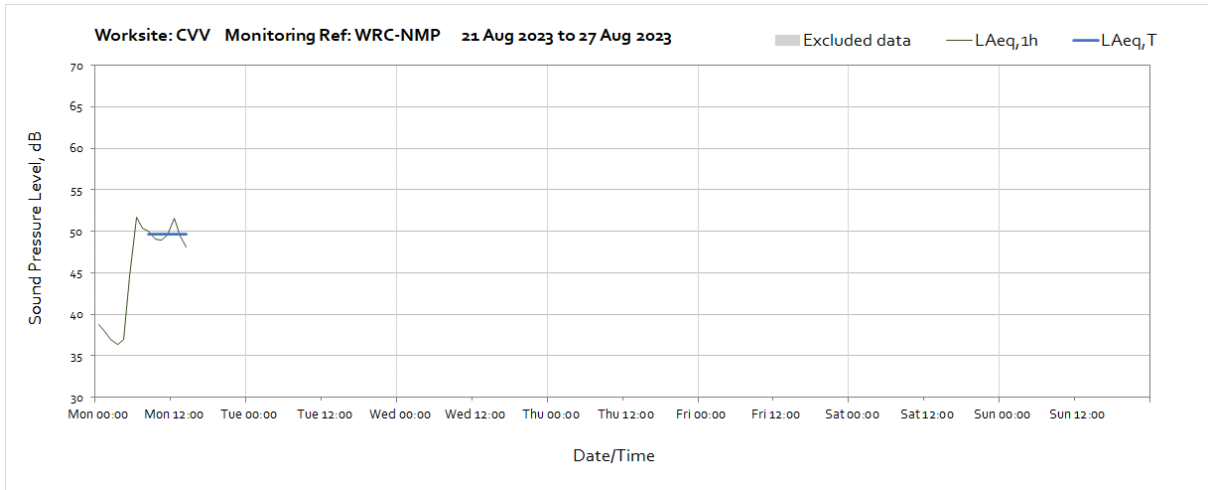
## Worksite: CVV – Monitoring Ref: WRC-NMP

Note: The noise monitor was decommissioned at 14:00 on Monday 21<sup>st</sup> August.

1.2.2 Noise monitor WRC-NMP, within the vicinity of Colne Valley Viaduct worksite, ref.: CVV, was decommissioned on 21<sup>st</sup> August due to monitoring at receptor no longer being required.

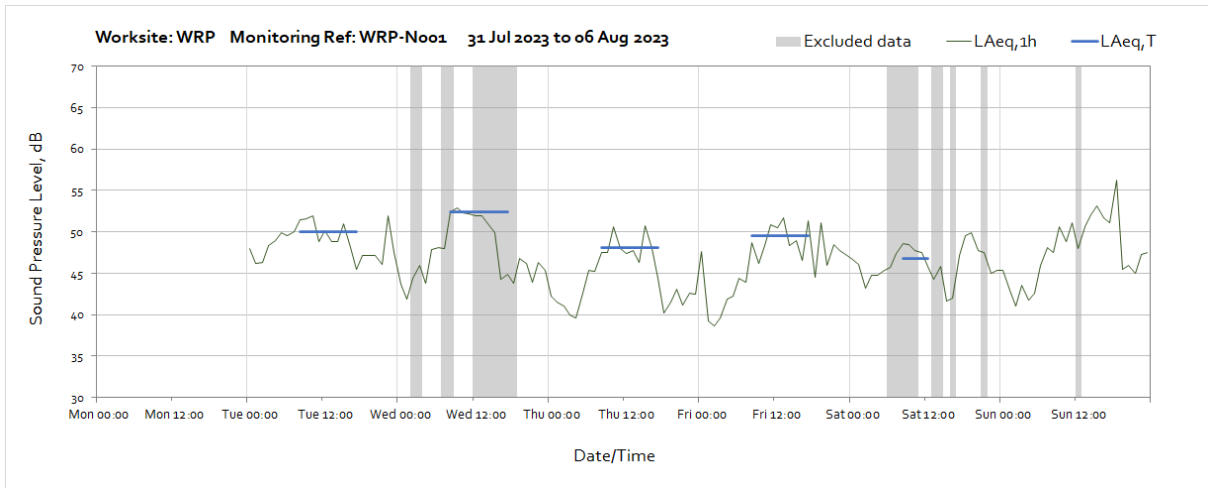
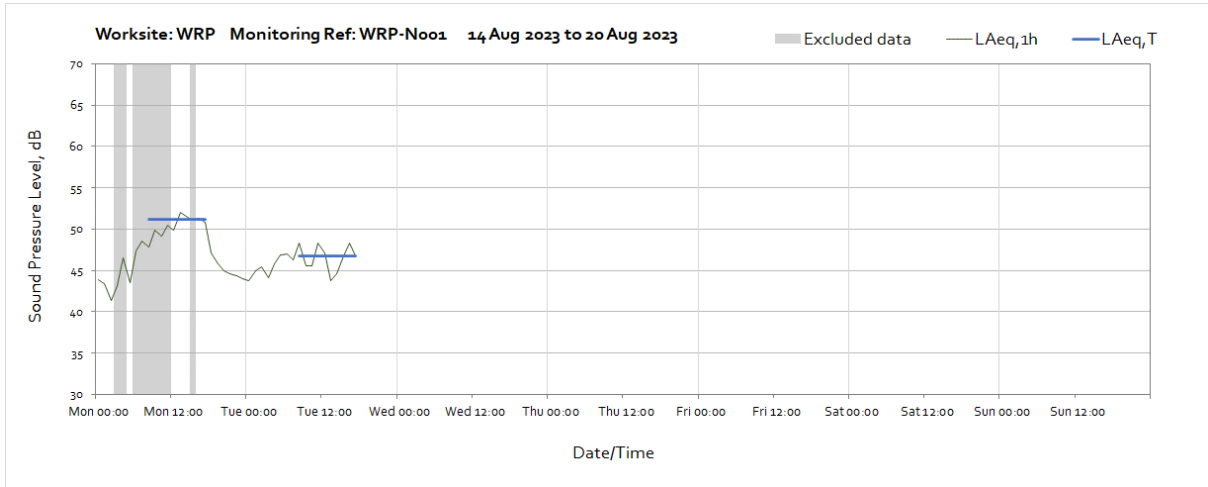
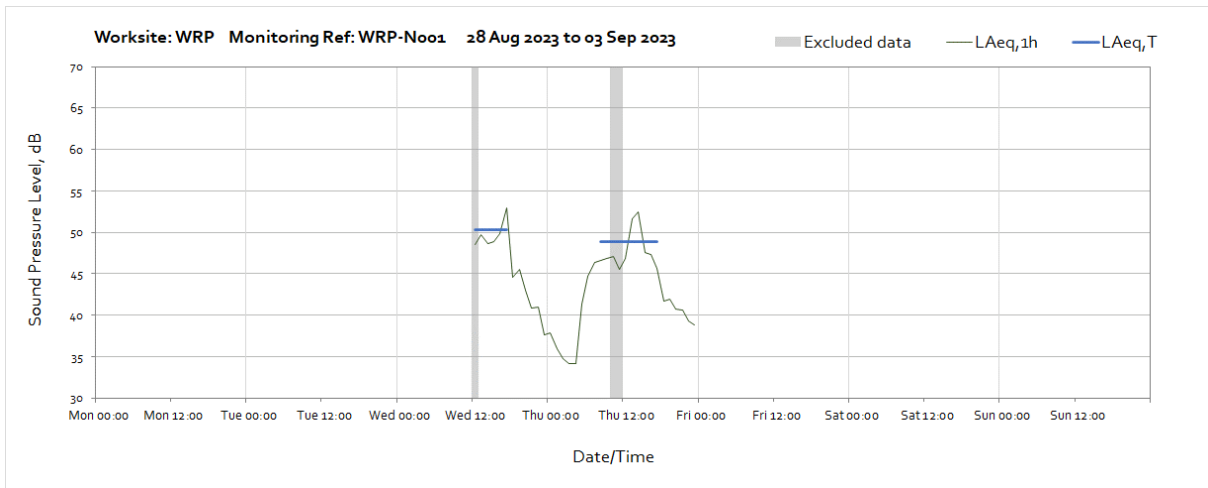
**Worksite: WRP – Monitoring Ref: WRP-N001**

Note: Missing data between 18:00 on Tuesday 15<sup>th</sup> August and 12:00 on Wednesday 30<sup>th</sup> August was due to depleted battery.

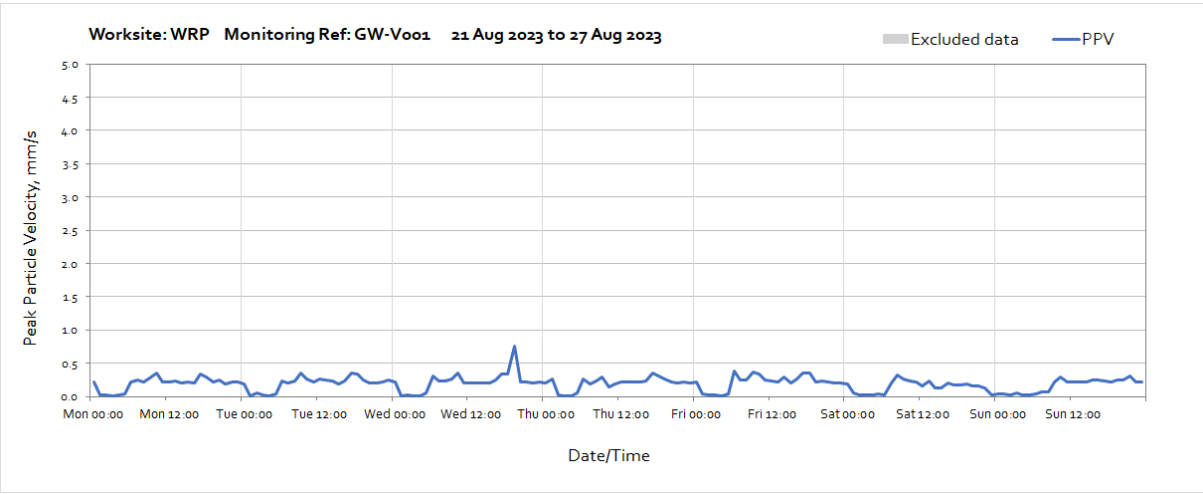
### Worksite: WRP – Monitoring Ref: GW-V001

The following graphs show the hourly measured peak particle velocity PPV recorded during the monitoring period. The graphs show the highest PPV of the three orthogonal axis x, y, and z. Periods where PPV values have been affected by local interference with the vibration monitor or only measured for part of the period, which are not representative of HS2 construction works, have been greyed out and excluded when calculating values in Table 4 of the main report.

Worksite Reference	Measurement Reference	Monitor Address	Highest PPV measured in any axis, mm/s
WRP	GW-V001	95 The Greenway, Ickenham, Uxbridge	1.38 (Z-axis)
SRVS	SRVS-V001a	Braintree Road, Ruislip	1.47 (Z-axis)
