## **Construction Noise and Vibration Monthly Report – August 2023**

**Lichfield District Council**

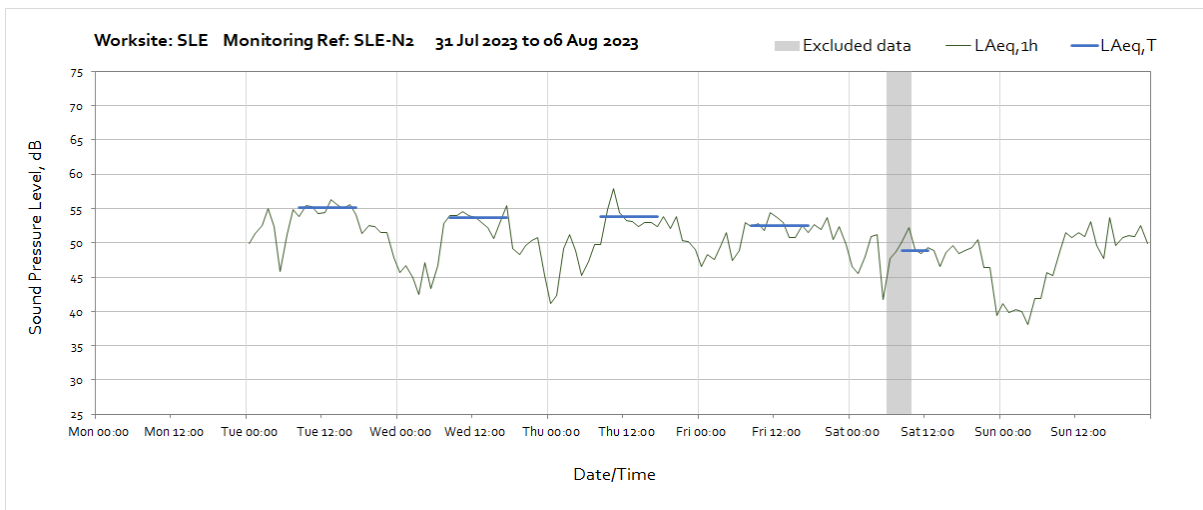
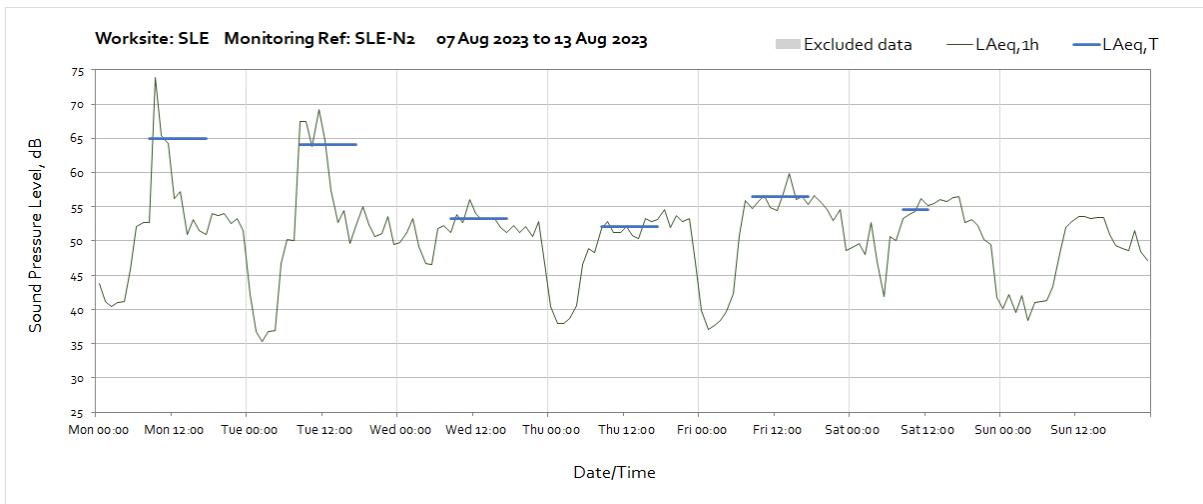
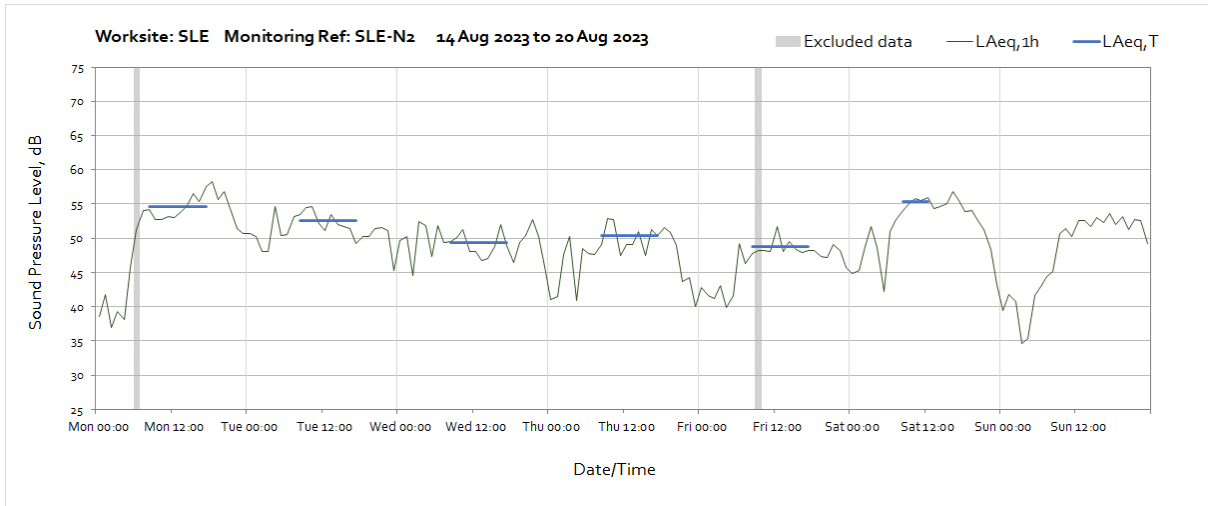
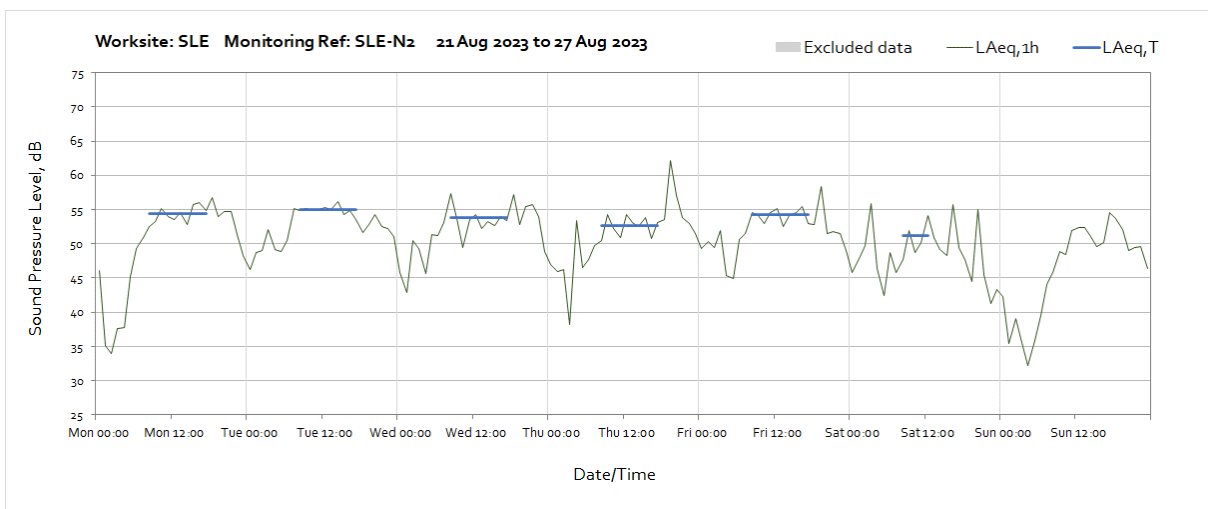
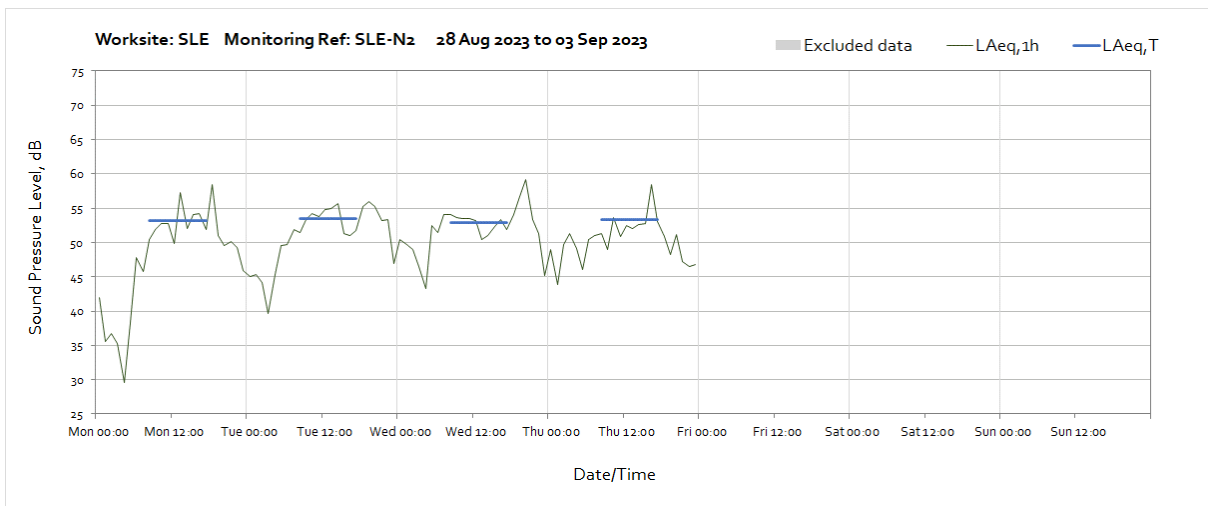
### Worksite:SLE - Monitoring Ref: SLE-N2

The following graphs show the hourly measured ambient noise level LAeq,1h and, where relevant, the averaged noise level LAeq,T values, where the time period T is as specified in Table 1 of HS2 Information Paper E23. Periods where noise levels are adversely affected by weather or only measured for part of the period, which are not representative of HS2 construction works, have been greyed out and excluded from the calculation of the LAeq,T values in Table 3 of the main report.

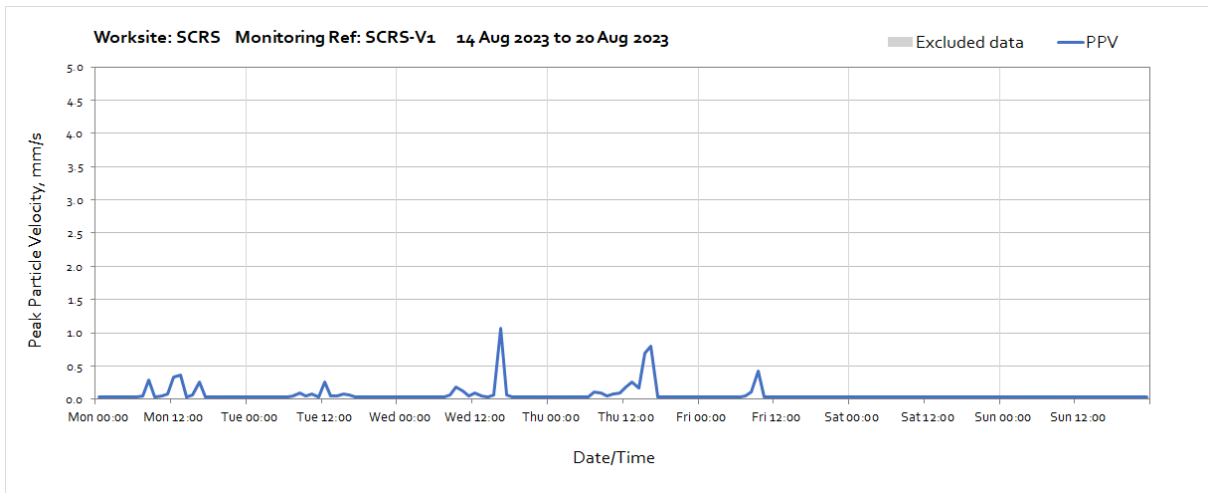
**Worksite: SCRS – Monitoring Ref: SCRS-V1**

Note: Data missing from 11:00 31<sup>st</sup> August until the end of the month due to monitor being decommissioned.

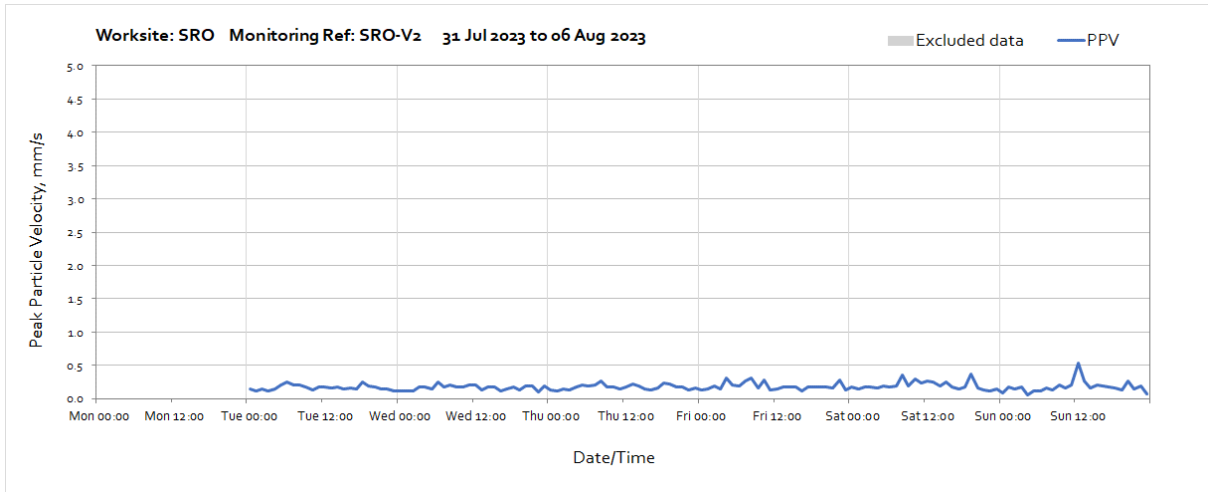
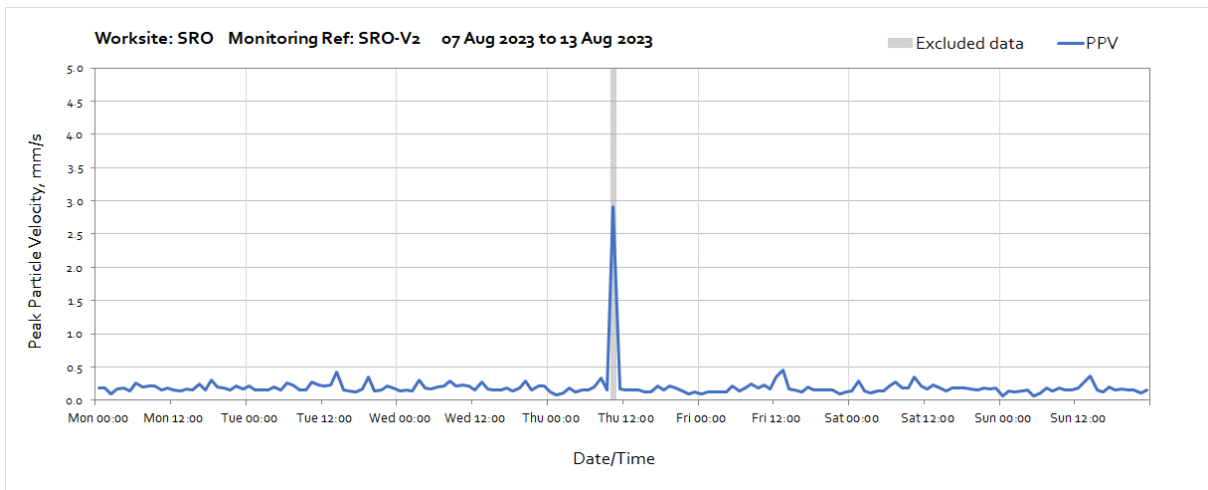
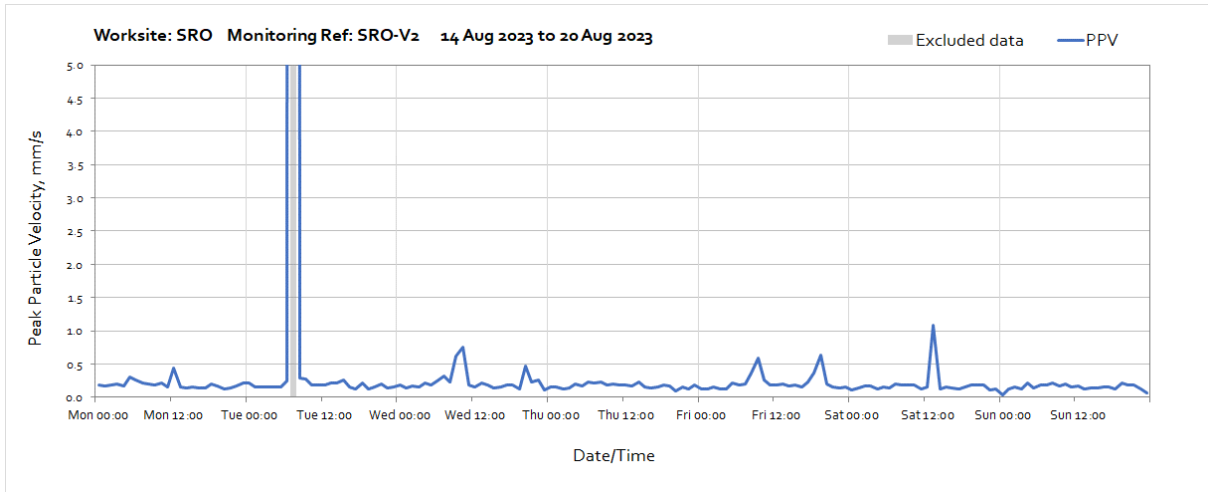
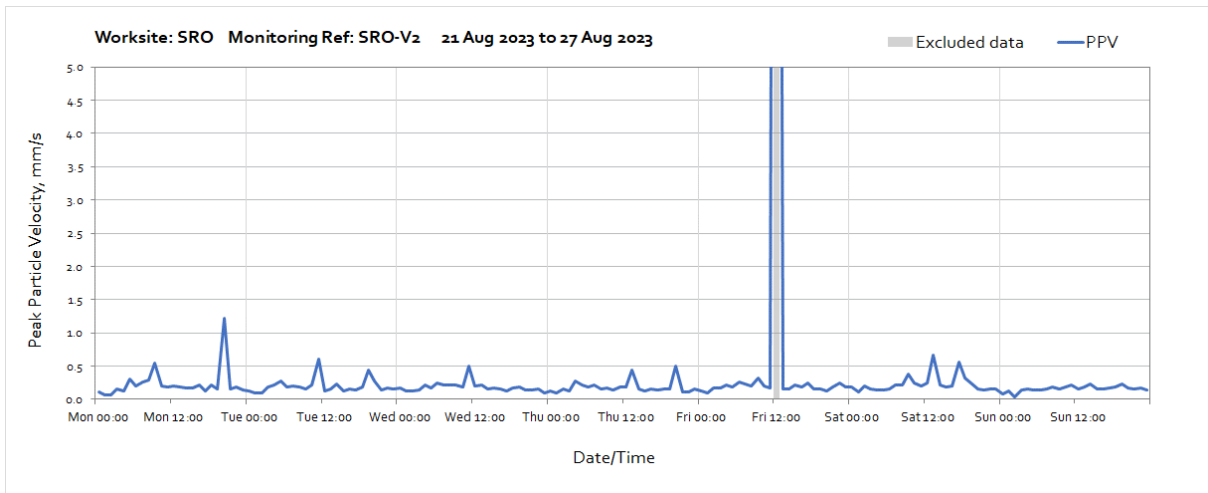
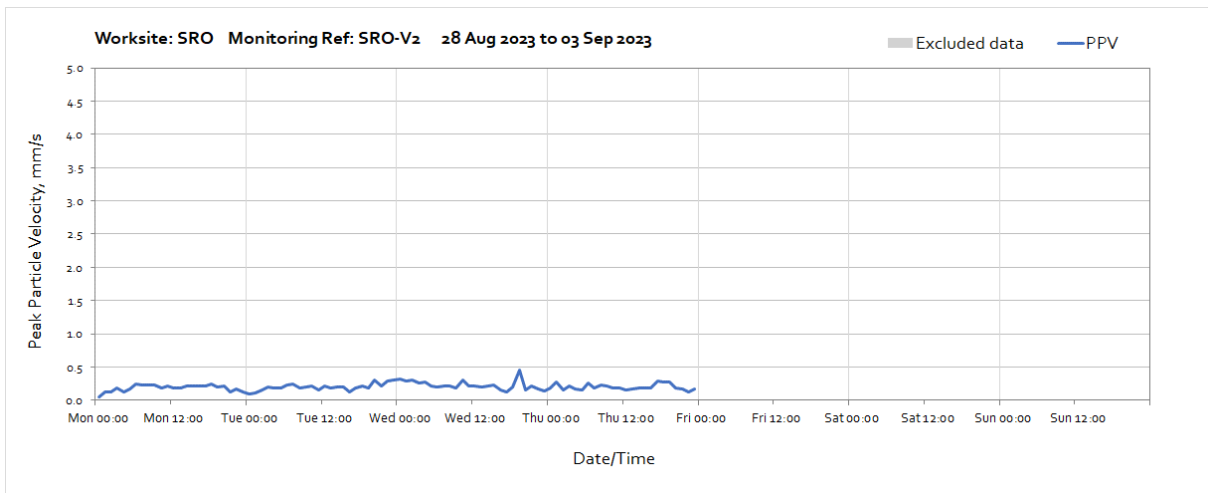
### Worksite: SRO – Monitoring Ref: SRO-V2

The following graphs show the hourly measured peak particle velocity PPV recorded during the monitoring period. The graphs show the highest PPV of the three orthogonal axes x, y and z. Periods where PPV values have been affected by local interference with the vibration monitor or only measured for part of the period, which are not representative of HS2 construction works, have been greyed out and excluded when calculating values in Table 4 of the main report.
